ZANON SS-Ti transition

Claudia Santos EN-MME

14.11.2024

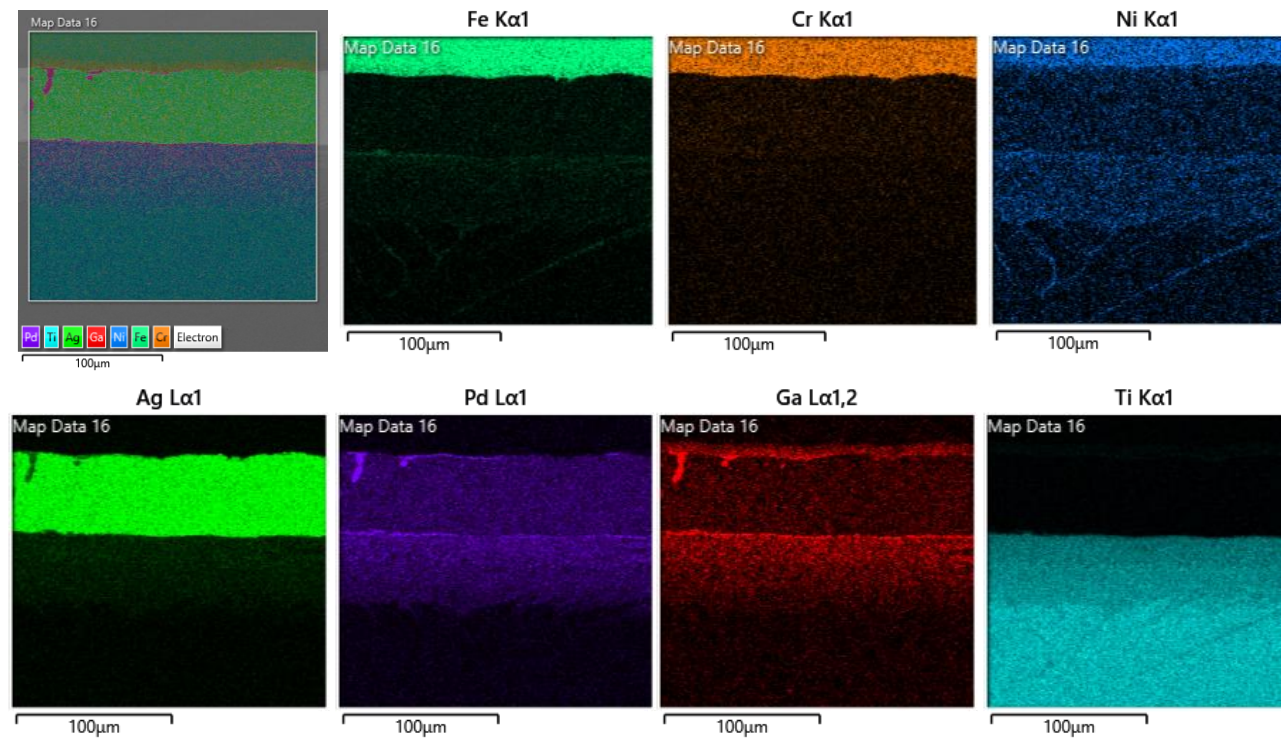
CERN (Shear lap region)

- Diffusion of Ni to the Ti region
- IMCs of Pd-Ga-Ni-Fe

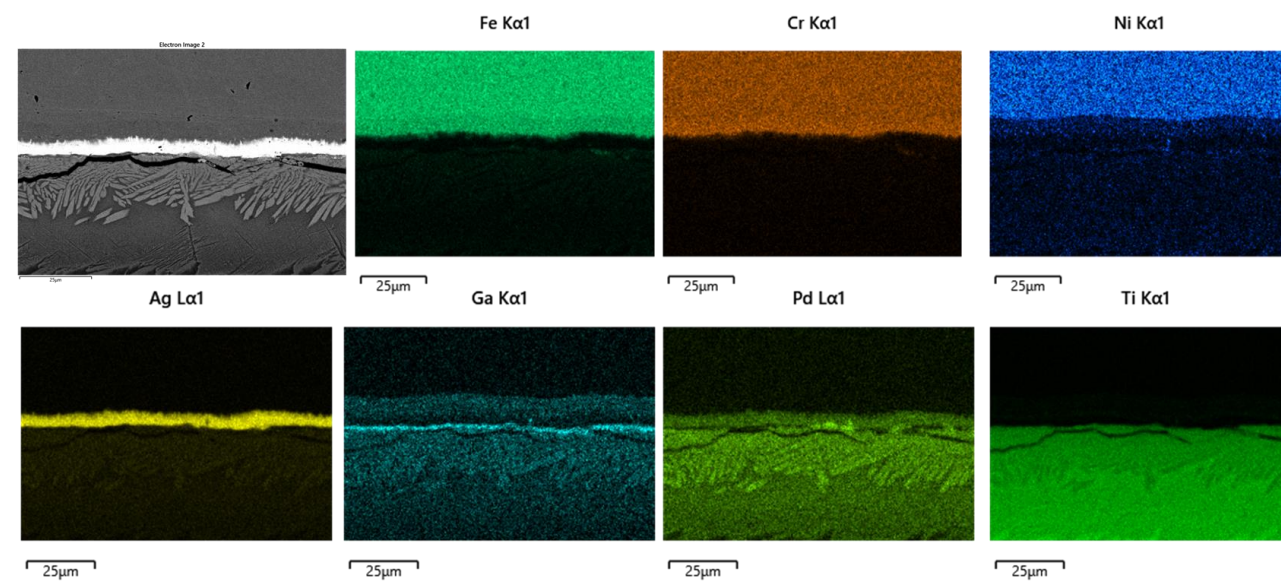
ZANON (Shear lap region)

During metallographic qualification it was observed the presence of cracks in the shear lap region, on the Ti side.

- NO or minimal diffusion of Ni to the Ti region
- IMCs of mostly Pd-Ga-Ti
- Strong formation of α -phase \rightarrow very fragile \rightarrow more stress concentration when stress relief by cutting

- ZANON Brazing 2024:
 - Based in BPQR:
 - No Stress relieved was applied to SS
 - No Ni-plating was applied
 - Based on EDX maps
 - There are abundant **IMCs of Pd-Ga-Ti**, which are believed to be more brittle than Ga-Pd-Ni
 - The brittle IMCs (**Pd-Ga**) near the Ti region makes that area more constrained → promotes crack initiation → will propagate through the Ti.
- The observation of cracks only after metallographic cut, might be induced due to the stress relief and the high presence of the brittle Pd-Ga-Ti IMCs and the presence of α -phase → Very brittle/fragile regions

- To **reduce the brittle IMCs and the strong presence of α -phase**, we strongly recommend:
 - Apply Ni-plating
 - For the brazing cycle: to **reduce the dwell time of 820 °C**.
