CMS ZDC Status

TREX 2025.01.31 D. Lazic Boston University

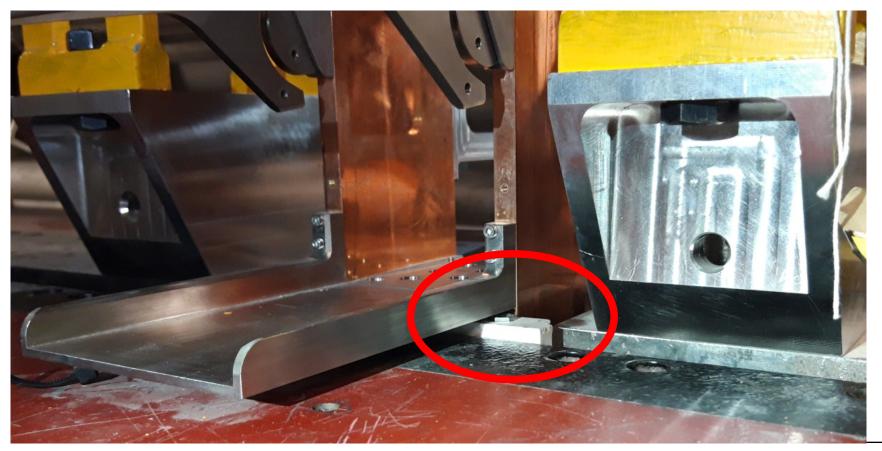
Steel bars

Presence of a shim under the BRAN reduces the available space for the insertion of the absorber bars. **Could it be replaced with a smaller piece?**

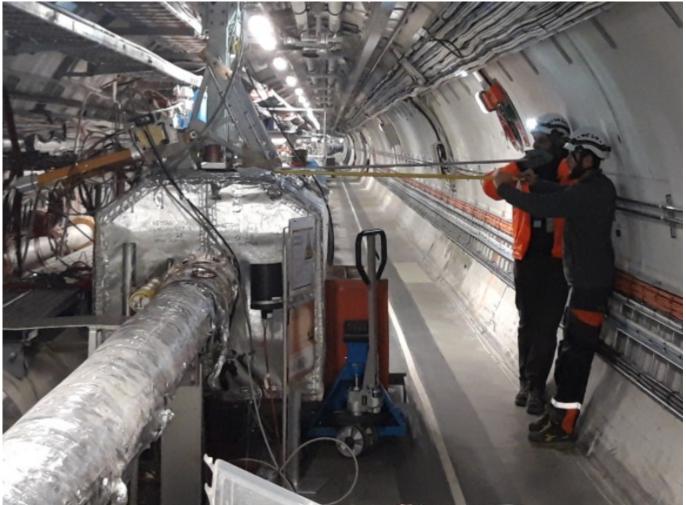
"The Tool"

Lowering objects into the TAN is always complicated due to uneven surface of the gaps. The bars and/or calorimeters occasionally get stuck.

Instead of wiggling the (highly radioactive) absorber bars by hand, the new tool allows to do it from a much safer distance!

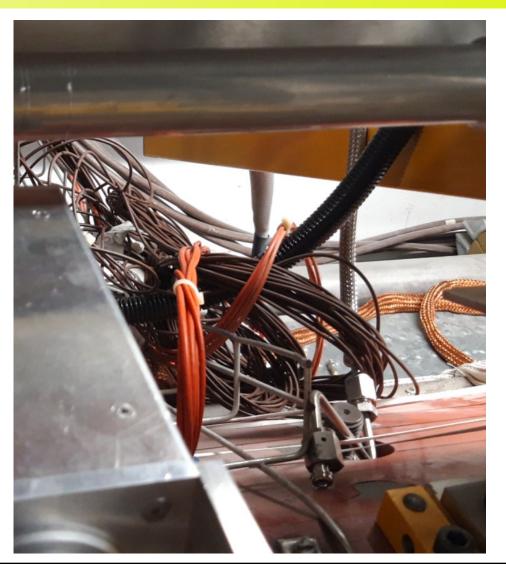
Not very pleasant access

During the ZDC installation in TS2 we had either to lean over the hot(!) TAN in order to get to the HV and signal cables or to access them from the platform behind TAN (requiring a special dispensation for work above QRL).

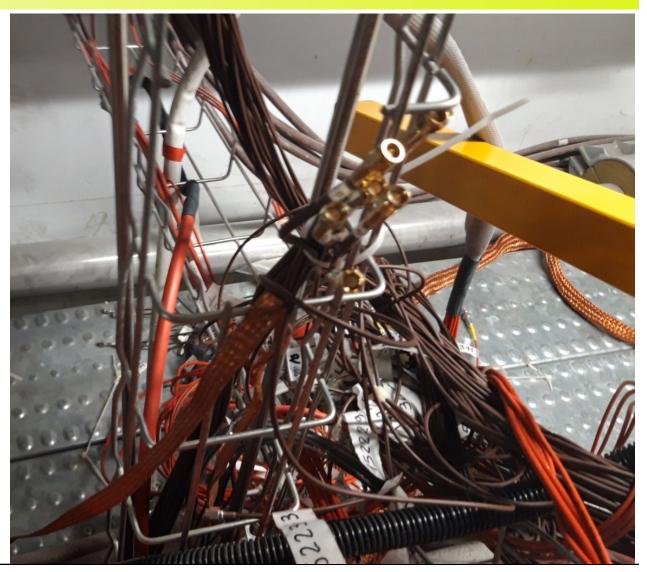
Not very pleasant view...

... you have to extract ZDC cables *without disturbing the others* and move them to the front of the TAN (Transport side).

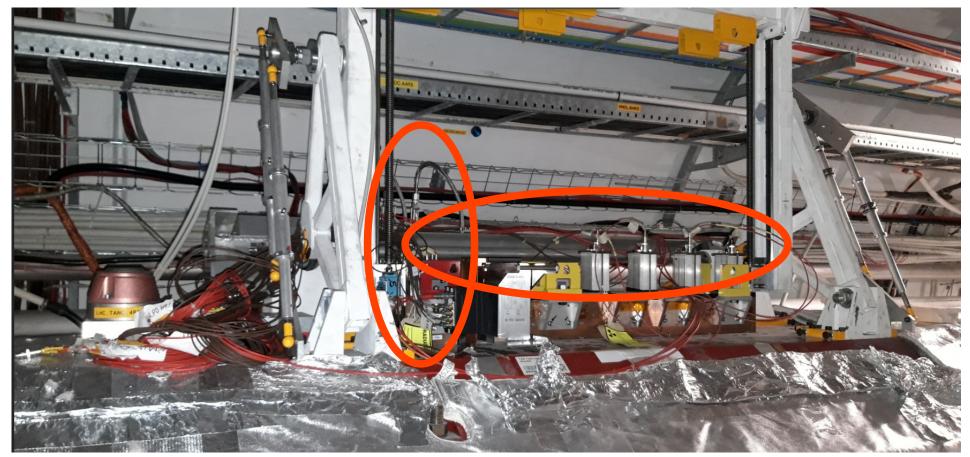
Conflict

... but it conflicts with ZDC removal and absorber bar insertion, so at the end of the run you have to disconnect the cables and put them back to the rather inconvenient place!

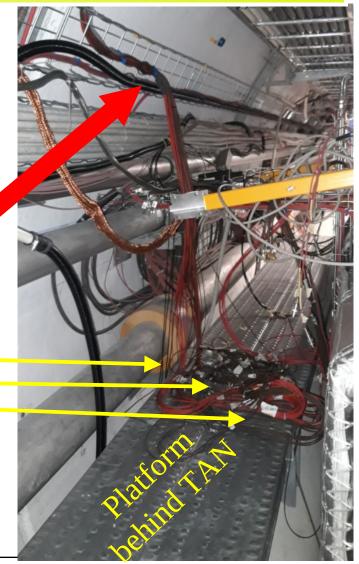
What will be done?

The intervention consists of moving the "loose" part of the cable bundles (yellow arrows) around the crane.

The first step will consist of accessing the work platform behind TAN to assess the available slack between the cable tray and the front of the TAN. Then the cable bundles will be routed around the crane and secured in place.

The cables remain attached to the cable tray on the wall! Non-ZDC cables remain untouched!

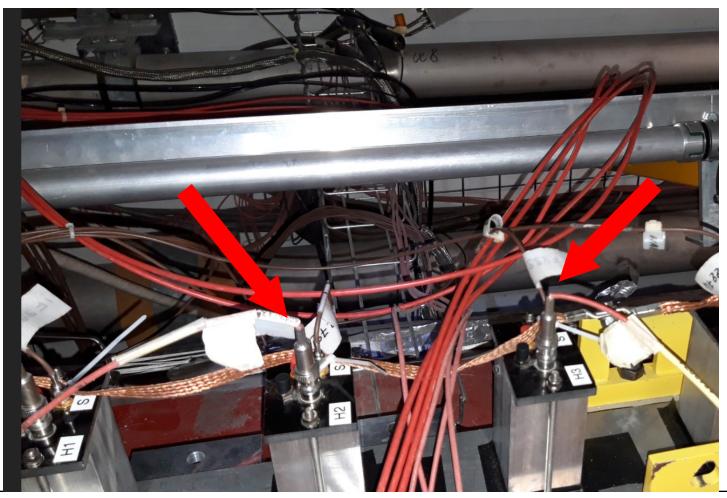
Something else

We found couple of HV connectors that require replacement. It will be done on the "safe" side of TAN behind lead shielding.
