MQXFB09 Coils: Coil fabrication, manufacturing data and NC

N. Lusa, S. Izquierdo Bermudez, L. Baudin, A. Vieitez Suarez, P. M. Quassolo,
L. Grand-Clement, R. Berthet

06/02/2025

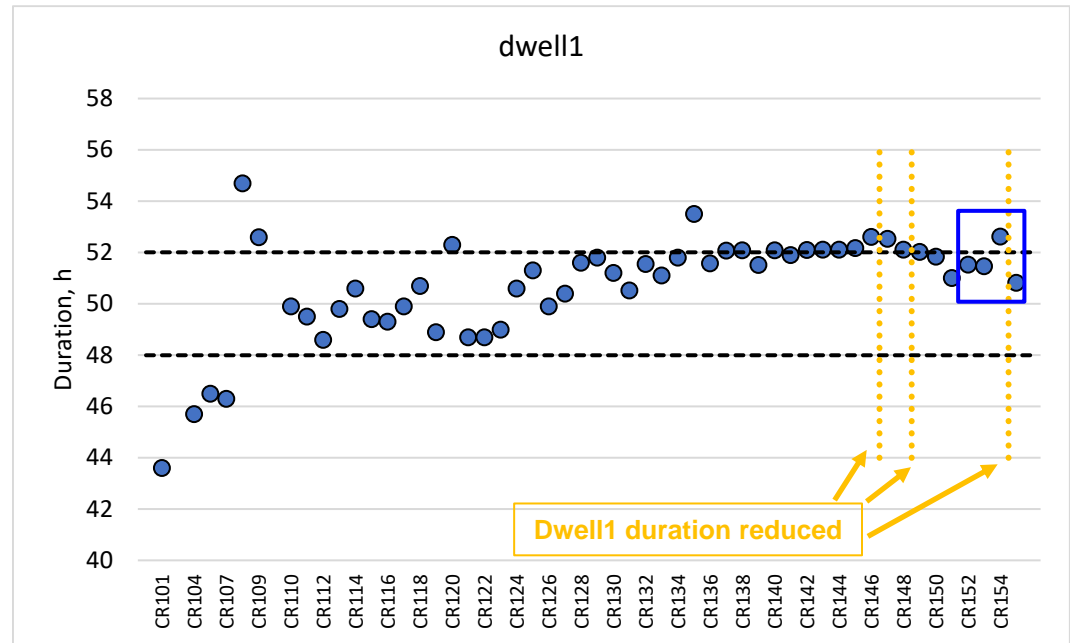
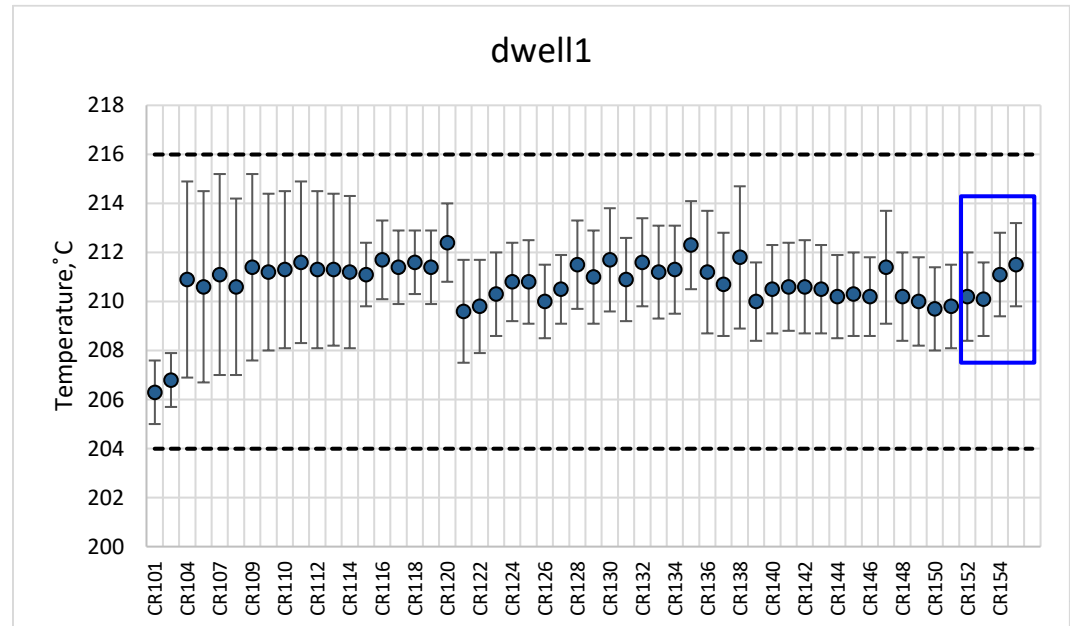
RHT NCR – dwell1

- The duration of dwell1 is slightly out of specification in 1 out of 4 coils:
 - CR152: 51.53 h
 - CR153: 51.47 h
 - CR154: 52.62 h
 - CR155: 50.82 h
 - Spec. 52 h maximum allowed
- Temperature homogeneity within specification

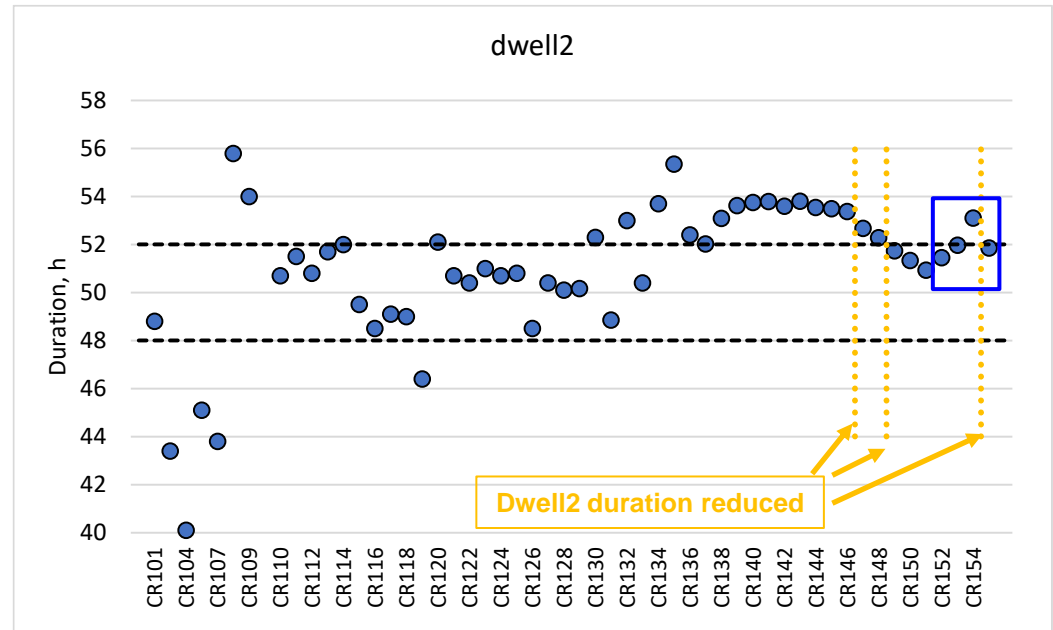
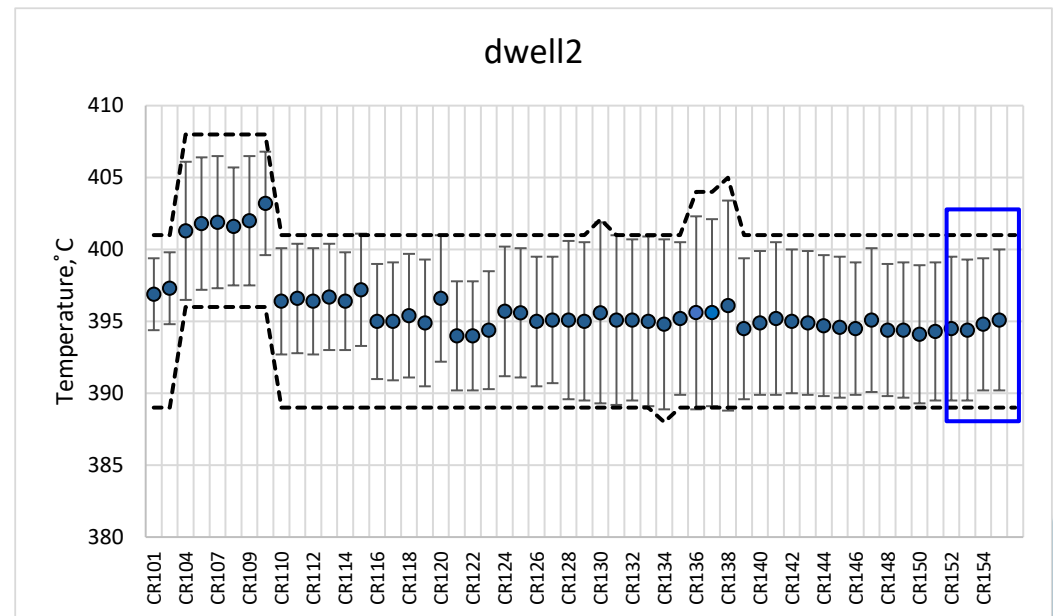
RHT NCR – dwell2

- The duration of dwell2 is out of specification for 1 coil out of 4:
 - CR152: 51.45 h
 - CR153: 51.98 h
 - CR154: 53.11 h
 - CR155: 51.86 h
 - Spec. 52 h maximum allowed
- Temperature homogeneity within specification

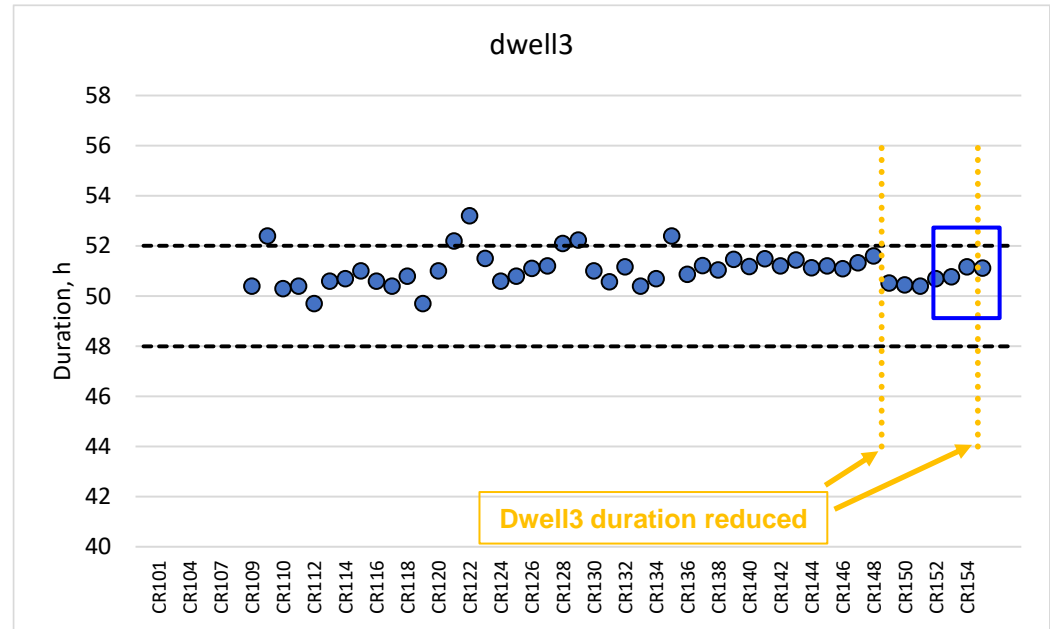
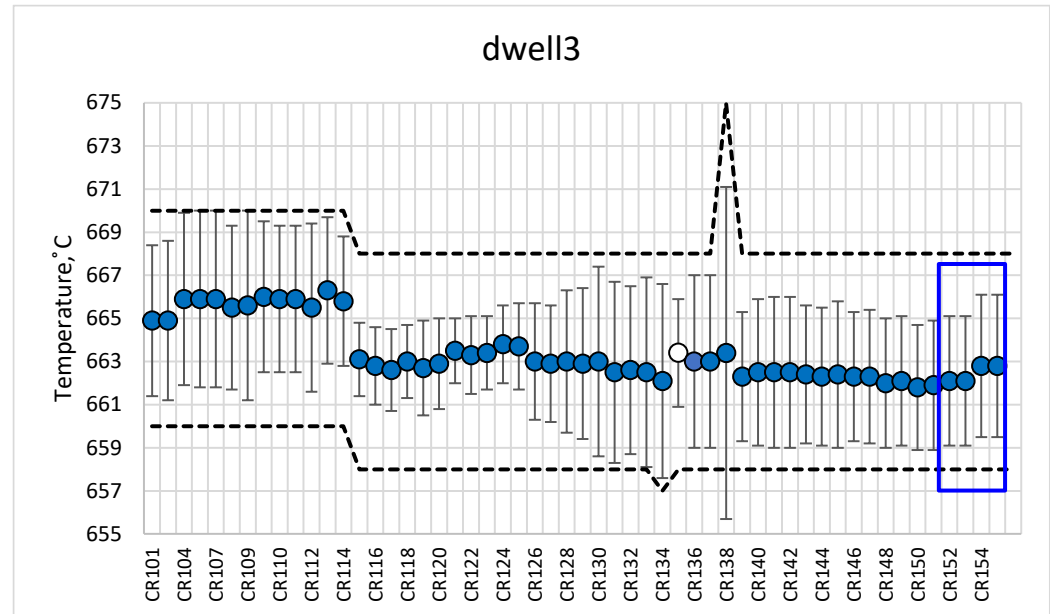
RHT NCR – dwell3

- The duration of dwell3 is within specification for the 4 coils (52 h max. allowed)
- Temperature homogeneity within specification but dwell3 H/2 out of specifications for 2 out of 4 coils
 - CR152: 3°C
 - CR153: 3°C
 - CR154: 3.3°C
 - CR155: 3.3°C
 - Spec. 3°C

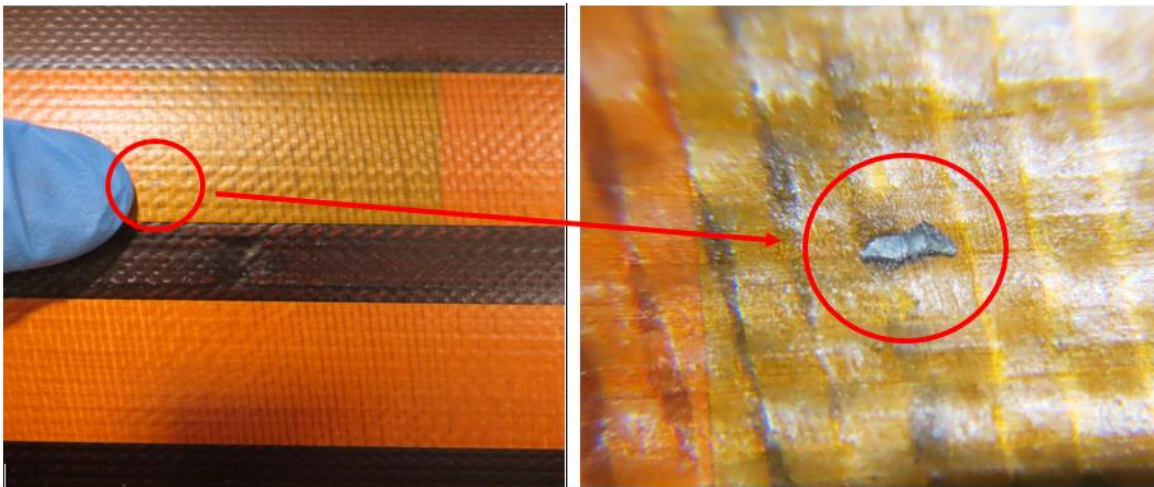
CR152 ([NCR 3190542](#)) → Particle trapped in the OD of the impregnated coil

- During the QA inspection after impregnation, a particle on the OD of the coil was noticed at 6940mm from lead end side at the level of the heater strip
 - Length of the particle was about 1.2 mm
 - Metallic aspect
 - Visually on top of the QH

- The SEM-EDS analysis clearly revealed that the particle was mainly composed of lead and tin ([EDMS 3184842](#))

- Cause:
 - Most likely a small chip of SnPb was trapped in the S2 glass while preparing the fiber for installation
 - Both the S2 glass preparation and the pretinning of the QH connexions are performed on the same bench, which apparently was not cleaned well enough
 - CORRECTIVE ACTIONS:
 - Improve the cleaning of the bench using adhesive roller before each use
 - Add QA controls when installing the S2 glass on top of the coil

- The OD of the coil was slightly scraped to extract the trapped particle (same process followed for coil CR149 ([EDMS 3154270](#)))
 - The collected particle was analyzed by SEM-EDS thanks to EN-MME team
- Local repair of the scratched area was performed with epoxy resin

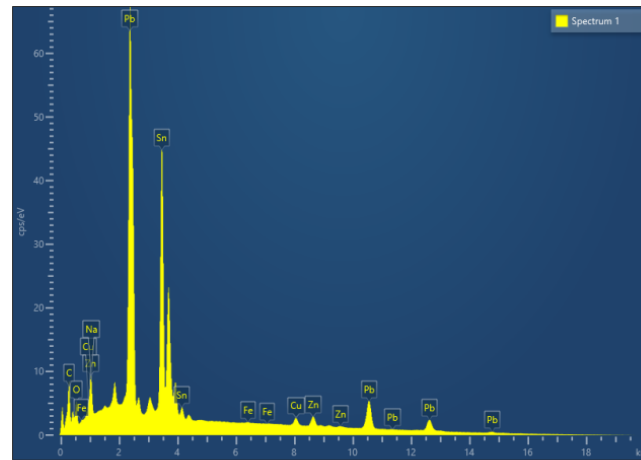
EDS spectrum: Pb 51.2 wt% - Sn 37.1wt% with traces of Zn, Cu, O and Na

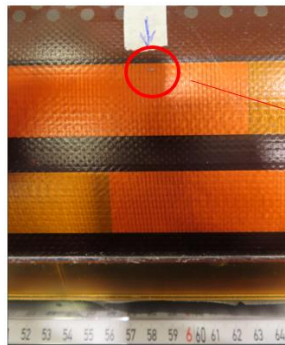
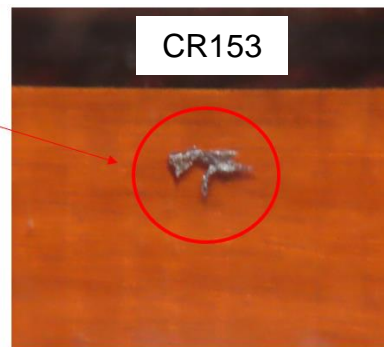
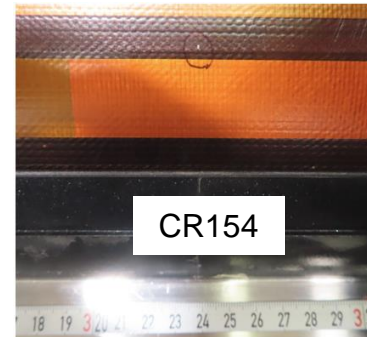
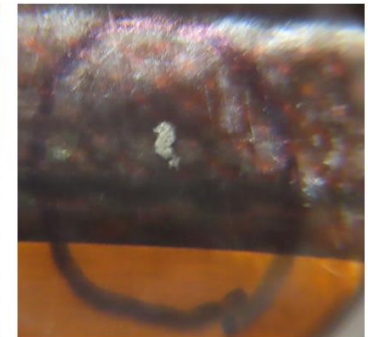
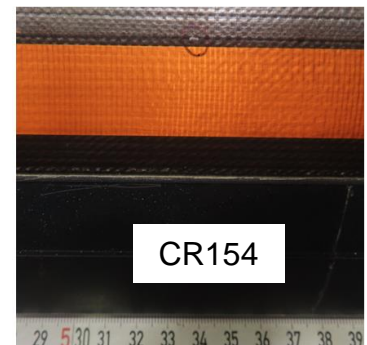
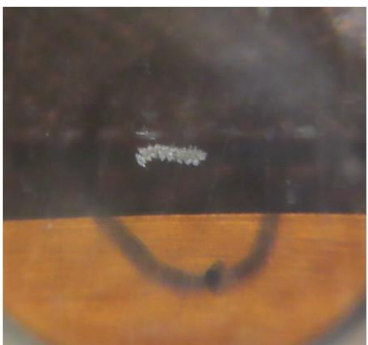
CR153 ([NCR 3194348](#)) and CR154 ([NCR 3212214](#)) → Particles trapped in the OD of the impregnated coils

- Those coils revealed particles trapped in the OD during the QA inspection after impregnation
 - CR153
 - 1 particle at 6580 mm from LE side
 - CR154
 - 3 particles at 3240 mm, 4670 mm and 5340 mm from LE side
 - Length of the particles about 1 mm and below
 - Greyish aspect

- The SEM-EDS analysis clearly revealed that the particle was mainly composed by fluor and carbon ([EDMS 3195498](#))

- **Cause:**
 - Given the chemical composition of the extracted particles, the origin is attributed to the degradation of the radial filler PFA coating which is in contact with the OD of the coil
 - **CORRECTIVE ACTIONS:**
 - Restart the coil fabrication in 2025 with a new set of PFA coated radial fillers

- The OD of the coil was slightly scraped to extract the trapped particle (same process followed for coil CR152 ([EDMS 3190542](#)))
 - The collected particle was analyzed by SEM-EDS thanks to EN-MME team
- Local repair of the scratched area was performed with epoxy resin

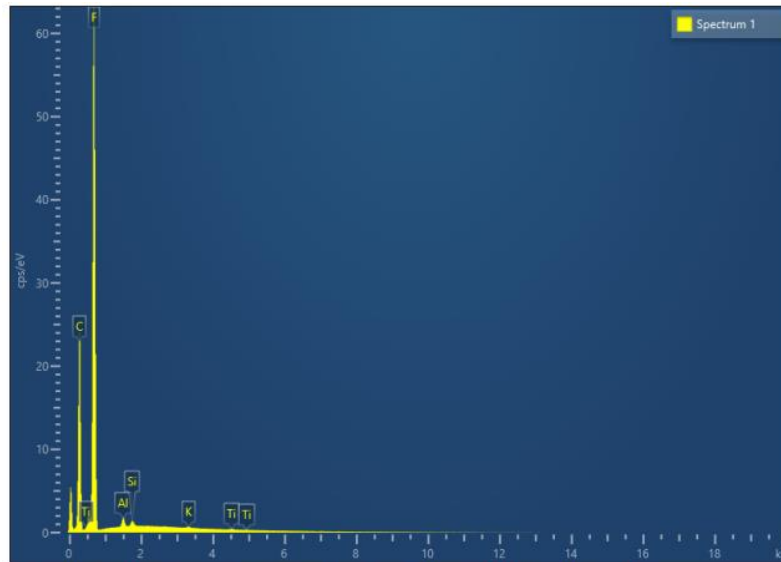
EDS spectrum #1: fluor and carbon are mainly present. Traces of titanium, silicon and potassium. Aluminium signal may come from the SEM chamber.

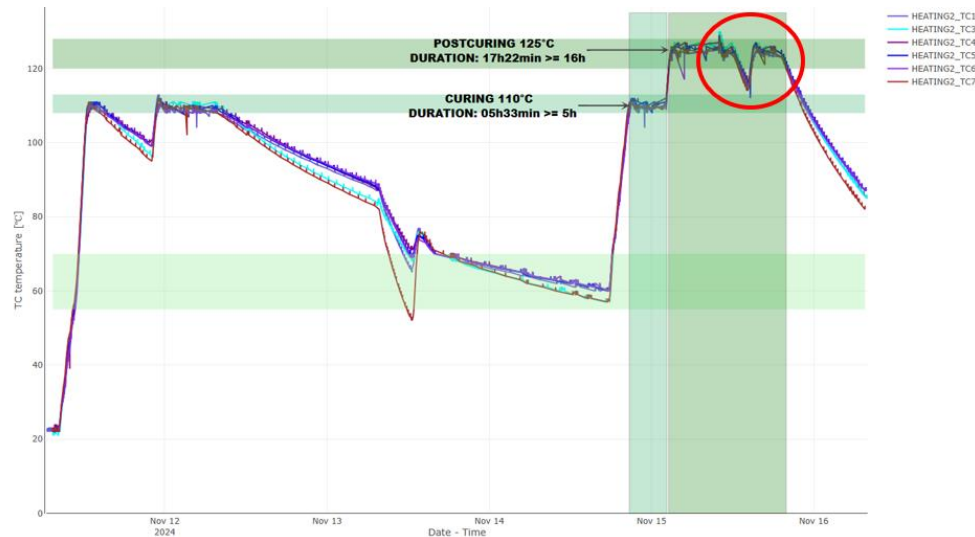
CR153 ([NCR 3202419](#)) → Temperature drop during epoxy post-curing plateau

- During the analysis of the impregnation cycle, a temperature drop related to the post-curing plateau was observed ([EDMS 3203617](#))
 - Duration of the drop about 3h reaching a minimum temperature of 114°C (nominal 125°C)

- The cause is to be attributed to an error made by the operator during the cleaning of the magmix who switched off accidentally the heaters circuit breaker
- The DSC analysis of the standard sample collected from each impregnated coil showed no significant differences w.r.t. a standard post-curing cycle

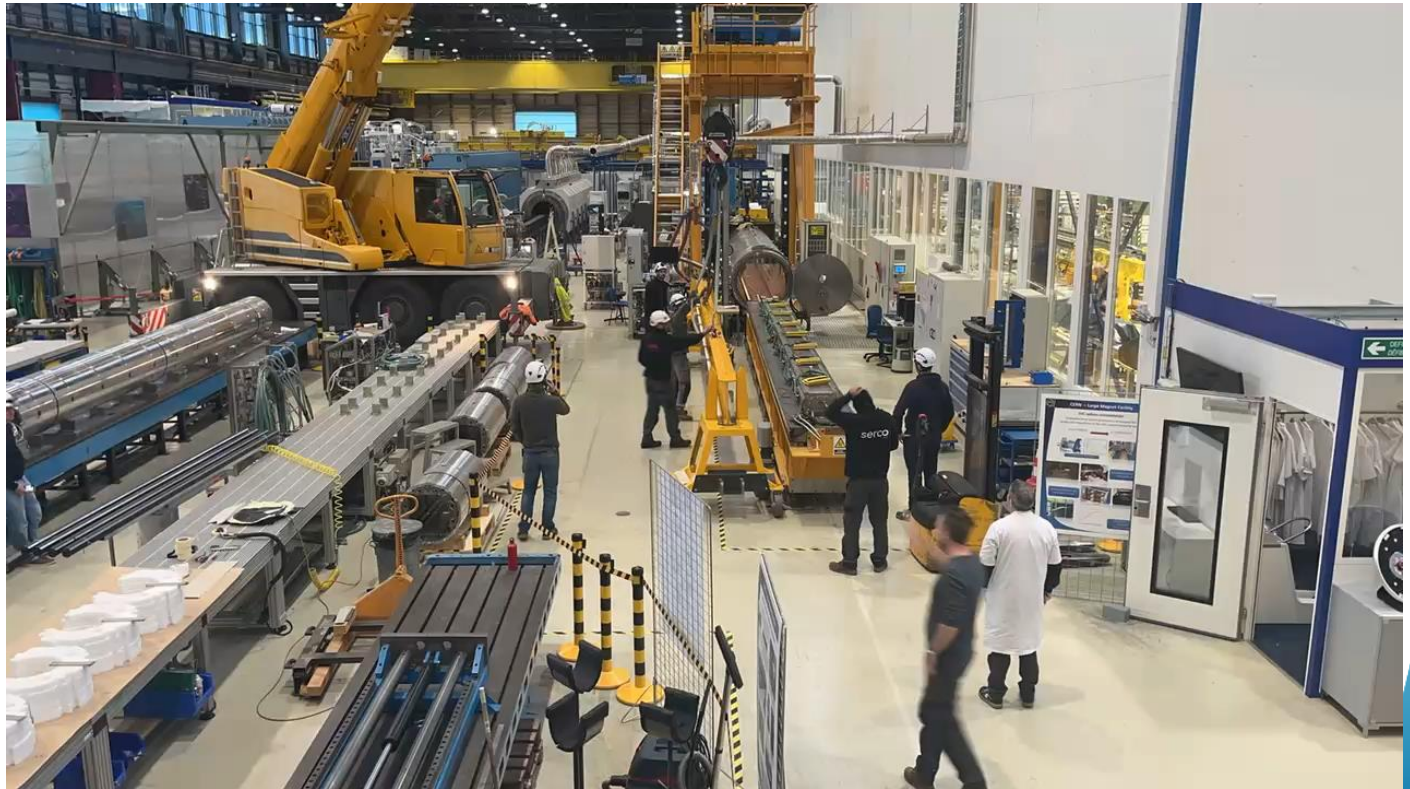
CR155 (NCR 3221969) → Non-standard handling of the impregnation mould

- Due to the unavailability of the overhead crane in building 180, the handling of the impregnation mould was performed with a 55t heavy-duty truck crane
 - The usual dedicated lifting beam was used
 - Very smooth handling
 - No sign of mechanical deformation of the mold w.r.t. standard handling

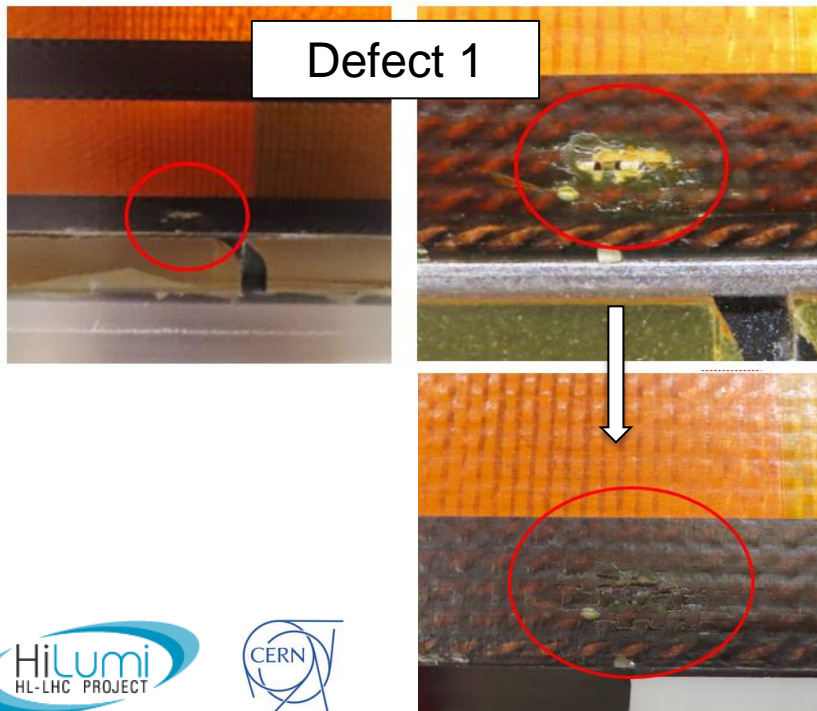
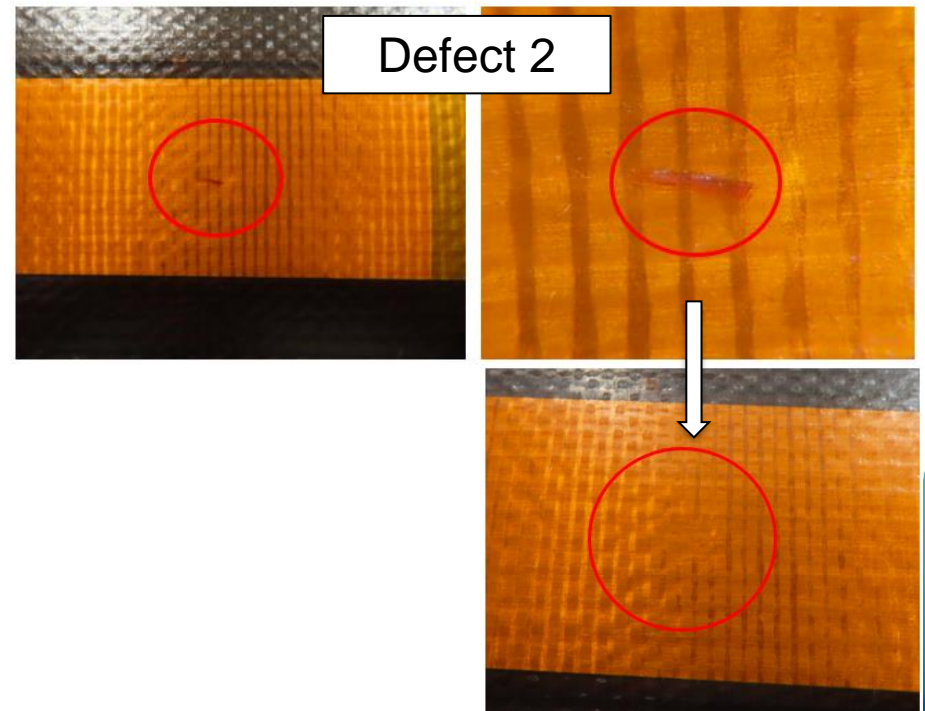
CR155 (NCR 3231379) → Impregnation defects on the OD of the coil

- During the visual inspection of the coil after impregnation, 2 defects were observed on the OD of the coil
 - Defect 1:
 - At 5800 mm from LE appeared like a small dry area
 - Repaired by local injection of epoxy
 - Defect 2:
 - At 7240 mm from LE revealed a trapped polyimide particle (most likely coming from the trimming of the QH)
 - Repaired by slightly scratching the OD of the coil and local application of epoxy
