Target Status

Edward Overton on behalf of the
Target Team

T1 Failure

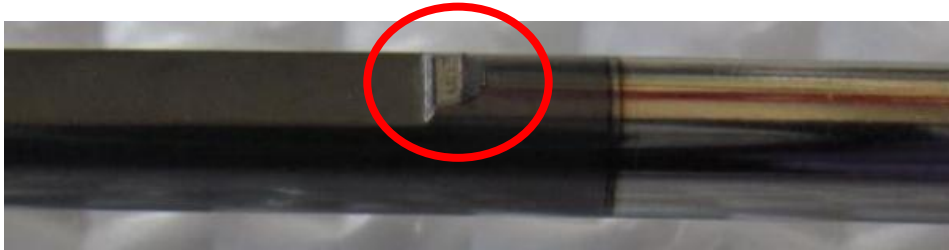
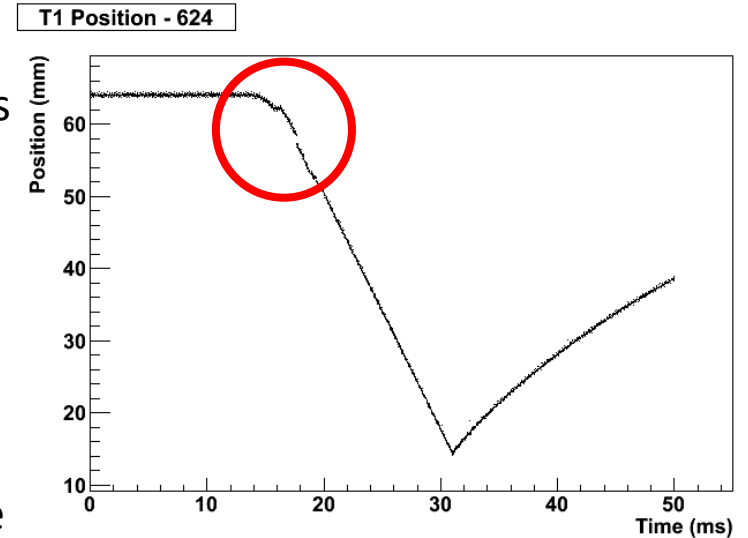
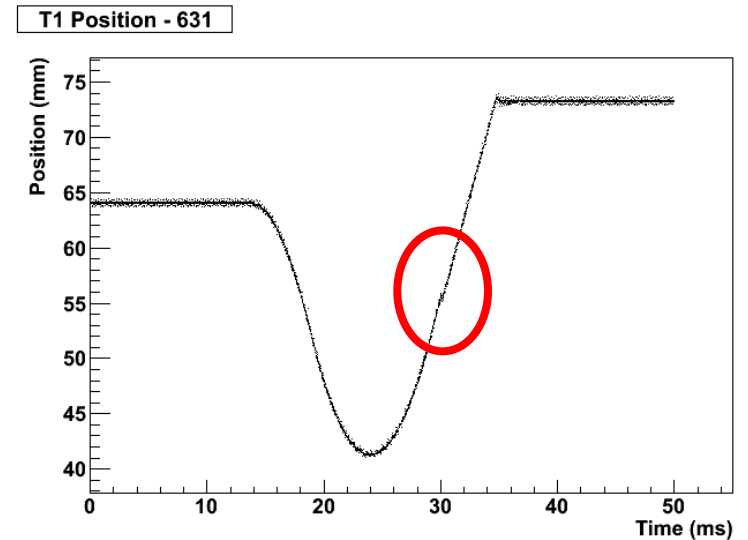
- T1 Failed on Wednesday 13th July
- Controller lost track of target position, visible as glitches in recorded position.
- These glitches caused the controller to drive target incorrectly
- Final glitch resulted in target being thrown upwards into bearing.
- This caused the shaft to become jammed in the bearing
- Upon inspection the shaft had visible damage to DLC coating.

- A problem occurred within the position monitoring system.
- Possible candidates are:
 - Mechanical damage to readout vane/optics block?
On inspection seems okay. Will do a full test in Sheffield. T2.9 uses a different optics block.
 - Fibre optic degradation?
No reference point, makes it difficult to compare. Brightness is now monitored by controller and will provide an early warning system.
 - Controller electronics problem?
Hard to see how this could be intermittent, but will be tested. Entire control system has been replaced with the Phase II FPGA controller.
 - Intermittent Laser / Fibre optics problem?
Looped the laser signals back from ISIS and tested for 16 hours. No dropouts detected.
- Have not found a “smoking gun”. Attempting to eliminate all possible causes, but could take some time.

- Replaced T1 with stator from R78 (T2)
- Using DLC/VESPEL design which has achieved 1M+ Actuators on T2.4 to T2.8
- T2.9 has been fitted with a new shaft and bearings
- T2.9 was installed on 13th September
 - Tested in R78 for 50K actuators, looks OK.

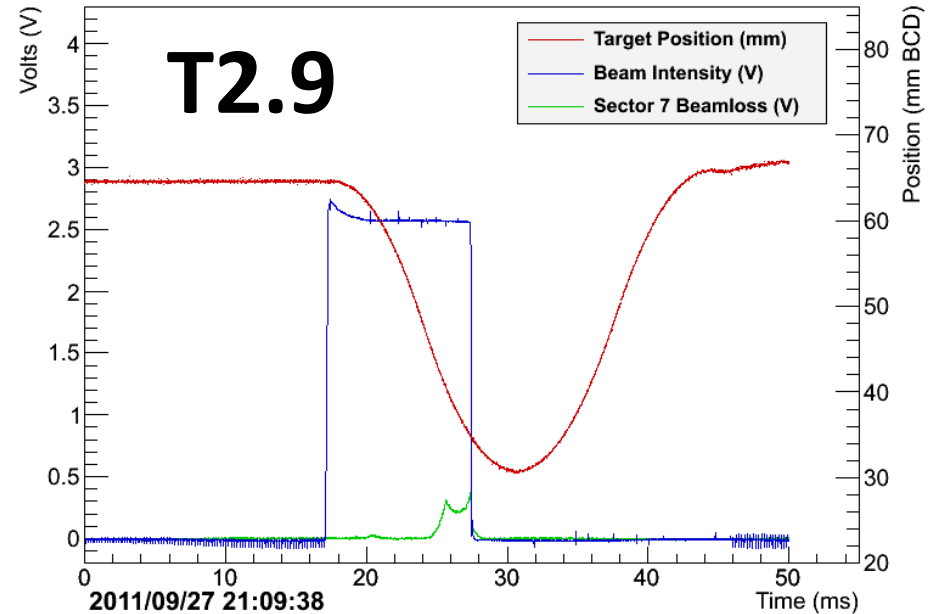
T2.9: Target Position and Beamloss

- T2.9 Shows double peak in beam loss, probably caused by scraping the beam.
- Maximising second peak required pushing apex back, in user run would be interfering with next spill.
 - ISIS crew informed us beam is in an unusual condition with lots of losses.
 - The acceleration of the T2.9 is 746ms^{-2} (compared to 774ms^{-2} for T1). Measured around the minimum position.

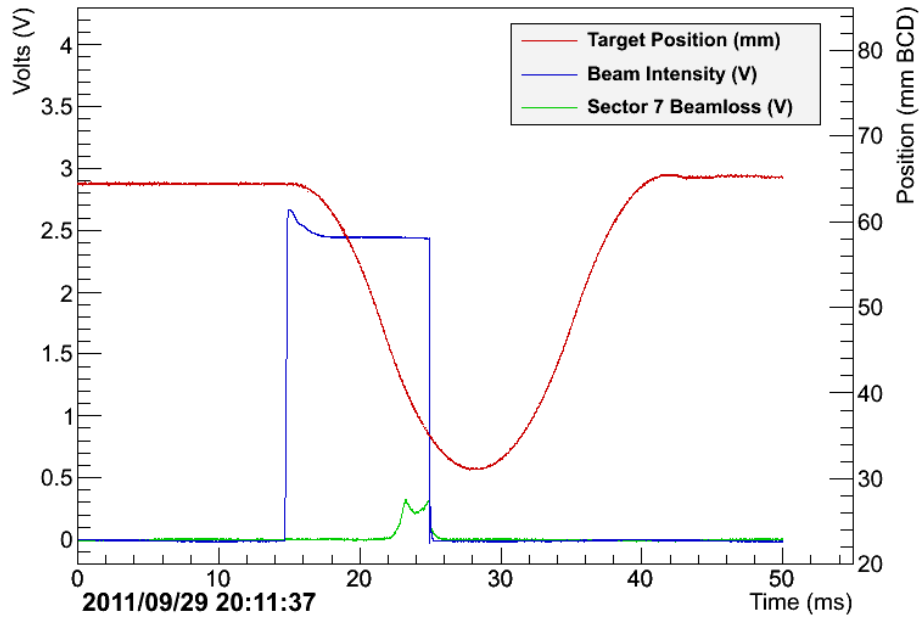
No Beam Bump

- First tested with no beam bump
- Saw same double peak structure as on Tuesday
- Beam was in same condition as on Tuesday 27th Sept.

- Dip depth: 31mm BCD
- User delay: 600000
- Same configuration as Tuesday 27th September

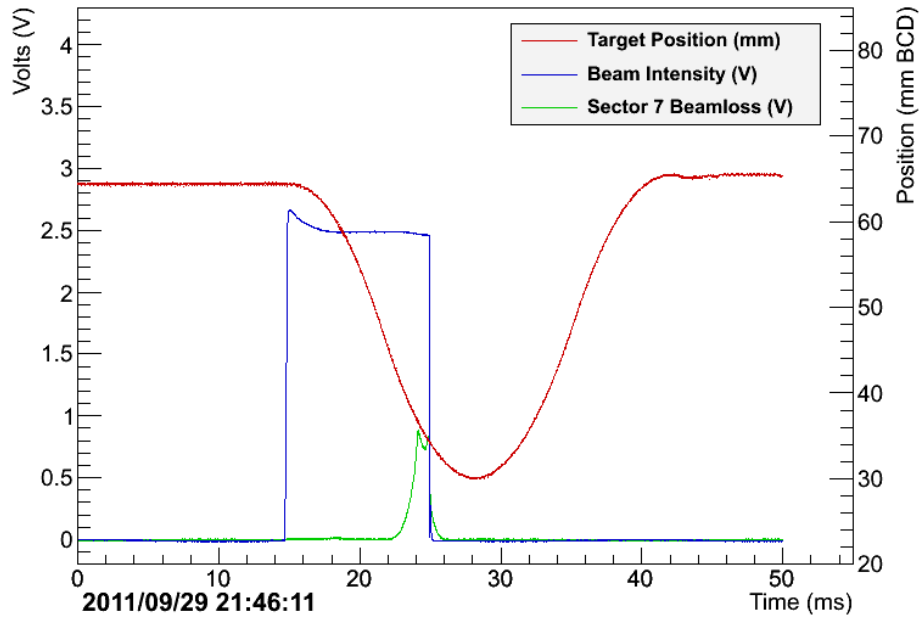
- Moved beam away from target 2mm between 6 and 8 ms.
- Dip depth: 30 mm BCD
- User delay: 600000

- Next tried to use beam bump to reduce early peak in beam loss
- Used beam bump to move beam away from target 2mm between 6 and 8 ms.
- This reduced the early beam loss by a noticeable amount.
- Allowed us to dip the target deeper for the same overall beamloss
- Double peak structure still there, but shifted to later in spill.

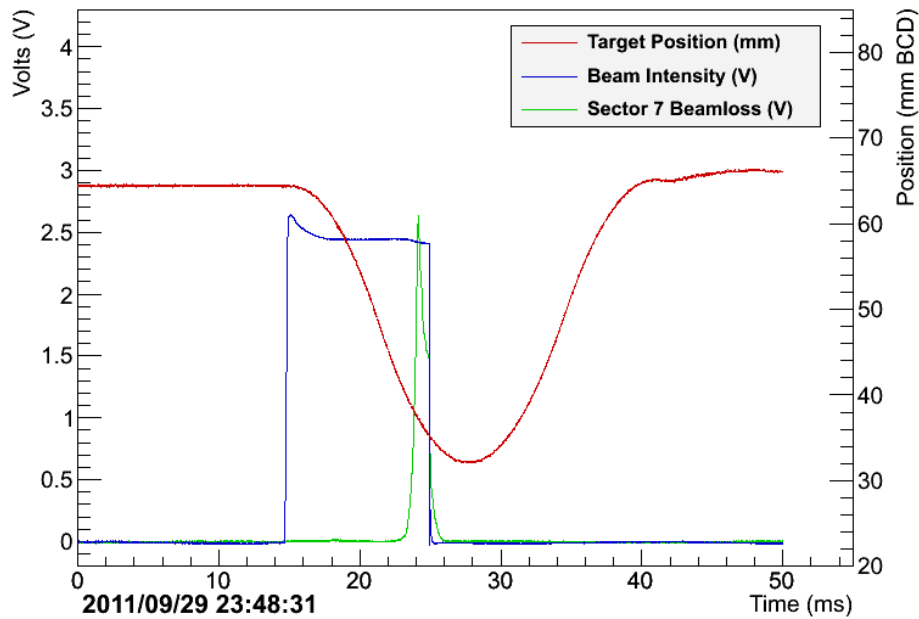
- Also tested moving beam towards target by 2mm between 8 and 9ms. Then moving beam towards target between 8ms and 10ms.
- Caused significant beam loss during last couple of ms, but very little before that.
- Had to move the target to 32mm BCD to reduce losses.

- Moved beam 4mm away from target between 6ms and 8ms.
- Then moved beam towards target 2mm between 8ms and 9ms.
- Dip depth: 32mm BCD
- User delay: 600,000

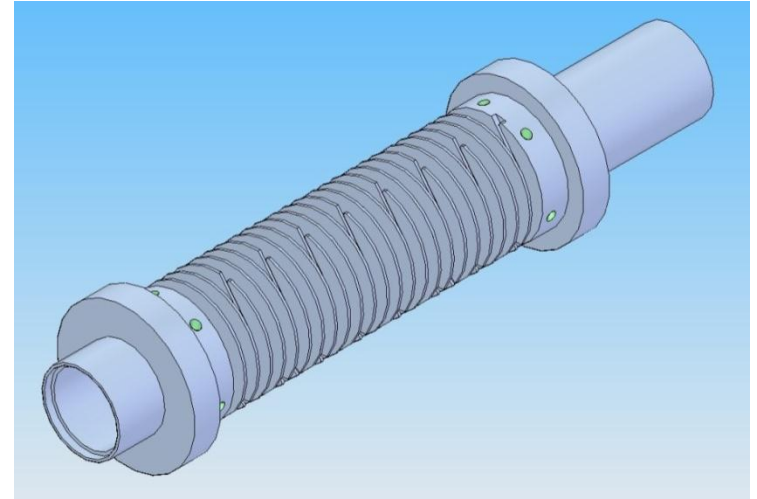
- An improved stator design is beginning production which should:
 - Improve magnetic field uniformity (increase reliability)
 - Increase acceleration (by bringing the wire closer to the magnets)
- Three bobbins have arrived from ac precision and oxford.
- Have had difficulty winding the wire onto the bobbin:
 - Wound coils would break down when 1000 Volts is applied between the coils and the body (this is part of the QA test).
 - Breakdown is believed to be caused by the sharp edges of the slits damaging the insulation of the wire.
