JUAS 2012, Archamps, France

One or Two Things That Can Go Wrong With Your Vacuum System: Examples of Vacuum Accidents at Accelerators

R. Kersevan, TE/VSC - CERN, Geneva

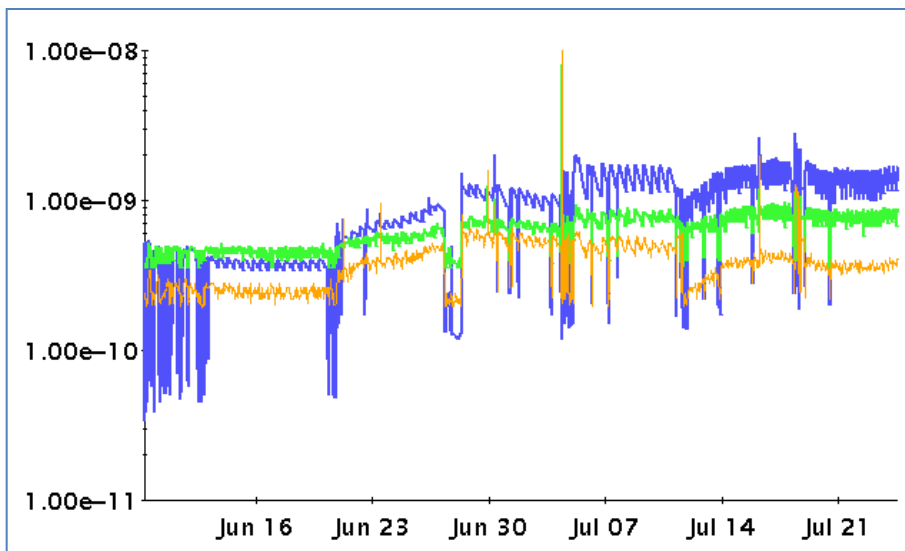
ESRF: CELL1 : CV11

The readout of several vacuum gauges shows, since a couple of weeks, a steady rising trend... Question: is there a vacuum leak?

Consequences: headaches for operators and vacuum people; few tens Euros for the silica-gel bags; As the problem reappeared later, *some vacuum gauges had to be replaced* (bad quality of the ceramic feedthrough)

Answer: No, what was actually happening was that the humidity level in the tunnel was going up (hotter summer days), and the cold-cathode gauges installed on the machine are sensitive to humidity.

Remedy: install silica-gel bags around the gauge connector

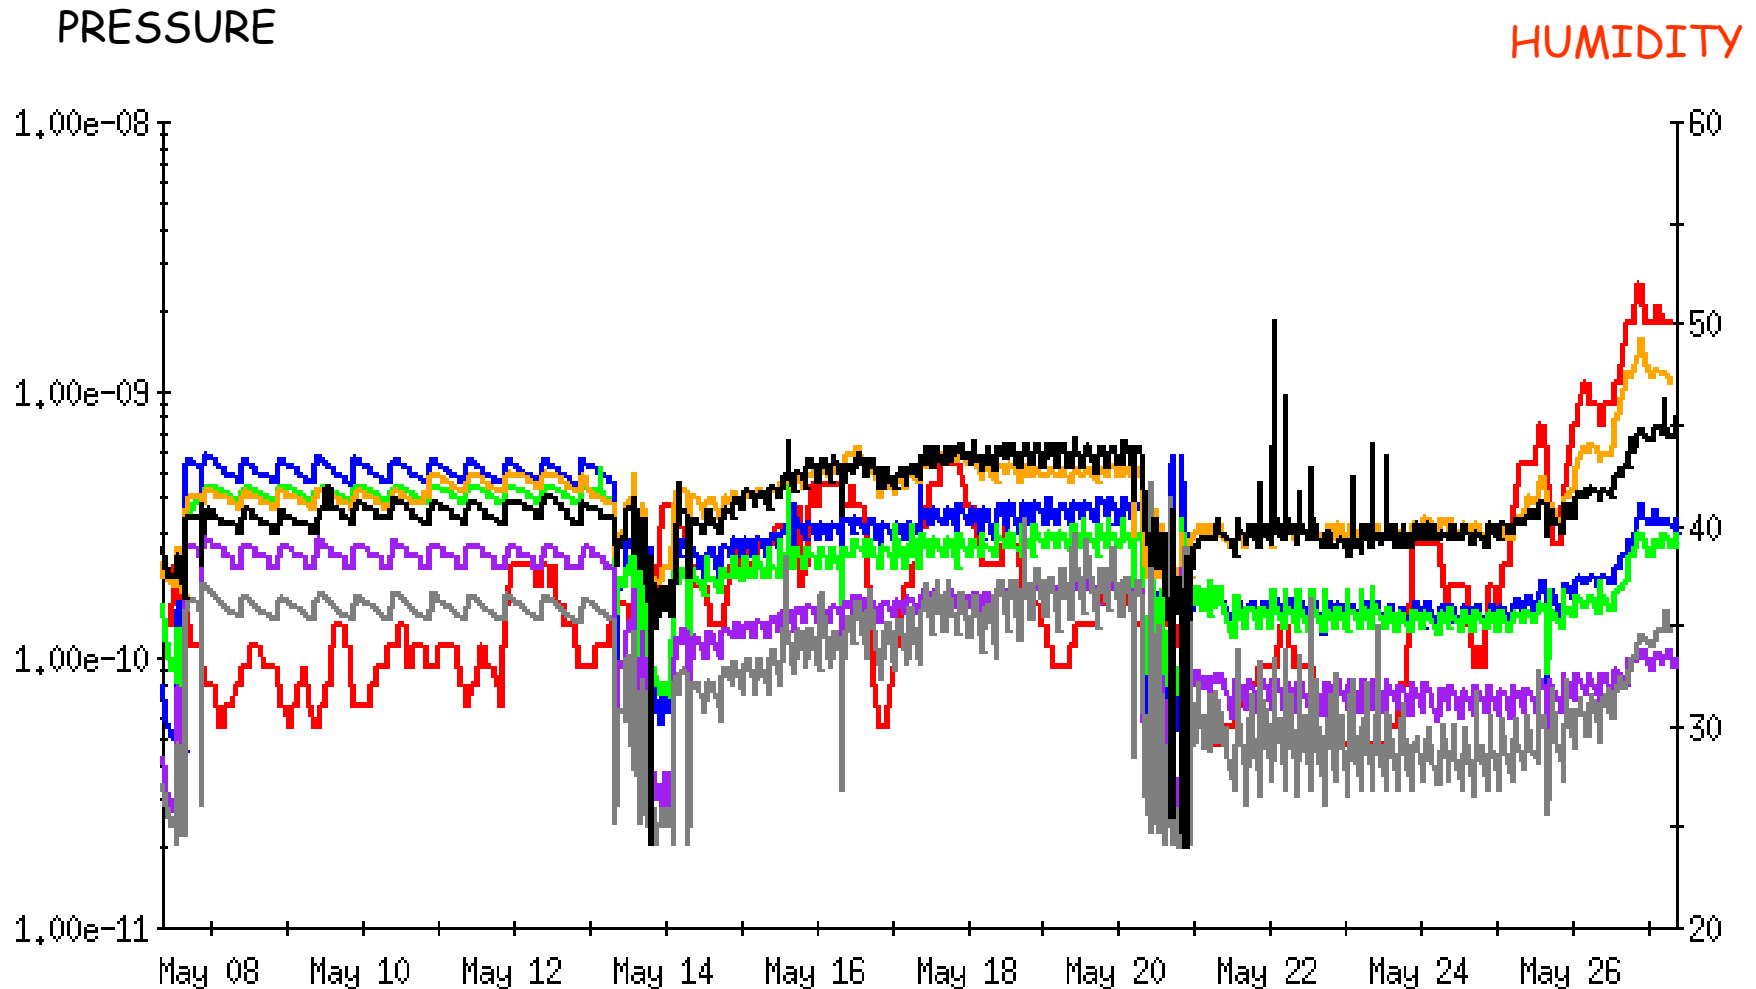
- More cases of the fake vacuum problem: again humidity on ceramic gauge feedthroughs...

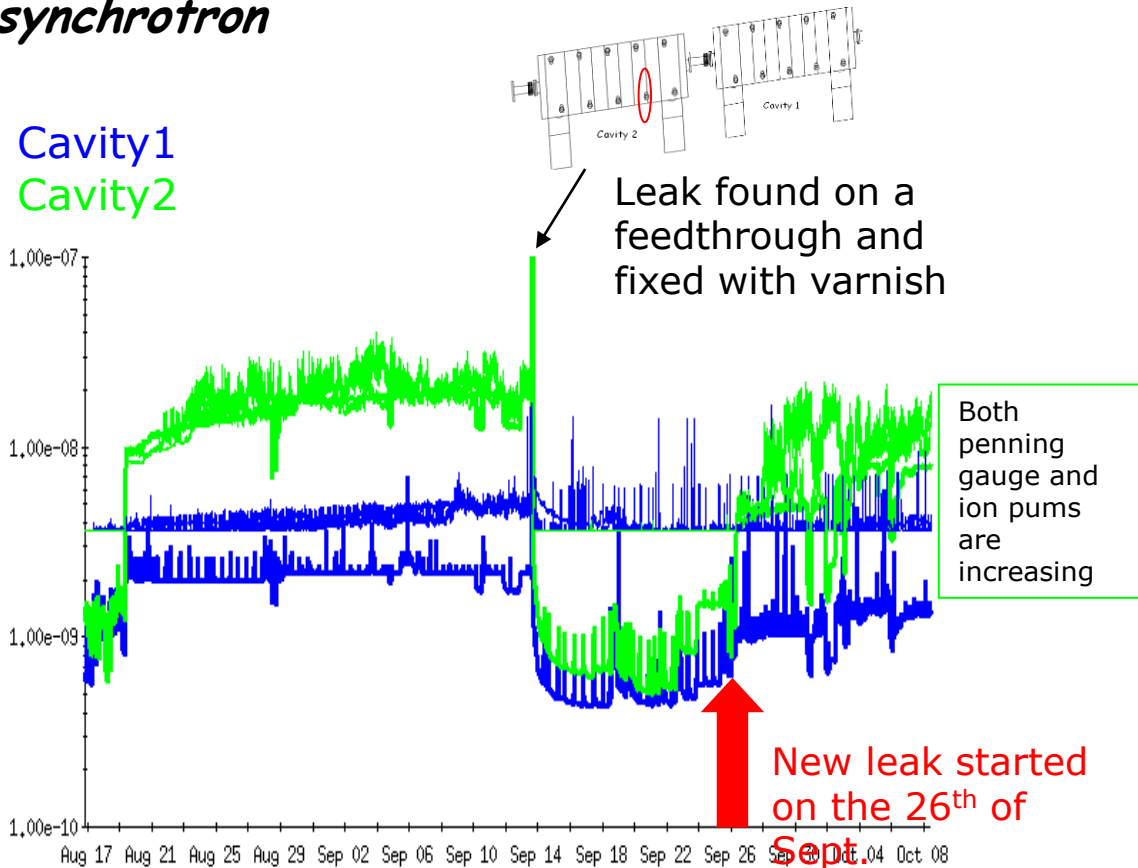
- A more serious case: *ESRF*, leak on an RF cavity in the booster synchrotron

Consequences: none, operation carried out during downtime;
As the problem reappeared later, *some feedtroughs had to be replaced* (bad quality of the ceramic).
Lost some machine time...

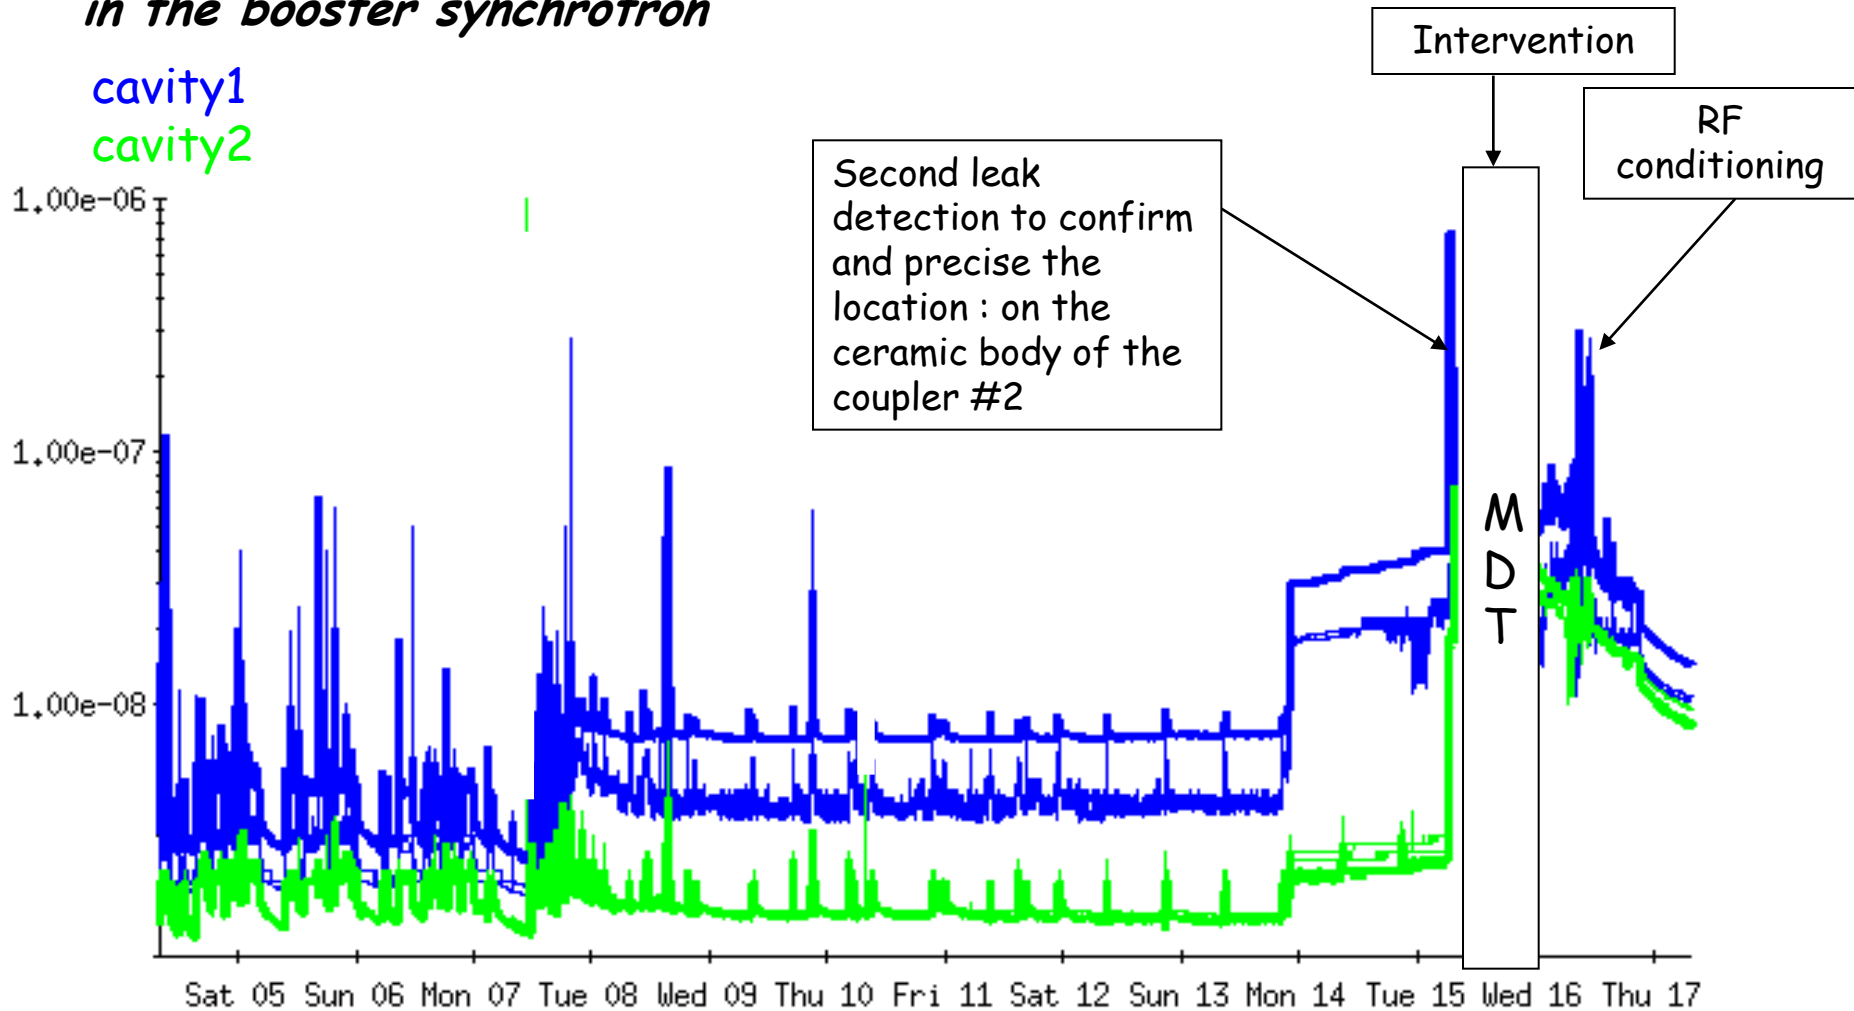
- **A more serious case: ESRF, leak on an RF ceramic coupler of one cavity in the booster synchrotron**

Consequences: none, operation carried out during Machine Dedicated Time (lost);
As the problem reappeared later (see next slide), *some couplers had to be ordered to industry. Long lead time.*

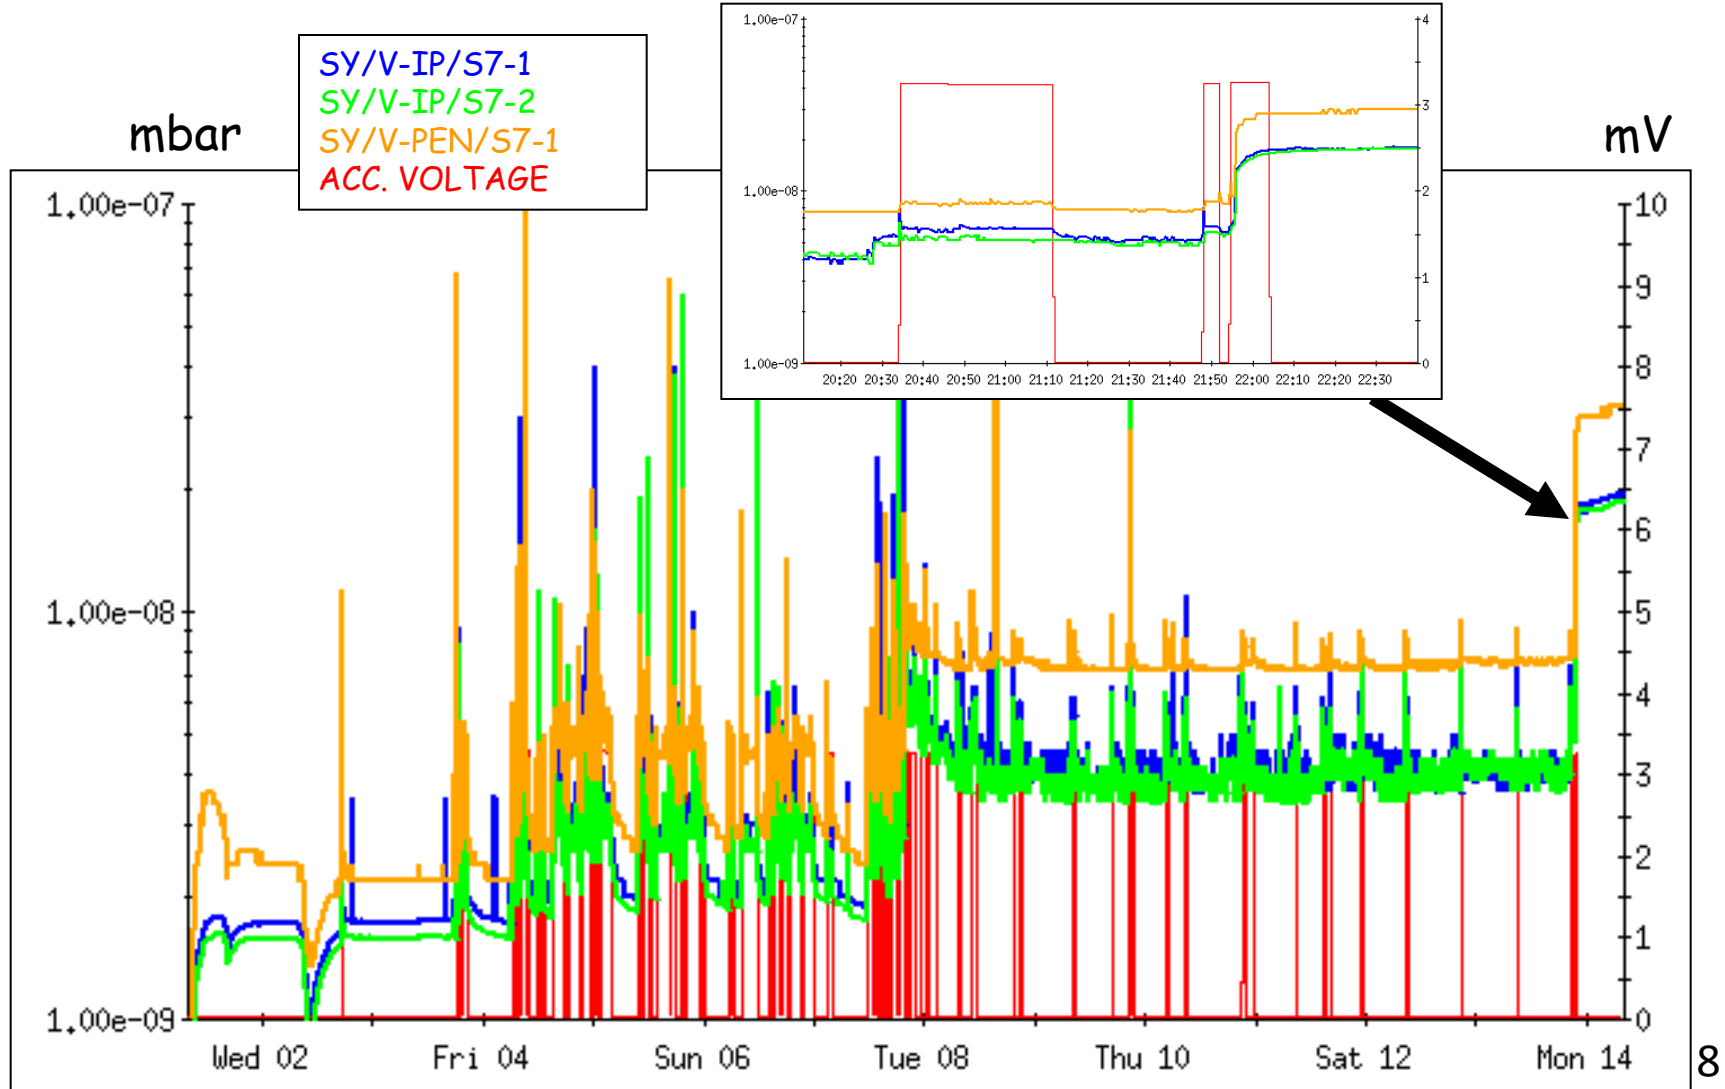
BOOSTER RF CAVITY 1

- *ESRF: Another leak on an RF ceramic coupler of one cavity in the booster synchrotron*

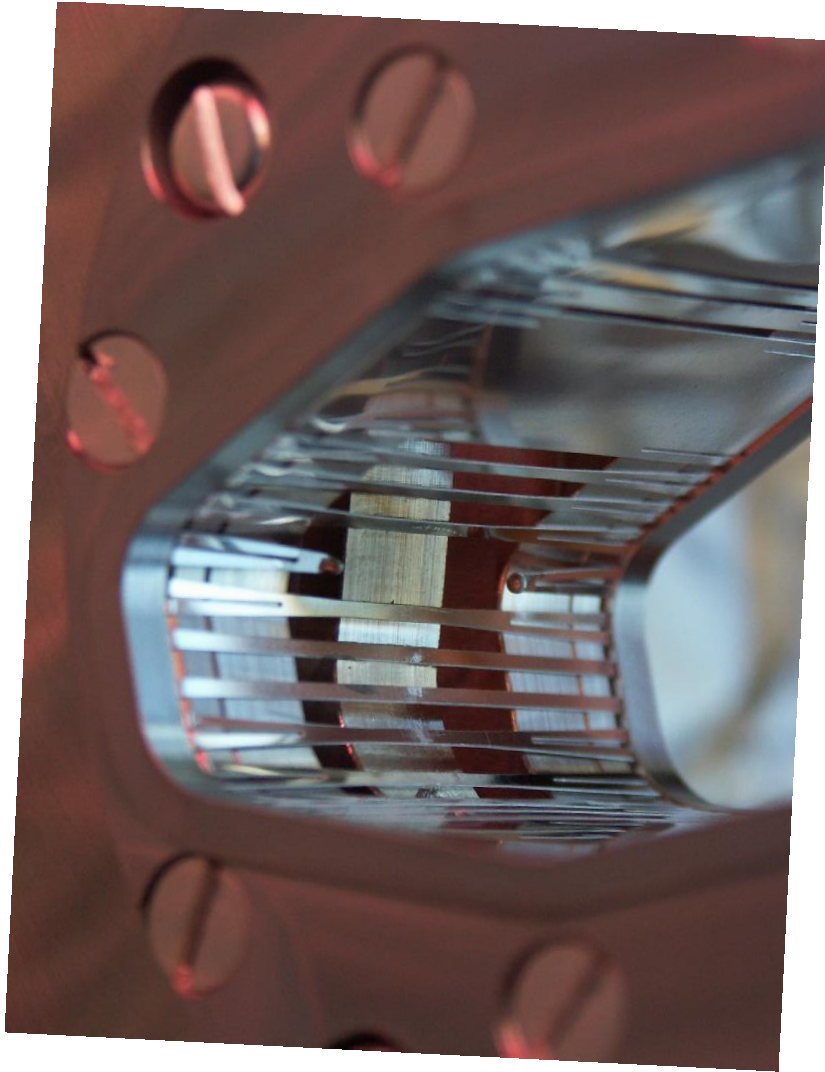
- **Increasing seriousness: *ESRF, damaged RF contact fingers inside an all-metal gate valve, with loss of tightness***

Consequences: valve had to be replaced, leading to venting of *additional cell*

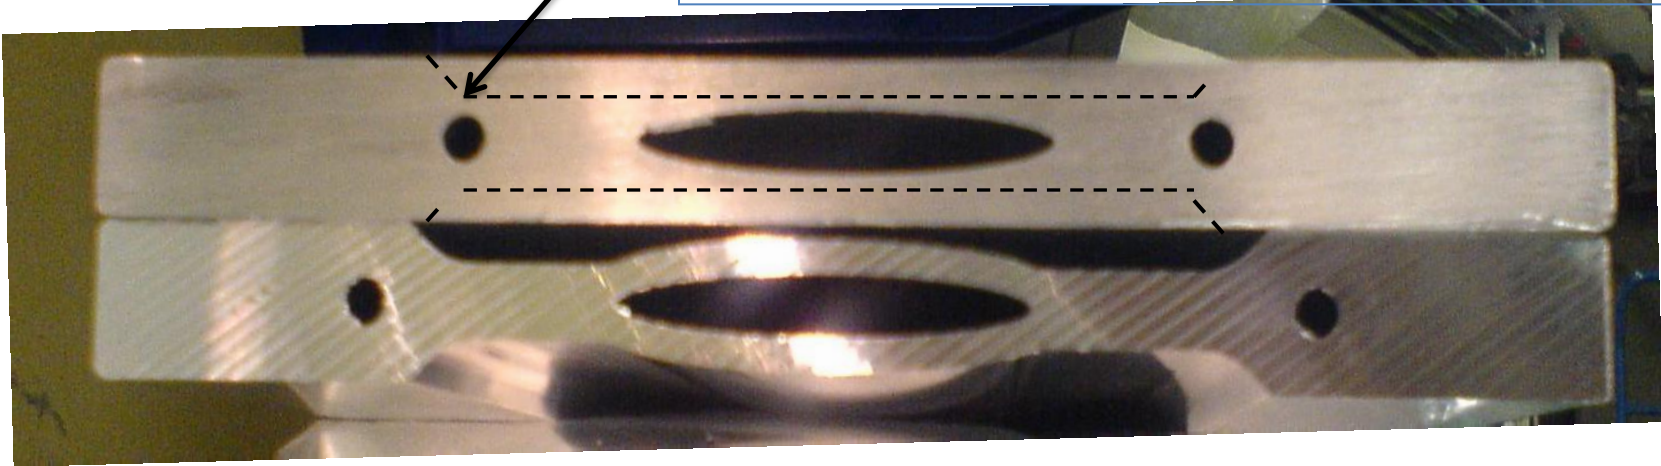
- **Increasing seriousness:** *ESRF, corrosion leak at NEG-coated "10-mm ID" aluminum chamber*

Top: Sharp corner machine here (45 deg) generates stress which leads to water leaking out of the cooling tube

Consequences: "Water leak alarms" in the tunnel. Lost machine and user time; extrusion dye had to be modified; new extrusions made; new NEG-coating made (can be a *long* process);

Solution: new extrusion with distanced cooling holes and rounded corner (**bottom**)

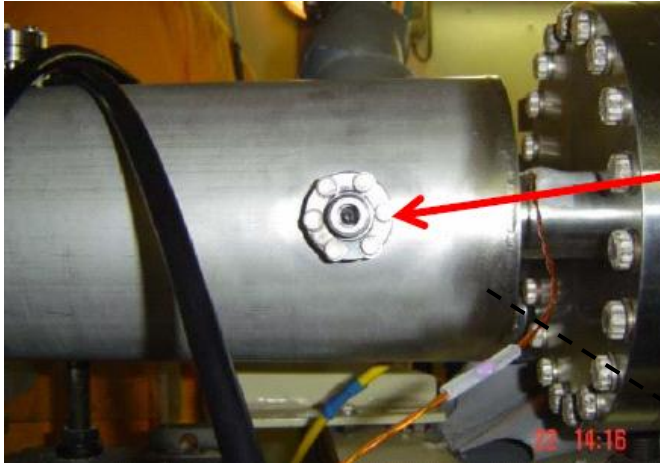
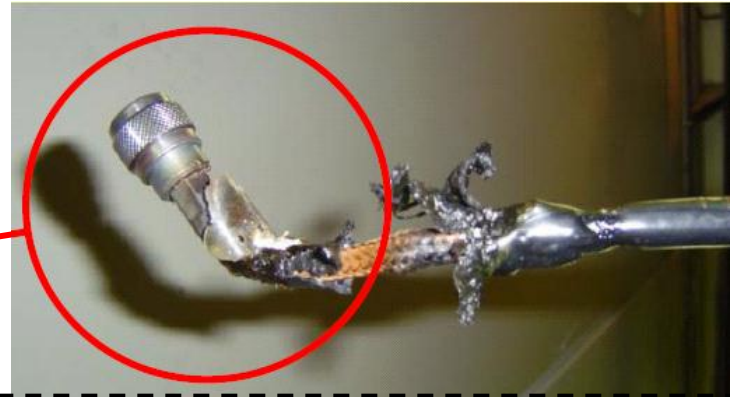
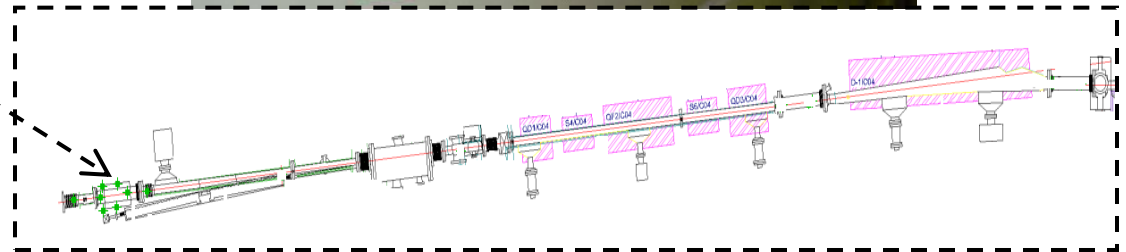
- **Dangerously serious:** *ESRF, failure of a stripline kicker*

Reason: high peak power induced by 4×10 mA and 16-bunch filling modes operation and faulty design of HV feed-through

Consequences: Fire alarm and broken feed through on the horizontal strip line in cell4 (injection straight); Two cells vented; injection straight vented; 1 NEG-coated aluminum ID chamber vented; Leak repaired, but end of the run cancelled, 75 hours lost (no time to re-bake the cells and IDs before scheduled end-of-run)

Cost: custom-made kicker to be re-designed and procured. Not for free.
Worst of all: 3 days of experiments cancelled... ☹️

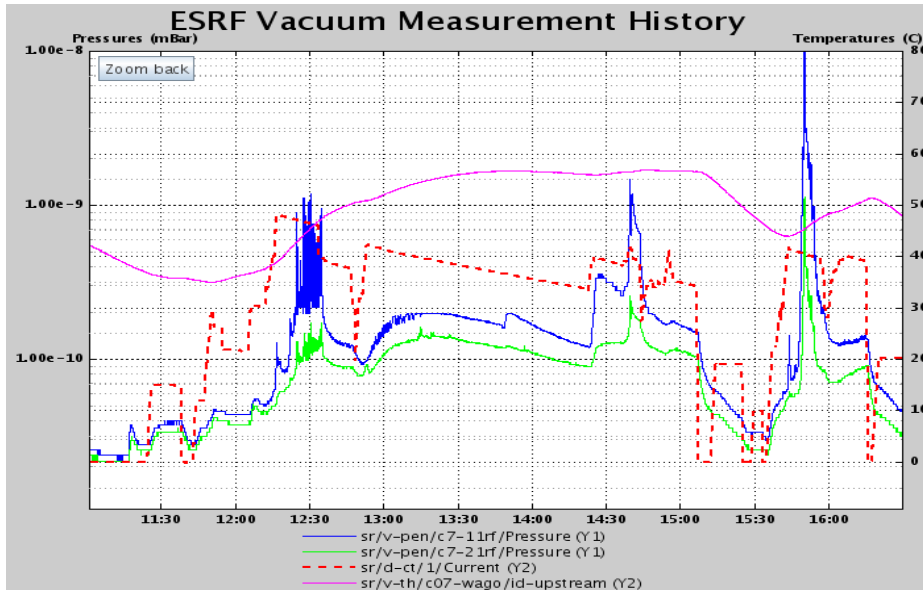
SR cavity3 : RF fingers on the upstream bellow

Consequences: pressure spikes affecting the beam lifetime, increasing the bremsstrahlung dose to beamlines (important safety aspect), potentially preventing operation (fingers can melt and go in the way of the beam)

Cost: Ag-coated, Be-Cu fingers are not made overnight. New/improved design had to be studied. Long procurement time.

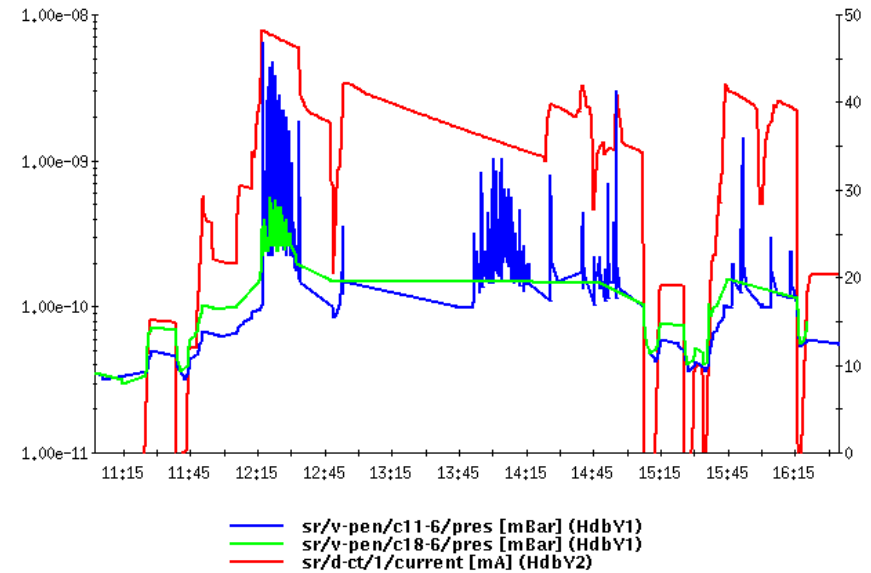
RF fingers problems on CV11 in (4x 10mA)

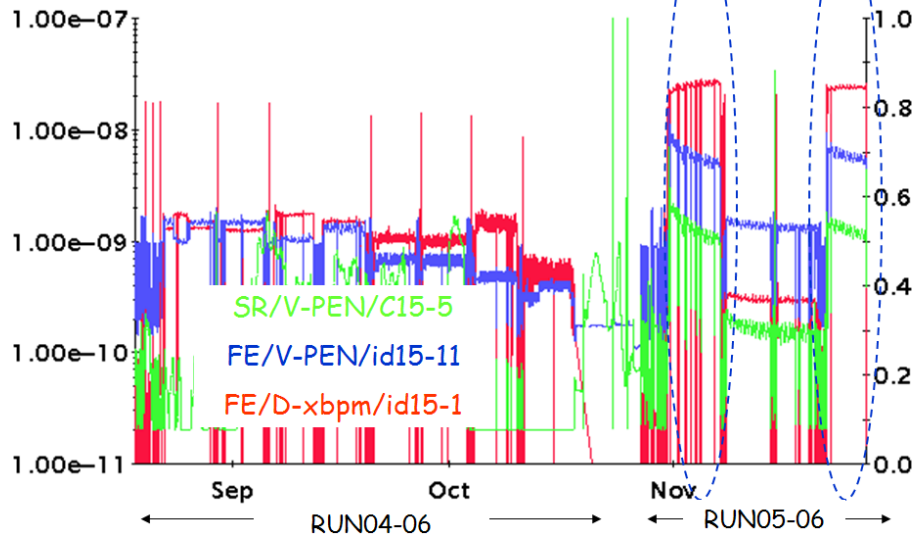
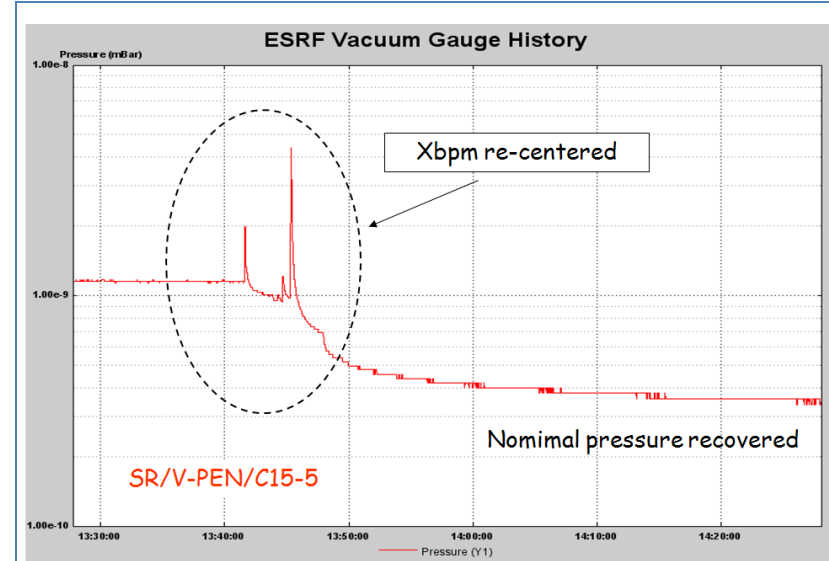
Cell15 : CROTCH1

- *Could be dangerous: ESRF, misalignment of X-BPM*

Abnormal degas on the CROTCH1 & the FE observed after the USM like (X6 records) and during the following USM week.

Consequences: pressure spikes affecting the beam lifetime, increasing the bremsstrahlung dose to beamlines (important safety aspect), could lead to triggering of valve closure and lost beam/experimental time.

Remedy: remote re-alignment of the device. No costs involved.

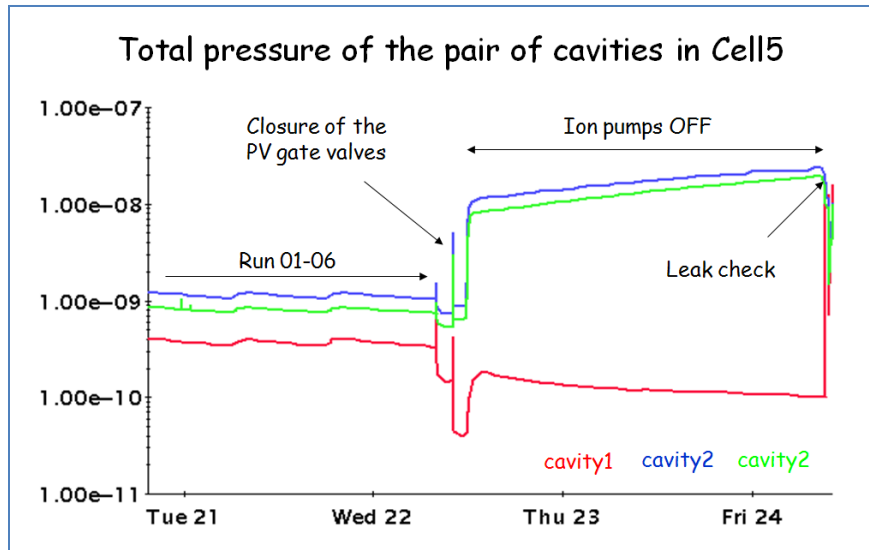
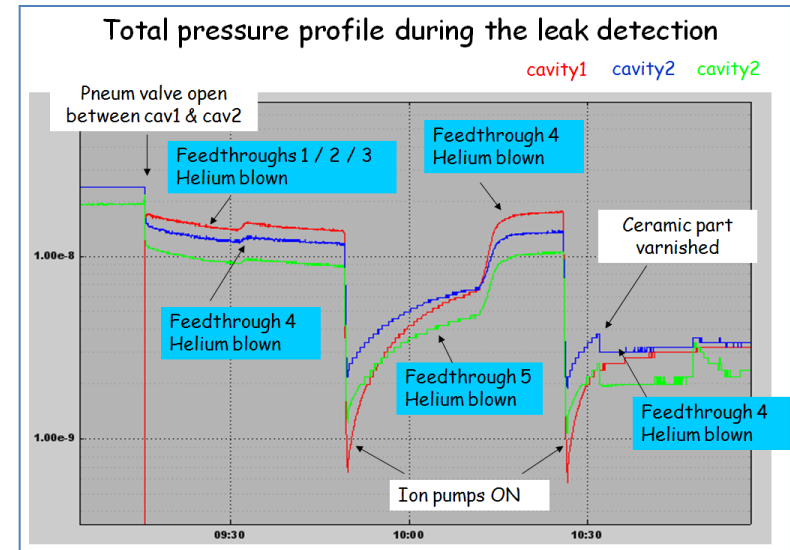
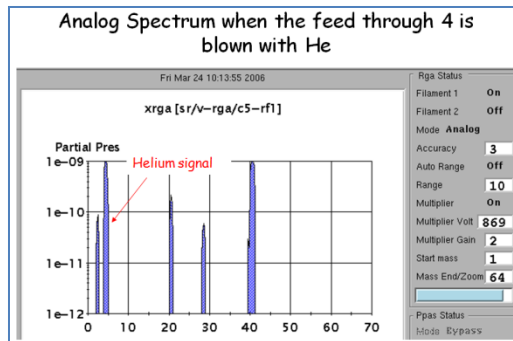
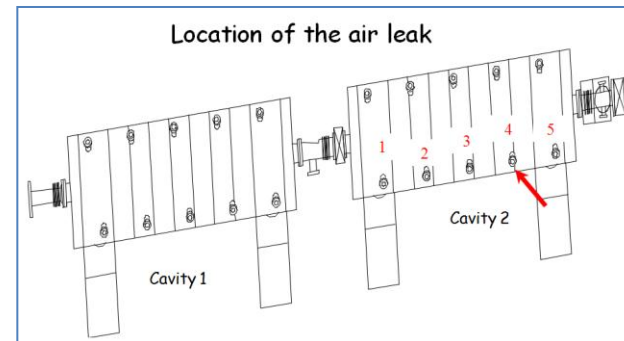
- **Time consuming: ESRF, leak on ceramic feedthrough of RF cavity in the storage ring**

Consequences: Lost machine and experimental time.

Remedy: Leak check; Vent cavity; replace feedthrough; pump-down and bake the cavity;

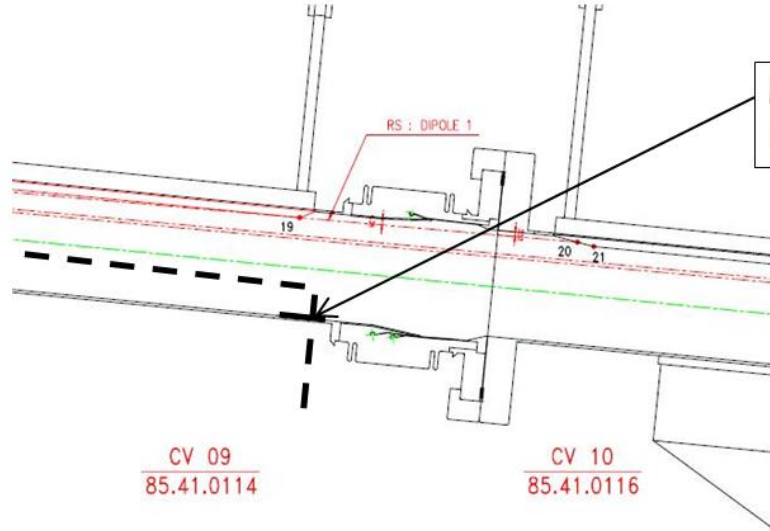
- **Annoying: ESRF, evanescent leak, coming and going. Cause: corrosion after contamination with chlorine on metallic support of cooling tubes**

• The leak had first appeared at the end of January 2005, and fixed on 1 Feb. It was located on the upper cooling tube support, downstream end of the CV9

- It has come back again on Sun Dec 3rd
- It has been sprayed with varnish during the MDT intervention time of Tue 6 Dec

Remedy: Fix temporarily with varnish until incoming shutdown; new chamber had to be fabricated.

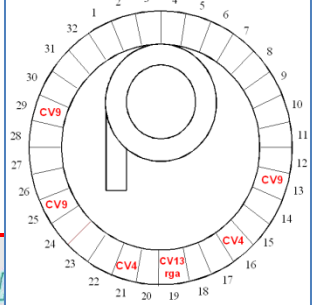
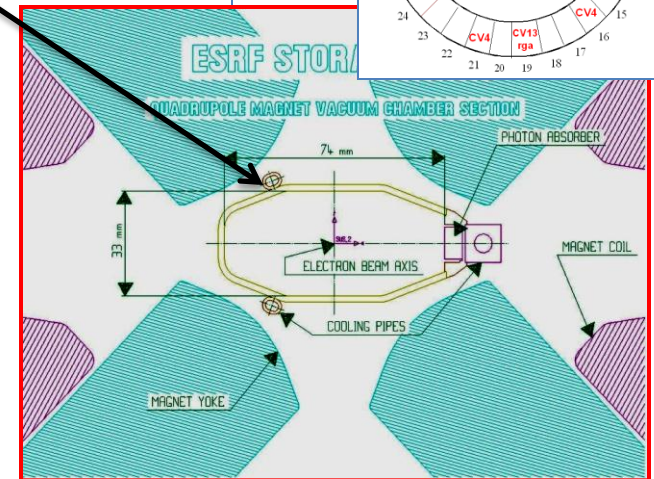
Status of the varnished vacuum vessels in the SR

Costs: recurring problem, tens of chambers with corrosion issues, capital costs are relevant (multi-year contract for spares)

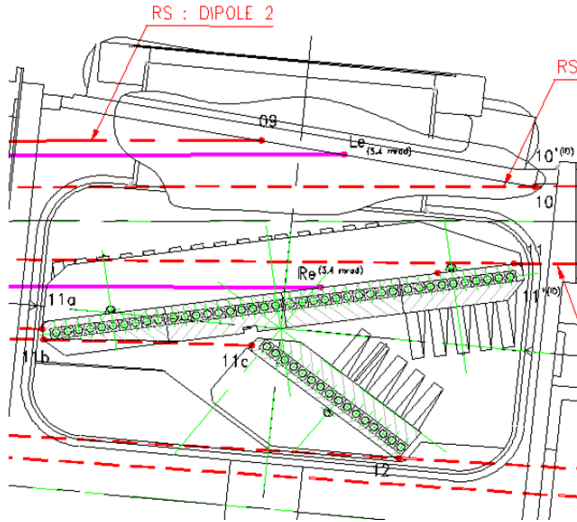
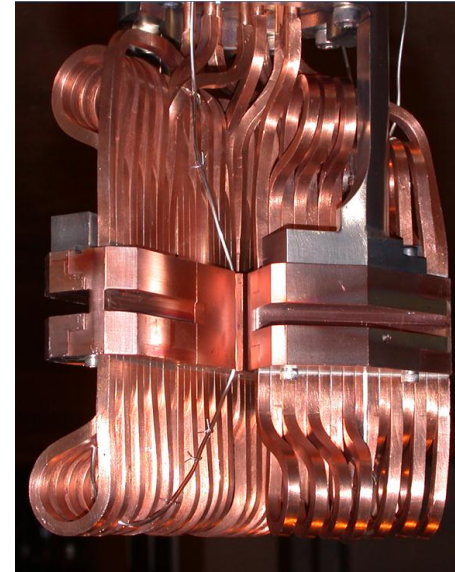
- *This looks really bad!:* ESRF, water leak on high-power crotch absorber

(preceding straight section: 5T SC wavelength shifter → 3T permanent-magnet wiggler)
 (preceded by 1.8T AMPW on same straight section)

Same design for "leading edge" as Standard Crotch-1 Absorber

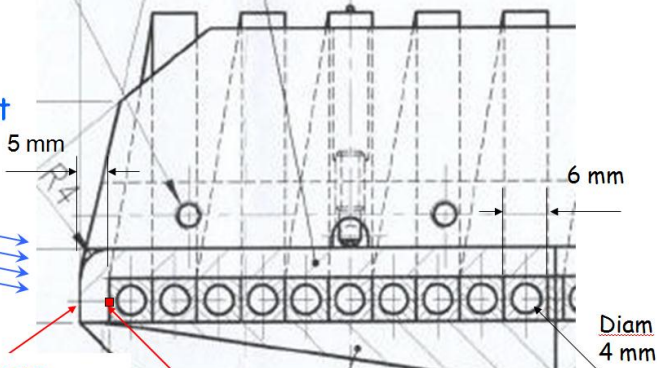
FEA Investigations

No Visible Damage
 83 W/mm; 206 W/mm² @ 200 mA
 T ~ 450 °C

Water Leak
 T ~ 80 deg C
 Stress ~ 50 Mpa

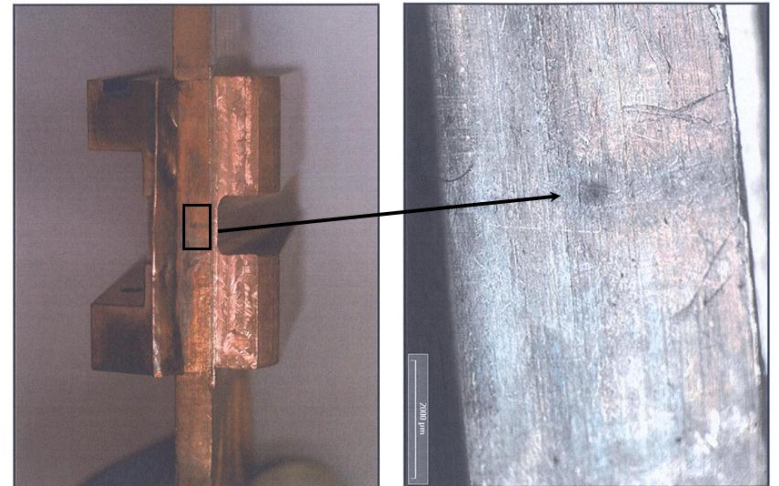
Hole in the first cooling tube

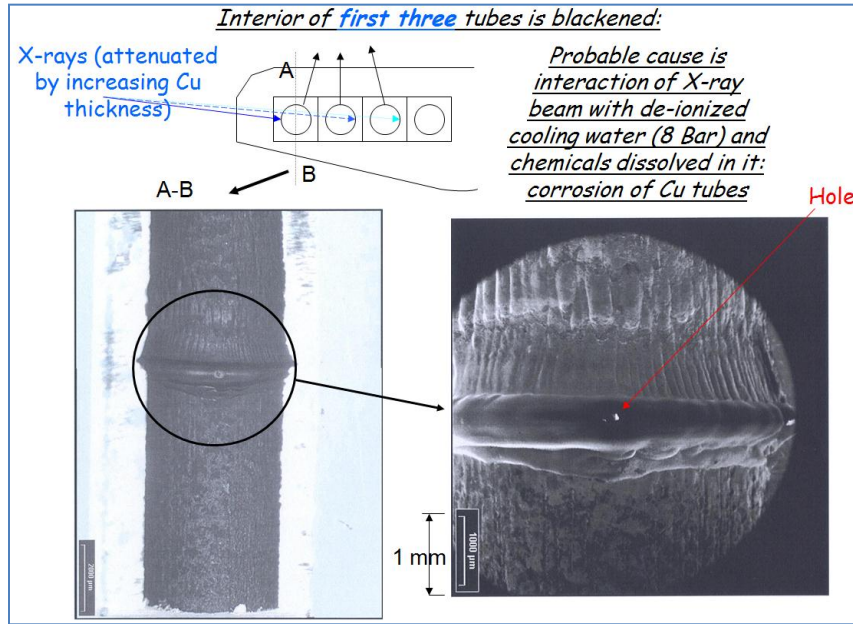
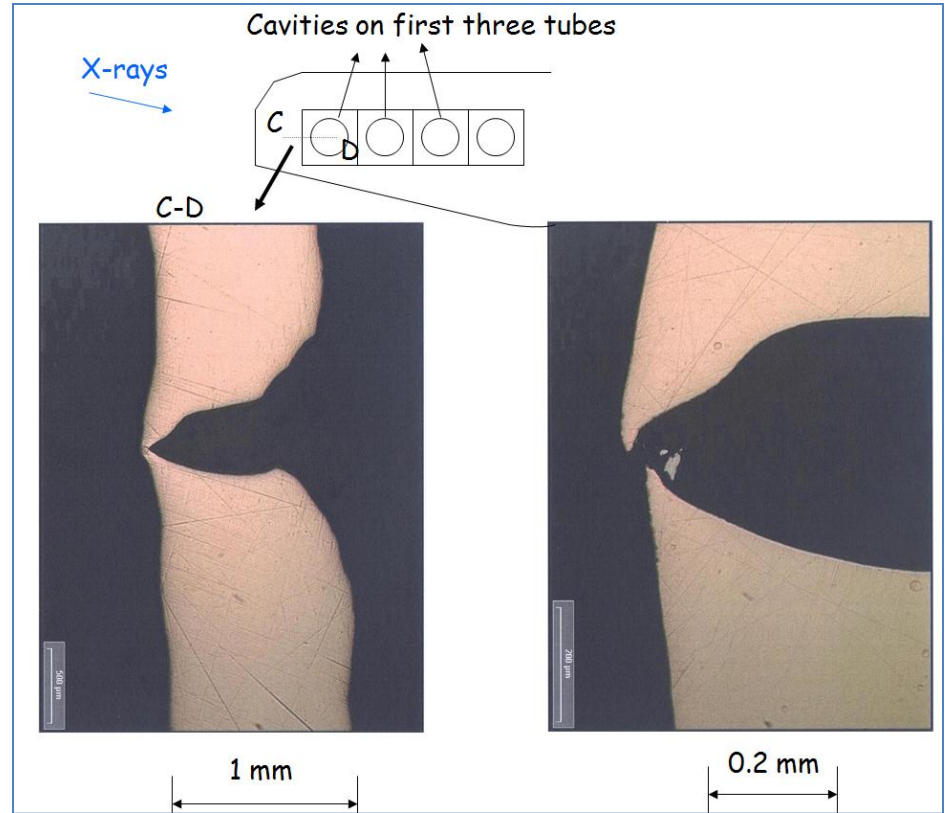
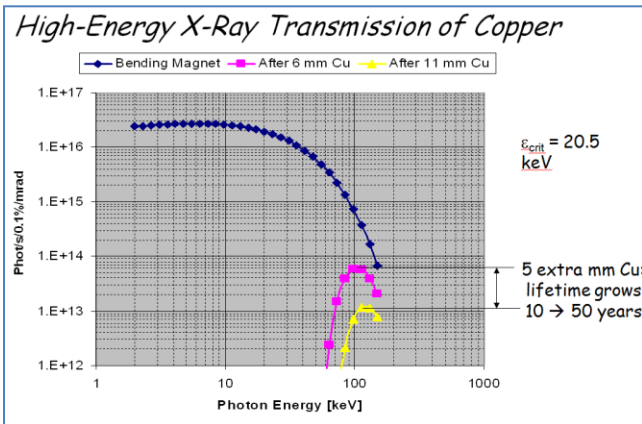
Consequences: Water leak inside the machine (one big ion-pump full!).

Remedy: careful analysis showed problem common to ALL 62 crotch absorbers; replace them all. Time to do it: couple of years. ☹

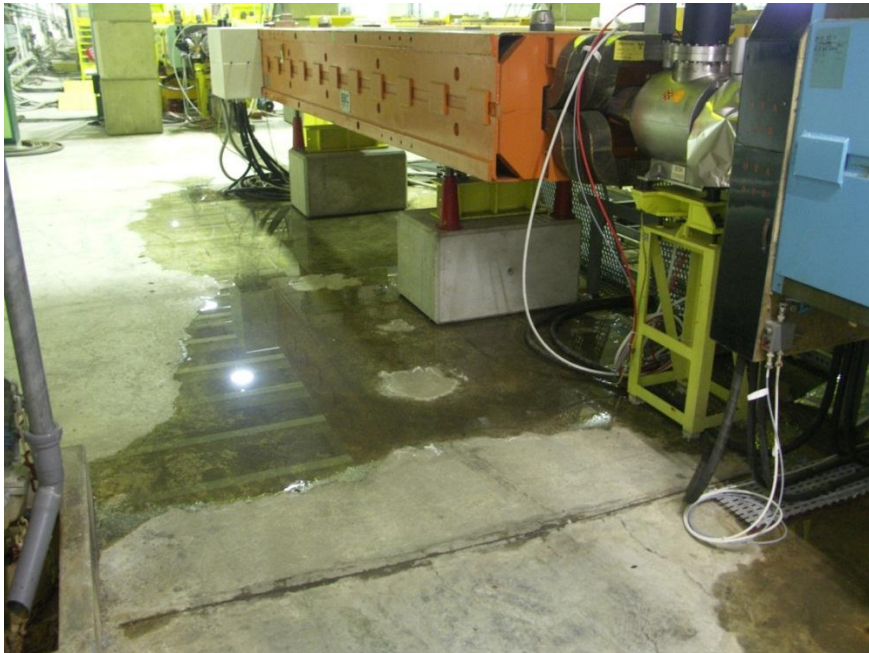
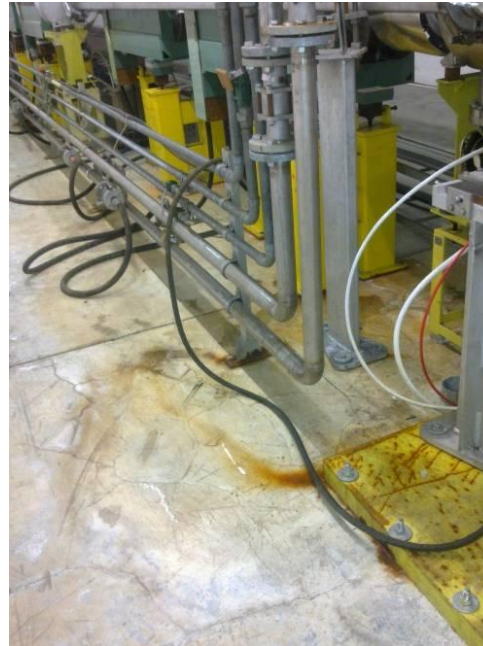
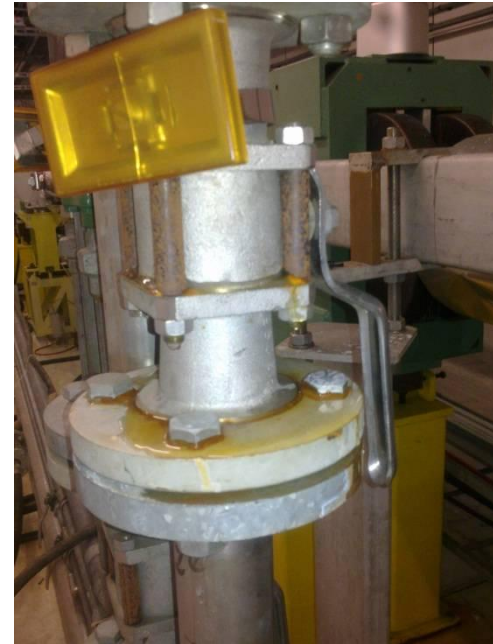
PVC components were accidentally installed in TDC2: hoses, cables (fire alarm), mechanical protections for vacuum bellows (☹). The recent events suggest that PVC is still there...

In the TDC2 there are several sources of moisture:

- Leaking magnet cooling circuits.
- Leaking water valves,
- Infiltration from the tunnel ceiling.

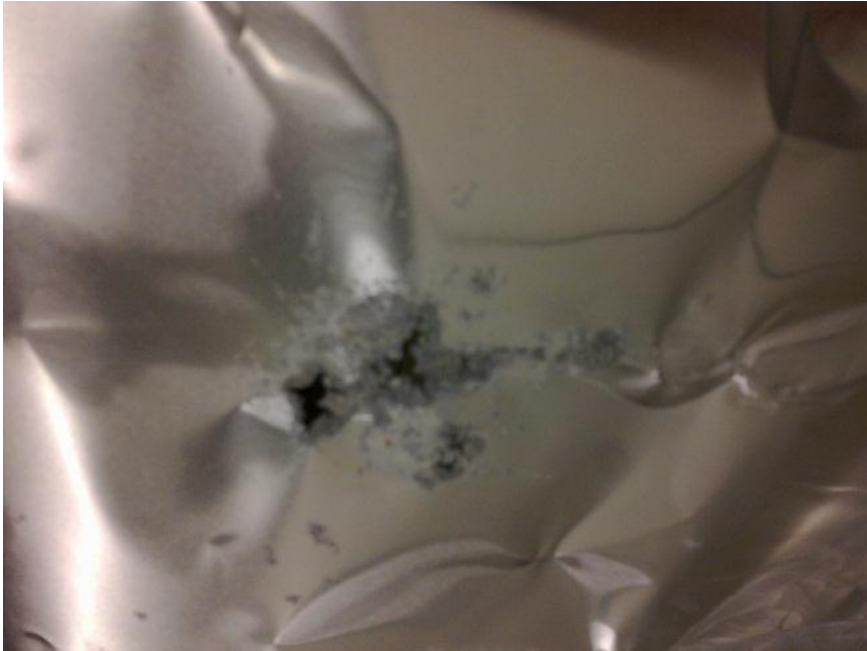
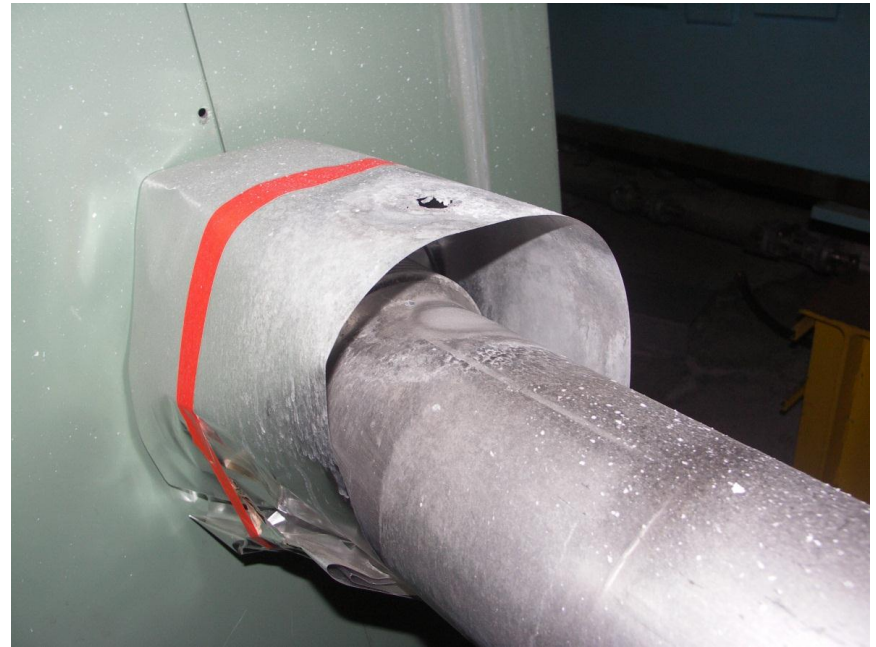
The last two leaks in sectors 2006 and 2007 appeared in 'protected' bellows. Their Al protections was not damaged at the time of the last survey in January 2011. Few droplets, maybe a single one, are enough to generate corrosion and failure in 'protected' bellows.

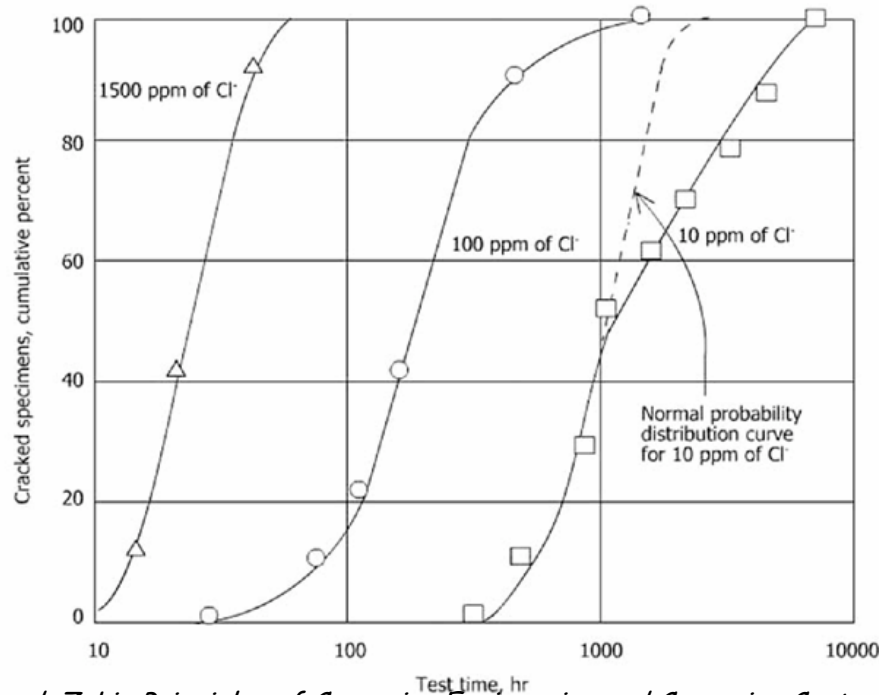
A few ppm of Cl^- ions are enough to develop a crack in austenitic stainless steels.

It is impossible to specify a Cl concentration threshold: even in small concentration (less than 10 ppm) Cl is concentrated to pitting site.

Vacuum leaks induced by stress corrosion cracking are characterised by a rapid, unexpected and huge pressure rise.

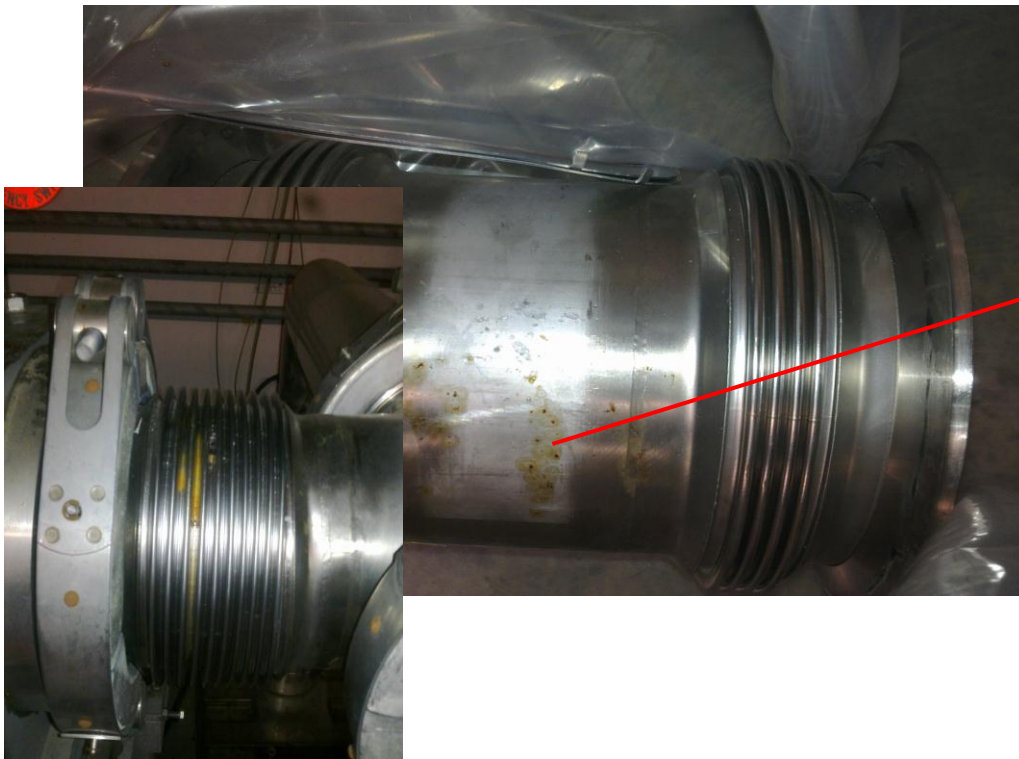
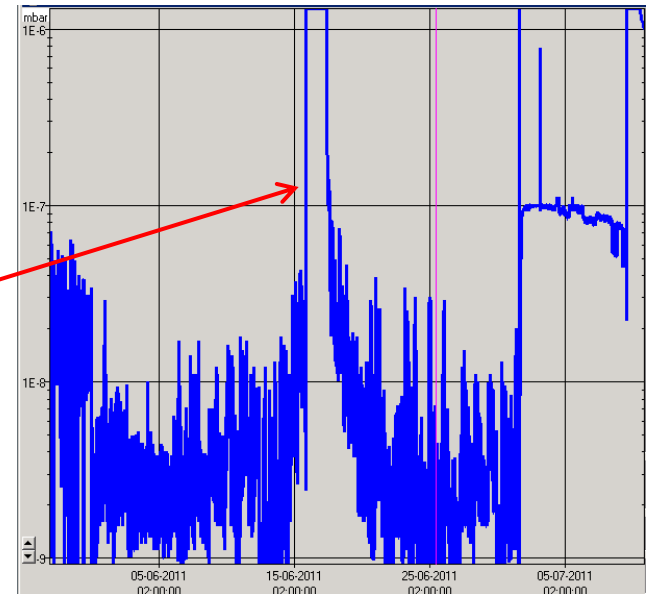
- The leak in sect. 2006 developed first.
- The bellow replacement and the pressure recovery was fast because the sector is short.
- The collective dose was shared amongst 8 TE-VSC staff members.
- At the same time a corrosion attach was observed in the bellow of the nearby sector. However the sector was not leaking.
- The corroded part was painted with **VacSeal**, the whole beam pipe covered with a thick stainless steel **protection**, and the **production** of the special **vacuum chamber** started. Hoping to keep the sector 2007 operational until the next winter shutdown...
