# Operating experience of the J-PARC RFQs

Y. Kondo, T. Morishita, K. Hasegawa

## contents

- Breakdown problem of the RFQ since 2008.
- Estimated cause of breakdown
- Improvement in current RFQ and next RFQs

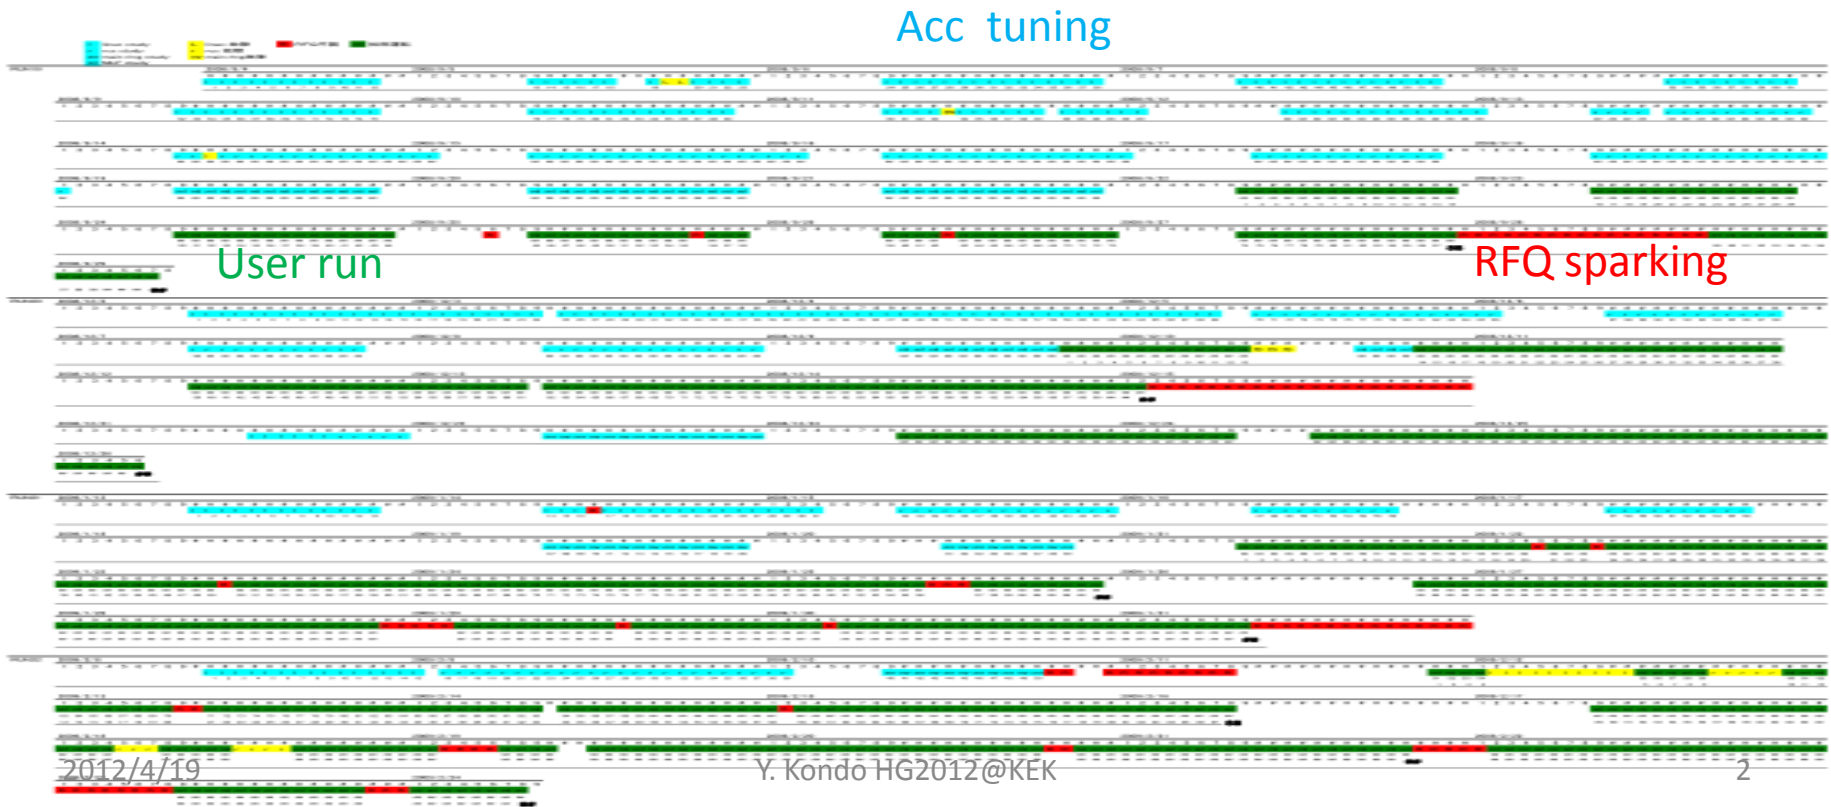
# Operation status of 2008

- In 2008, it was revealed that the RFQ cannot withstand long term beam operation. (linac commissioning was started from 2006)
- Critical discharges were started after about 100 hours user operation. (1 box=1 hour, Red: doing RFQ conditioning)

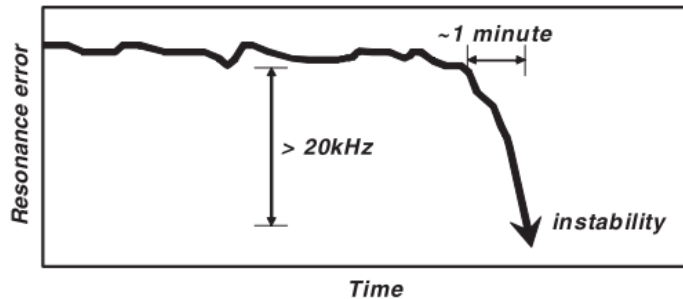
FIG. 3. The typical behavior of the RFQ resonance error when the RFQ shows instability.

When the RFQ enters an unstable region, the typical symptom is that the resonance frequency of the RFQ drops rapidly within a minute by more than 20 kHz and the low level radio-frequency resonance control is lost as shown in Fig. 3, and is sometimes accompanied with structure arcing. We refer to this sudden loss of resonance control as the

RFQ and rf field. The theory for the instability is as follows; hydrogen from the ion source is continuously absorbed on the surface of the RFQ. At the beam-off state 65 kV negative hydrogen beam is dumped around the upstream part of the RFQ, and at the beam-on state some portion ( $< 10\%$ ) of the negative hydrogen beam will hit the vanes during acceleration by design. Ion beam bombardments are known to be very efficient for gas desorption from metal surfaces [7–9]. The source beam, either at beam-on or beam-off states, enhances hydrogen desorption, which degrades the local vacuum, especially around the vanes even though the vacuum gauge reading at the wall side does not change. Local discharge starts around the vanes where the local vacuum and rf field meet the discharge condition even though it is very mild. This local discharge absorbs the rf power and consequently heats up the vanes, which results in variations of the net rf power at a constant rf field in the closed loop rf control and, consequently, the resonance error changes. Local discharge and vane heating can become even worse if hydrogen desorption increases due to ion beam bombardment and local discharge in the structure. The RFQ can become unstable with a thermal run-away condition causing a sudden decrease of the resonance frequency of the RFQ structure.

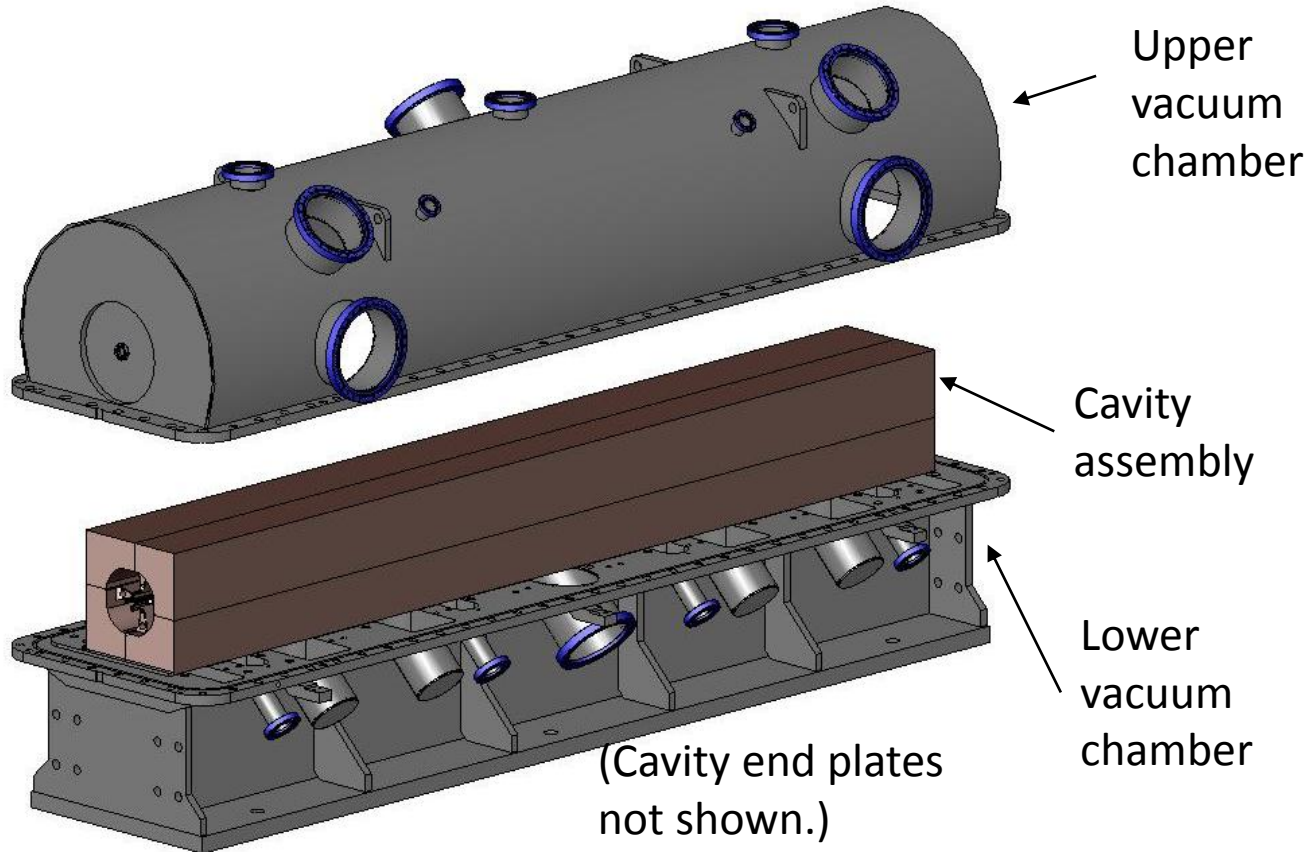
# Structural problems of J-PARC RFQ

- Volume and especially surface are extremely large.
- Conductance of pumping port is small (pumping speed is slow)

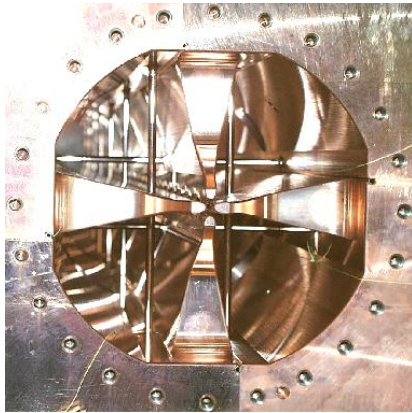
# PISL (dipole mode suppresser)

Jungle-gym like structure

- Breakdown: rod-penetration
- Multipacting: rod-cavity wall

- PISL -> DSR (Dipole stabilizing rod)
  - Reduce high field region and source of multipacting

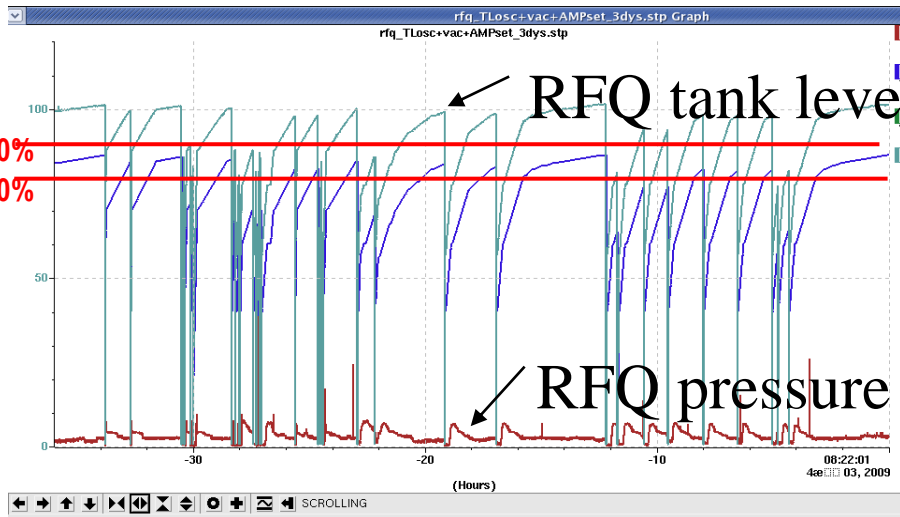
There are multipacting region around 80% and 90% tank levels

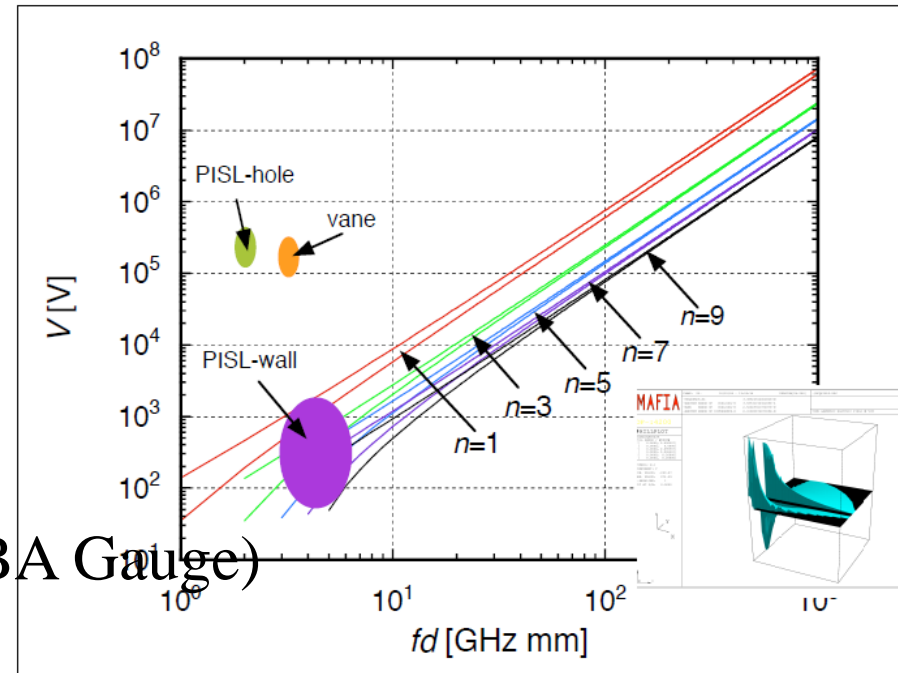
Rod-cavity wall meets multipacting condition (S. Yamaguchi)

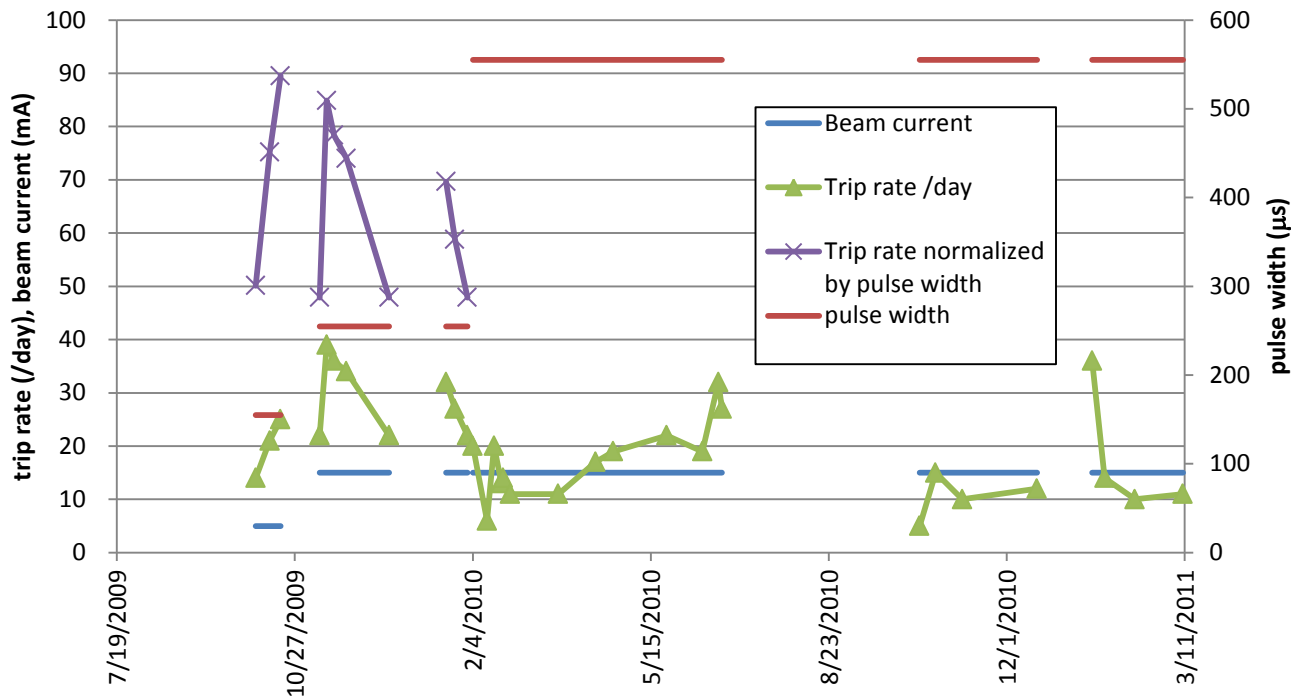
# Trip rate before the earthquake

- The series of improvements were effective at a certain level.
- Trip rate had become tolerable level ( $\sim 1/\text{hour}$ )

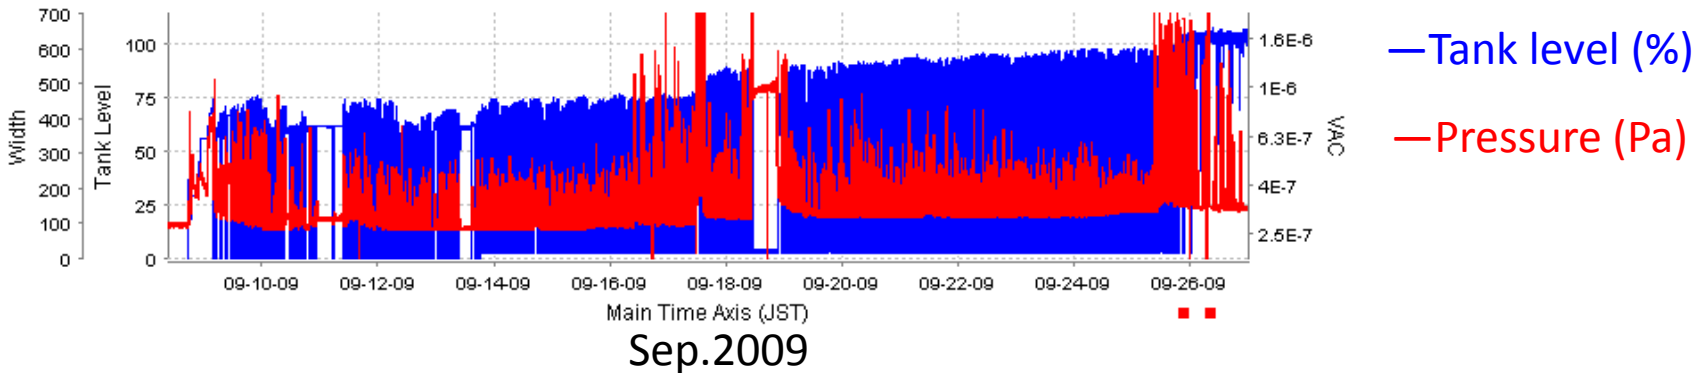
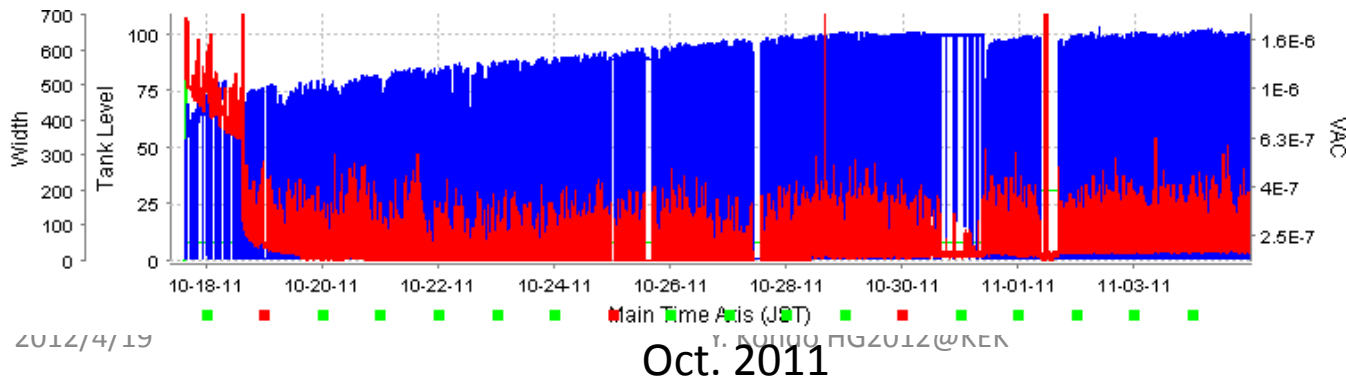
# Reconditioning after the earthquake

- Fortunately, there was no damage due to the 3.11 earthquake.
- All vacuum valves kept close (pressure was 6.3 Pa) and continuous pumping was restarted from May 26 2011.
- Nevertheless, conditioning similar to after the pump upgrade was needed.
- In Sep. 2011, baking was done again, because the pressure had been getting worse during two years beam operation.
- We guess, gases baked out from the vessel were absorbed in the vanes.

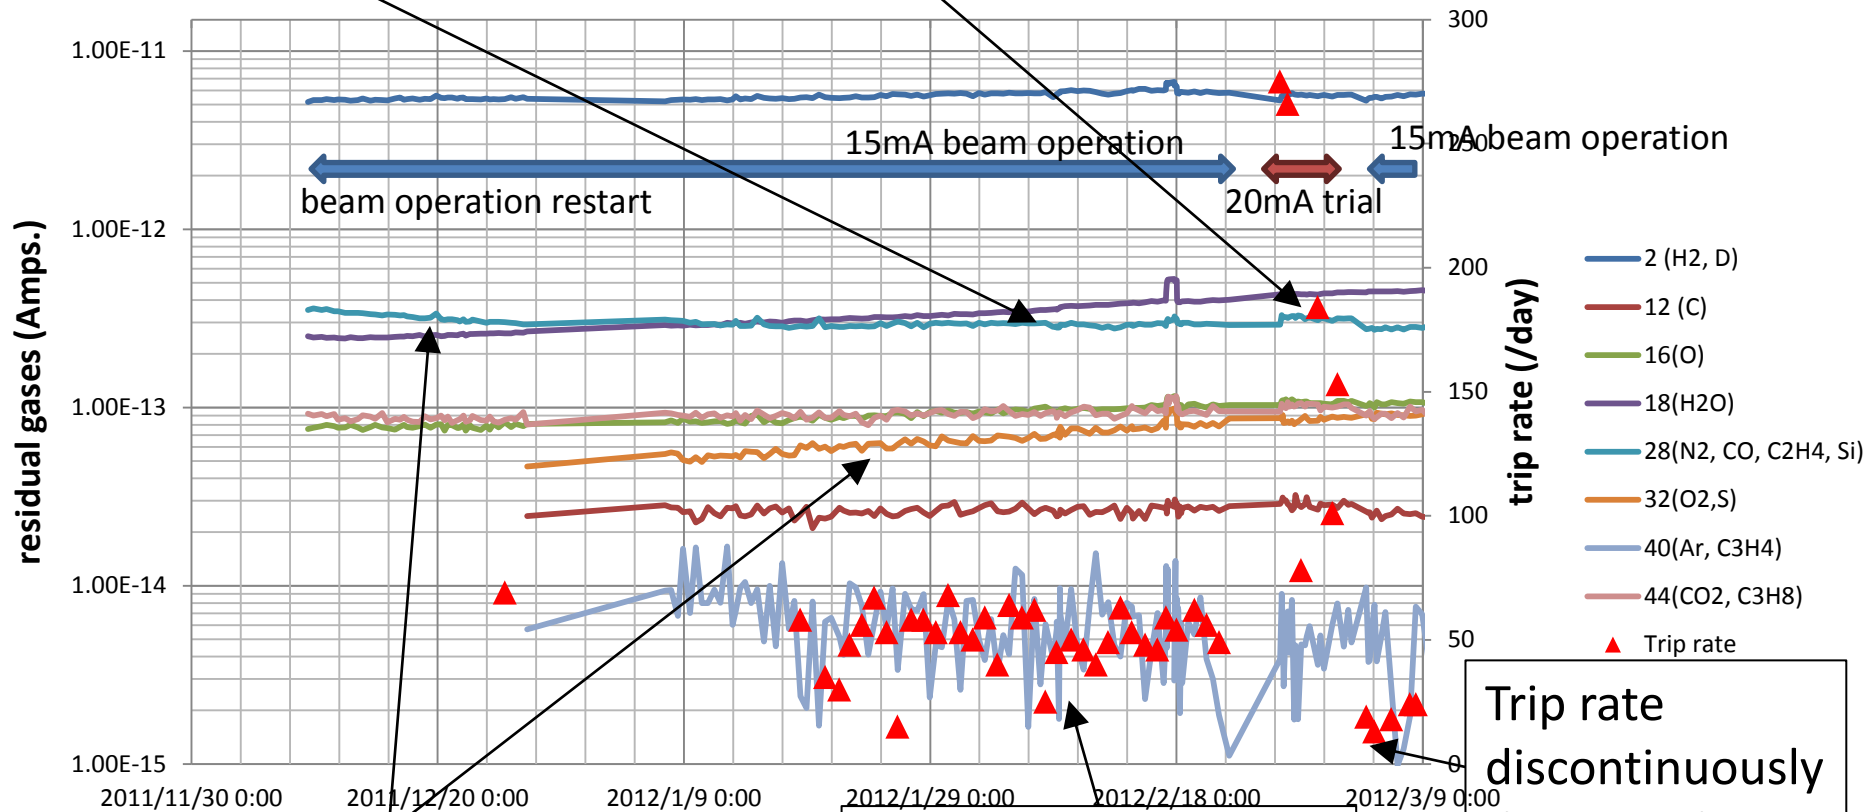
# Residual gas analysis

- mass number 28, we guess relating to hydro-carbons, both accumulating in the vanes and directory flowing from IS have strong relation to the trip rate.

28 is continuously decreasing

During 20mA trial, 28 increased

18,32 are continuously accumulating

Trip rate is gradually decreasing

Trip rate discontinuously decreased

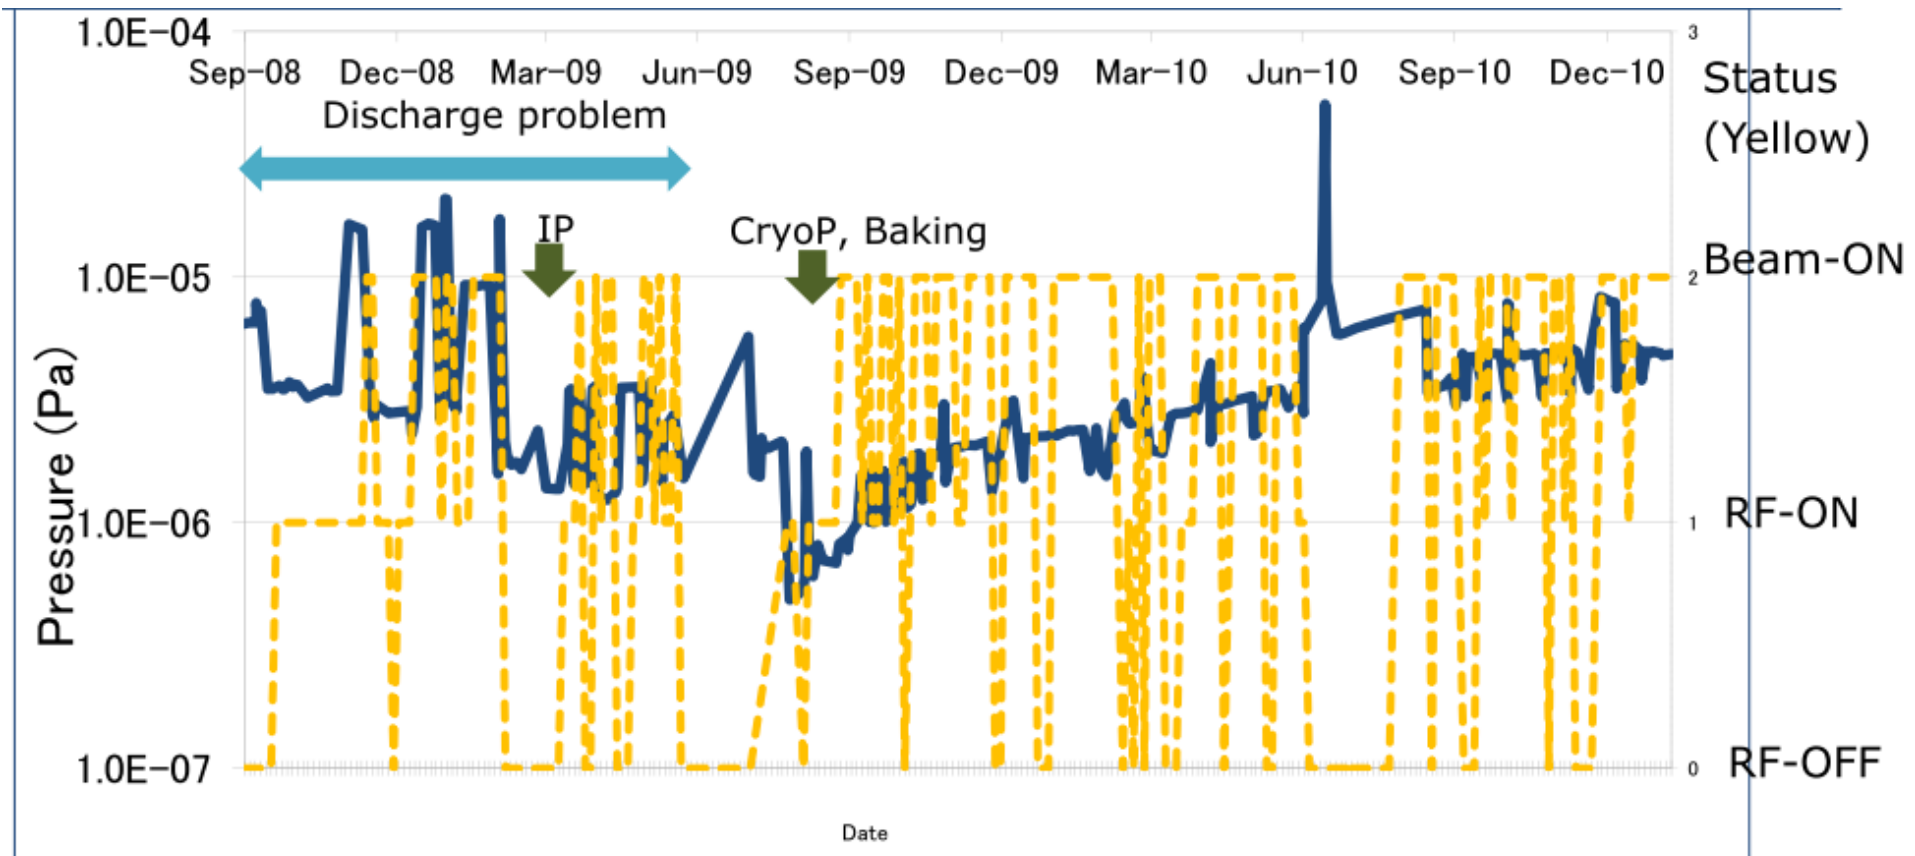
# 震災からの復旧

- 震災により、真空リークはなく、ポンプ復旧まで封じ切っていた。

Vacuum pressure at the RFQ in blue, and status of the RF/beam in yellow.
