System overview

The LHCb Silicon Tracker is part of the LHCb main tracking system and provides data for the region of high track densities. For the tracking station TT in front of the main dipole magnet, the Silicon Tracker covers the full acceptance angle of the experiment, while for the stations T1-T3 after the magnet, the Silicon Tracker only covers the region directly around the beam pipe. The analogue hit information of the silicon strip detectors, which is amplified by the Beetle readout chip, is transmitted via copper cables to the Service Boxes, which are located outside the acceptance area. This not only reduces the amount of material inside the detector but also relaxes the requirements on the Service Box electronics concerning radiation tolerance. The Service Boxes hold the Digitizer Boards, on which the analogue signals from the Beetle front-end chips are digitized and encoded into a Gigabit data stream for transmission via VCSEL diodes and 120m of multi-ribbon optical fibre to the counting house. In the counting house, the optical ribbons can be directly connected to TELL1 preprocessor boards equipped with two multi-channel optical receiver cards.

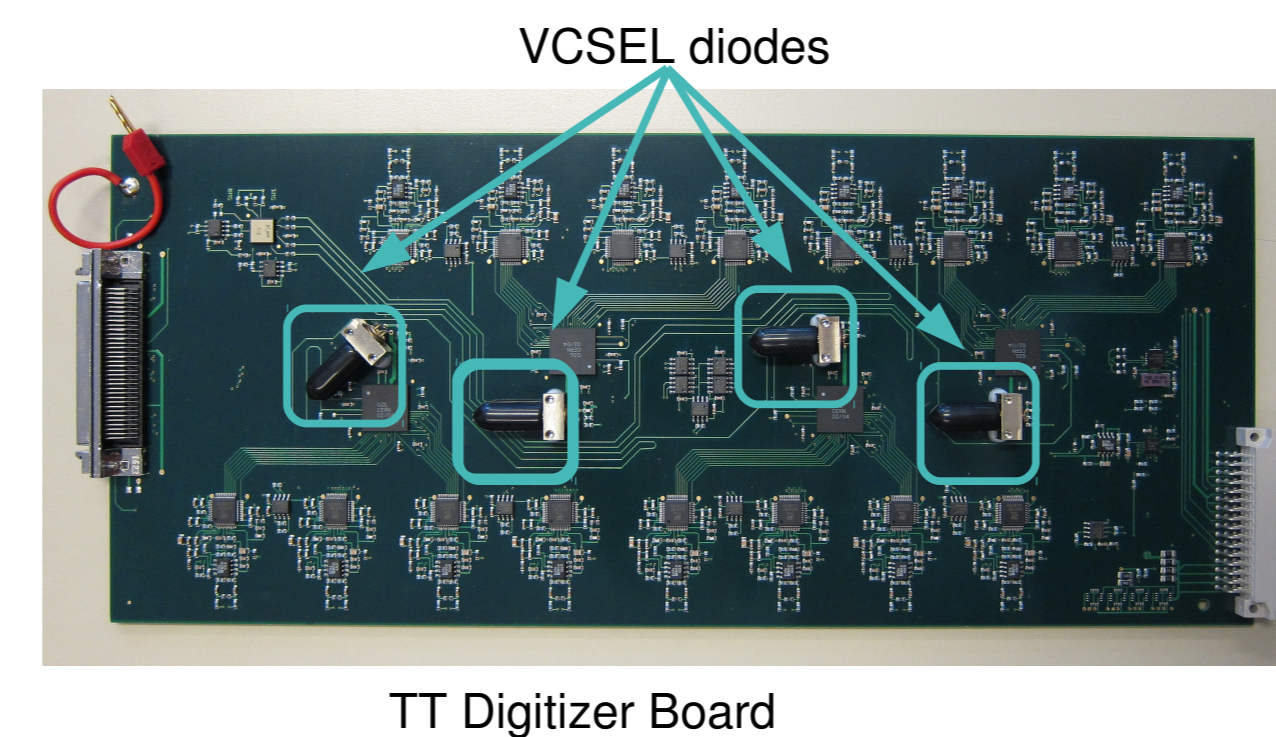
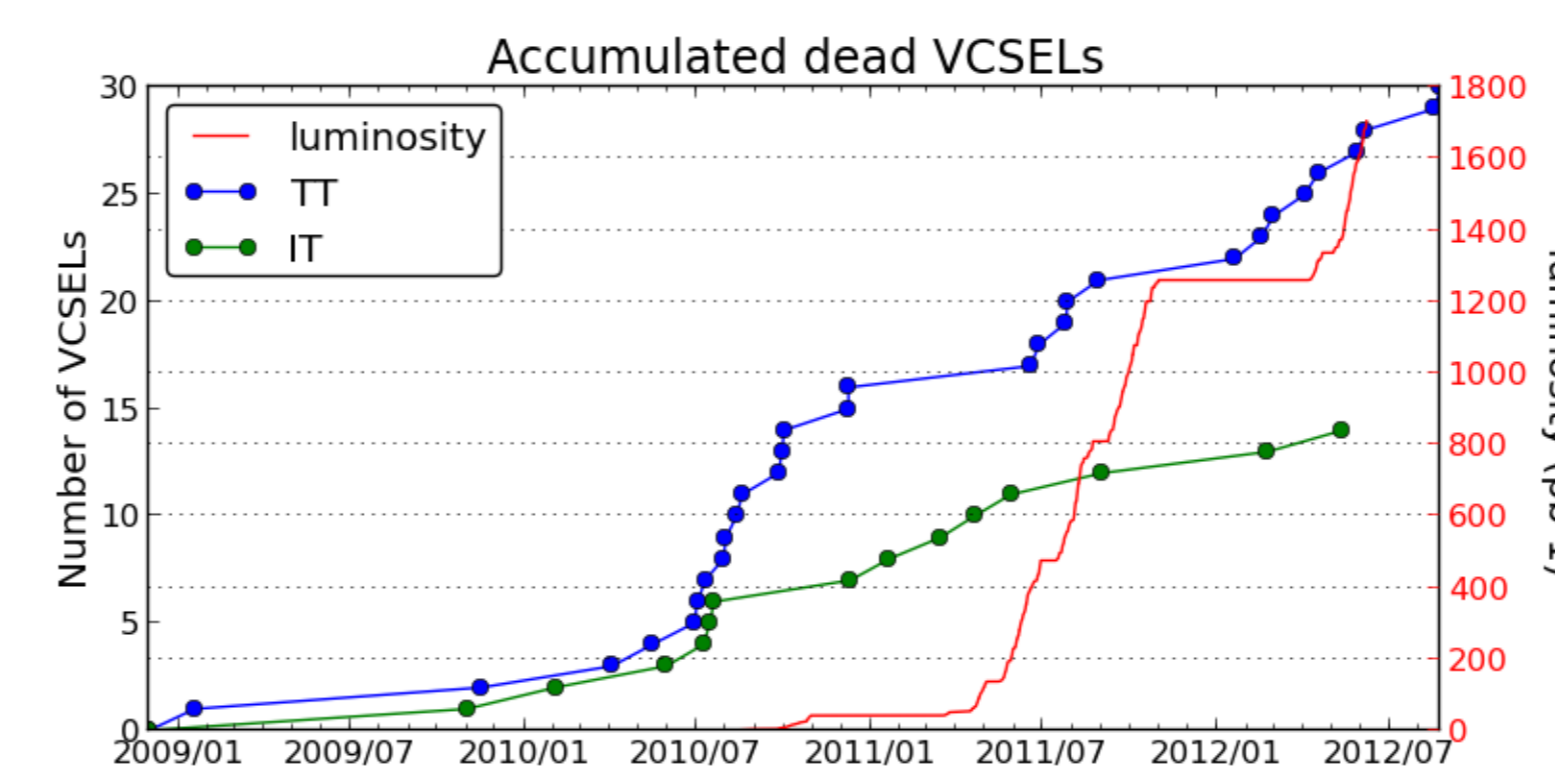
VCSEL reliability

A study was already presented in TWEPP 2008. The VCSEL diodes used in the readout system were wave soldered in production. 30% presented low output power, these were hunted and replaced.

Since then some other VCSEL diodes had to be replaced due to malfunction (only 2%). No significant correlation has been observed.

The VCSEL diodes are not exchanged "in situ", the whole digitizer board is replaced, and in the process multiple cables need to be unplugged, sometimes including the optical fiber carrying the clock signal. This has caused another problem, only understood this year.

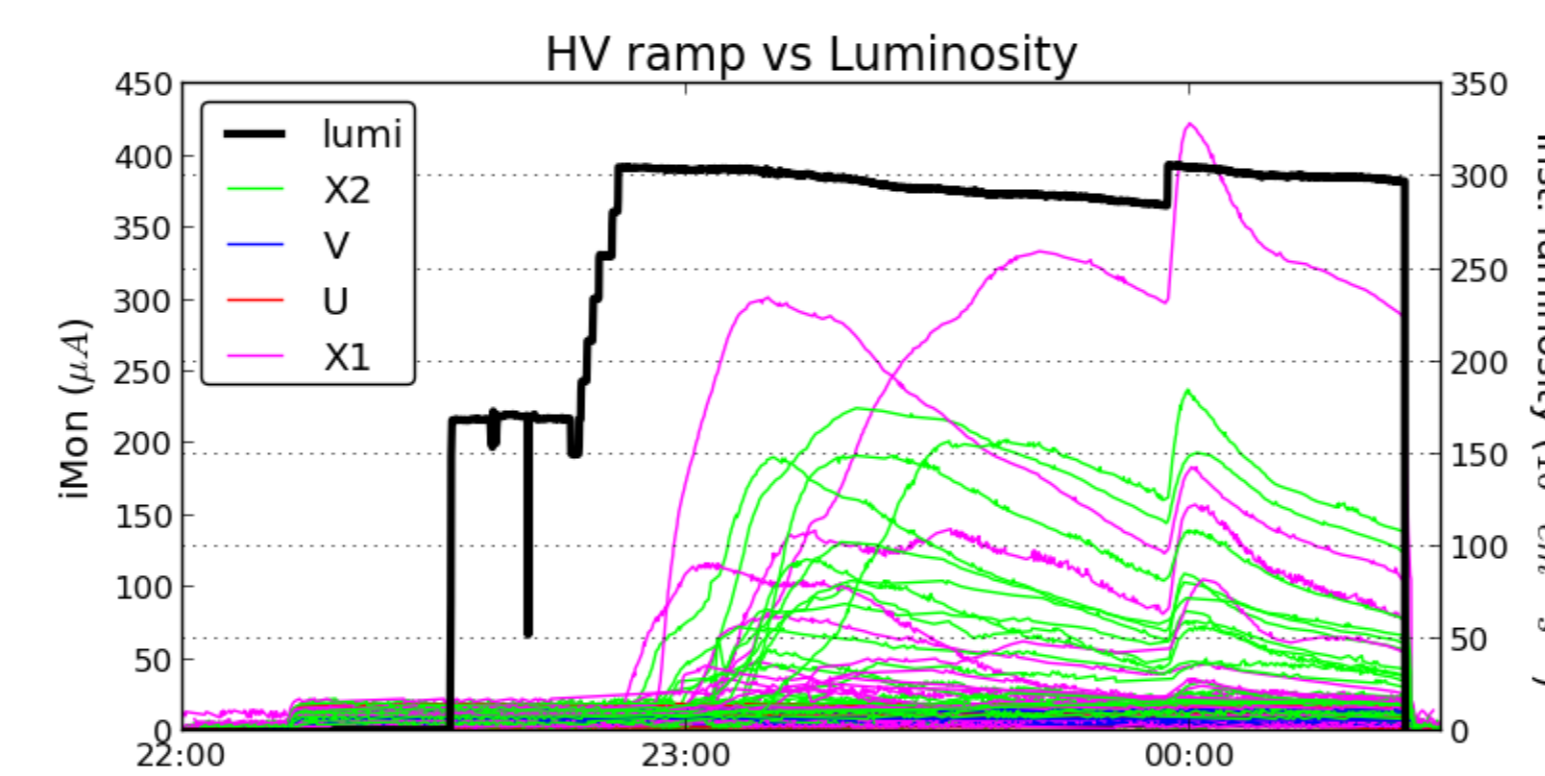
Ramping HV with beam

Since October 2010, various TT detector biasing voltage channels present peaks in the current that sometimes reach 1 mA while taking data, and can reach 5mA with no beam, which leads to the trip of several HV channels.

- Correlation effect with instantaneous luminosity ramp
- Moderately fast ramp up
- Slow ramp down
- Mostly X1 and X2 layers

- Lowering the Voltage from 350V to 300V ✓
- Lowering the Temperature from 5°C to -15°C x
- Training the detector HV without beam ≈
- Luminosity leveling (ramp luminosity in small steps) ✓
- May 2012: Installing Kapton insulation (confined the problem to X layers) ✓
- May 2012: Installing electrostatic shield ≈
- Mid June 2012: Keep HV and shield on after beam dump ✓
- Mid June 2012: Change in LHC beam filling scheme ?

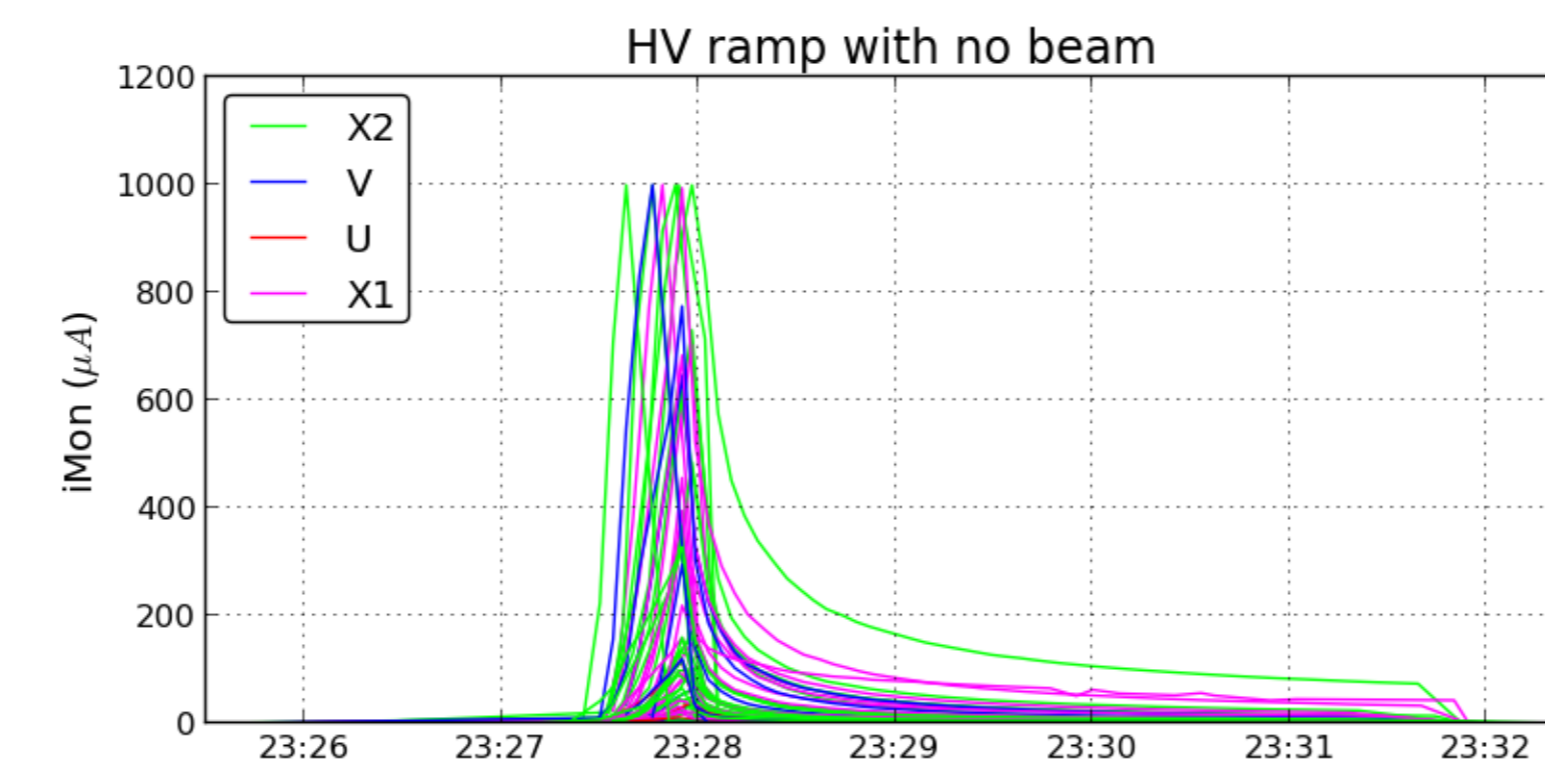
Ramping HV with no beam

- Considerably higher peaks (Trip limit set at 1 mA)
- Very fast ramp up and ramp down
- Training effect not conclusive
- Effect also observed in few channels for U and V layers

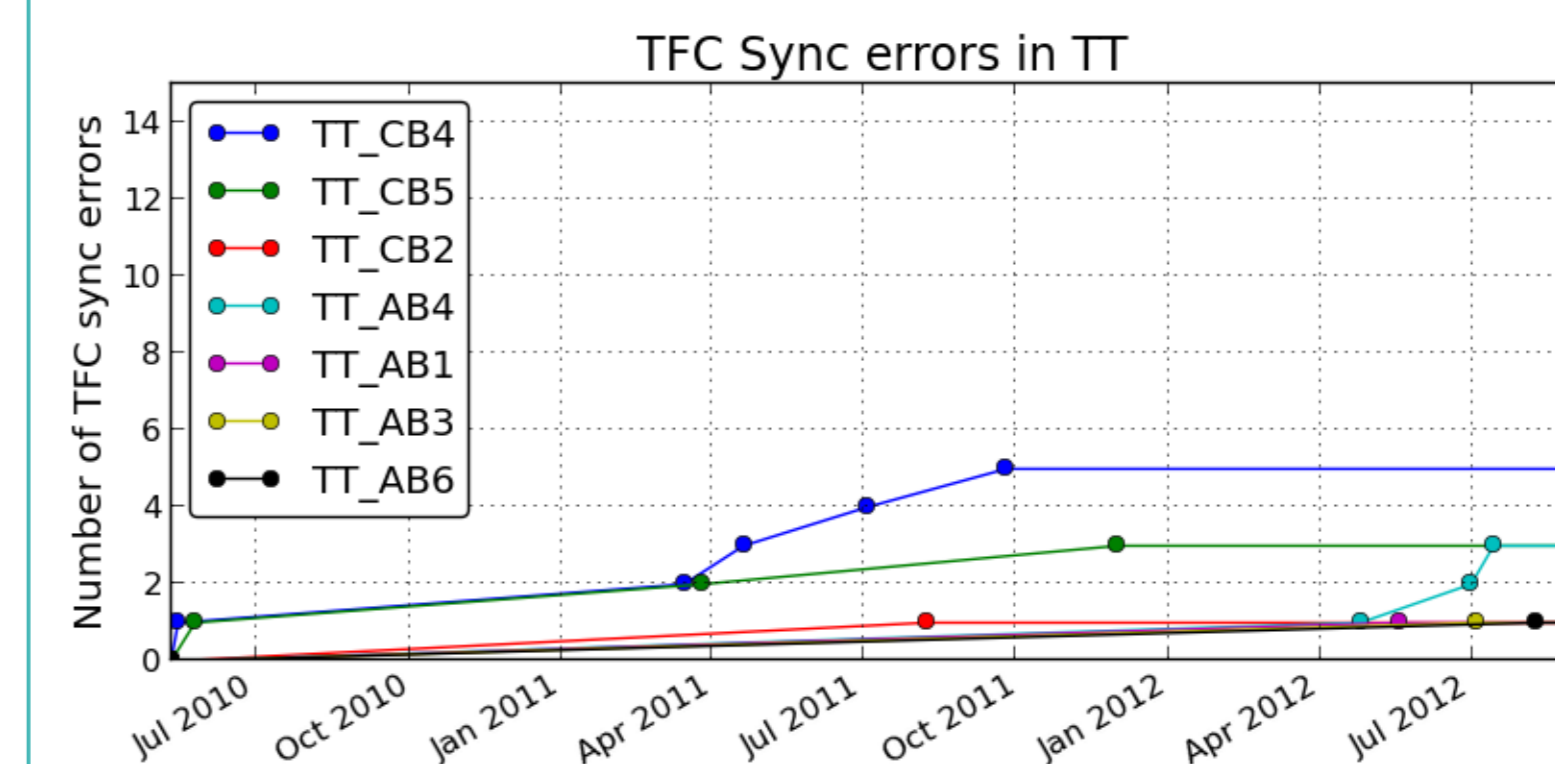
Plots may be incomplete due to problem masking and loss of log files

- Before January 2012, only seen in one quadrant (Cryo-Bottom).
- January 2012. VCSEL exchange operation.
- Afterwards, problem fixed in CB quadrant but now shows in AB (Access-Bottom) quadrant.

- Deduced problem was in the clock (TFC) fiber connection with the Control Board in the Service Boxes
- 19th April 2012. Software automatic recovery workaround was put in place. No access to the hardware

- The automatic recovery takes almost 2 minutes since the error detection until the detector is taking data again

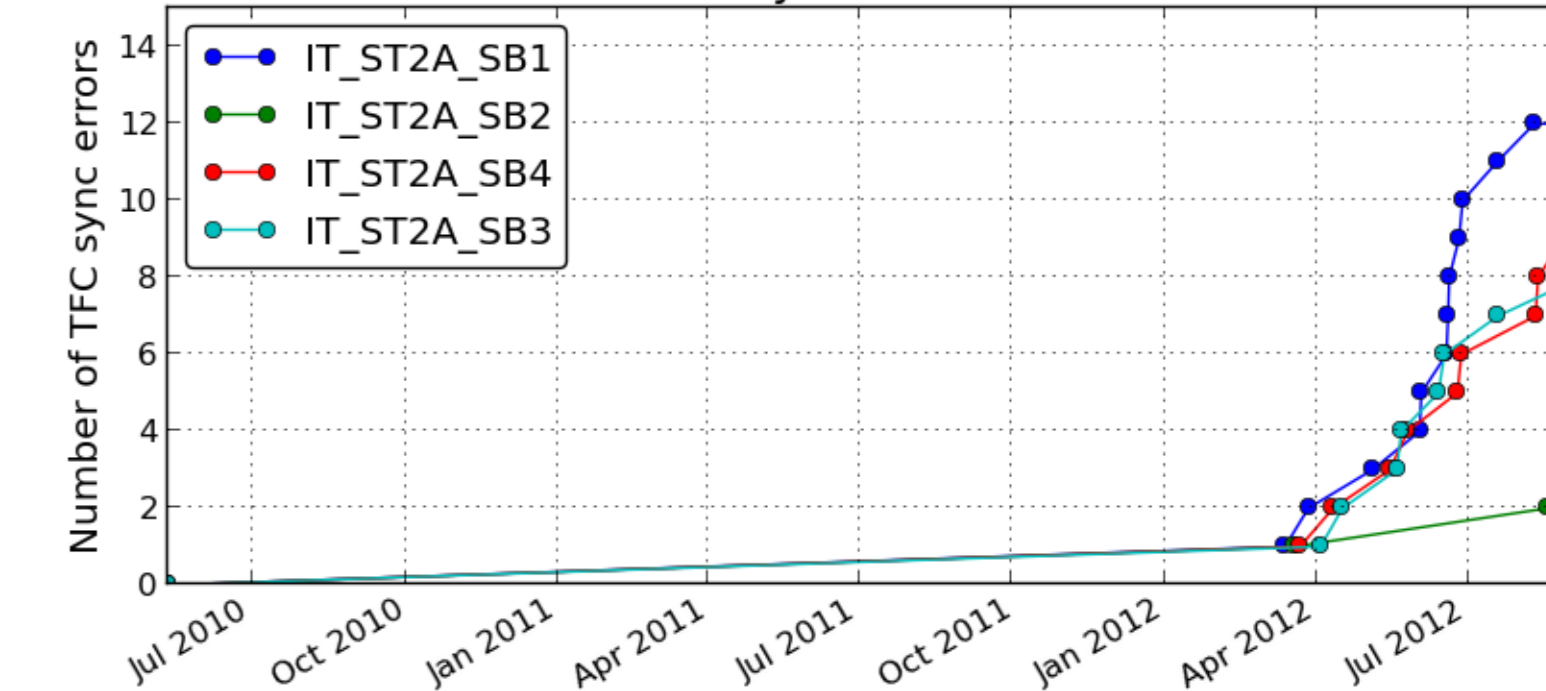
TFC Sync errors in IT

- Before March 2012, problem not observed
- January 2012. VCSEL exchange operation
- SPECS software problem until March 2012
- March 2012, problem shows in ST2A half-station
- 24th April 2012, attempt to clean the TFC fibers reduces the frequency of the problem.

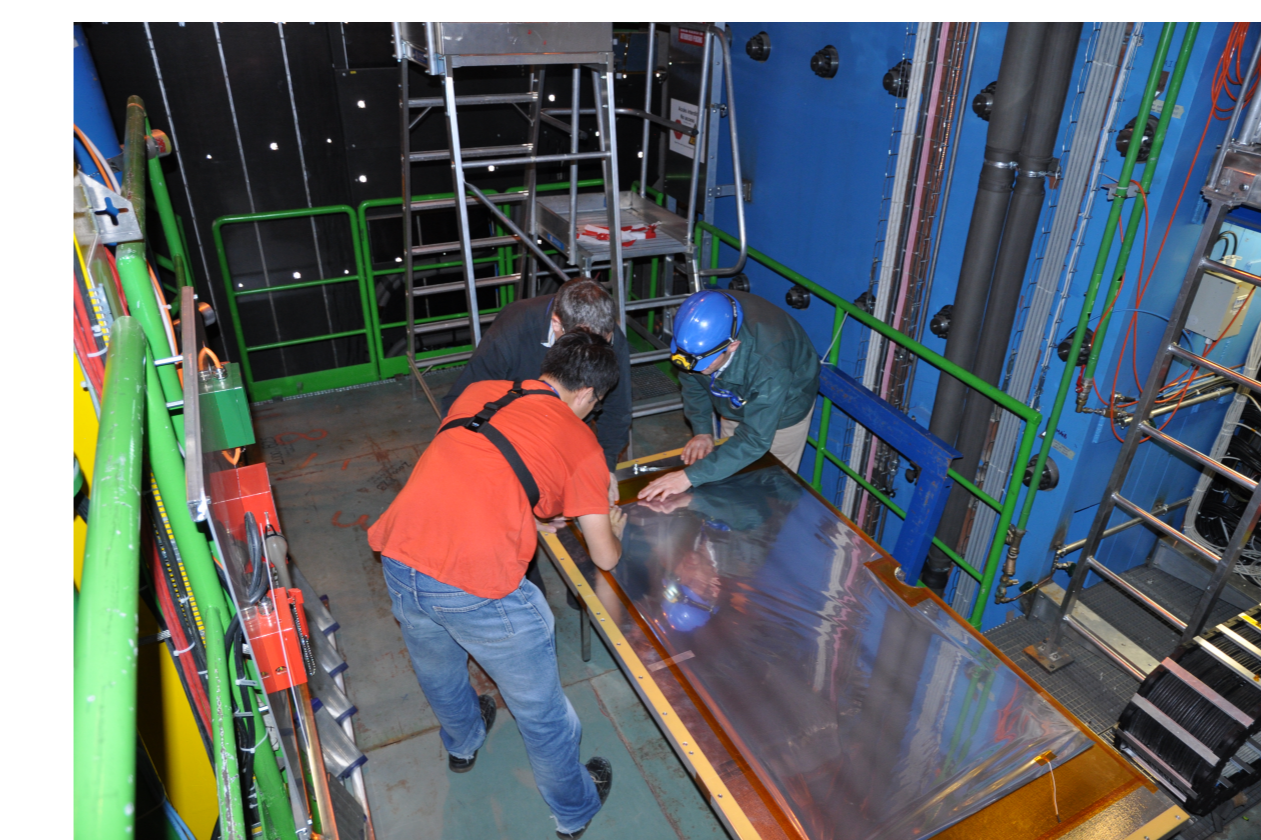
The electrostatic shield

U and V layers have the biasing voltage on both sides of the sensor, while X1 and X2 layers have the Detector box cover lid in one of the sides, connected to ground voltage.

- MYLAR (since May 2012)
- Aluminium foil (electrostatic shield, May 2012)
- KAPTON (since May 2011)
- Aluminium foil (existing cover lid)
