#### **Paul Scherrer Institut**

Current activities on the rf-system for the proton accelerator facility at PSI

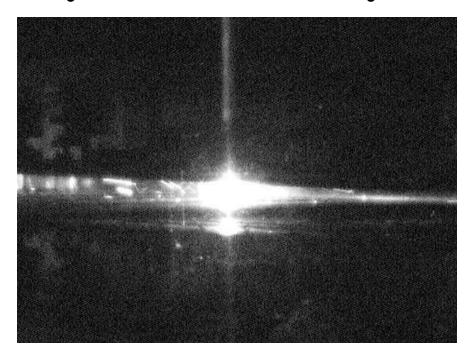
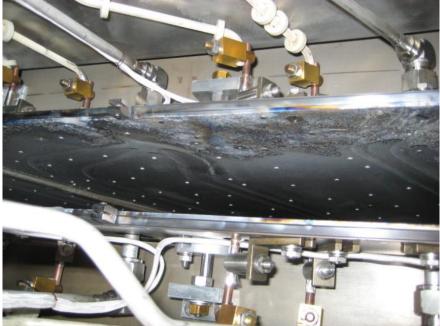
During operation in 2010 a failure of the cooling system for trim coils in sector magnets occured. The Magnet power supplies were switched off, rf was still running. Temperatures of trim coils went up to 100° C. Since this event the voltage of cavity 3 had to be reduced from 850 kVp to 650 kVp. At higher levels there was a lot of arcing in the cavity and no stable operation possible.

View inside the cycloton at the end of operation period 2010 during tests to push the cavity 3 to nominal voltage.

Trim coils of sector magnet 5.

During shutdown 2010 they were replaced.

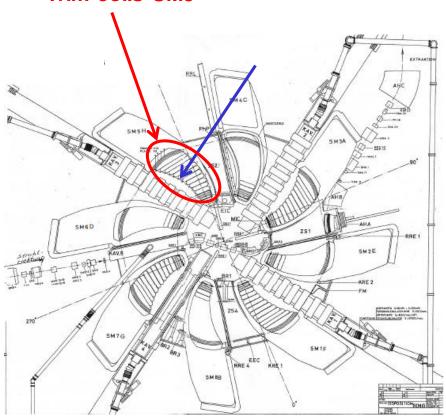
#### Trim coils SM5

# cavity 3 suffered from the trim coils SM5

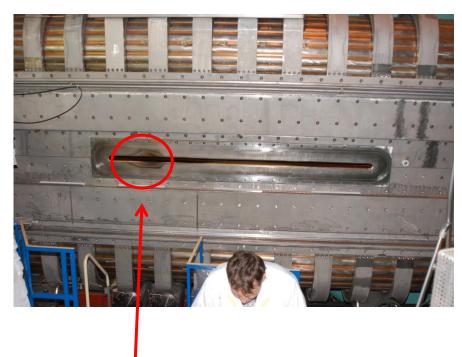
#### View on cavity 3

Marks from the "fire work" in the cyclotron

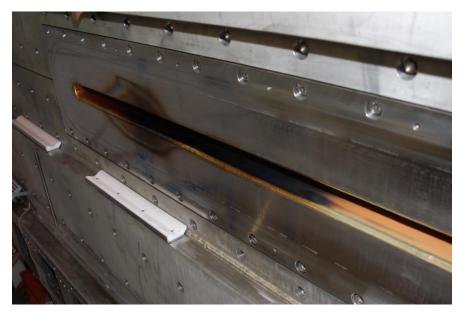
Closed view on cavity 3

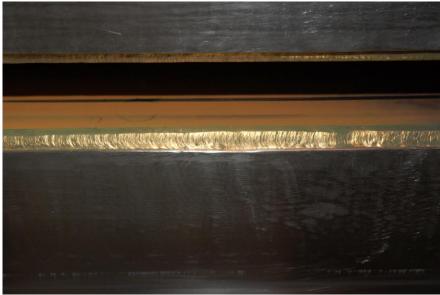
Beam slit of cavity 3

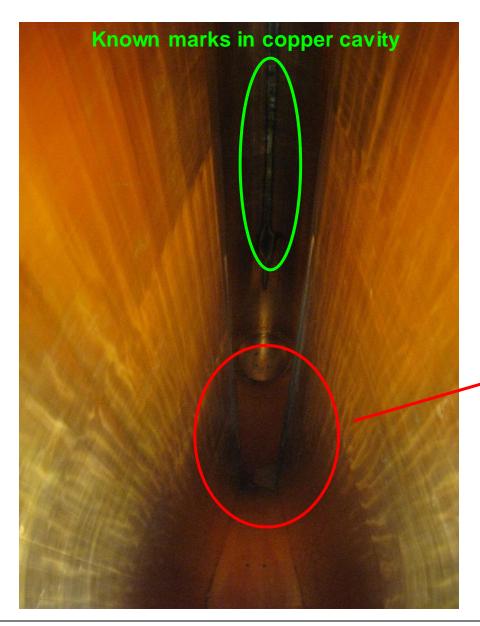
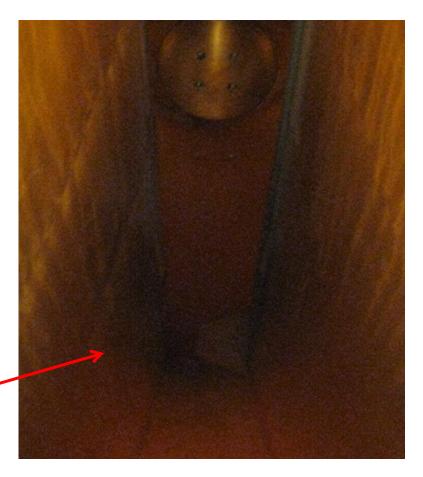
## Inside cavity 3

Dirt (aluminum an stainless steel)

→ material from trim coils

Cavity 3 cleaned during shutdown 2010 and afterwards conditioned to 900 kVp

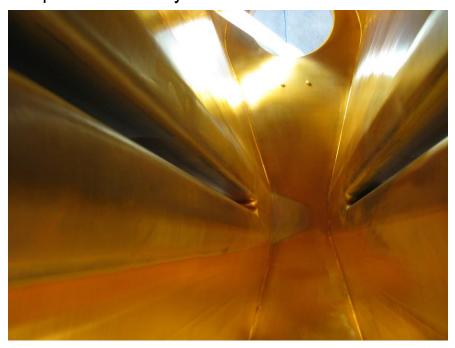
During operation in 2011 we observed in cavity 2 about 7 to 10 times more micro sparks than in the other cavities. A micro spark is a short spark in the cavity and the rf is switched of for about 200 µs. Inspection of cavity 2 in shutdown 2012.

Inside cavity 2. The same mark as in cavity 3 but from the other direction.

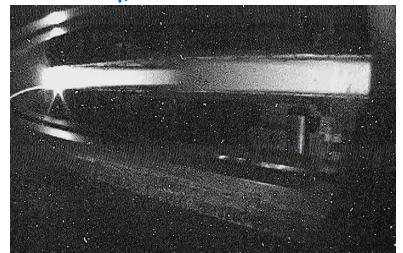
We have to live with some glowing in the cyclotron...

View at plasma from window at flattop cavity toward SM7

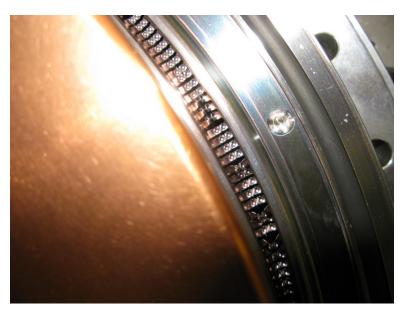
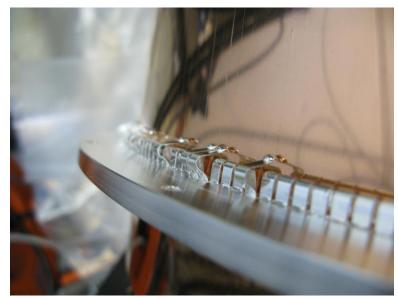
Finger contacts of upper and lower tuner were bent.

Distance between plunger and contact was wrong calculated.

New contact rings were machined and plungers were polished

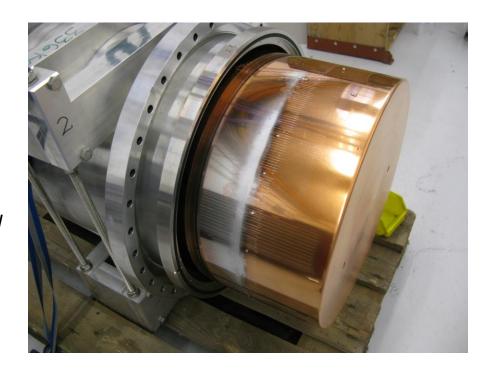
During this second test sequence the resonator was fed with power between 150 kW and 200 kW by a mistake.

Later again a strange behavior of the tuning system was observed.

⇒ Melt down of finger contacts

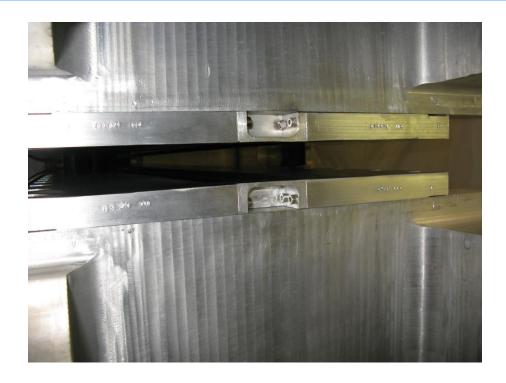
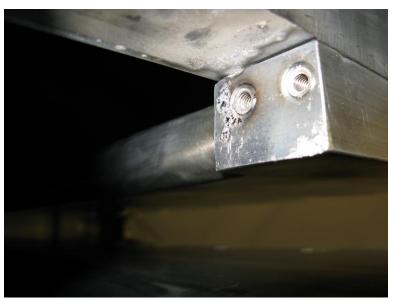
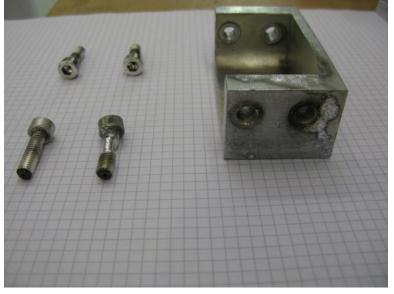
Bad rf contact at the bridge between the lips in the central region. Molten screws and marks from arcing were found.

Redesign of bridge?

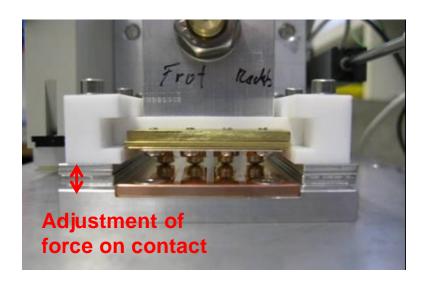
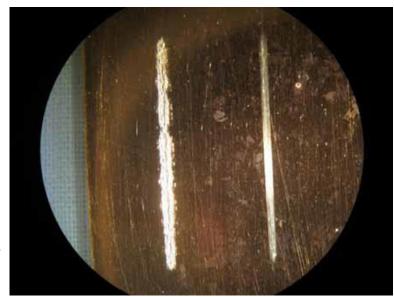
Copper plate after 800 moves over a distance of 50mm.
