# CMS Preshower Leakage Currents Measurements and Observations

Alan Honma  
*on behalf of the CMS Collaboration*

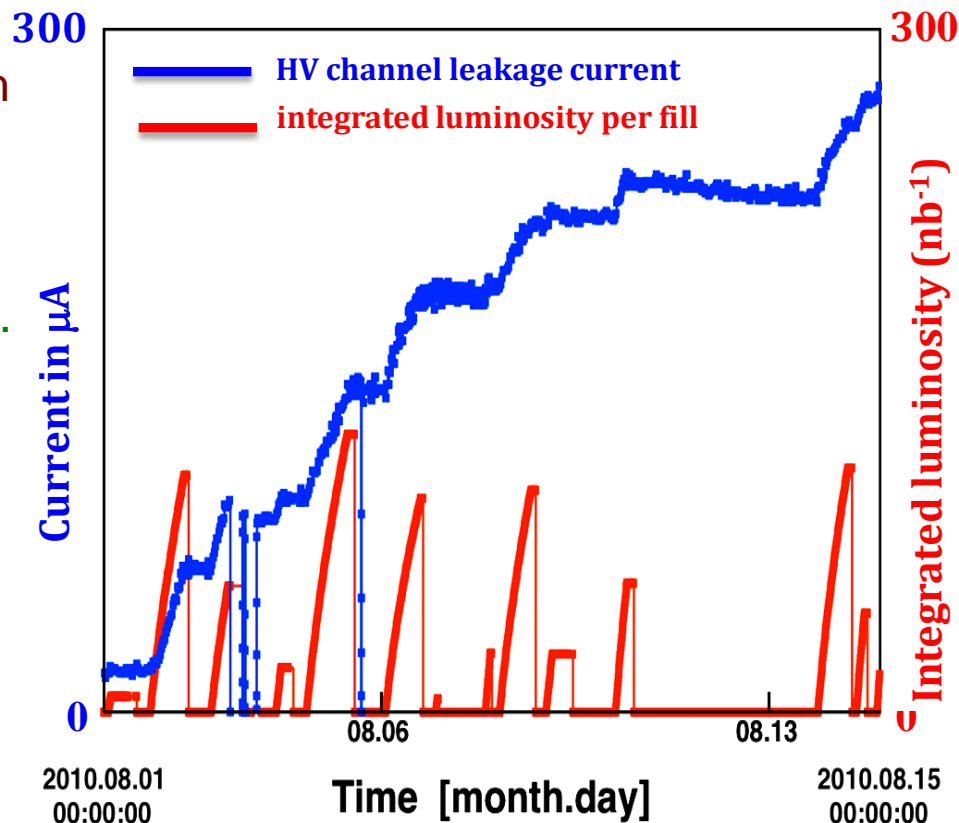
Starting in Aug. 2010, had HV channels with current reaching max safe limit (2mA). Since a HV channel powers 6 to 35 sensors, the sensors that were responsible had to be identified and then unplugged. However, many sensors not responsible also had to be unplugged because most sensors are powered in pairs.

Current increase correlated with luminosity.

Became problematic with very little lumi ( $10^{31} \text{ cm}^{-2}\text{s}^{-1}$ ,  $3.5 \text{ pb}^{-1}$ ). Bulk damage from this lumi should be  $\ll 1\mu\text{A}$ .

A total of 81 sensors (2% of all Preshower sensors) were unplugged, mostly in Aug-Sep 2010, the last in April 2011.

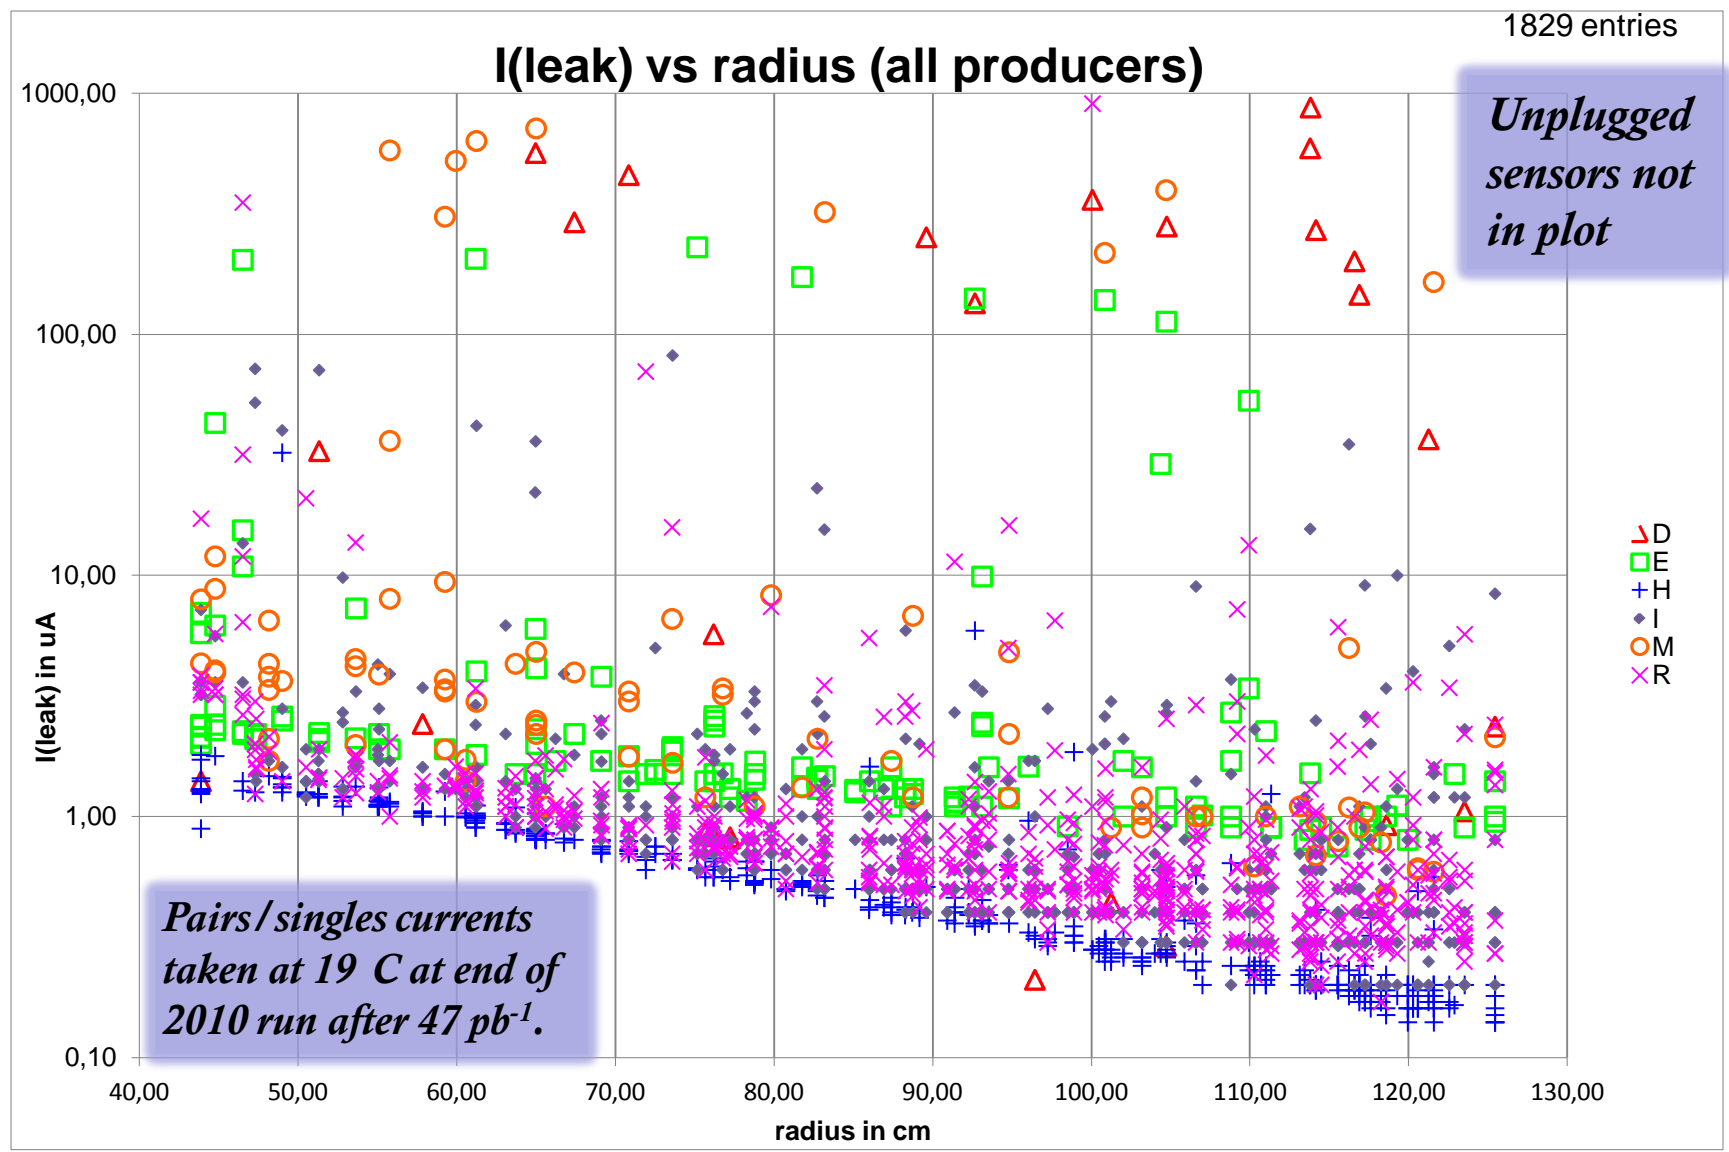
# Producer dependence and radial dependence

H sensors have very uniform and lowest currents. R and I sensors have some excess current but few have very large values ( $>100 \mu\text{A}$ ). Some E sensors have large currents but most are OK.

Even though many M sensors were unplugged, many of those still working have large currents. Most D sensors have high currents.

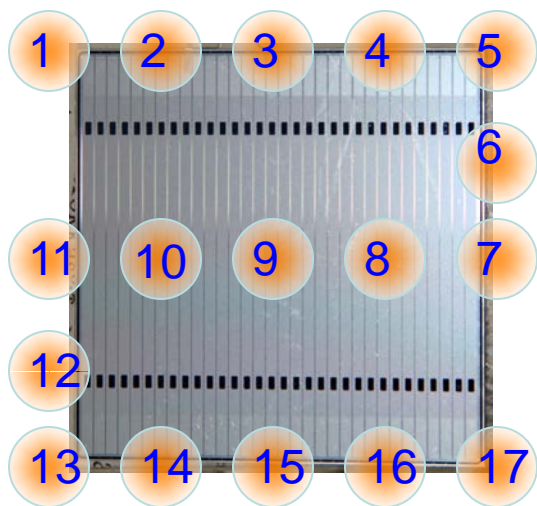
H sensor, 60 Gy per point

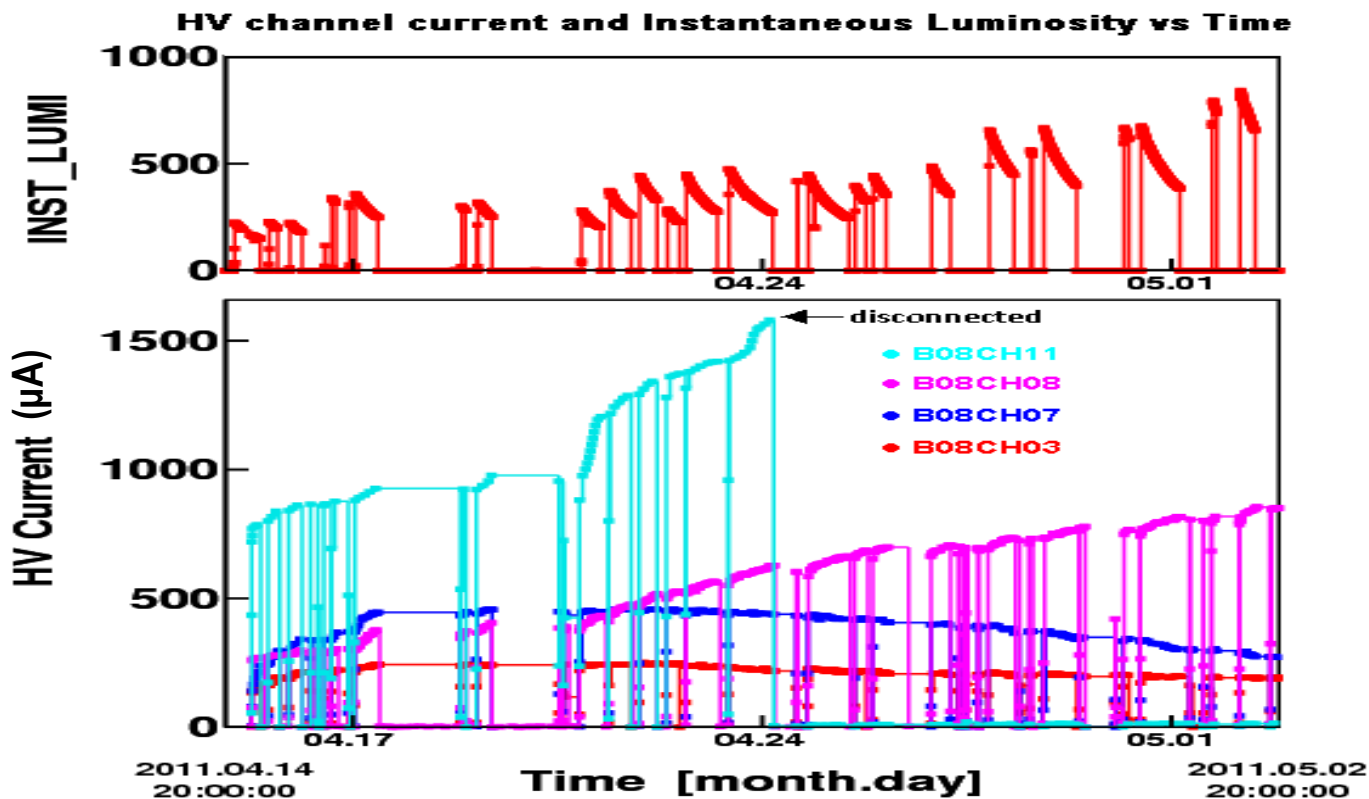
From May 2011 onward, most HV channels showed slowly increasing, flat, or slowly decreasing leakage currents. By end 2011, many saturated then started to decrease.

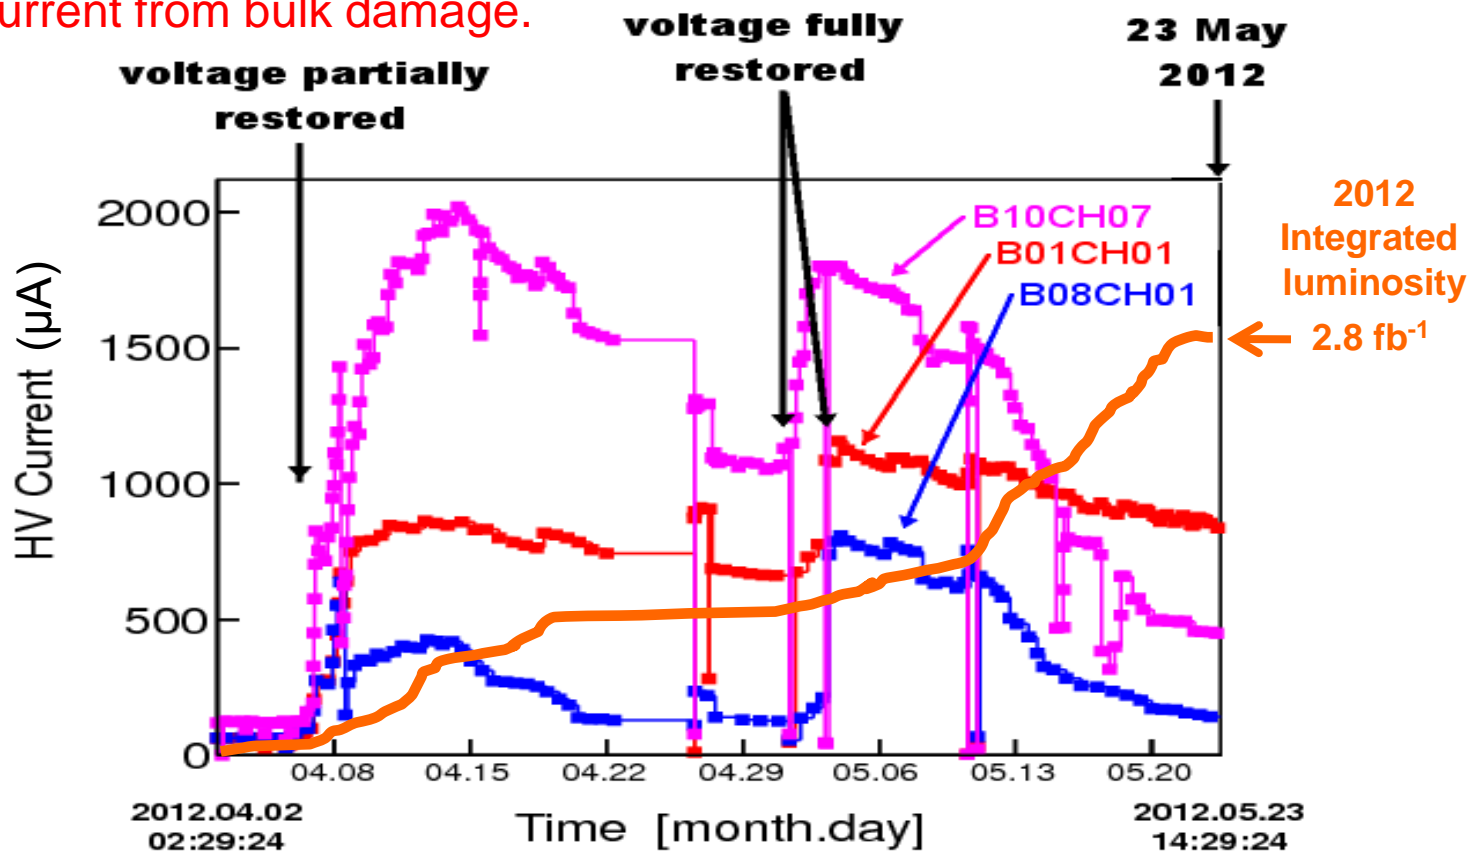
On 8 April 2012 we turned on the HV to all previously unplugged sensors and checked their currents after about  $10 \text{ pb}^{-1}$ . Some went to high current and we had to lower their voltages. Most increased in current but not to a dangerous level. But most saturated and the currents decreased, albeit at different rates. Nearly all are back to their nominal voltage and many are back to their expected current from bulk damage.
