# PSB DUMP ENDOSCOPY LIU-PSB Meeting

February 16, 2012 Alba Sarrió

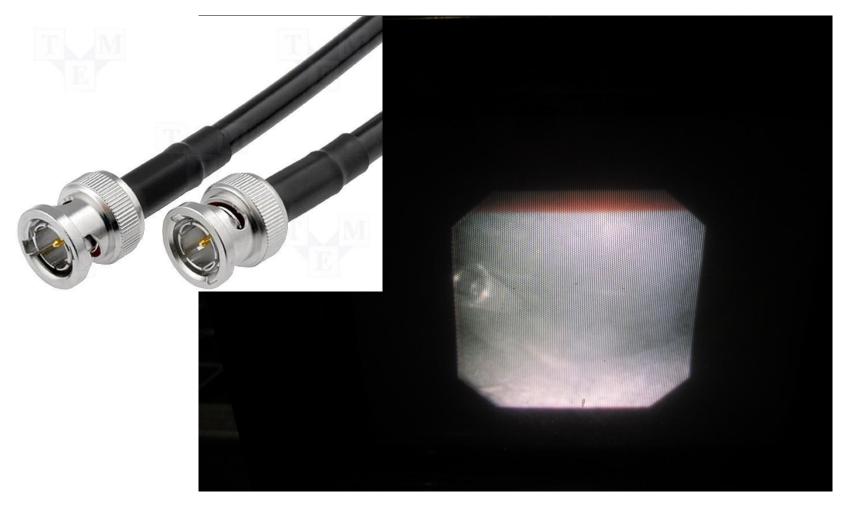
BCN connection for the thermocouple?

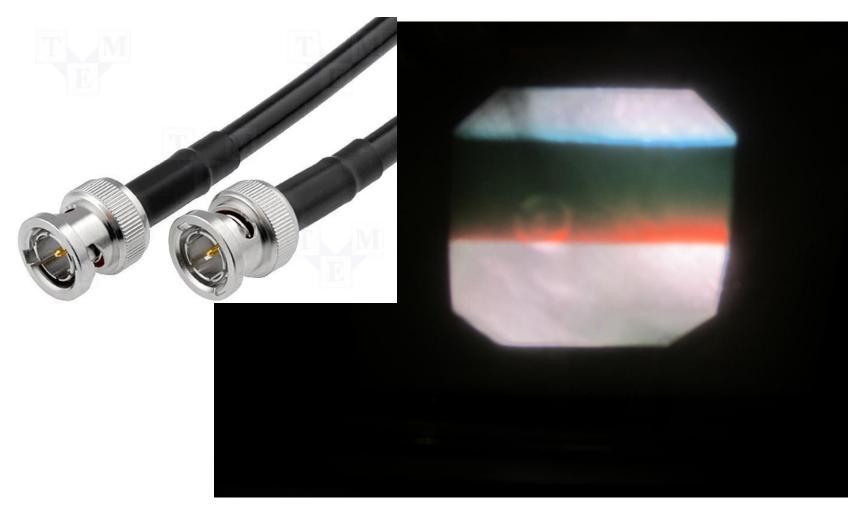
BCN connection for the thermocouple?

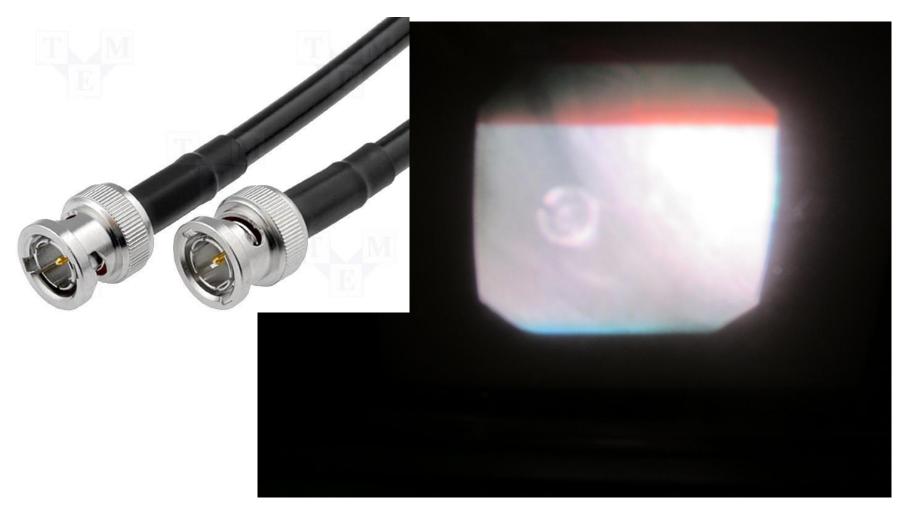
BCN connection for the thermocouple?
