CMS Preshower Excess Leakage Currents

Alan Honma

Excess Leakage Current Problem History

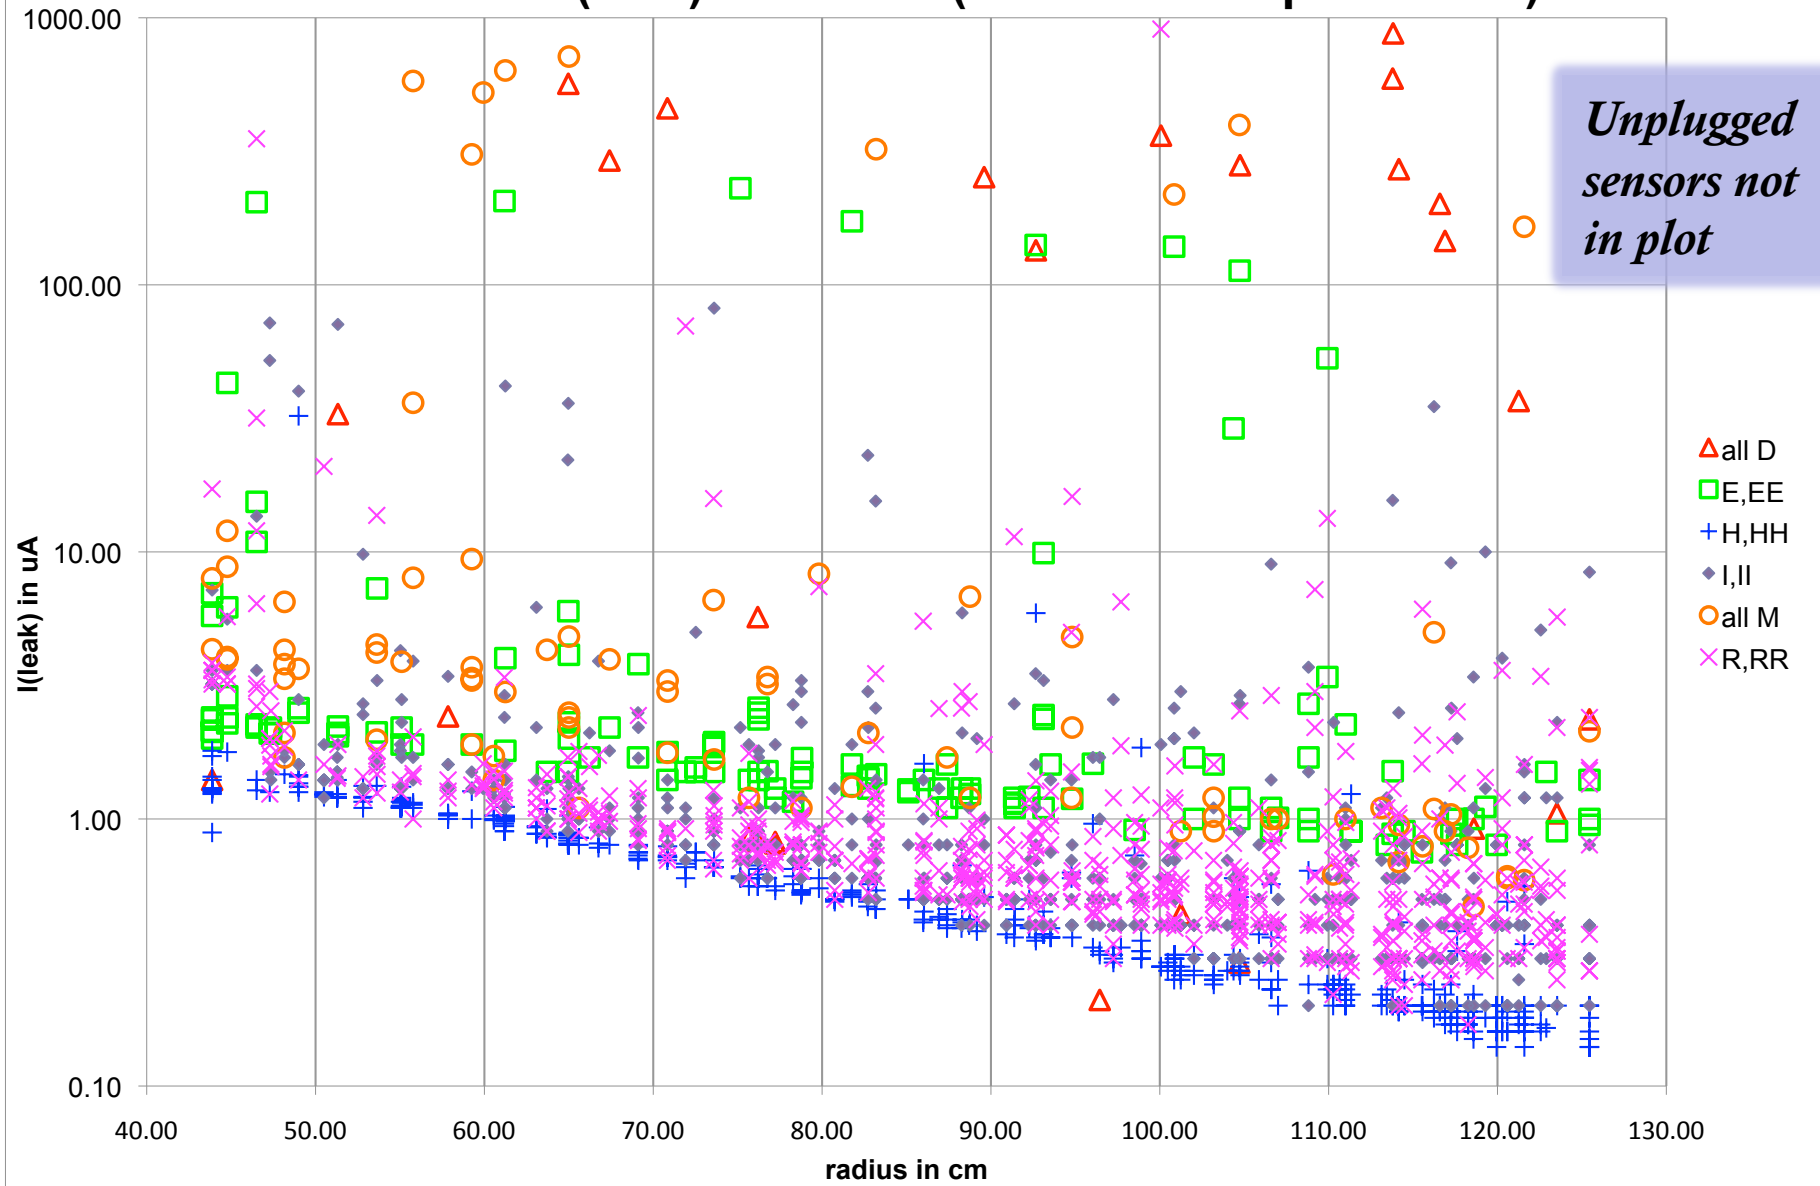
17 Nov 2010: I(leak) vs radius (for identified producers)

- Hamamatsu (H) sensors have very uniform and lowest currents.
- Russian (R) and to a greater extent Indian (I) sensors have some excess current but few have very large values ($>100 \mu\text{A}$).
- Some ERSO (E) sensors have large currents but most are OK.
- Even though many MTC (M) sensors were unplugged, many of those still working have large currents.
- Most Demokritos (D) sensors have high currents.
- Calculated bulk damage follows closely the line formed by the H sensors. The implication is that H sensors have very little excess current. All other producers have varying degrees of excess current.

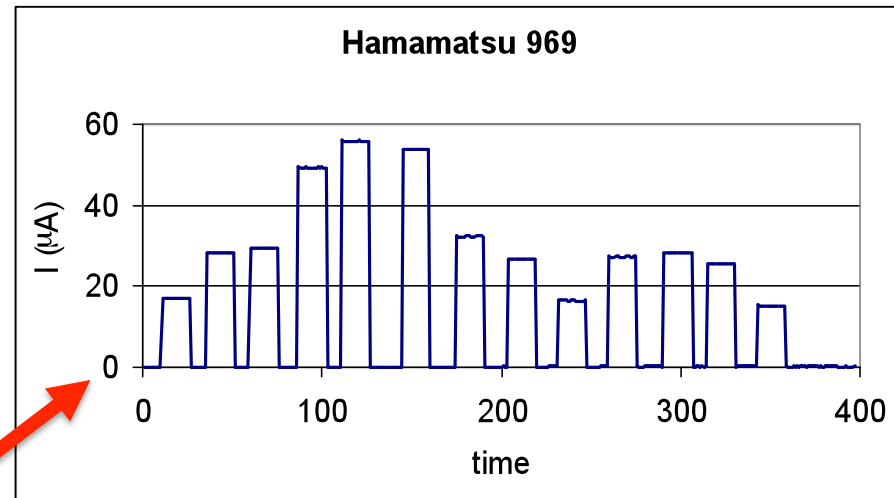
H sensor, 60 Gy per point

- So far excess currents from X-rays observed for MTC (6/6), ERSO and Indian sensors. Not for Russian or HPK even up to 60 Gy/point. No Demokritos available for testing.
 - Results not reproducible systematically.
 - No position correlations found so far.
 - Amount of radiation required (for MTC) is much more than we should be receiving in LHC (highest expected dose ≈ 5 Gy for all 2010)
- Interesting positive results with higher humidity to remove excess current. Likely explanation is humidity leads to negative surface charge which increases hole mobility, eliminating trapped charges. Unfortunately, adding humidity to Preshower volume could cause condensation/frost problems.
- Conclusion: many similarities between X-Ray induced currents and excess currents in Preshower. Thus, strong evidence for surface leakage but mechanism not fully understood.

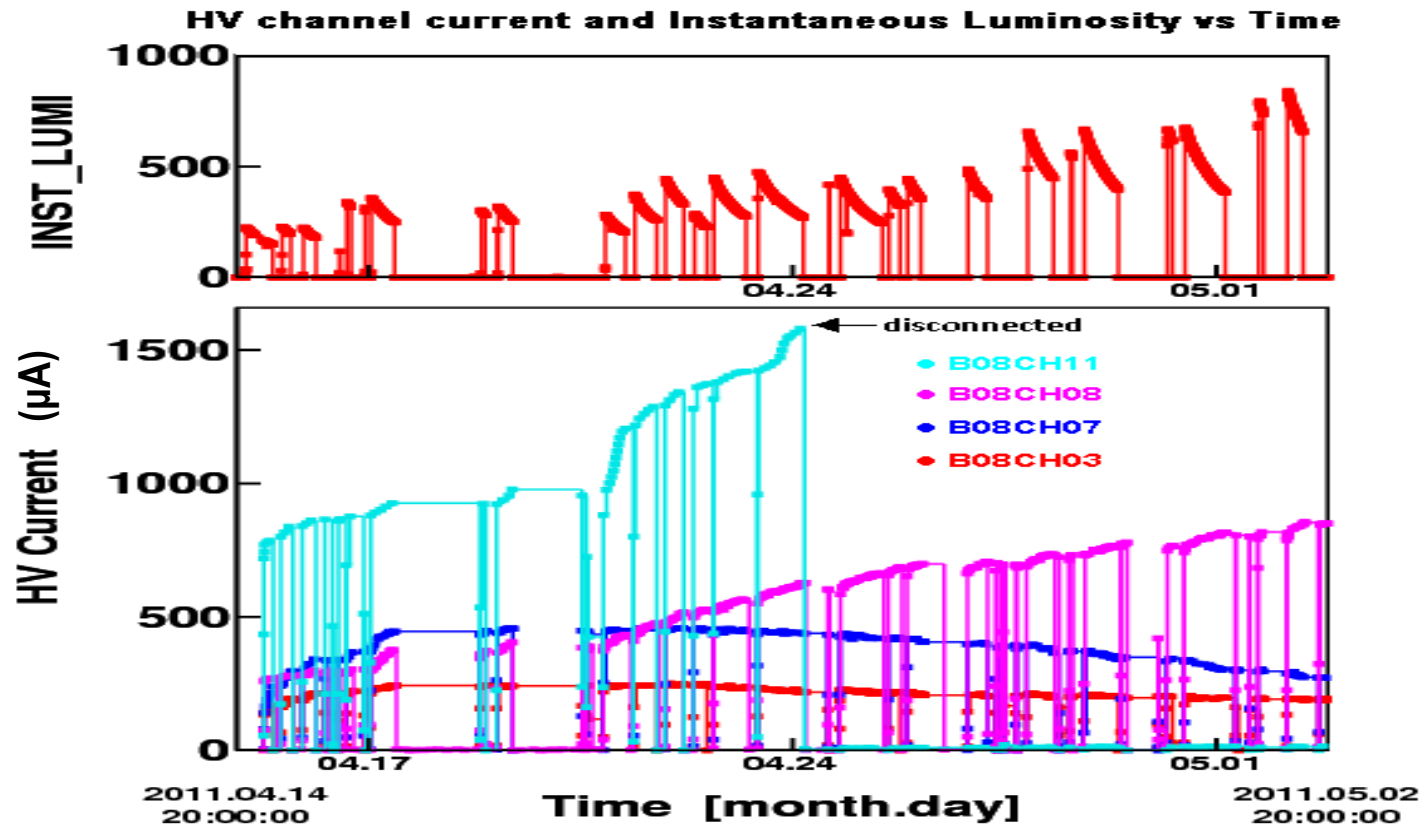
From May 2011 onward, most HV channels showed slowly increasing, flat, or slowly decreasing leakage currents. It appears that there is a saturation effect.

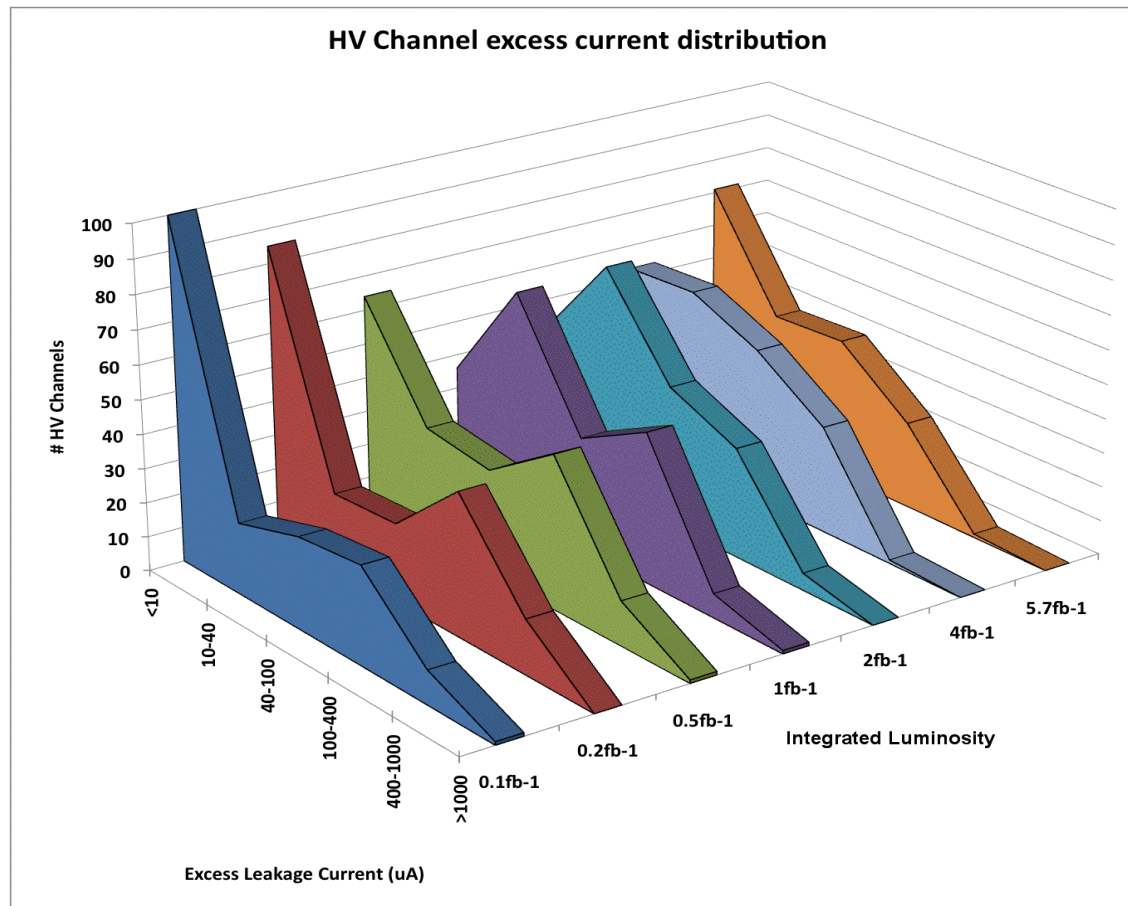
Saturation effect is more clear looking at the distribution of the amount of excess leakage current for HV channels as a function of integrated lumi.

After 1 fb⁻¹, fewer and fewer high excess current channels are observed.

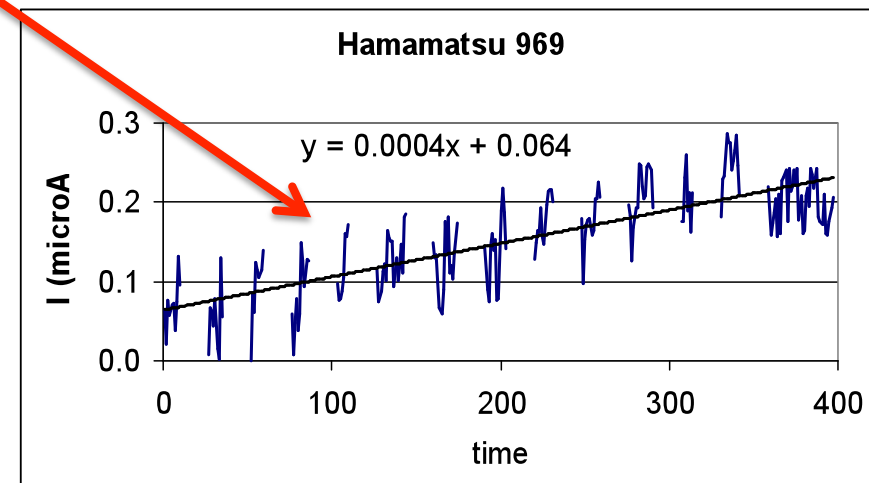
Hamamatsu (HPK) sensors irradiated 60 Gy per point. No undesired effects observed.

The baseline current increases between the irradiations. Observed on two different HPK sensors.

This may be “permanent” surface damage as observed in other experiments (notably e+e-). Causes could be interface and/or oxide hole traps.
