**2nd inter-experiment workshop
on pixel operational experience**

CERN, March 8, 2012

FLOW RATE ISSUES IN THE ALICE SPD COOLING

Rosario Turrisi

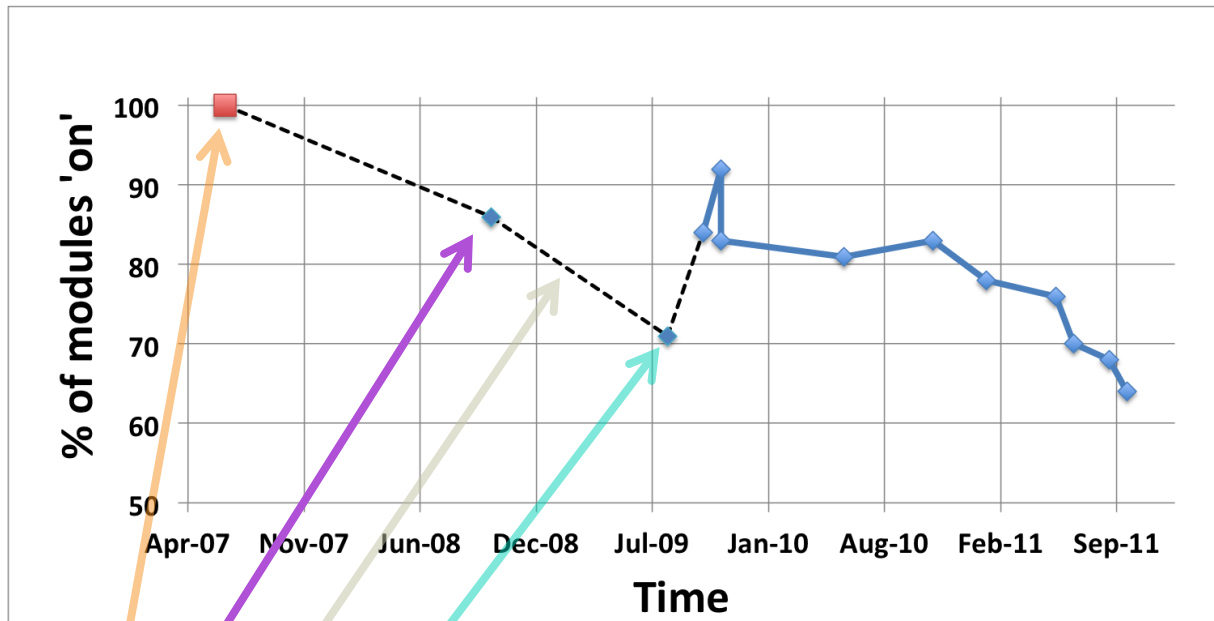
DSF status (tests pre-installation): efficiency = 100%

First switch on after installation: efficiency = 87%

Long stop (you know why...) – minor rerouting of return pipes

Restart after long stop: efficiency = 71%

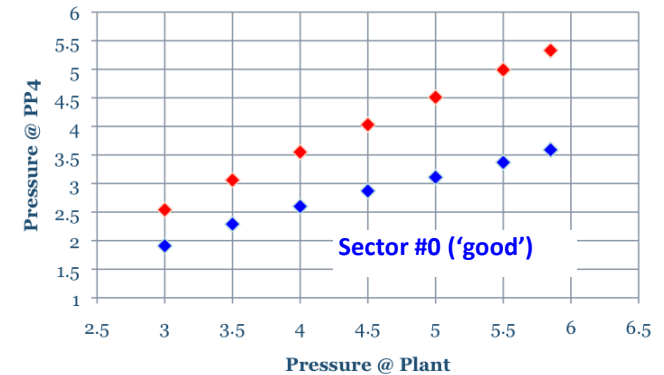
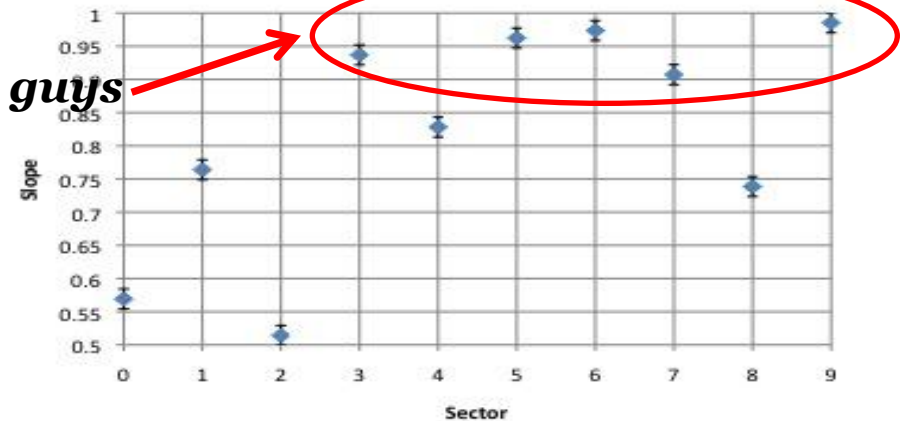
Observed behaviors:

1. "Good" sectors have a higher pressure drop
2. "Bad" sectors are more "sensitive" to pressure changes ...

bad guys

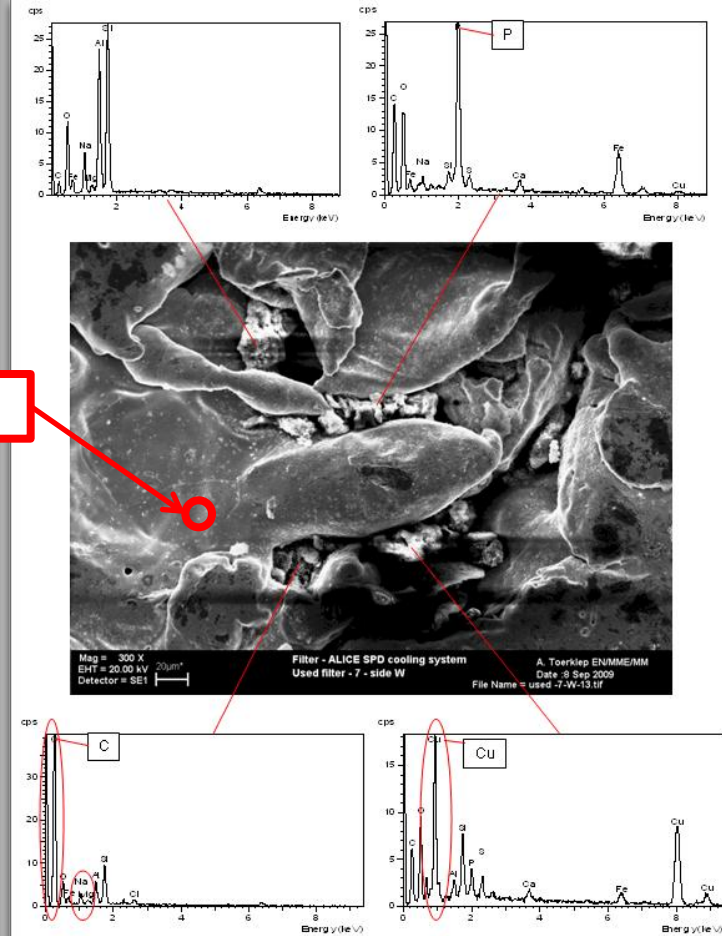
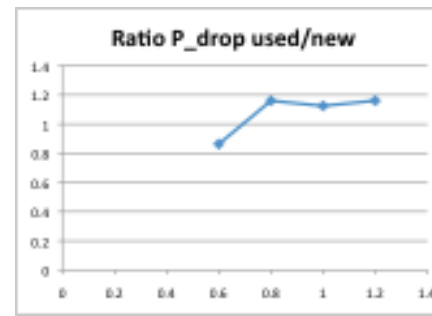
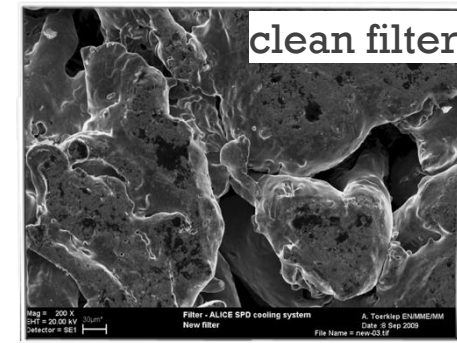
Analysis of a filter taken from PP4, in place for 1 year approx.

Results and conclusions: "In the used filters several exogenous fragments were located clogging the filter. There were several fragments containing different composition elements. In addition to elements from the Stainless steel, the following traces of elements were found: O, Al, K, C, Sn, Cu, P, Ca, Cu, Na, Cl and Zn."

Possible origin of the fragments:

- pumps (graphite)
- hydrofilter (aluminium oxide)
- weldings (TIG weldings remnants)

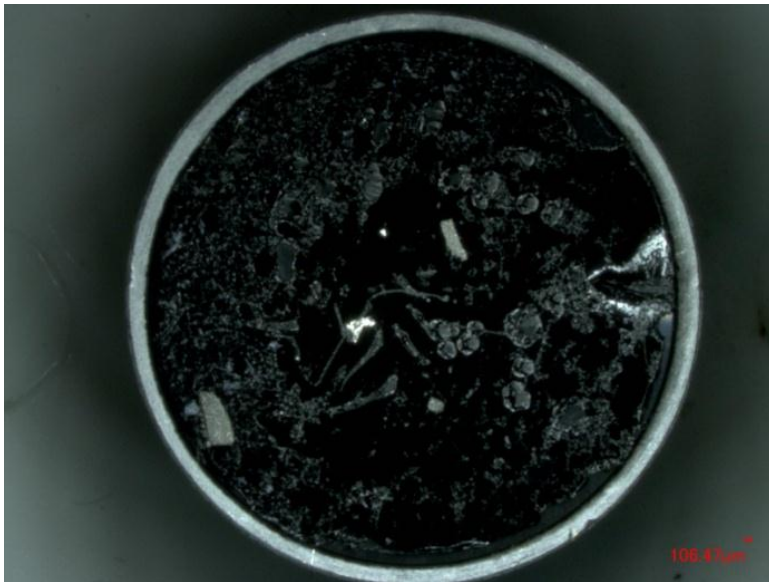
Residuals collected

before...

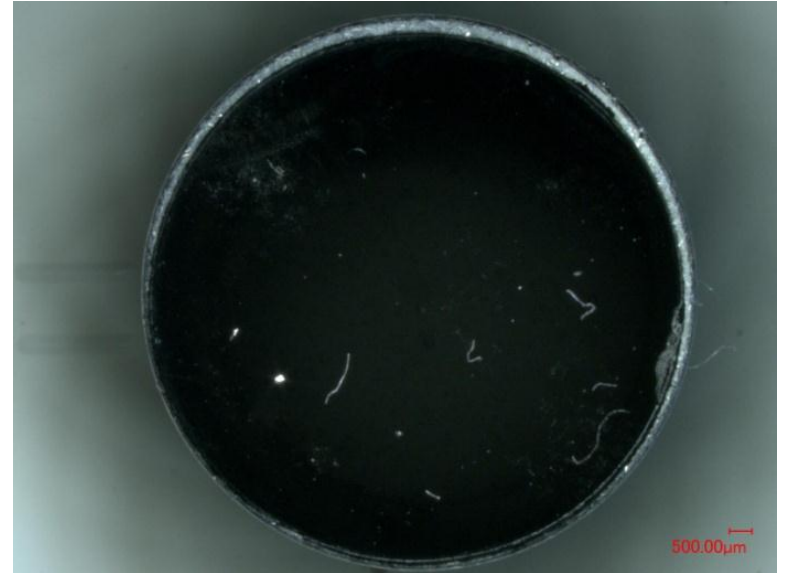
...and after the cleaning!

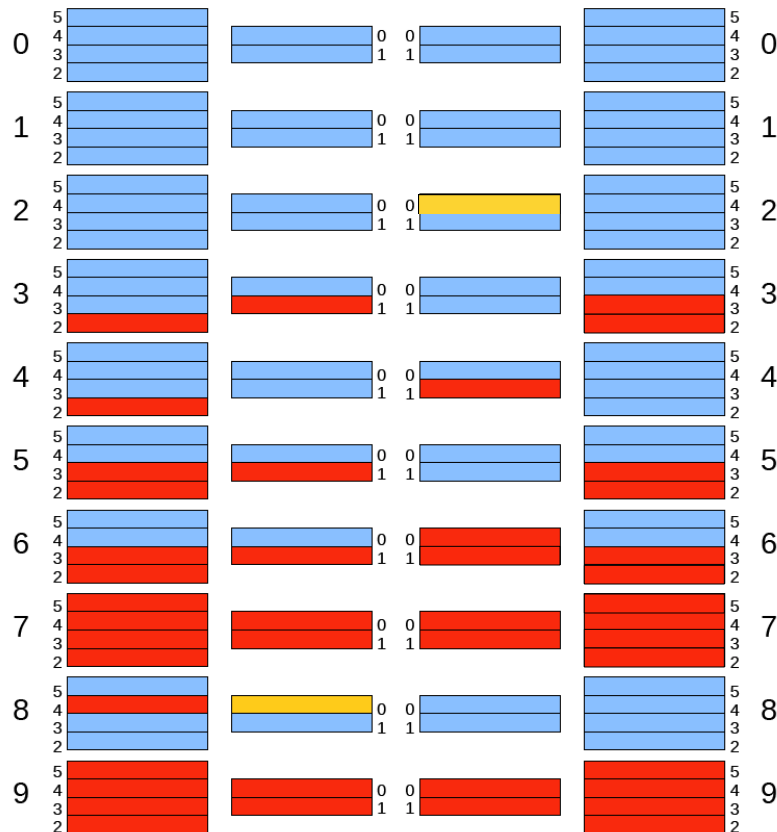
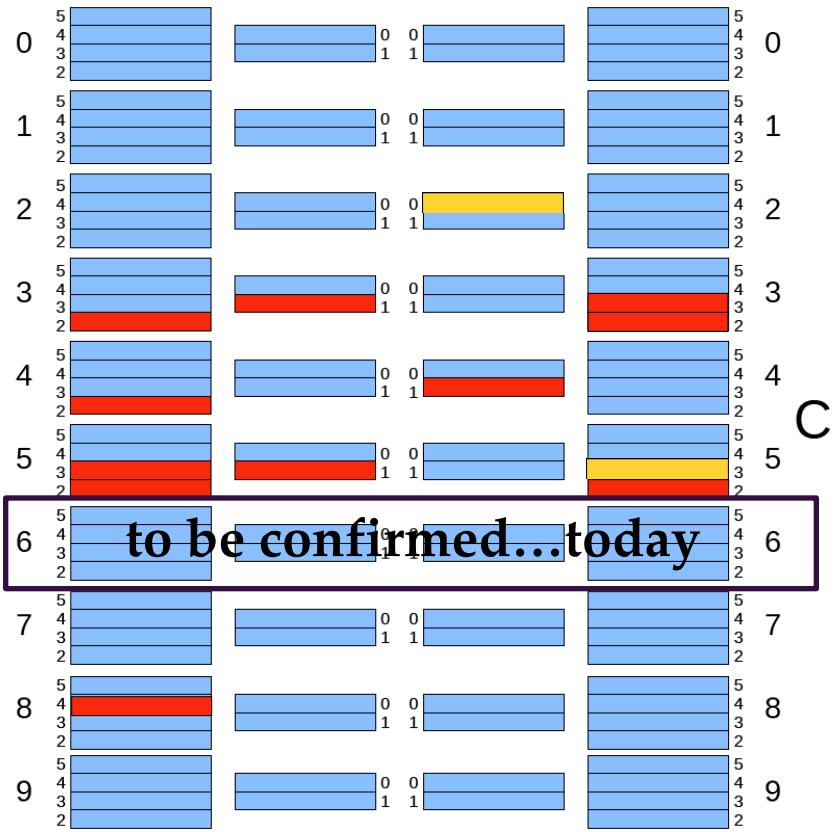
Efficiency changed from this...

to this! (and more to come!)

62.5% (75/120 on) - Nov, 30 2011

89.2% (107/120 on) - Mar, 8 2012

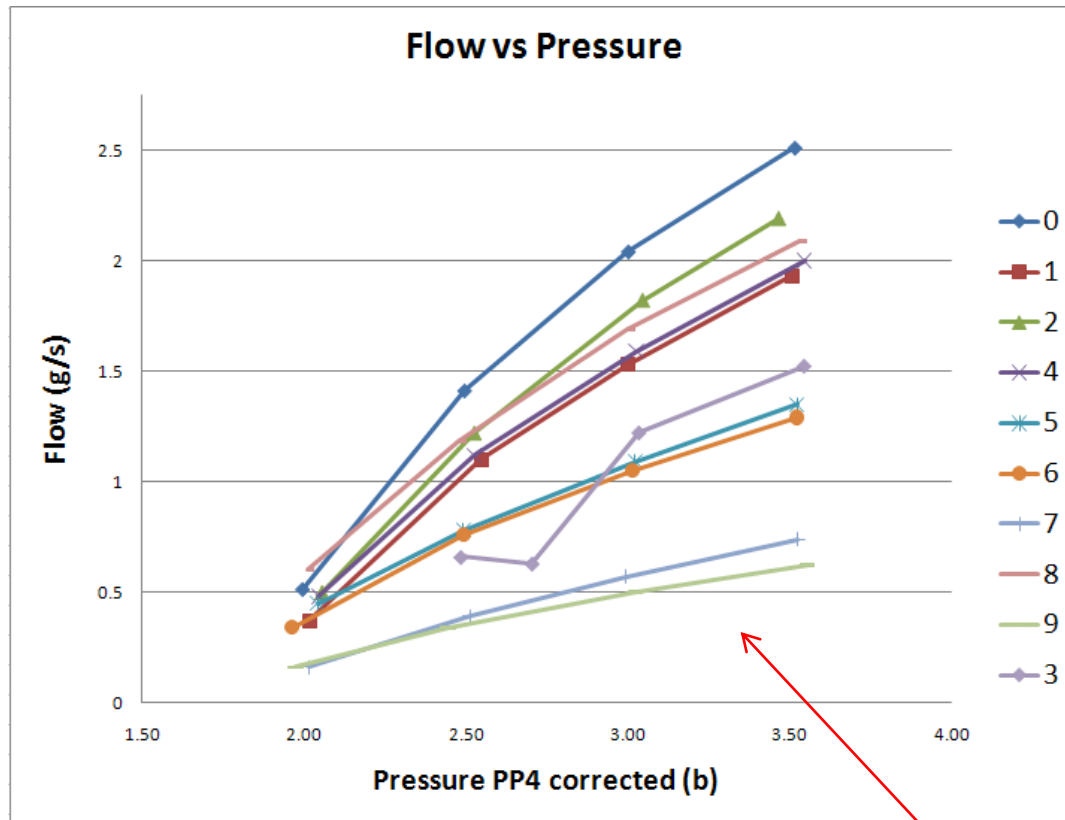
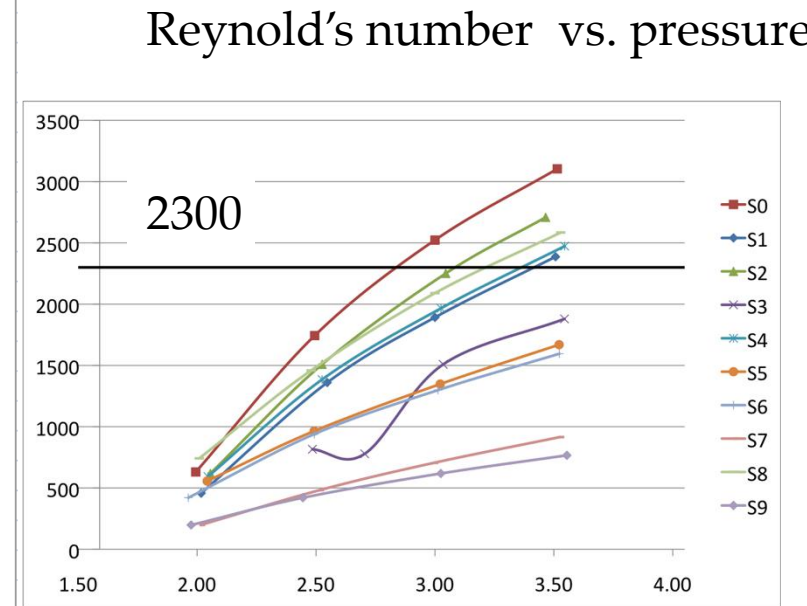
Very low flow rate in sectors 7 and 9;

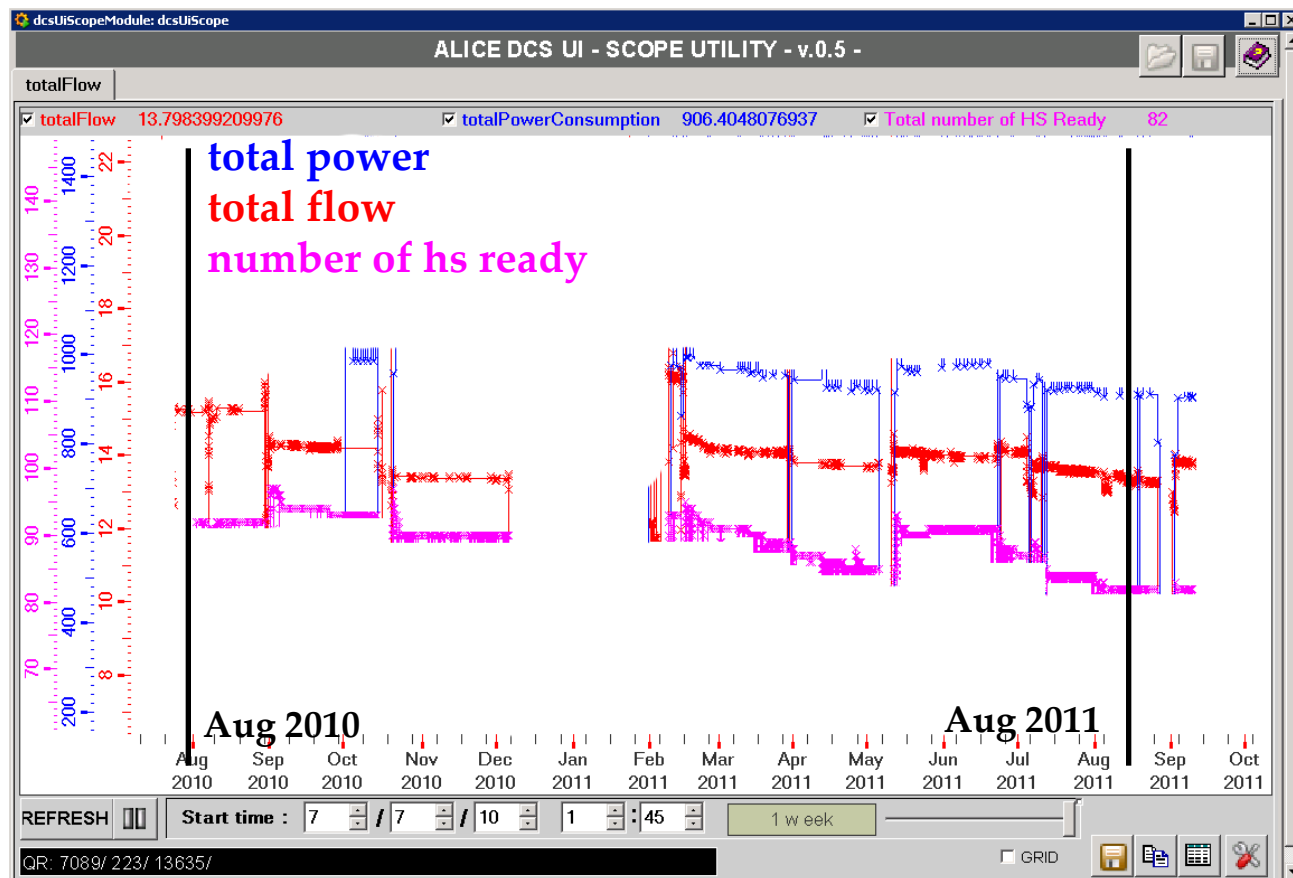
- Slowly decreasing trend of flow
- The flow doesn't tell the whole story – stable # of modules must depend on local thermodynamical conditions (not monitored)
