ULM 10 Gb/s VCSEL Array Accelerated Lifetime Study

K.K. Gan, H.P. Kagan, R.D. Kass, J. Moore, S. Smith
The Ohio State University

June 8, 2012

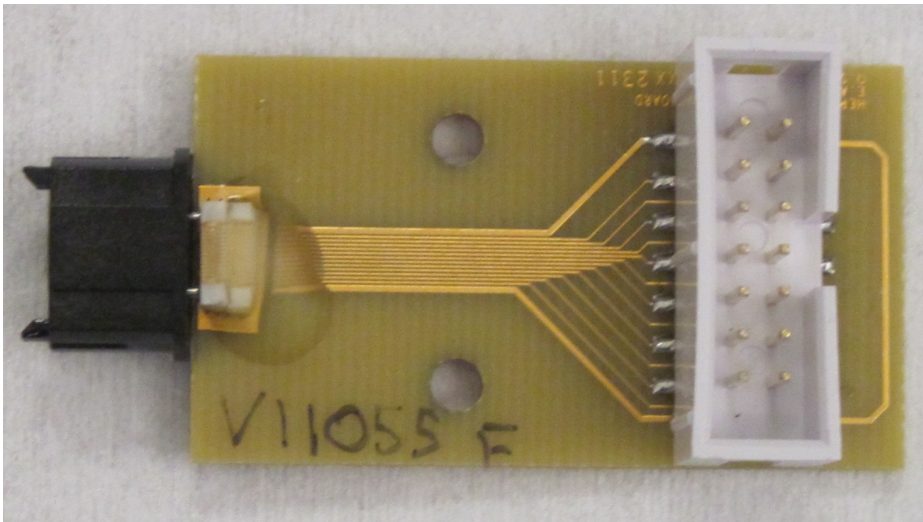
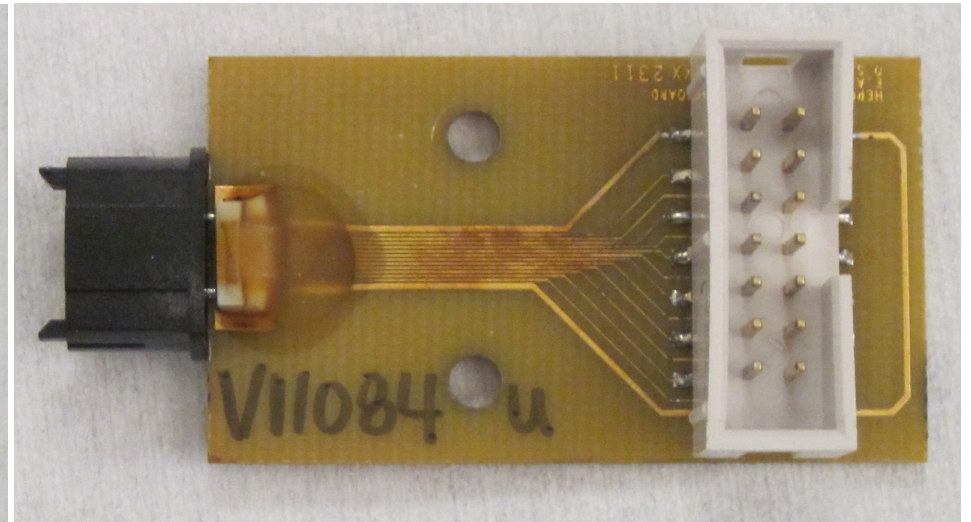
Visible Effects of 85/85 Test

Untested array/PCB
room temp/humidity

Array/PCB after 2200 hrs
85°C/85% Humidity

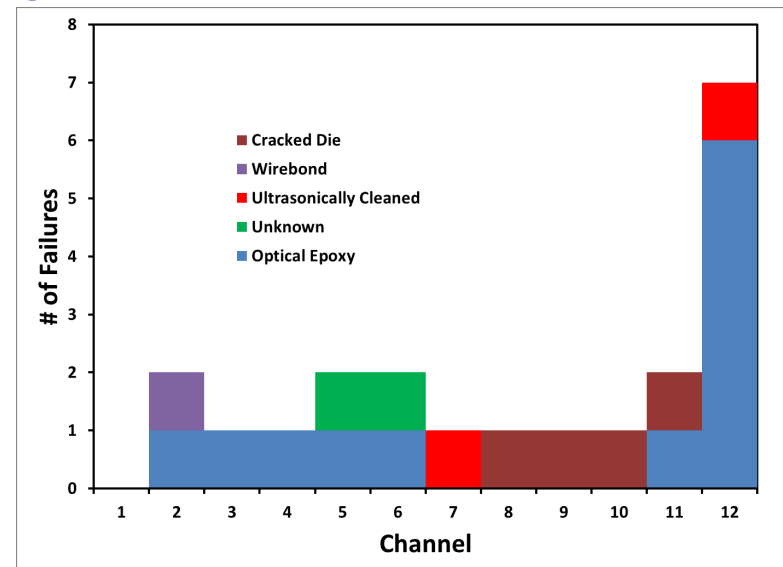
Failure Analysis

- 16 - optical epoxy coverage/scraping
 - ◆ including 4 on a cracked die
- 2 - no obvious/correlated cause
 - ◆ discolored die
- 2 - ultrasonic cleaning of die before placement
- 1 - broken wire bond during test

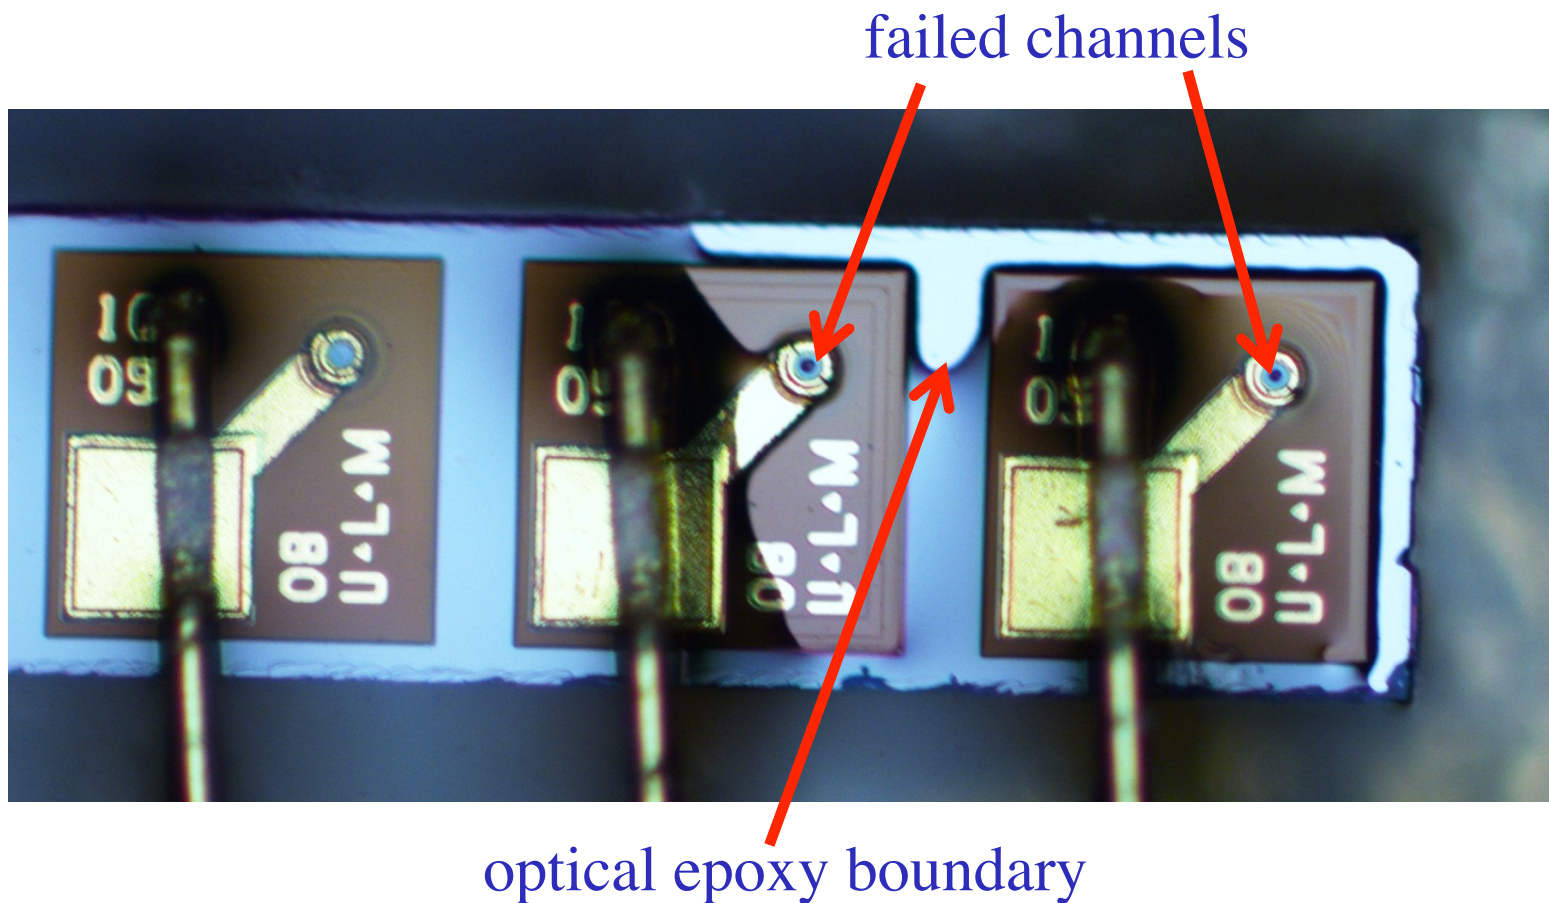
Optical Epoxy Coverage Failures

- All channels with incomplete epoxy coverage failed

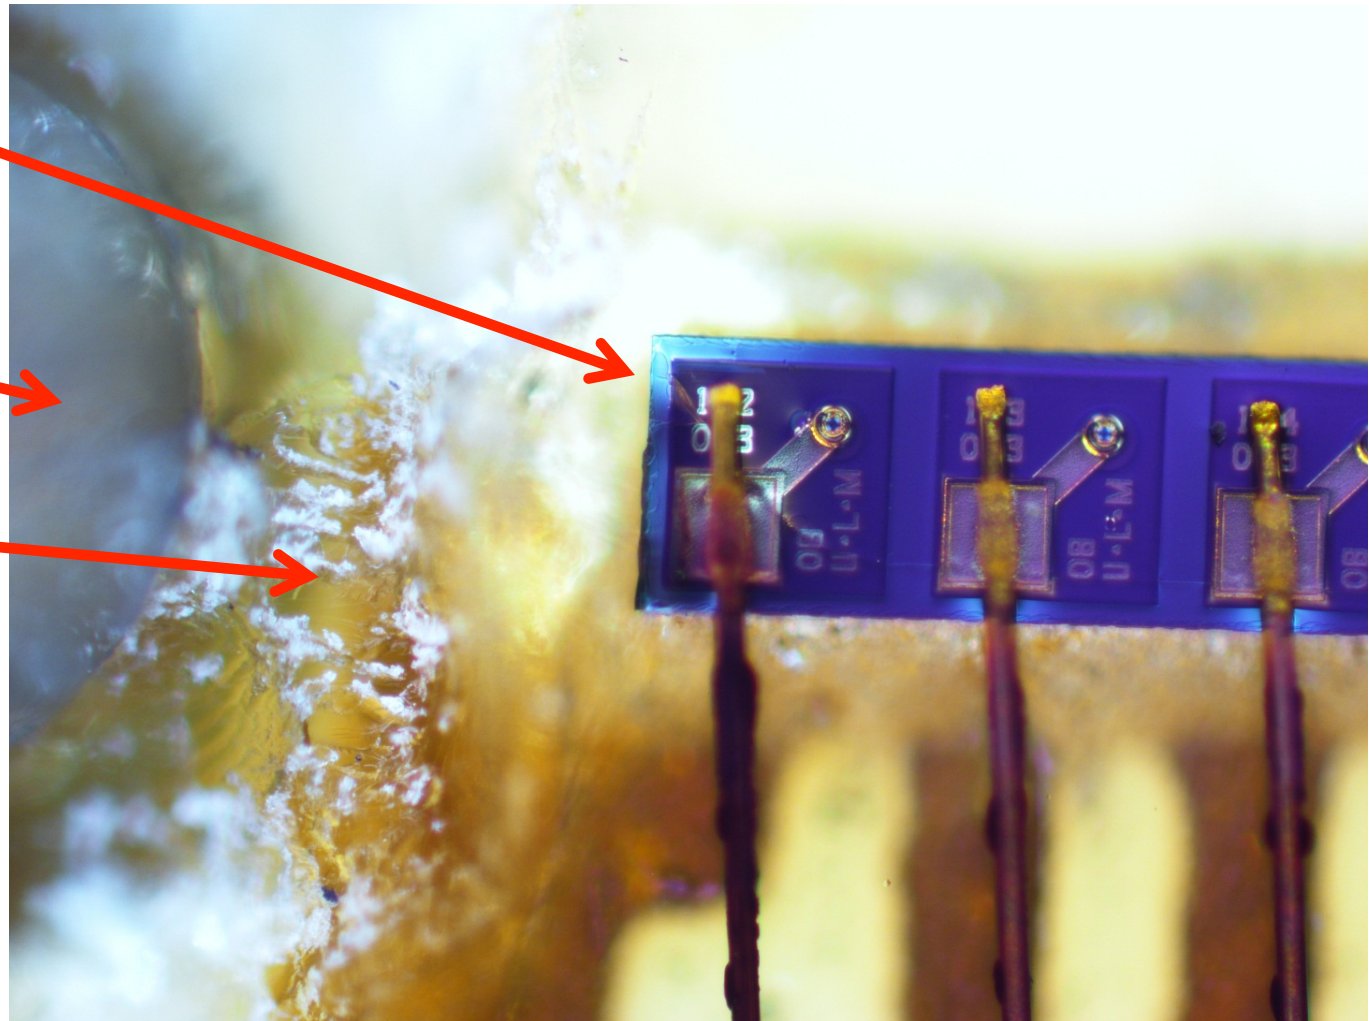
Cracked Die

- not possible to have complete epoxy coverage without epoxy around MT guide pins
 - ⇒ epoxy wick up the guide pins due to capillary effect
 - ⇒ scrape epoxy from guide pins to allow proper fiber coupling
 - ⇒ the accelerated lifetime study reveals that this might cause long term reliability issues:
 - ◆ cracked a die (which survived nearly the whole test)
 - ◆ introduced stress in a few arrays

Crack in die
(continues to
channel 8)

MT guide pin

Scraped
optical epoxy

- Add an optical epoxy dam
 - ◆ keeps epoxy from climbing the MT guide pins
 - ⇒ no optical epoxy scraping
 - ◆ adds reservoir to assist in complete epoxy coverage
 - ◆ doubles as MT ferrule bumper
- Presently constructing 20 Finisar arrays with the optical epoxy dam for next lifetime test
 - ◆ dam successfully tested on two arrays

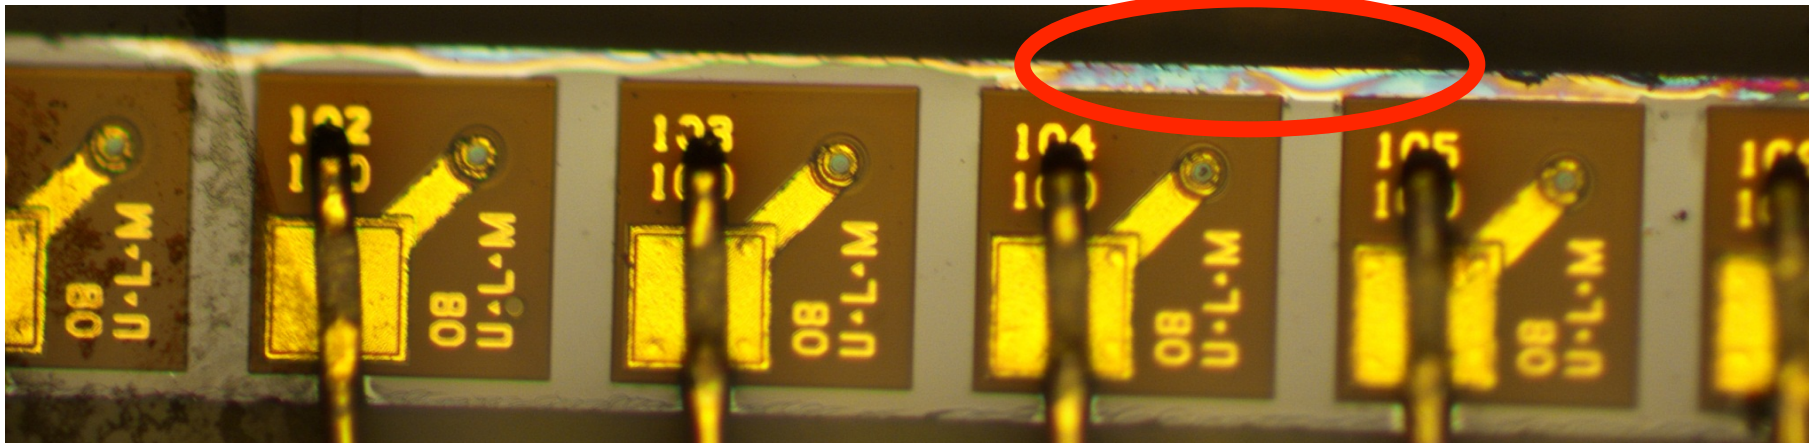
Discolored Die

- Discoloration on the die with a failed channel

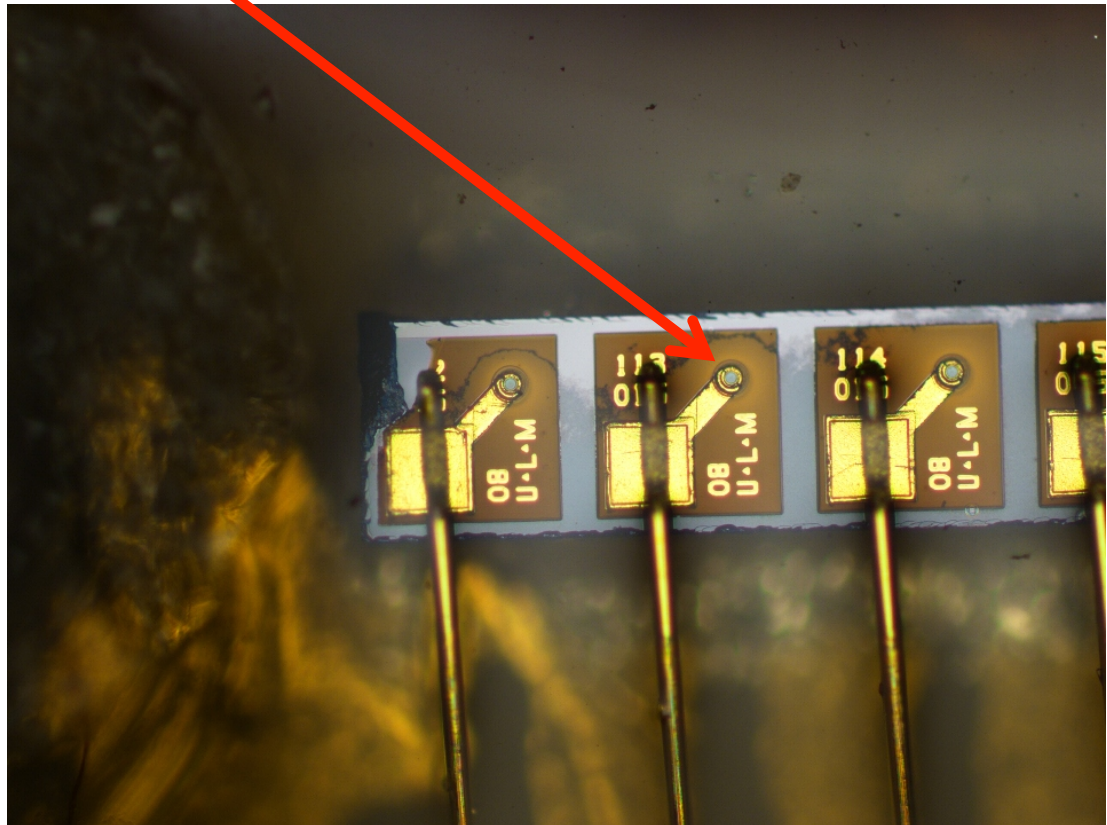
Discolored Die

- This die has discoloration but it passed the 85/85 test
 - ◆ ring around the MESA
 - ◆ problem with polyimide on channel 1

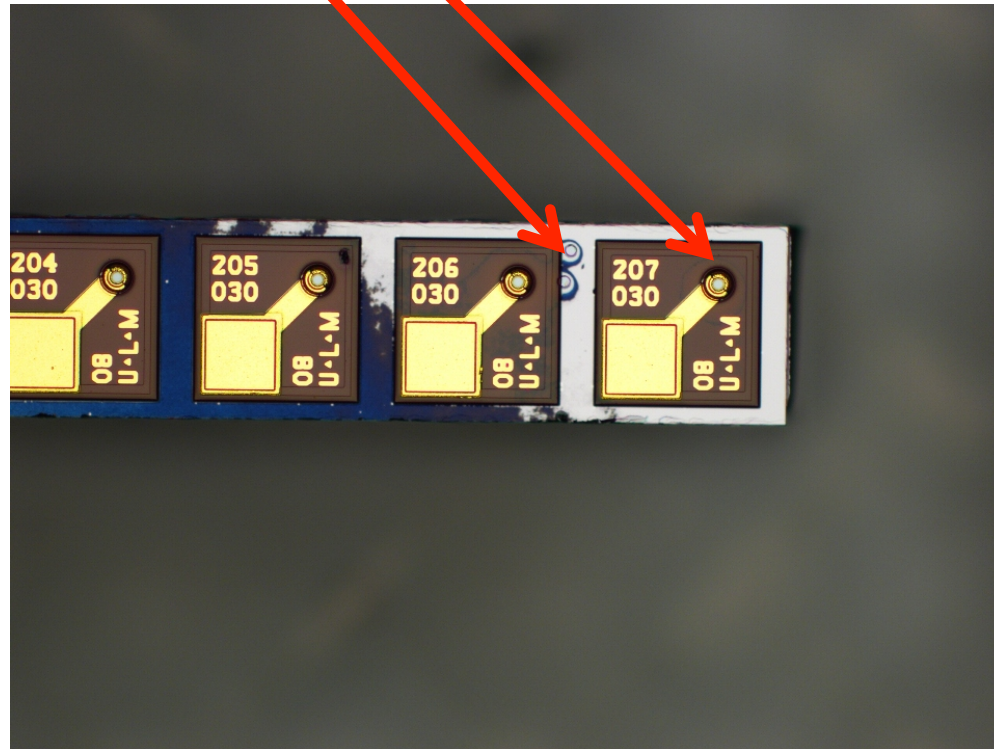
Unused Die with Discoloration

- Rings around MESA
- ◆ ULM says they are normal
- strange bubble structures
- ◆ present on many dice
