# Cooling Tubes-Pipes & their connections from the ATLAS SCT

Richard French – The University of Sheffield

Forum on Tracking Detector Mechanics– CERN 04/07/12

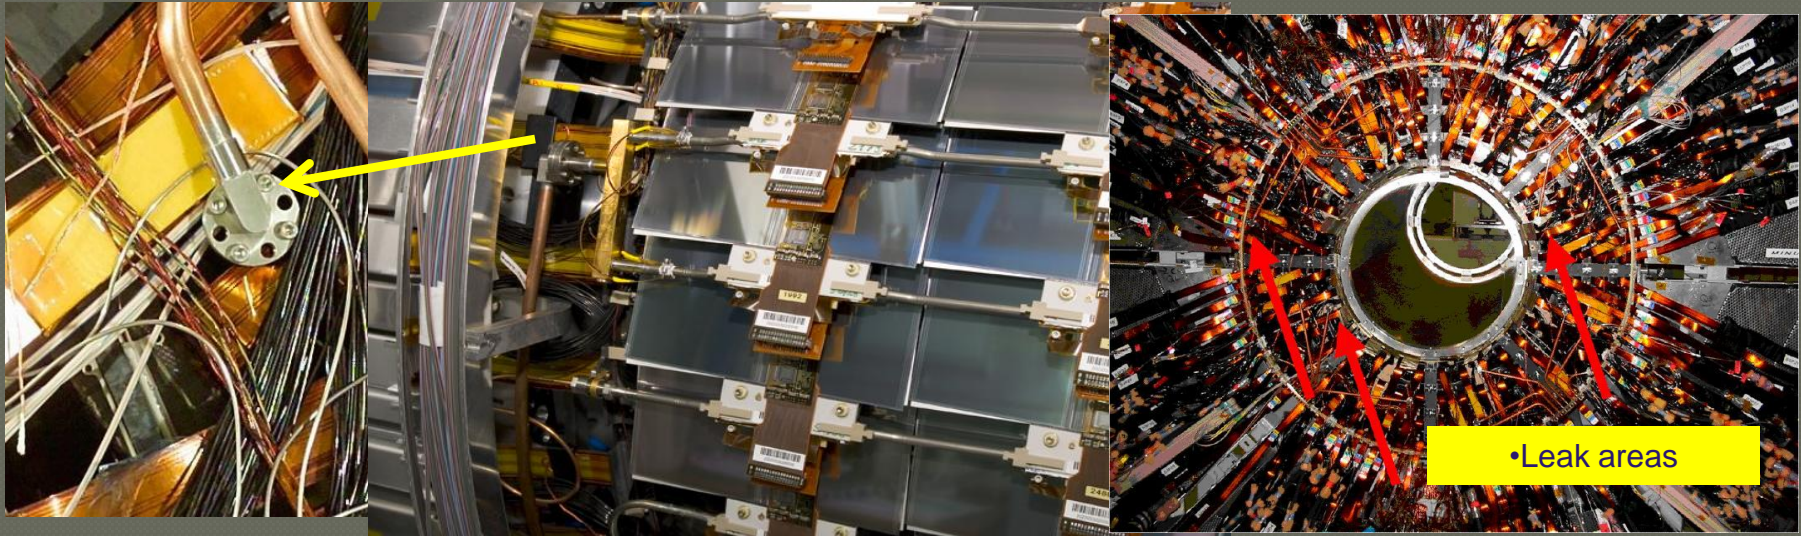
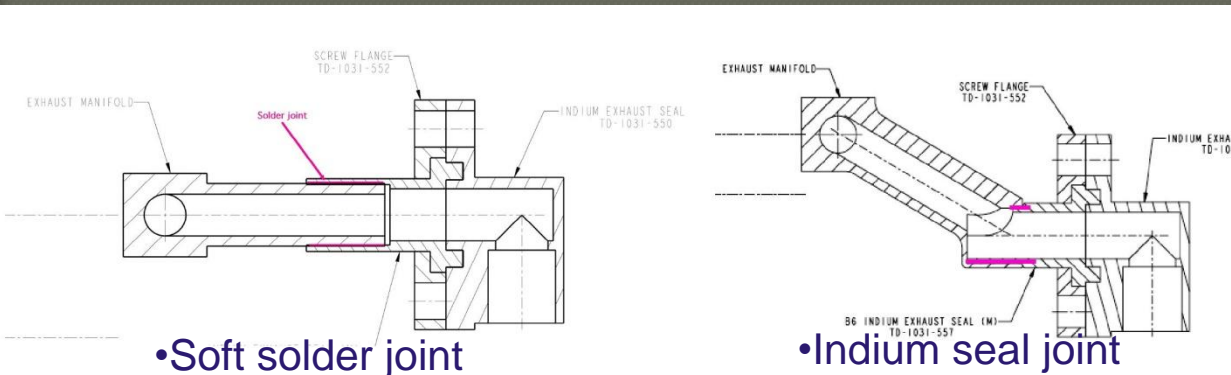
# SCT Barrel permanent joints

- Predominantly CuNi tubes
- Using mainly solder joints
- Leaks repaired as found during construction
- Joint encapsulation required
- Some scary moments but ok
- Leak rate defined by vacuum

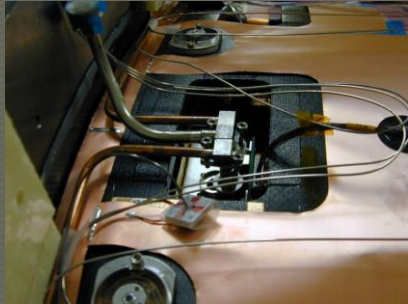
## SCT End Cap connectors.

- Helicoflex seal uses plastic deformation of a jacket of greater ductility than the flange materials. Elastic core is close-wound helical spring. The spring is selected to have a specific compression resistance.

- Using Ti bolts to compress seal and to hold PPO connection in place.

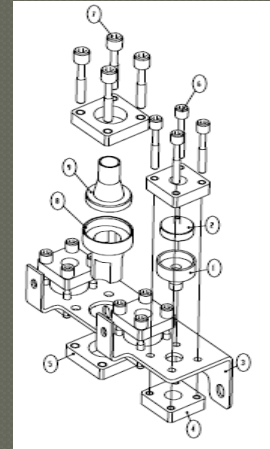
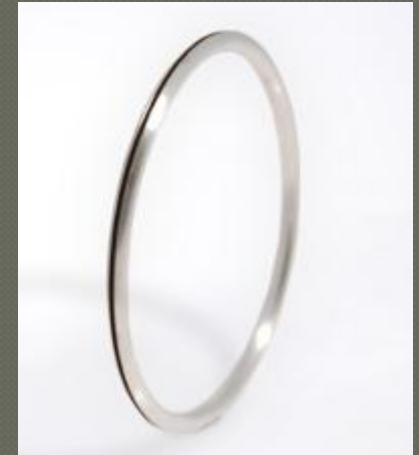
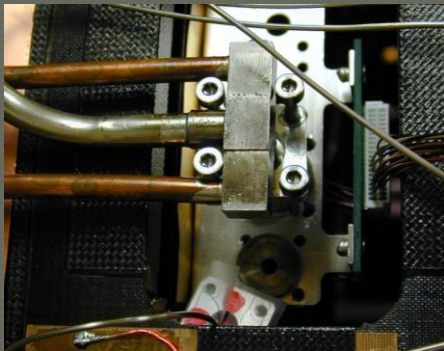
- The Helicoflex seal faces were Aluminium, concerns grew about corrosion issues (CuNi to Al) so changed to a Cu seal material

- The Cu seal was too tough to compress fully and leaked

- The Ti bolts suffered from creep and stretched.

- We kept the Cu seal, selecting a softer spring & switched the Ti bolts to 316L stainless.

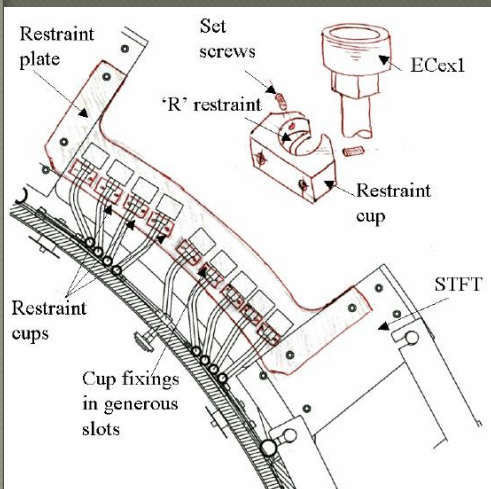
# On cylinder cooling (STFT)

- Services Thermal Feed-through
- Design of restraint problematic
- Torque from fitting damages either:
  - Restraint device or
  - Cooling circuit
- Circuits not ideal fit in area.
- Eventually “made to work”
- Schedule prevents alternative

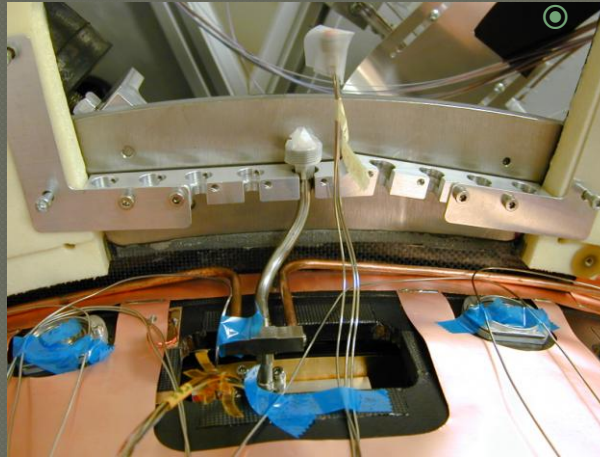
# D9 leak after cavern installation

- Pre-installation of HEX in SR1 altered original plan
- HEXs installed but fouled on integration frame
- HEX's removed by mystery people to proceed with tests.
- Loop 186 never rechecked until after installation as combined cosmic run used opposite quad

- D9 first to install both disc & loop on detector
- D9 last to connect in cavern
- Loop 186 was 2<sup>nd</sup> to last connection made
- Strain relief on ECex3 to STFT questionable
- LMT cooling acts as lever arm on manifold
- D9 main pipe uncomfortable fit in feed-through
- Connection torque easily transmitted to solder joint.

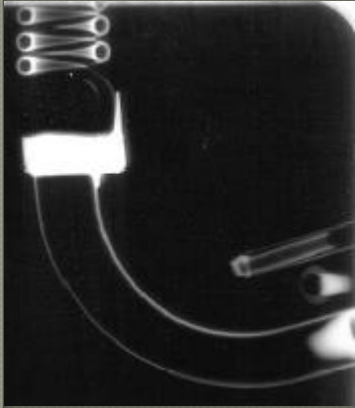
# Off detector – Heat Exchanger

- 3mm OD tube to 4.6mm ID tube brazed sleeve joint -
- Faults = POOR DESIGN due to gap size in sleeve joint
- Found - porous joints - asymmetric alignment - lack of penetration into joint = Rework time (again) and this time 100% PRESSURE TESTING.
- Q:How did they even manage to make this joint??
- A: By building a jig and getting very clever with low temp solder.
- Repaired by crimping 5mm tube and reducing gap – brazed ok.

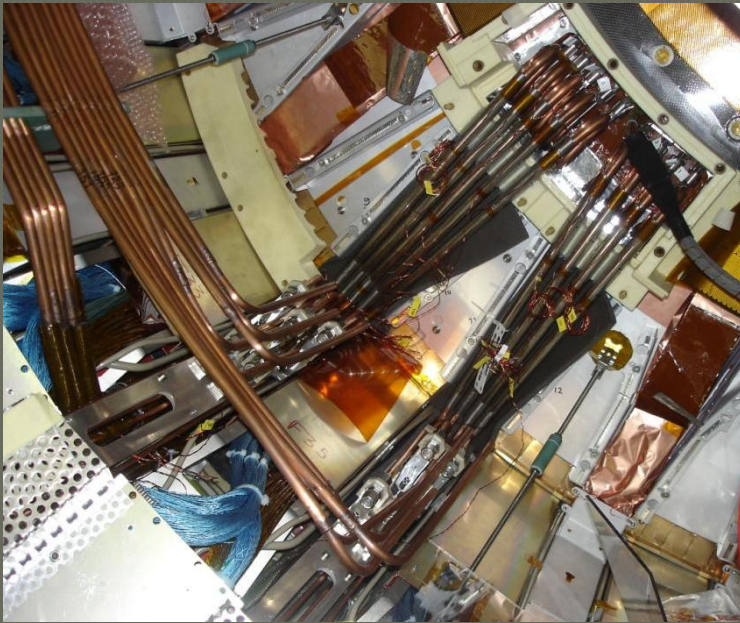
# Far Heater Solution

- Due to many failures and worry over the performance of the heaters, they were relocated to the cryostat face.
- Compression fittings with reducing ferrules were used to join pipe OD changes to minimise space usage.
- Compressing the larger OD tube ferrules proved to be highly problematic.

Teams of people spent 100's of hours trying to make these fittings seal.

They were not suitable for the way we were trying to use them

Fortunately using hydraulic equipment and lots of experience making them work properly – we were able to get reasonable reproducibility (eventually)
