Experience with services for the CMS Tracker endcap

The Good, The Bad and The Ugly

Nick Lumb

CERN, 3 July 2012

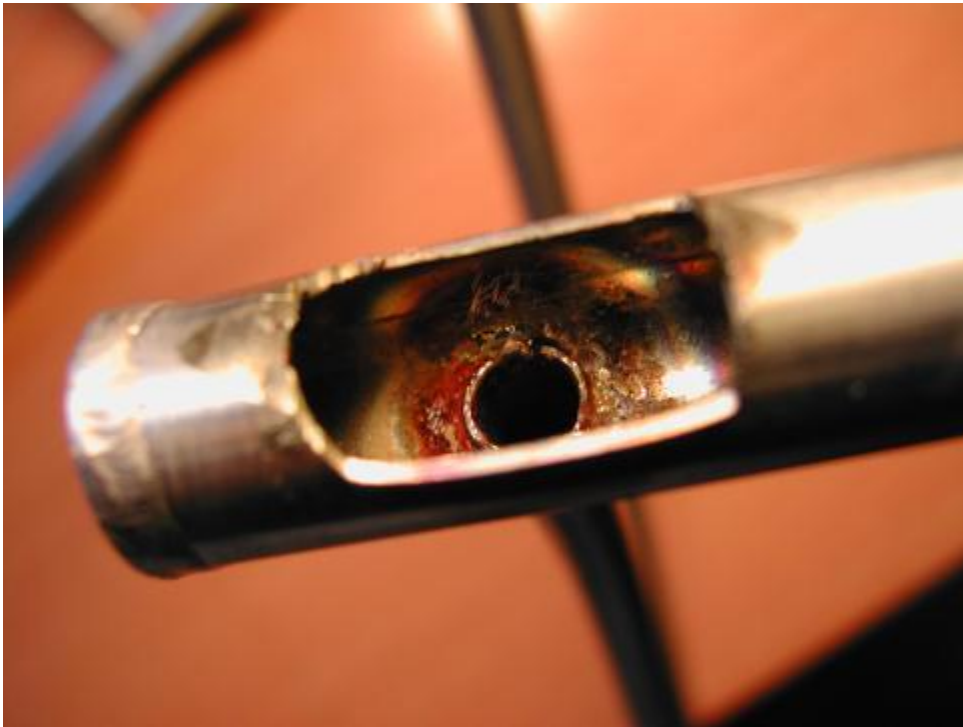
- Windows cut in prototypes to examine weld quality
- Rusty condition indicates lack of inert gas flow during welding
- Problem reported to Lancashire Fittings and second series produced
- Problem is solved
- All other parameters within spec: production launched

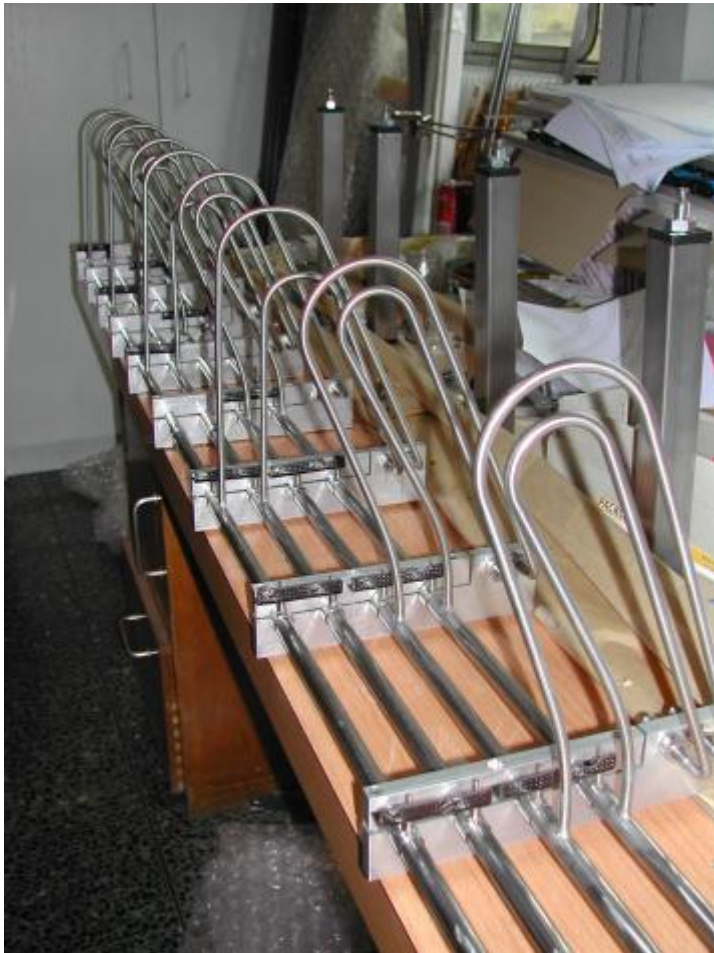
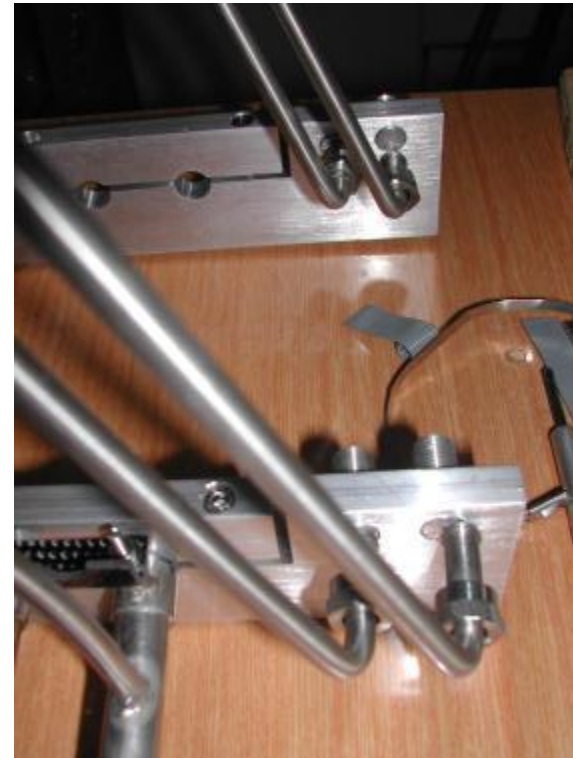
Good mechanical tolerance seen in prototypes begins to drift
Not a problem for single connection, but constraints become too big if many mis-aligned on same feed pipe

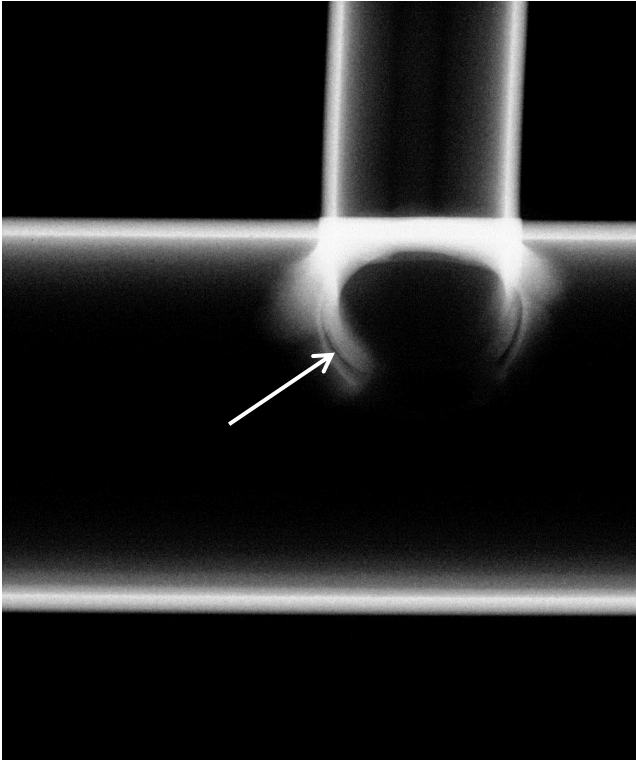
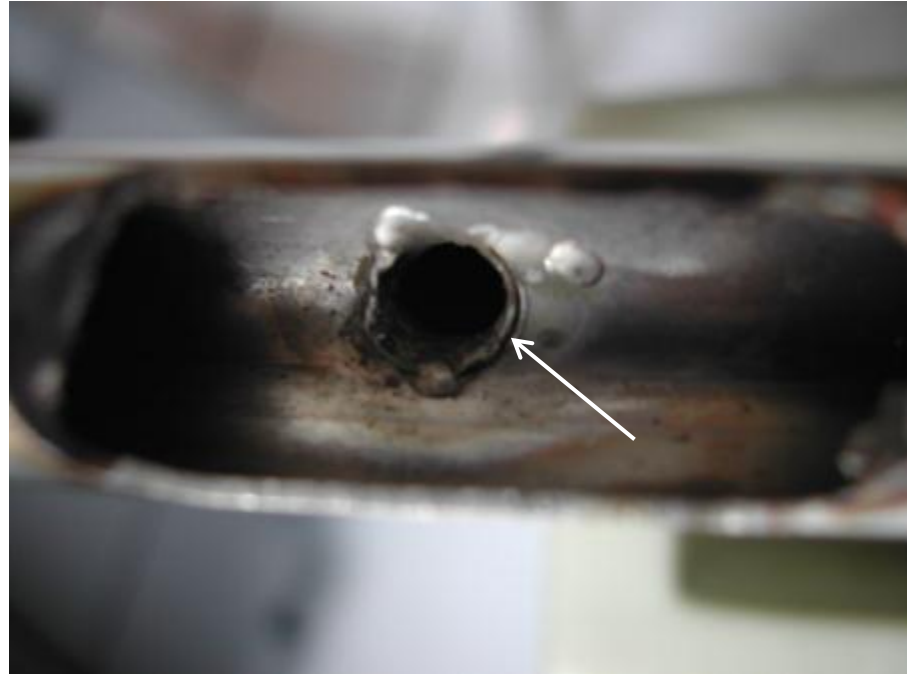
Weld defect: 'lack of penetration'

- Tests performed at Norisko (France)
- Standard: ISO 5817, class C; 2 X-rays per weld
- Results:
 - Lancashire second protos (4 welds tested) – FAILED (lack of penetration)
 - Lancashire production set (5 welds) – FAILED (lack of penetration)
 - ACC, Paris, 0.5 mm (1 weld) – FAILED (lack of penetration)
 - ACC, Paris, 1.0 mm (1 weld) – FAILED (lack of fusion)
 - Microsoude, Lyon (3 welds) – FAILED (tungsten inclusions)

Welding stopped at Lancashire Fittings and company asked to resolve the problem
Search for alternative companies launched in parallel

- Finally a company (Fraunhofer Institute / IPT, DE) is found
- Back-up company also found (Process Fluides, FR)
- Both capable of passing X-ray tests and providing needed mechanical precision
- Lancashire Fittings to provide cut and bent pipework but to cease welding
- Branch pipes compared to drawings by IPT and adjusted when necessary
- Process Fluides produces spares
- 100% X-ray testing of welds (704 welds)

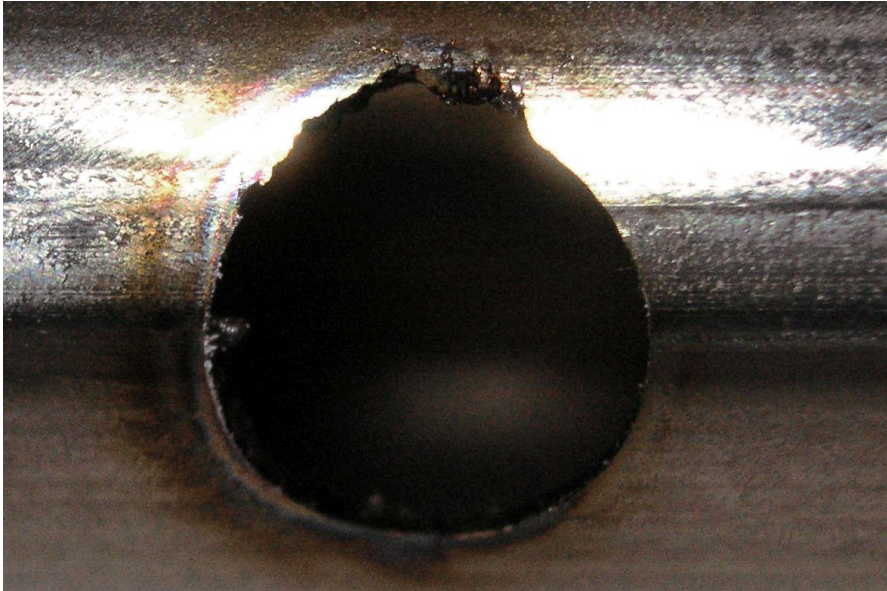
- Holes laser cut into feed pipes prior to welding branch pipes
- Sub-contracted to another company by Lancashire Fittings
- The holes are not round!
- All affected feed pipes need to be re-done

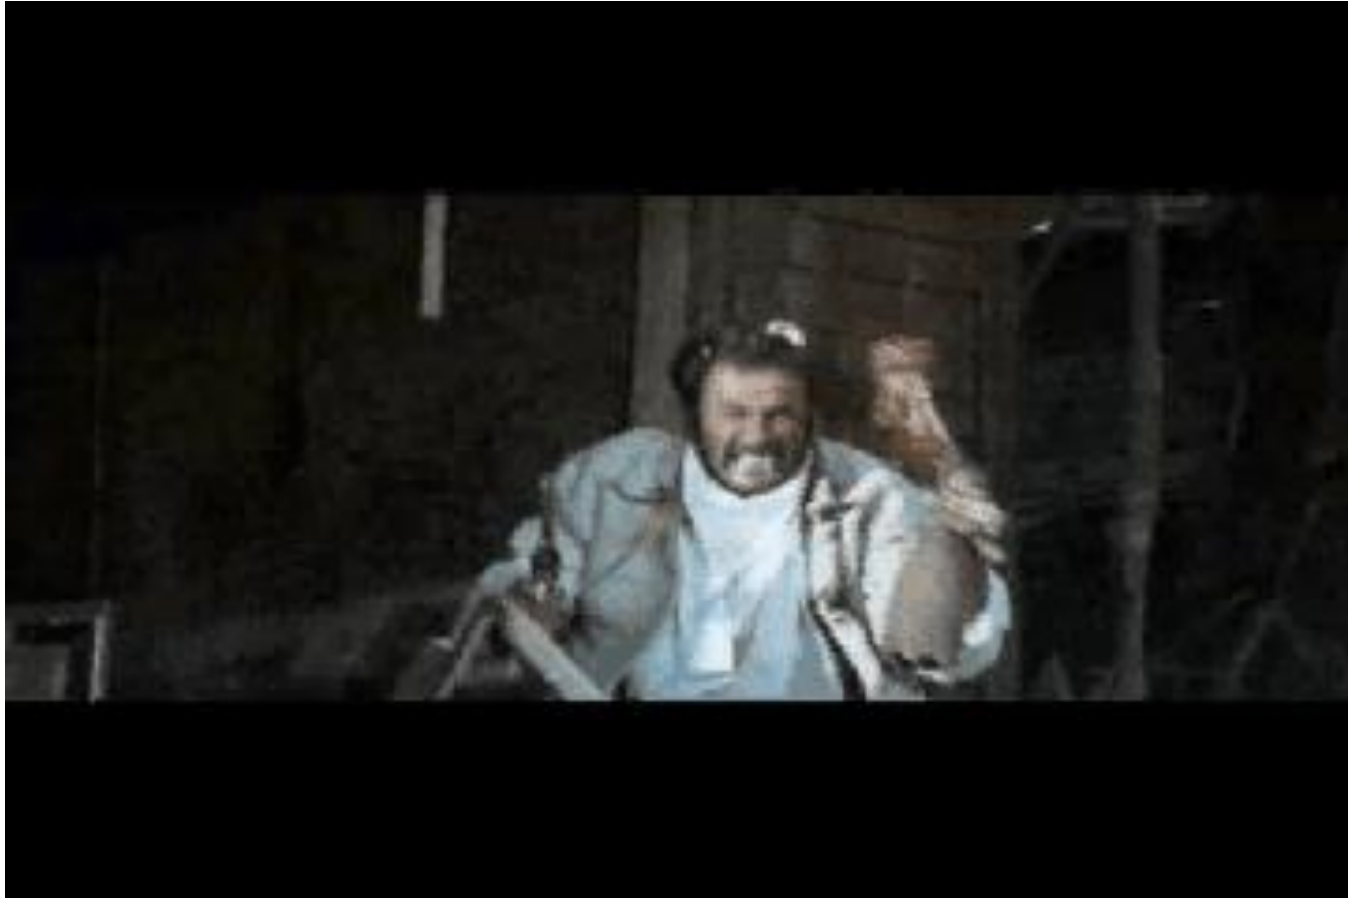
Some branch pipes completely blocked with sand on arrival at IPT!
(sand is used during bending)

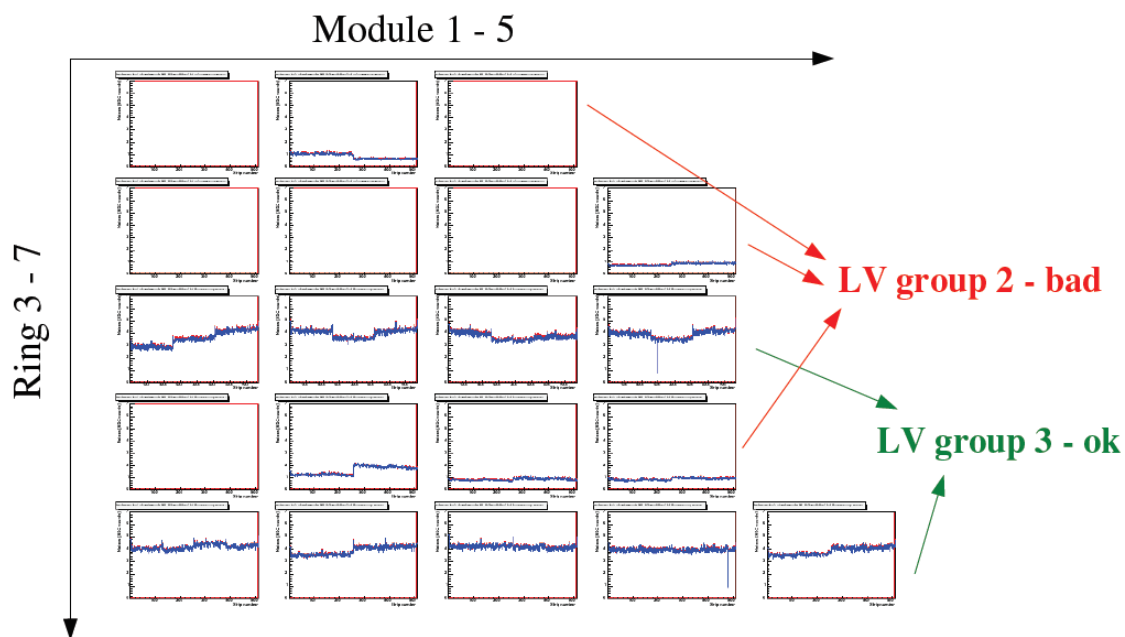
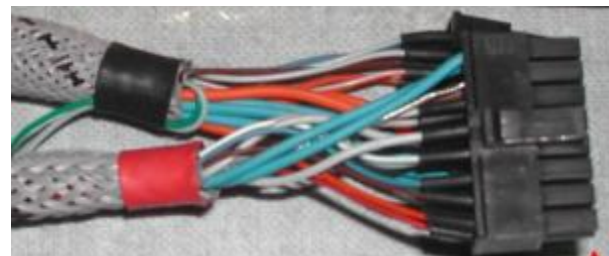
- Symptom: Very low or very high noise on a power group
- Could be temporarily fixed by unplugging and re-plugging Molex connector on petal
- All cables had passed electrical tests before installation on endcap!
- At this stage, all cables were already installed

- Problem finally identified as bad crimp contacts within connector
- Visual inspection shows only a few cases where insulation is fully below crimp contact
- But many 'non-standard' crimps

Decision to **repair ALL connectors** (LV, HV, control) in following way:

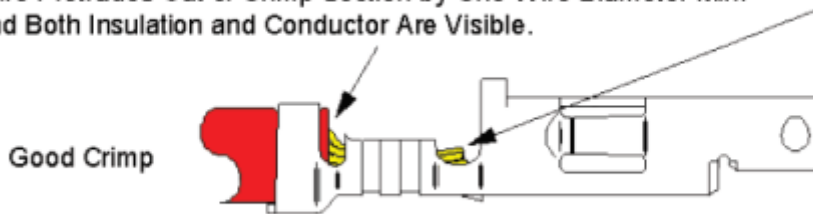
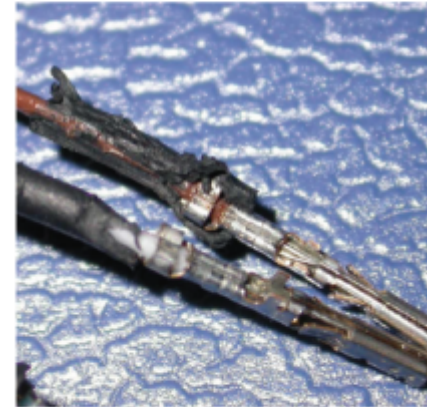
WIRE INSERTED TOO FAR

Wire Conductor Extends Into Transition Section of Terminal
and Insulation is Into Crimp Section

Wire Protrudes Out of Crimp Section by One Wire Diameter Min.
and Both Insulation and Conductor Are Visible.

Solution: Strip Length Too Long or Wire Inserted Too Far Into
Crimp Section Before Crimping. Check Wire Stop Location on Press.

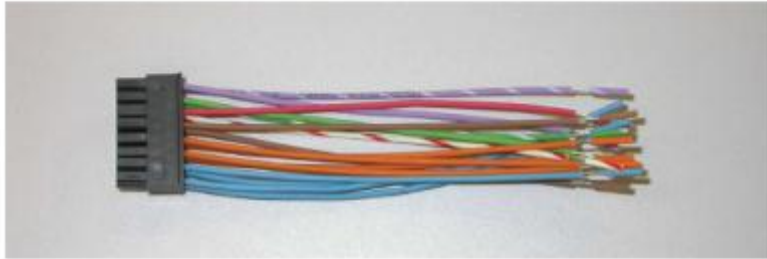
pigtails as delivered by Adapt:
stripped, crimped and inserted into connector
