# Recent experience with NuMI graphite targets and dumps (plus some NOVA & LBNE target information)

Jim Hylan / Fermilab

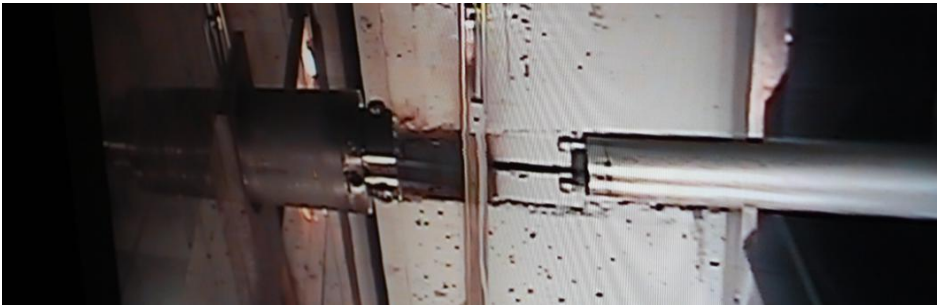
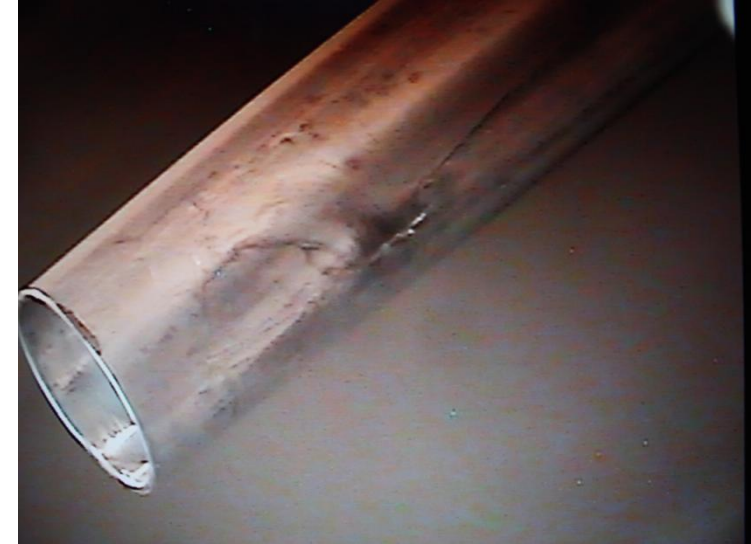
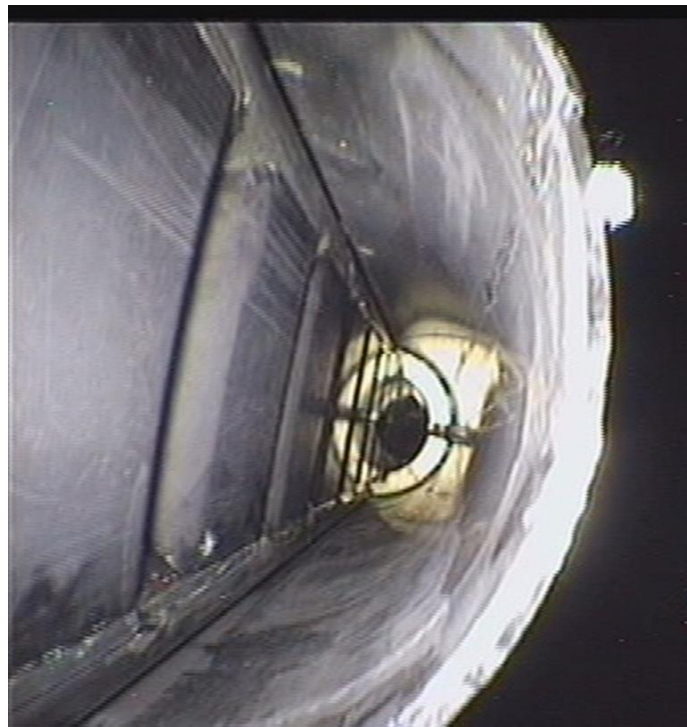
# NT-05 Autopsy

Some damage of outer tube

Cut off end of tube

– see water-pipe welds had failed completely

Not corrosion or pipe failure;  
just break of laser welds

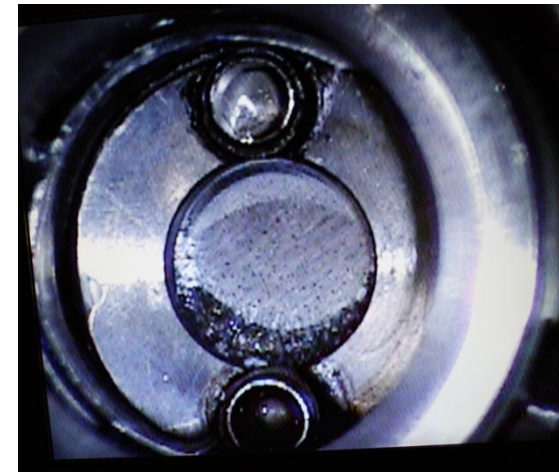
*1<sup>st</sup> direct view of  
graphite after running !*

*Visible graphite looks perfect  
after 1.25e20 POT  
( NT02 took 6e20 POT )*

*No corrosion of aluminum  
Solder joint to graphite fine  
Steel cooling pipes look fine*

*Downstream spacer ring walked several inches upstream*

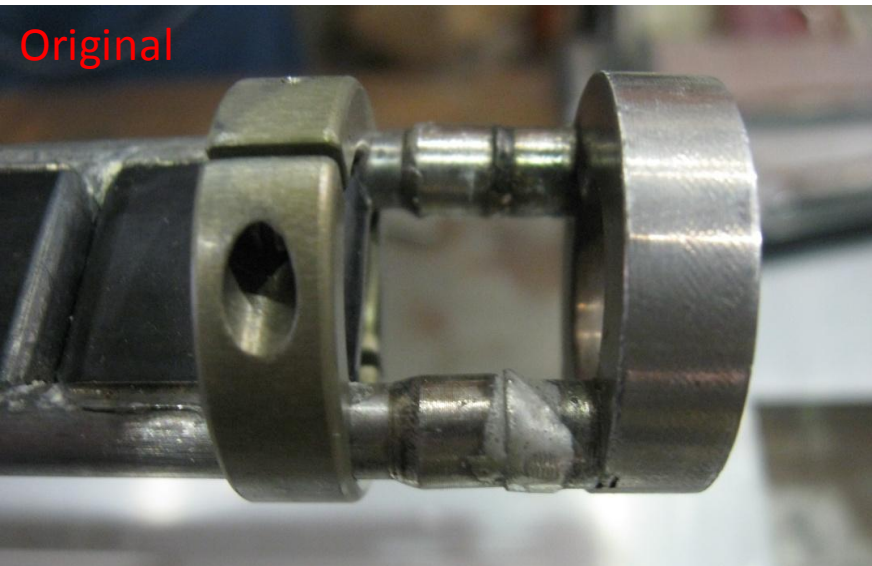
Original

# NT-06 tip reworked, but water-line failed elsewhere

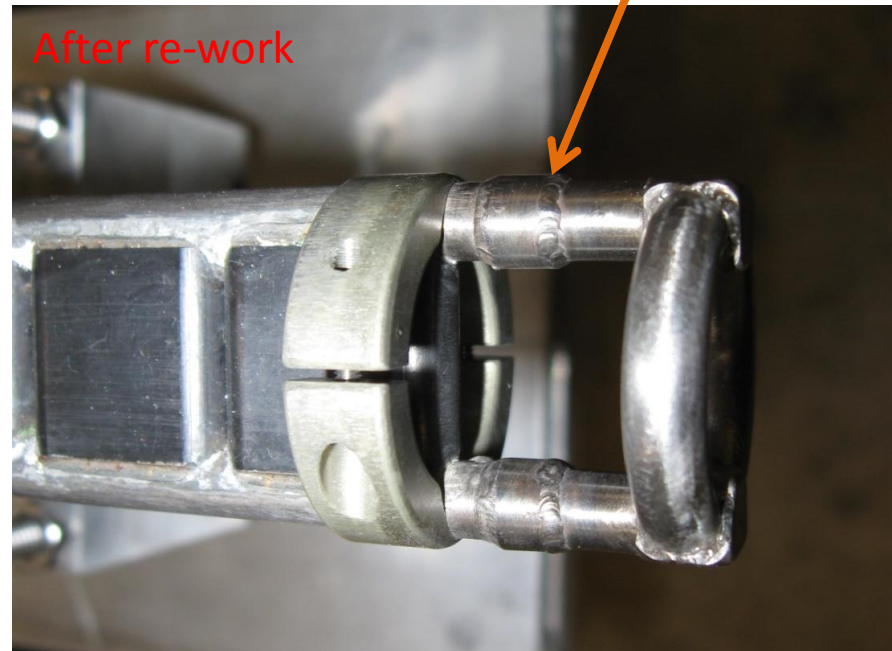
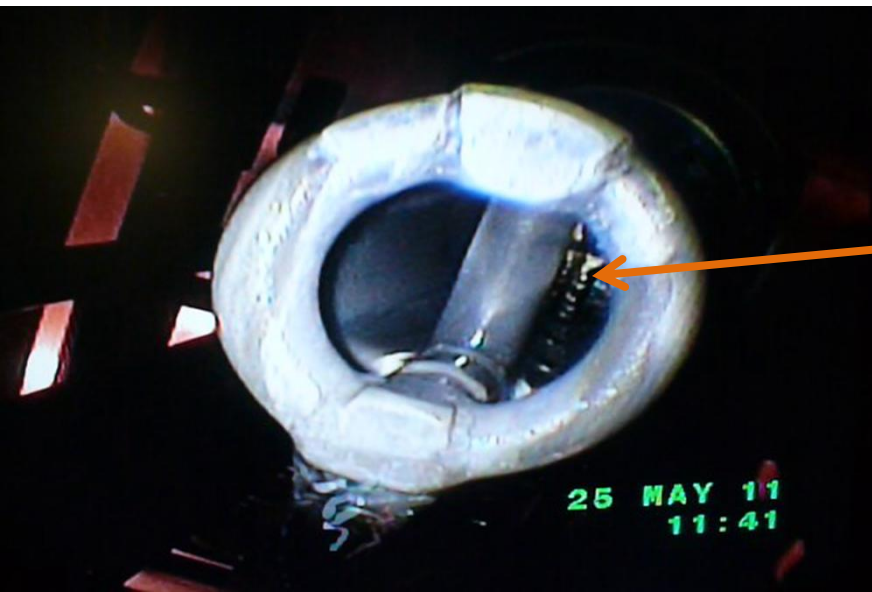
After re-work

TIG weld

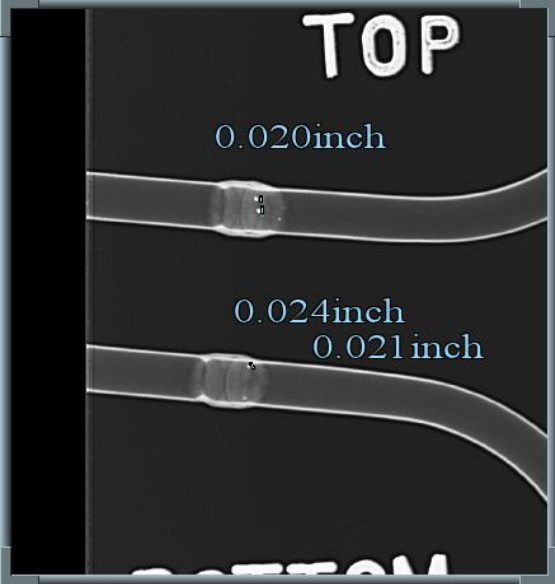
NT-06 failed quickly as well, but autopsy showed it was **upstream**, not the tip welds

Autopsy, showing water flowing down from upstream end of target

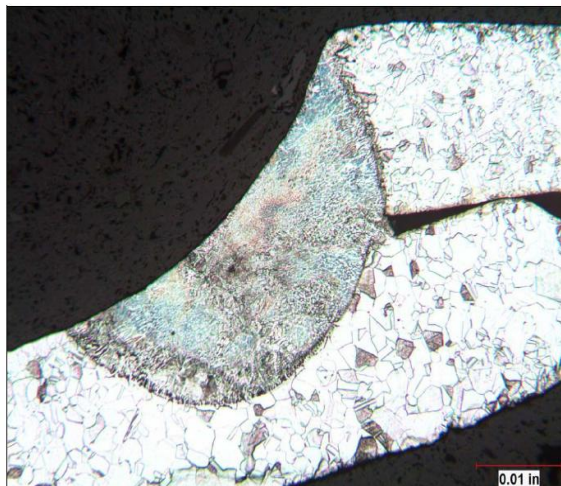
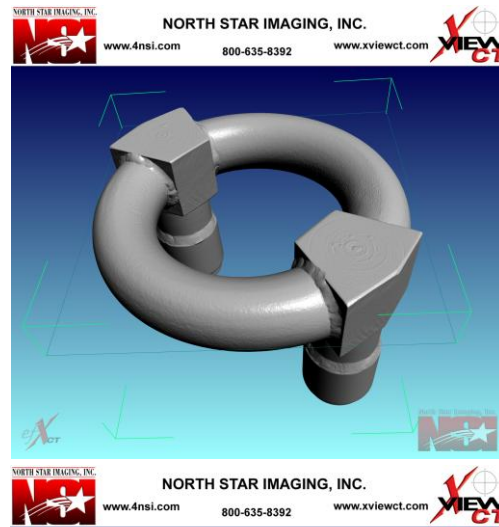
← Original welds from target vendor showed tungsten inclusions  
 Replaced these even though they passed pressure test.

*Re-did all welds internal to the hydrogen volume.*

*Rework welding development and microstructure analysis was conducted by contracted material science engineering experts*

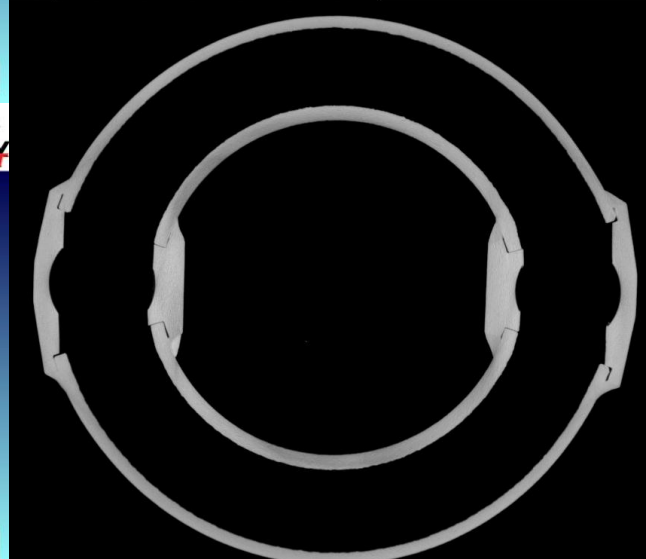
*CT Scan to Qualify Downstream Turnaround Ring Weld Integrity (Difficult Geometry for Conventional X-ray Inspection)*

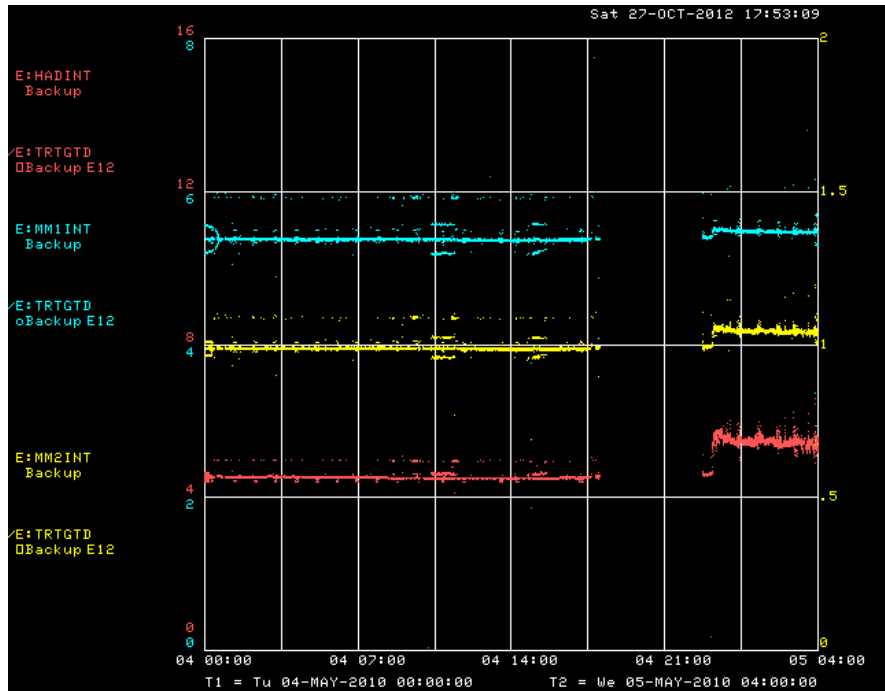
May 4, 2010 hydrogen explosion  
damages ceramic holding the target tube,  
throwing target out of alignment.

Absorber core temperature relative to beam  
power (and baffle temperature)  
clearly indicates problem
