Performance of the Advanced Photon Source 350-MHz 1MW CW Klystrons

Doug Horan

CWRF08 Workshop

March 25-28, 2008

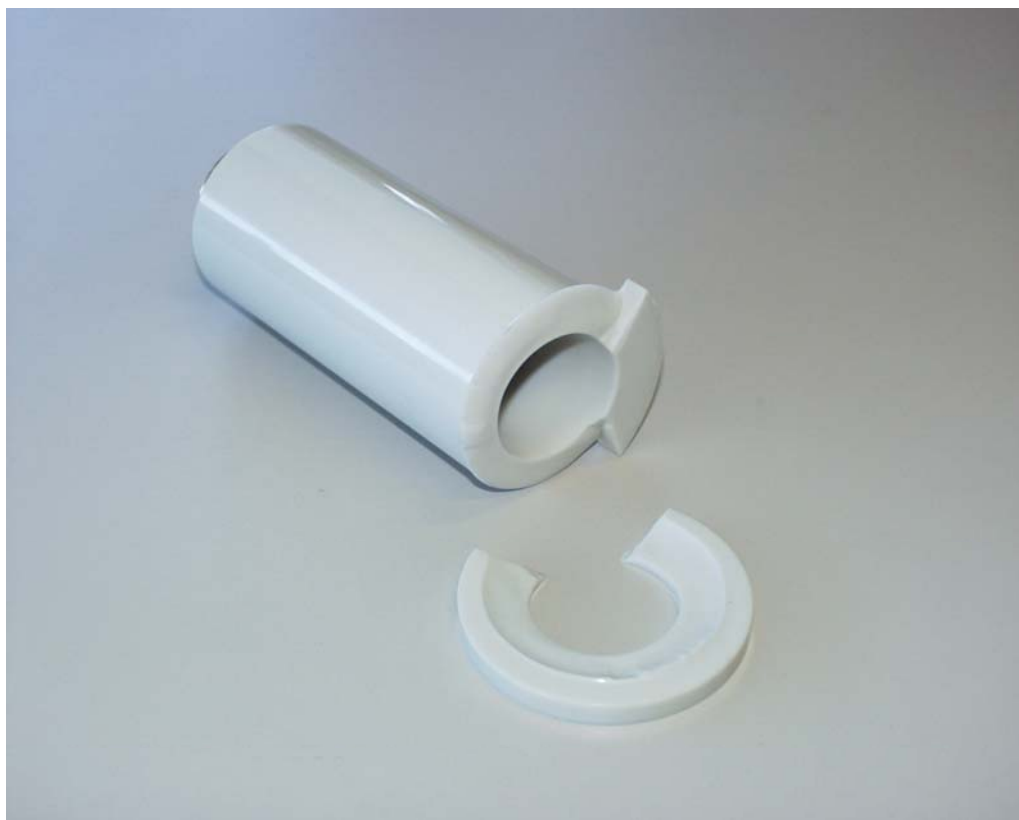
• Pantak Socket Problems

- *cracked sockets*
 - *over-tightening?*
- *broken or distorted contact springs*
 - *caused several cases of intermittent heater current*
- *oil seepage into socket*
 - *causes swelling of cable plug, loss of cable (~ \$6K!!)*

WHITE PANTAK SOCKETS CAN BREAK!

More attention to proper maintenance has reduced these failures

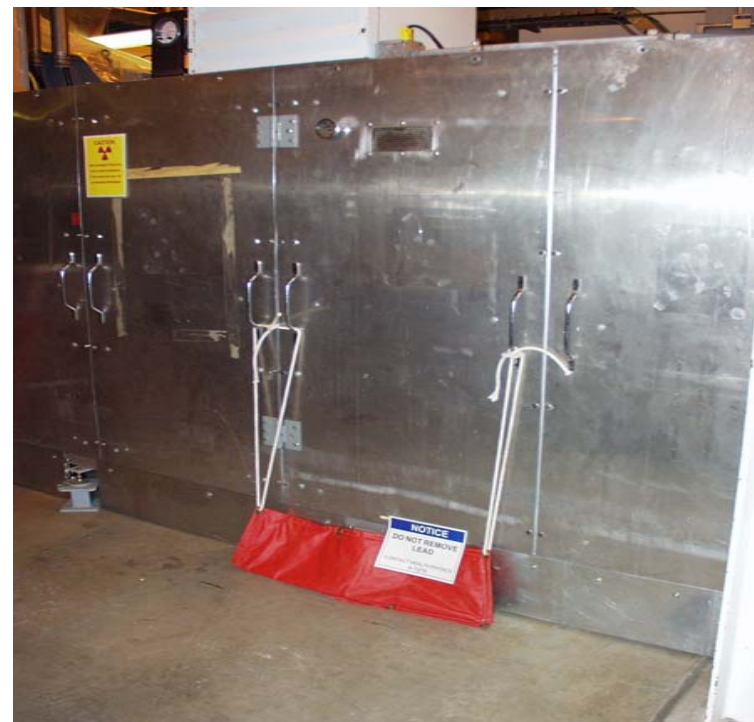
- **Excessive x-ray emissions from RF2 klystron garage** – *Thales s/n 089041*
 - *Routine Health Physics monitoring indicated ~ 7-25mr at mid-point of garage (same region of klystron where drift tube melted in 1999)*
 - *Excessive Body1 power dissipation (~9-15kW!)*
 - *Ongoing problem.....many attempts by Thales to resolve problem*

Supplemental lead shielding added to garage!

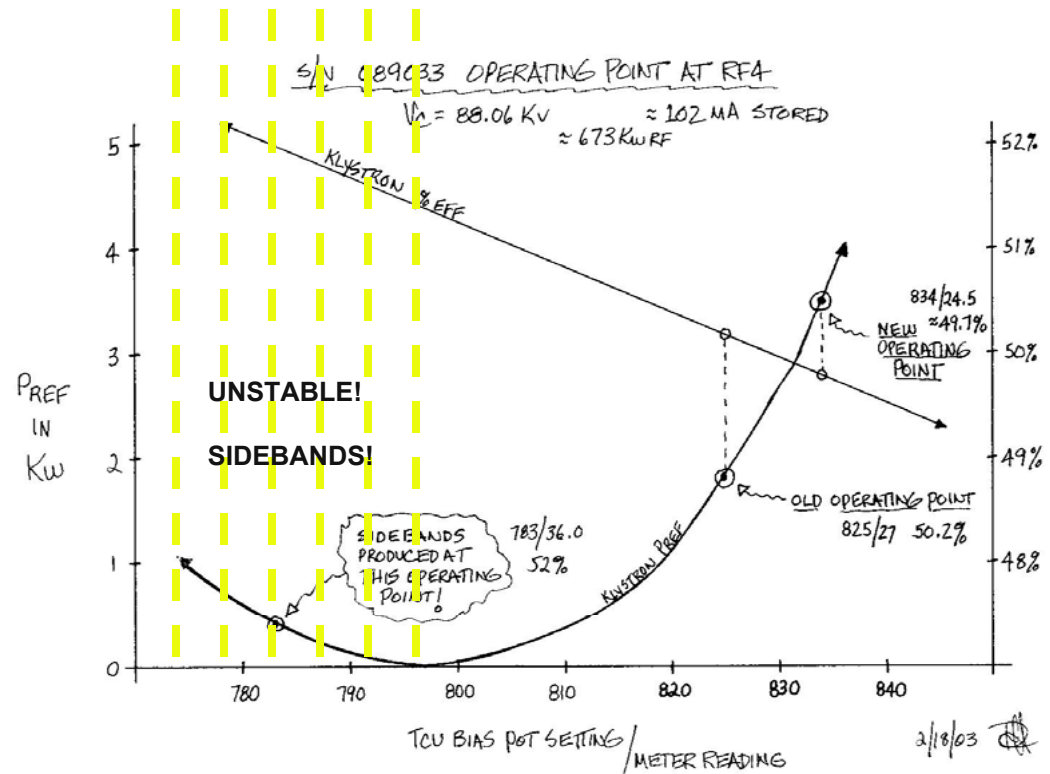
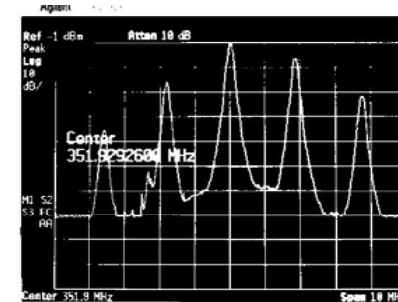
- **Sideband instabilities**

→ Can cause sudden beam losses and are hard to diagnose

→ Only seen on Thales klystrons

- s/n 089041 particularly bad

Typical klystron sidebands
 $\pm \sim 1.8$ MHz from carrier

→ Best remedy is to adjust circulator bias for additional reflected power on the low-efficiency side of the curve

- sacrifice ~ 1-2% efficiency

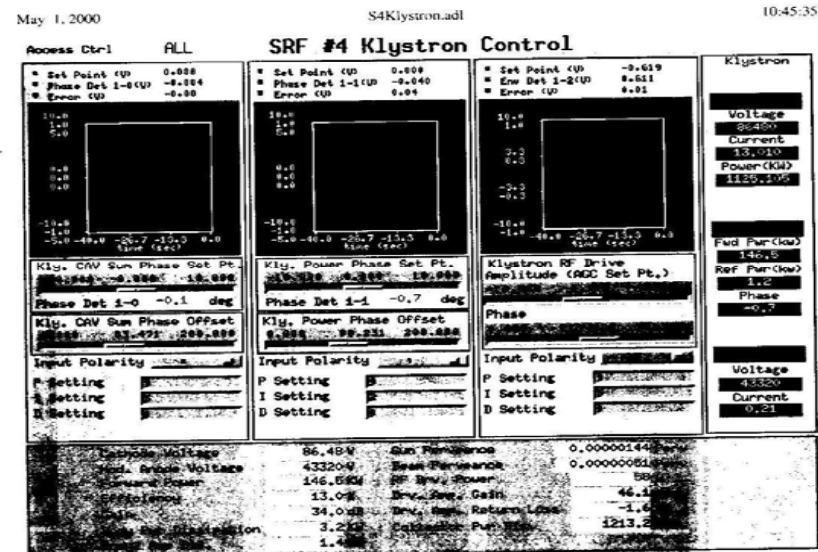
- Unstable rf output due to suspected electron instabilities

- multipactor in 1st or 2nd cavity suspected
- severe ~ 800kHz sidebands
- kept under control by determining a stable range for rf drive power

- Thales s/n 089041 particularly bad.....only stable between 42-46 watts of rf drive power!

1/2000 Serious loss of efficiency at RF4 & severe sidebands

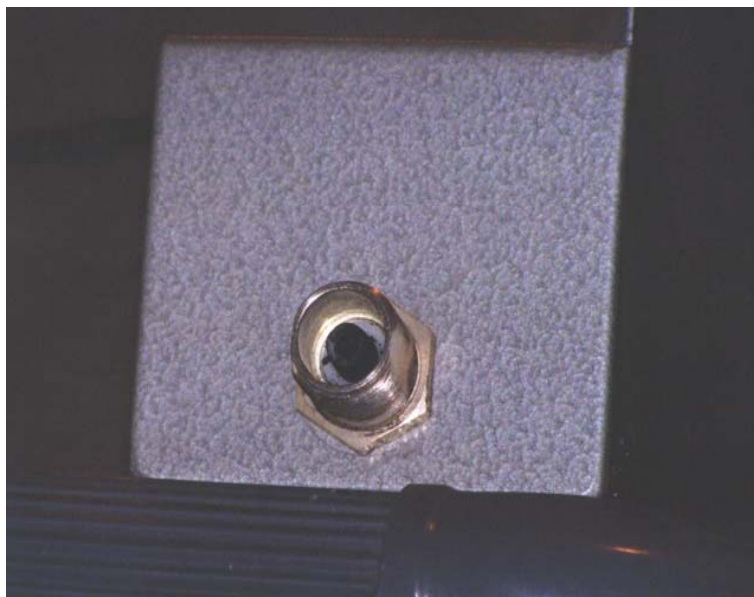
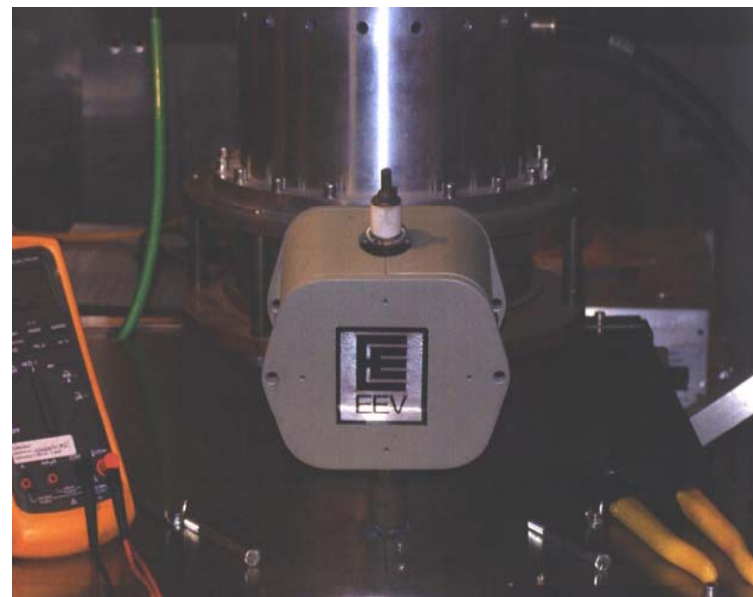
- **Arcing in ion pump connector -- EEV s/n 01**

→ *Dirty connector ????*

→ *Did not result in downtime (auxiliary non-interlocked ion pump)*

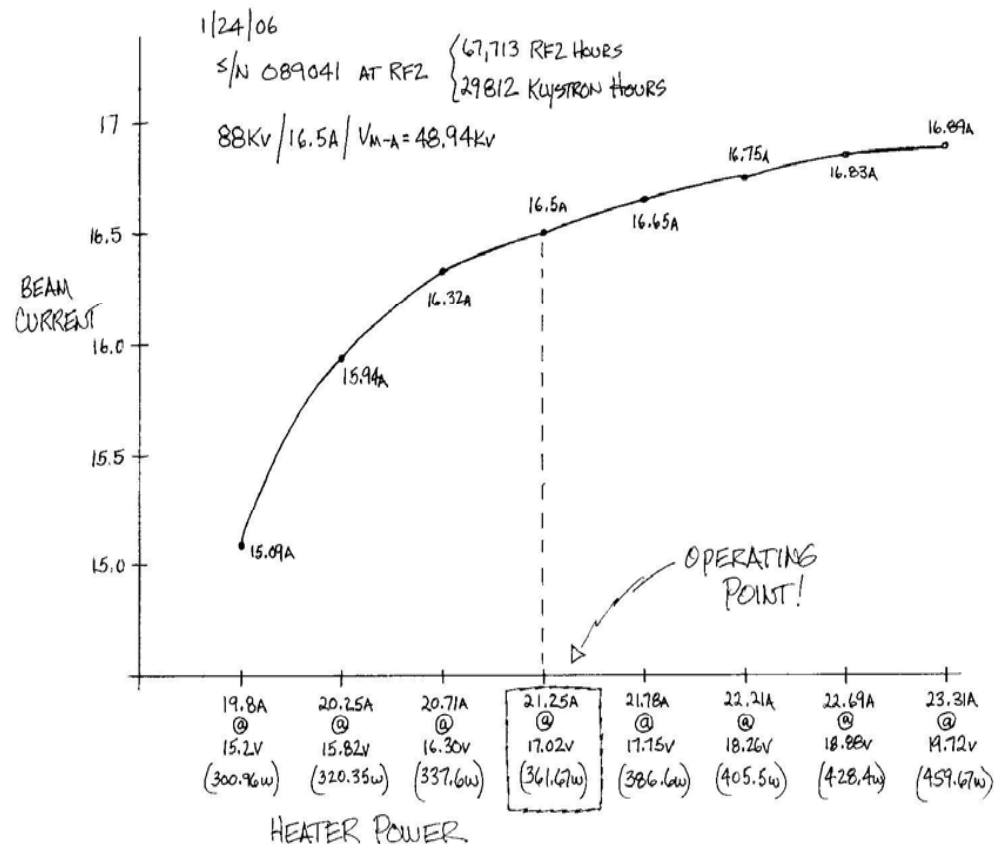
- Perform emission checks every 7000 hours at nominal operating point.

→ *Running the cathode hotter than necessary can cause many types of chronic problems!*
