ABSTRACT

The CMS Silicon Strip Tracker was successfully completed and first operations started in March 2007 in the Tracker Integration Facility at CERN. In September 2007 the Silicon Strip Tracker will be lowered to the LHC to get integrated into the CMS experiment. To finalise the two CMS Tracker End Caps 6400 silicon microstrip detector modules in 10 different geometries were needed. In total 7228

TEC MODULE PRODUCTION

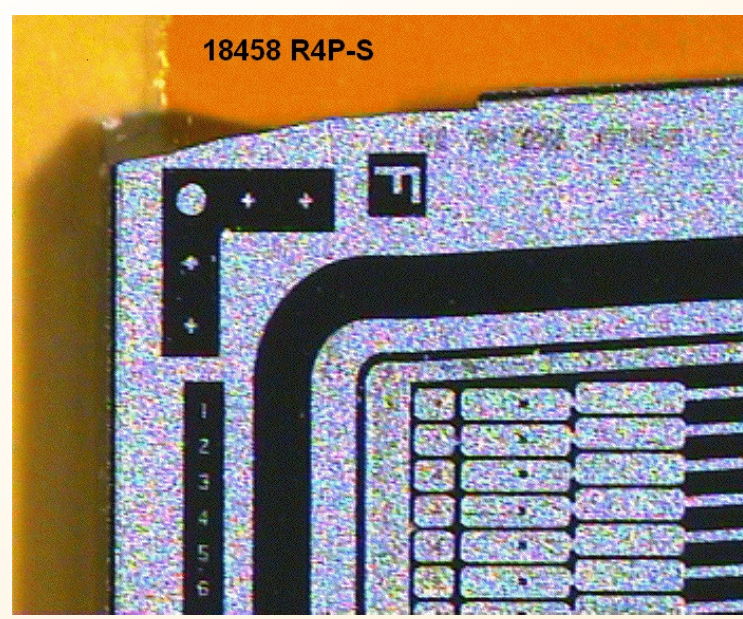
Mechanically Broken

- carbon / graphite frame → sensor recuperation
- hybrid → sensor recuperation
- sensor → frame + hybrid recuperation

Touched Bonds between

- sensor and sensor → repairable: remove and rebond
- pitch adapter and sensor → repairable: remove and rebond
- pitch adapter and APV or APV and hybrid → sensor recuperation (the APV bond pads are too small to proper bond a second time)

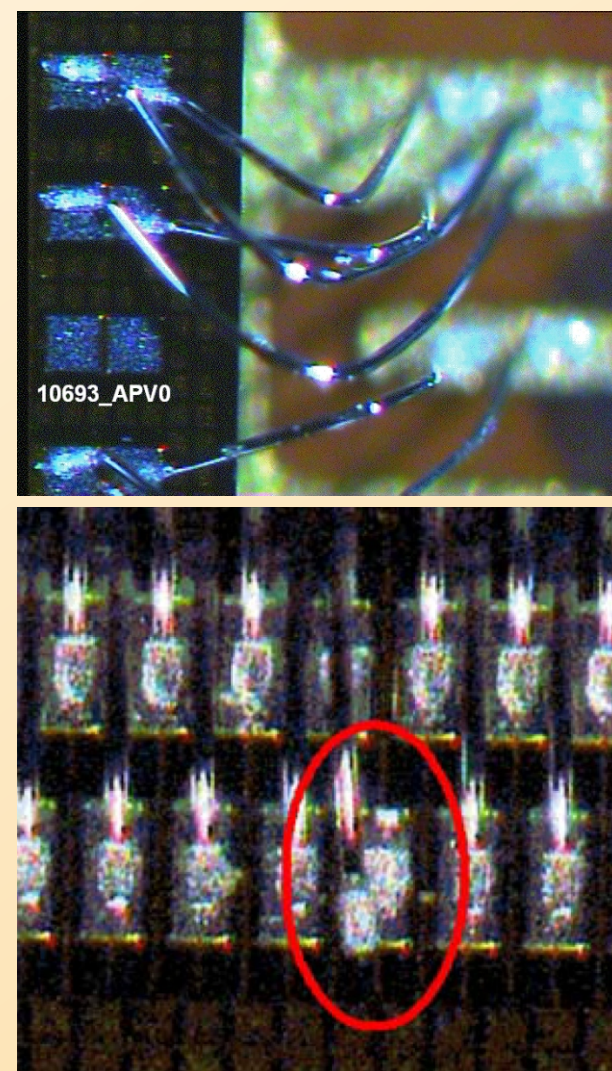
Scratches on

- pitch adapter → increased number of bad channels → sensor recuperation
- sensor → increased number of bad channels or IV problem → frame + hybrid recuperation

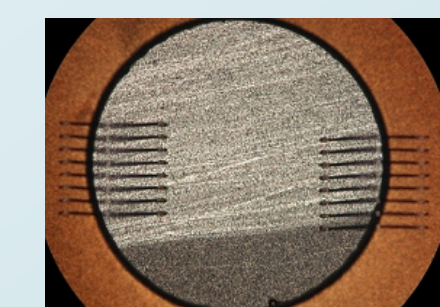
The connection was realised by a few dots of conductive glue. Problem:

The resistance of this connection increased during long time tests including thermal cycles and occasionally ended in a complete failure.

The isolating aluminum oxide layer on the sensor backplane was not efficiently broken during the automatic assembly procedure.

A so-called "glue enhancement procedure" was introduced:

- 1) prior the application with glue the oxide layer was removed via brushing.
 - 2) a much larger glue dot was applied.
- no further failures were observed with this enhancement

- For safety reasons it was further decided to bond the backplane connection.

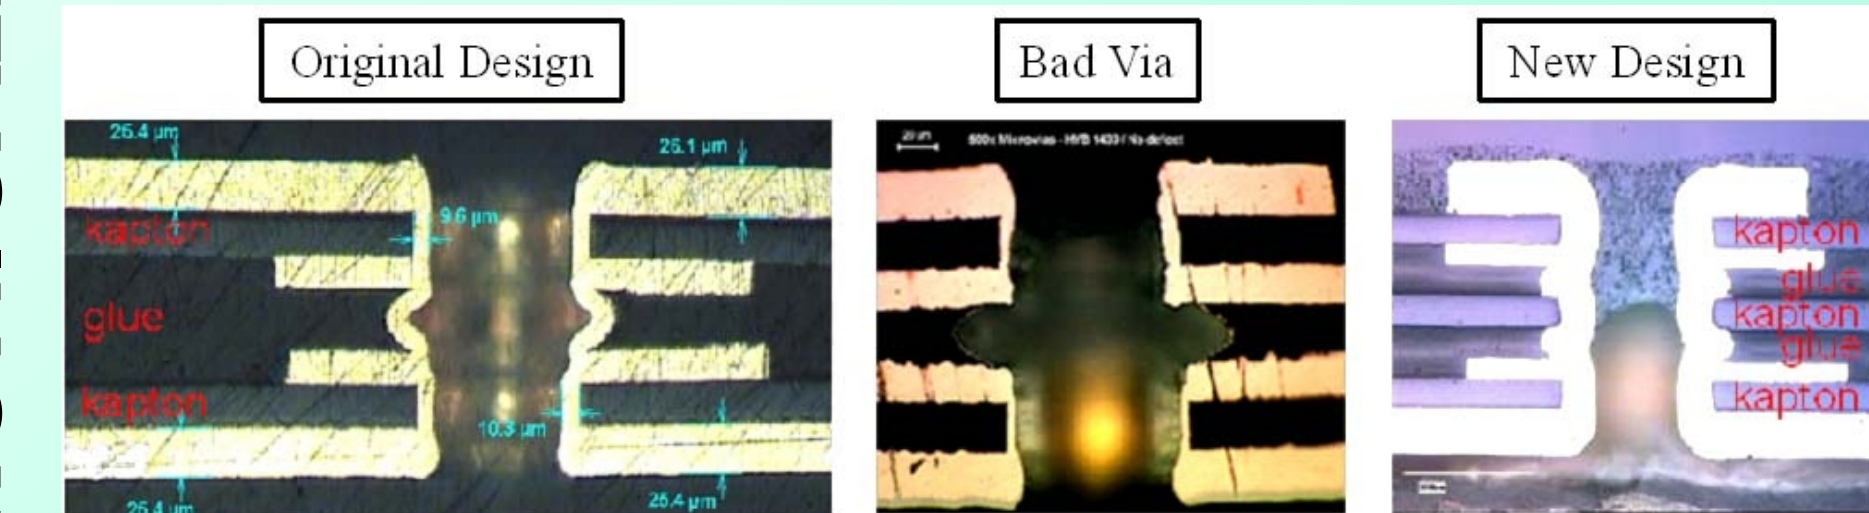
167 modules were build with hybrids containing bad vias connections. Electrical failures of the hybrids occurred during long term tests of the modules. The subsequent investigation showed that vias between different layers of the hybrids systematically broke. These failures forced a complete stop of the hybrid production and a redesign of the hybrids:

- 1) the hole diameter of the vias was increased from originally 100 μm to 120 μm
- 2) to reduce the thickness of the glue between the layers an additional central Kapton layer was introduced

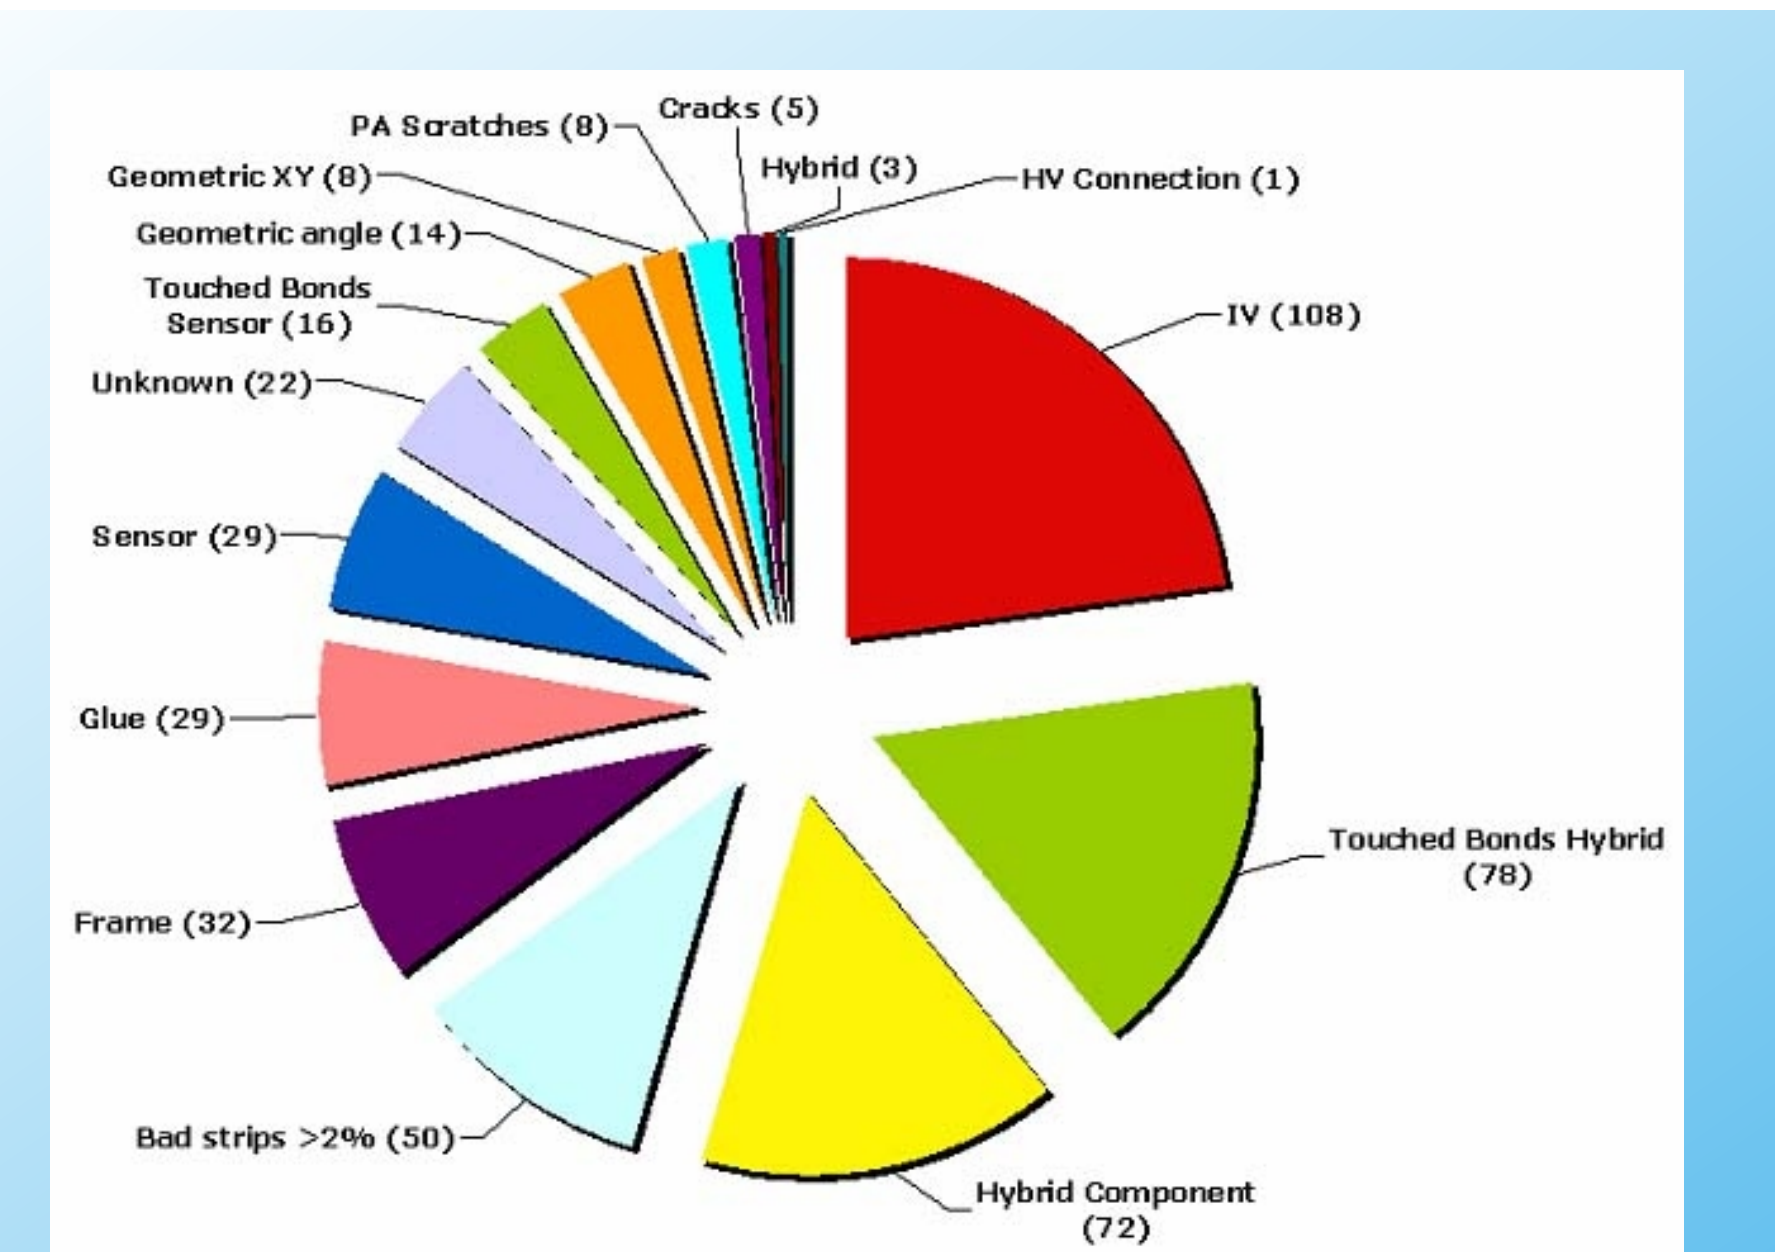
Final distribution of the faulty TEC modules divided by the different faults (number of modules). After all repairs 467 modules are left faulty, leaving 6761 (93,54%) good modules.
