# (1) SEM Study of bent silicon

- Using the low power SEM at QMUL's NanoVision.
- Small sample of bent silicon.
- Radius of curvature is 25mm.
- Sample size  $\sim 11 \times 11 \text{mm}$

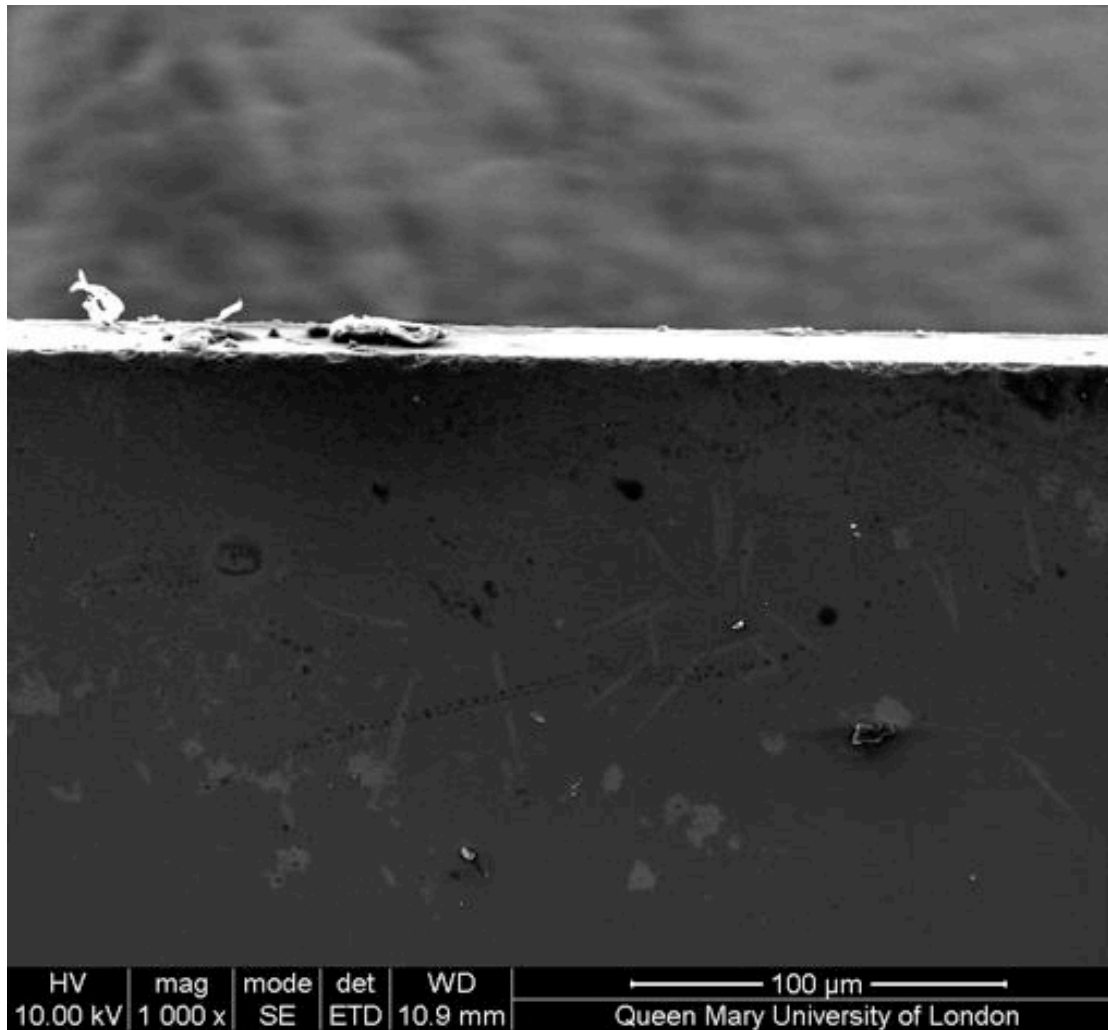
# Edge of a die

chipping visible at the edge  
(from the dicing procedure)

While the edge is mostly well defined, there are burrs that are left on the silicon after the dicing procedure (as shown).

Some surface marks for the first few 00 um a the edge.

Some dark spots near the edge.

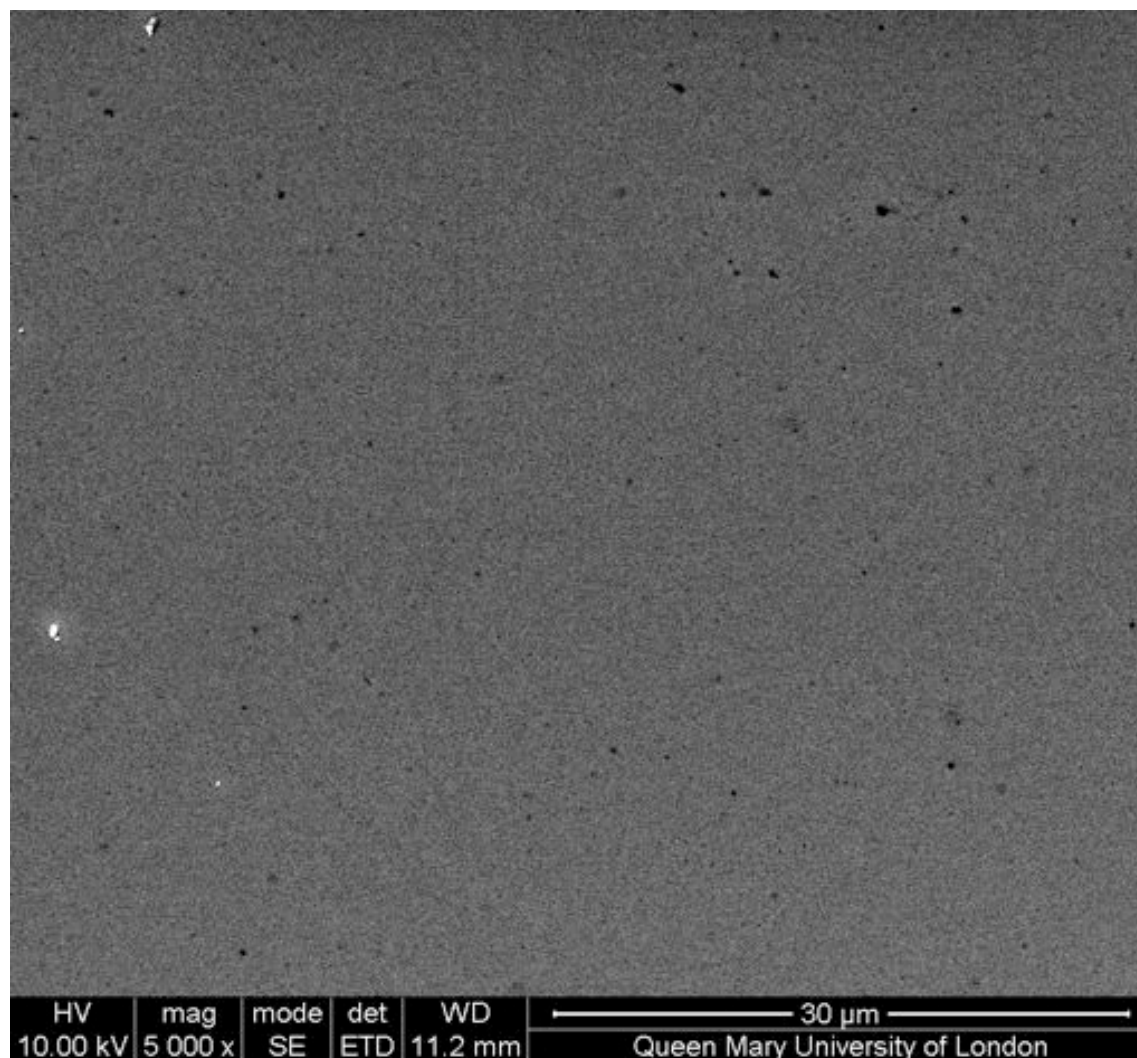
# Left side of the sample

Some dark spots on the surface.

These correspond to low density regions (pot holes?).

Density (and size) larger toward the top (i.e. toward the edge) of the sample.

Bright spots correspond to dust on the sample.

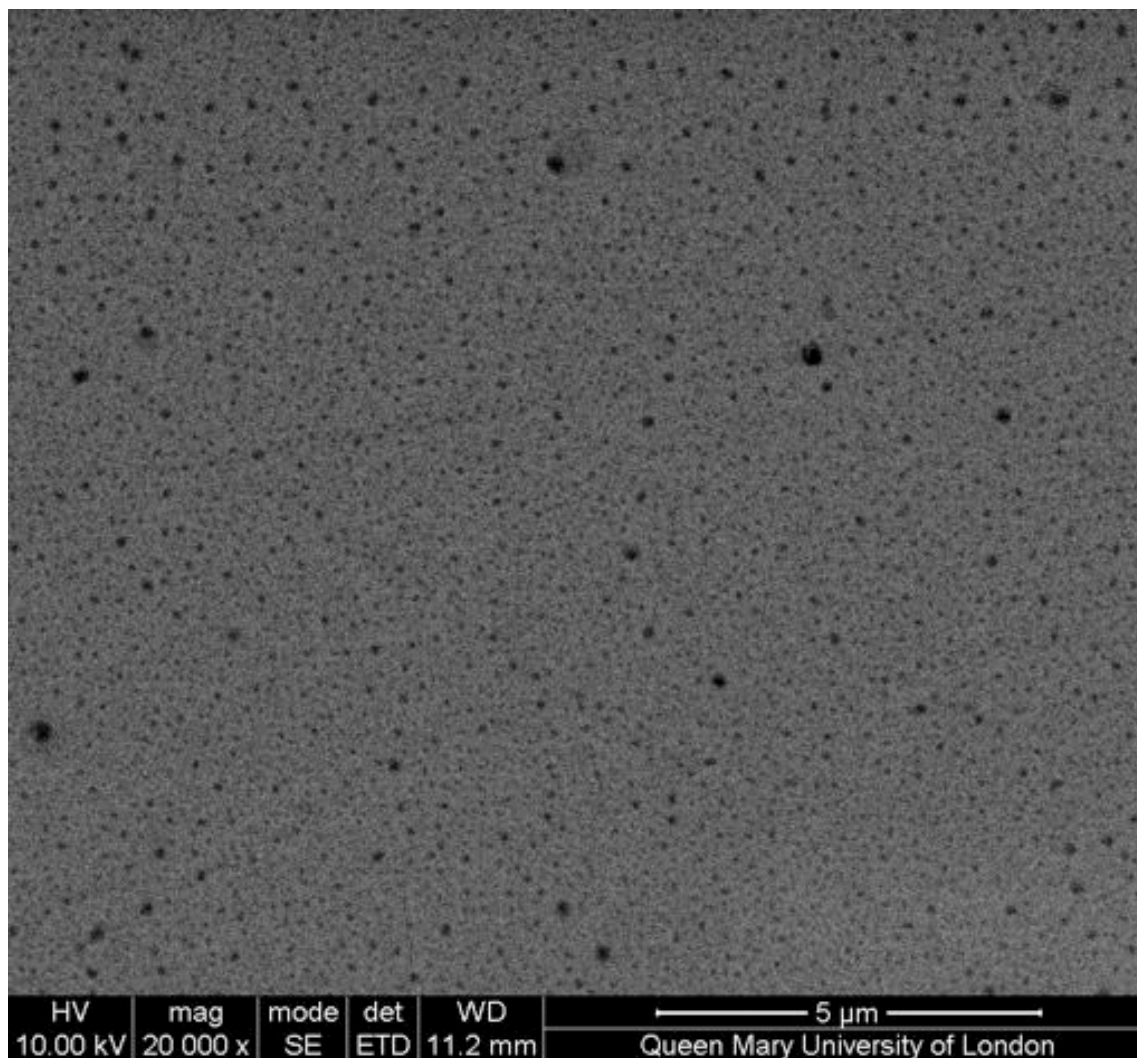
# Left side of the sample

Zooming in we see lots of dark spots: not a good sign.

Also see some lines (probably corresponds to the scratches near the edge that we saw on the first SEM image).

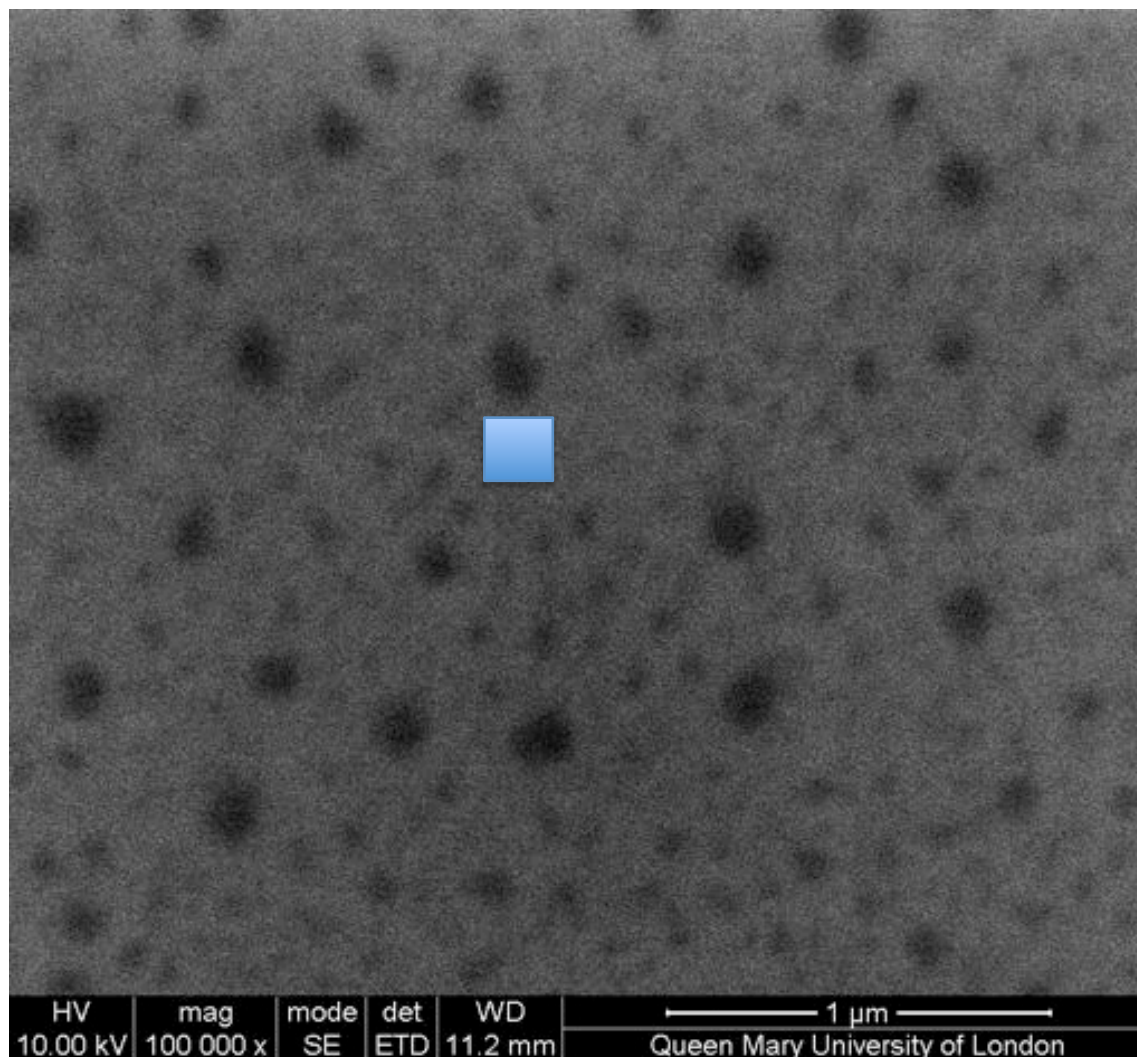
# Left side of the sample

And the pattern seems to repeat itself.

Note actually that the feature size of 180nm on an INMAPS device is comparable to the size of the large holes.

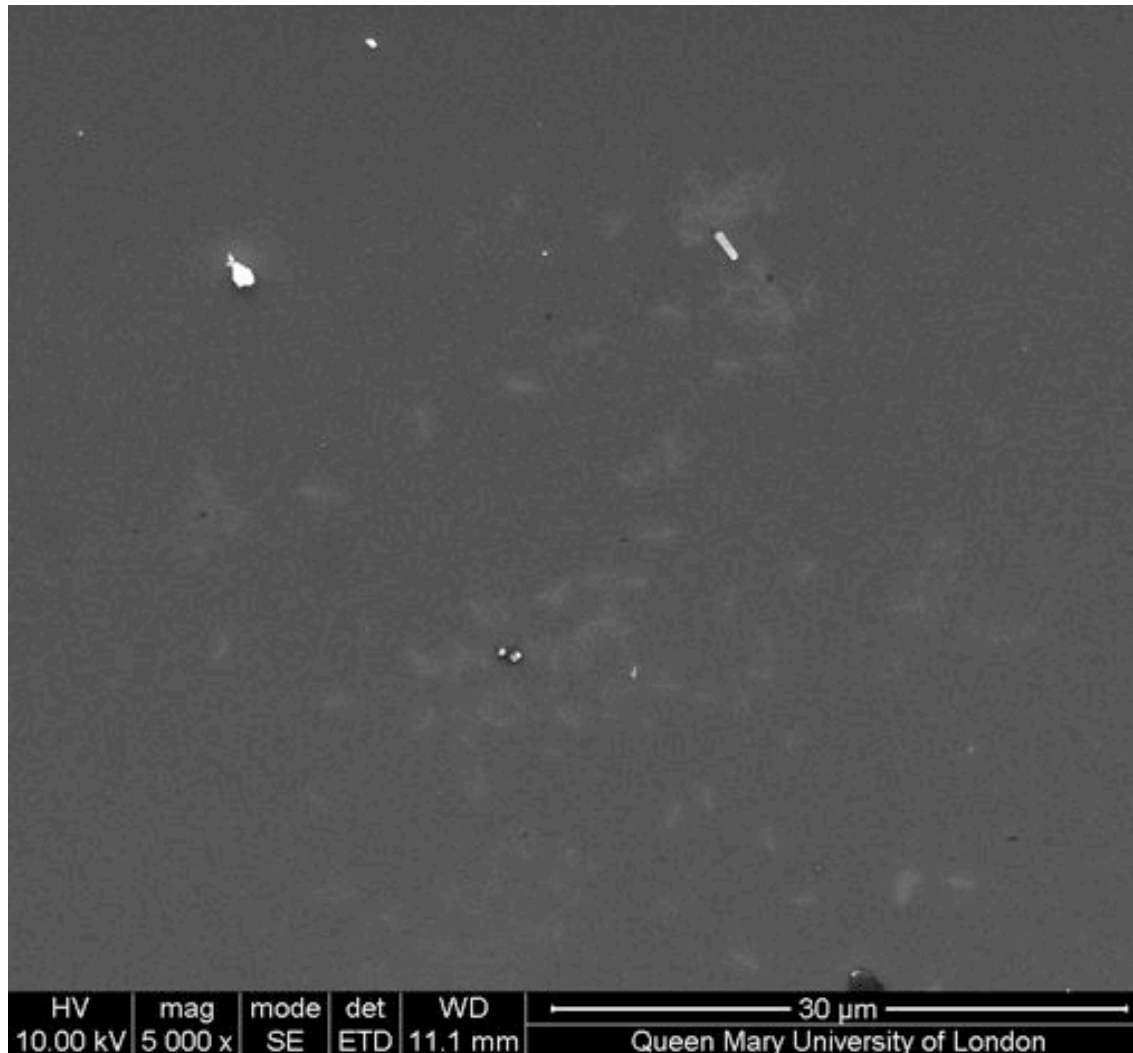
# Middle of the sample

Bright spots on the surface is dust on the sample.

The stippled effect is probably a result from using the non-stick coated release film when bending and gluing the sample down.

this was also the reason for wicking of the glue across part of the sample.

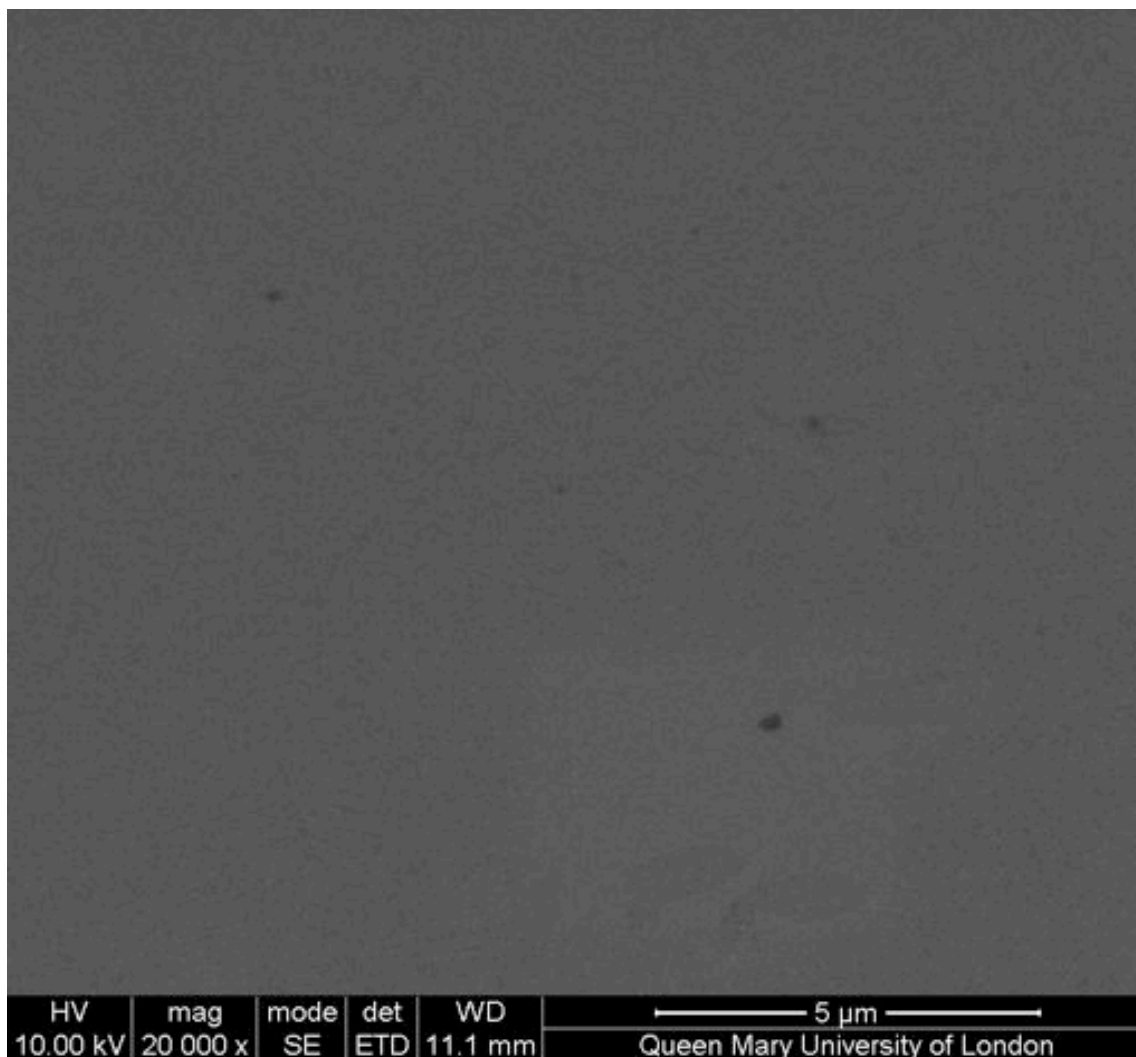
# Middle of the sample

Mostly featureless surface  
(what we expected to see).

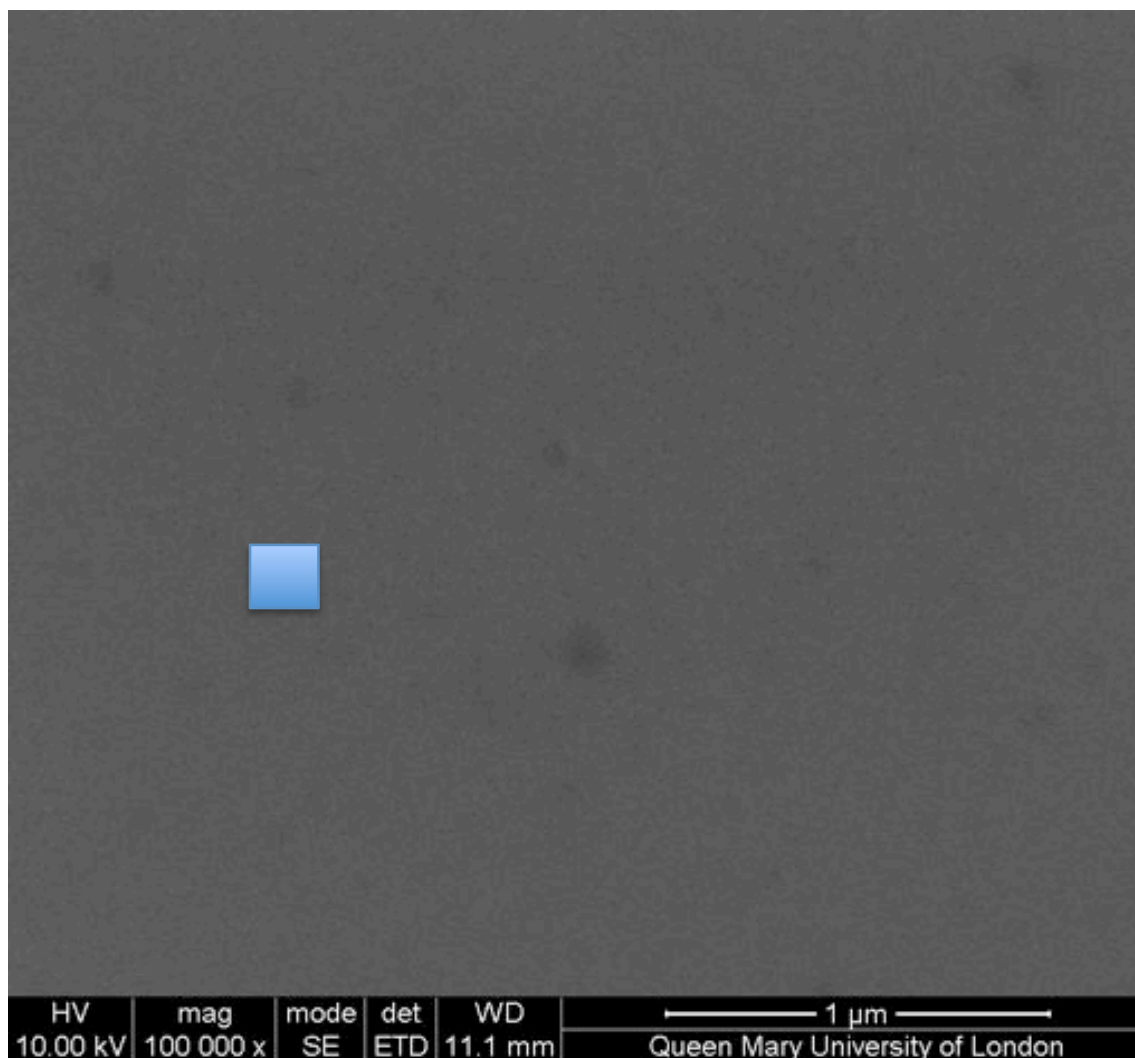
# Middle of the sample

Mostly featureless surface  
(what we expected to see).

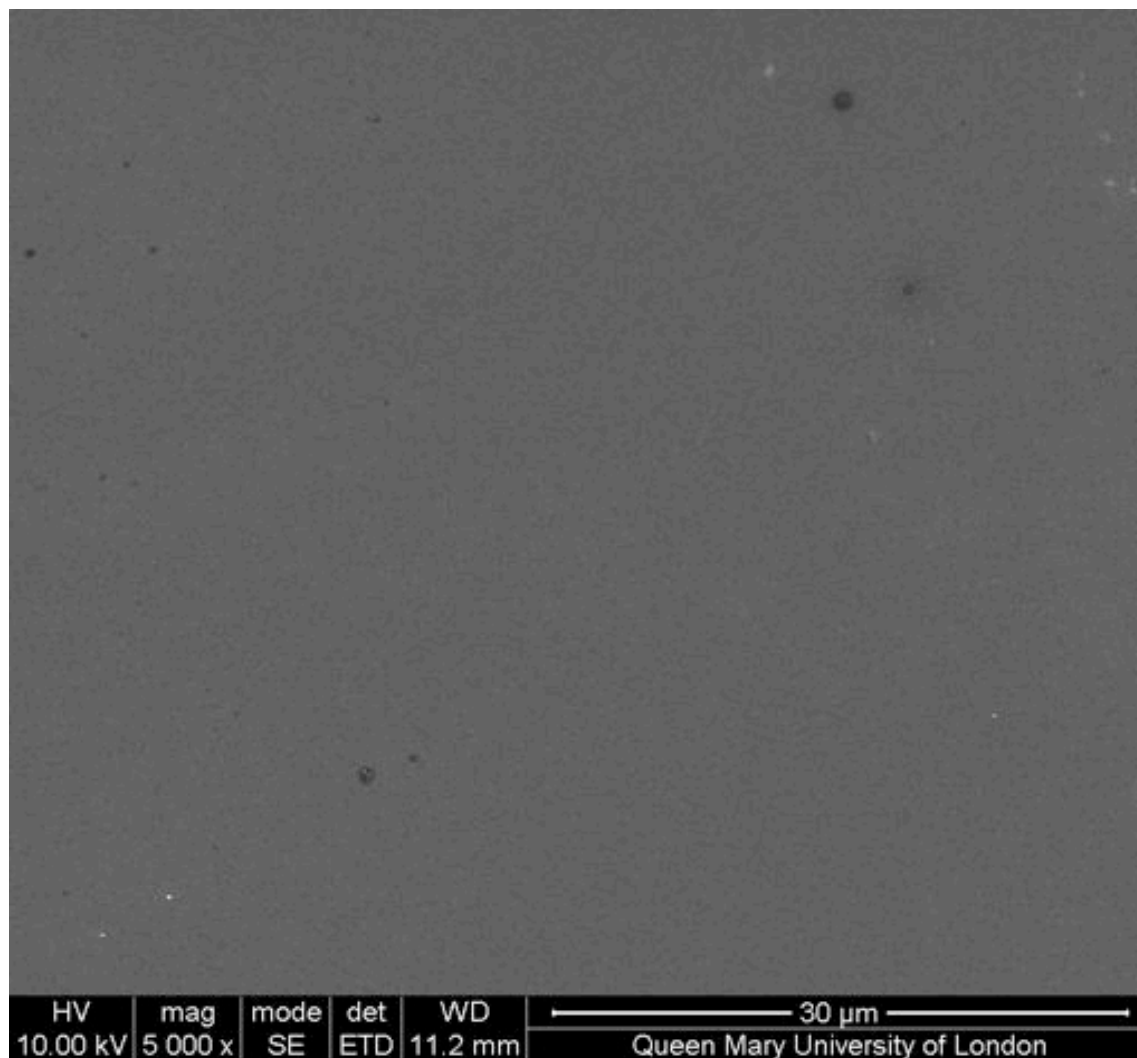
# Right side of the sample

Mostly featureless surface  
(what we expected to see).

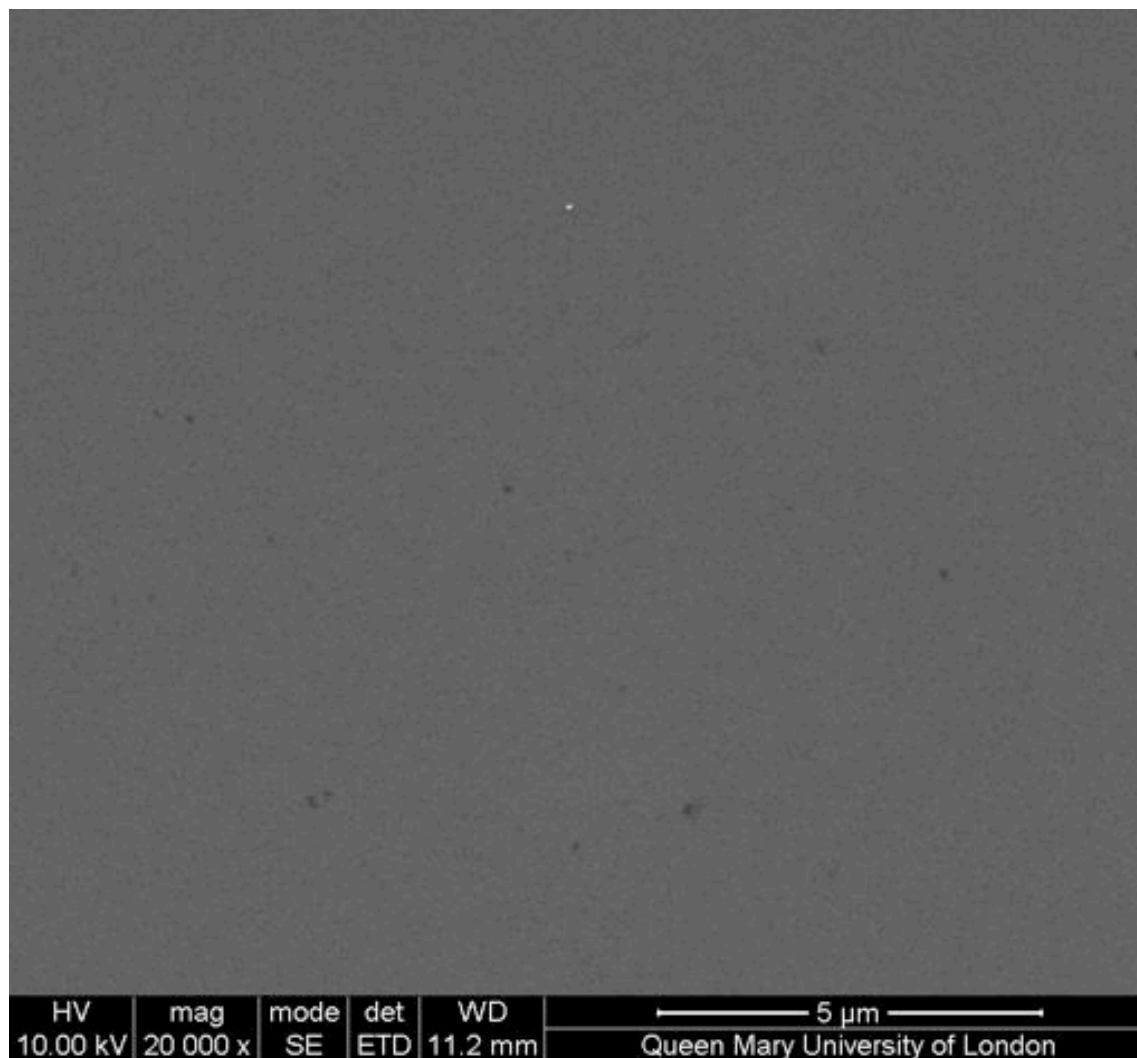
# Right side of the sample

Mostly featureless surface  
(what we expected to see).

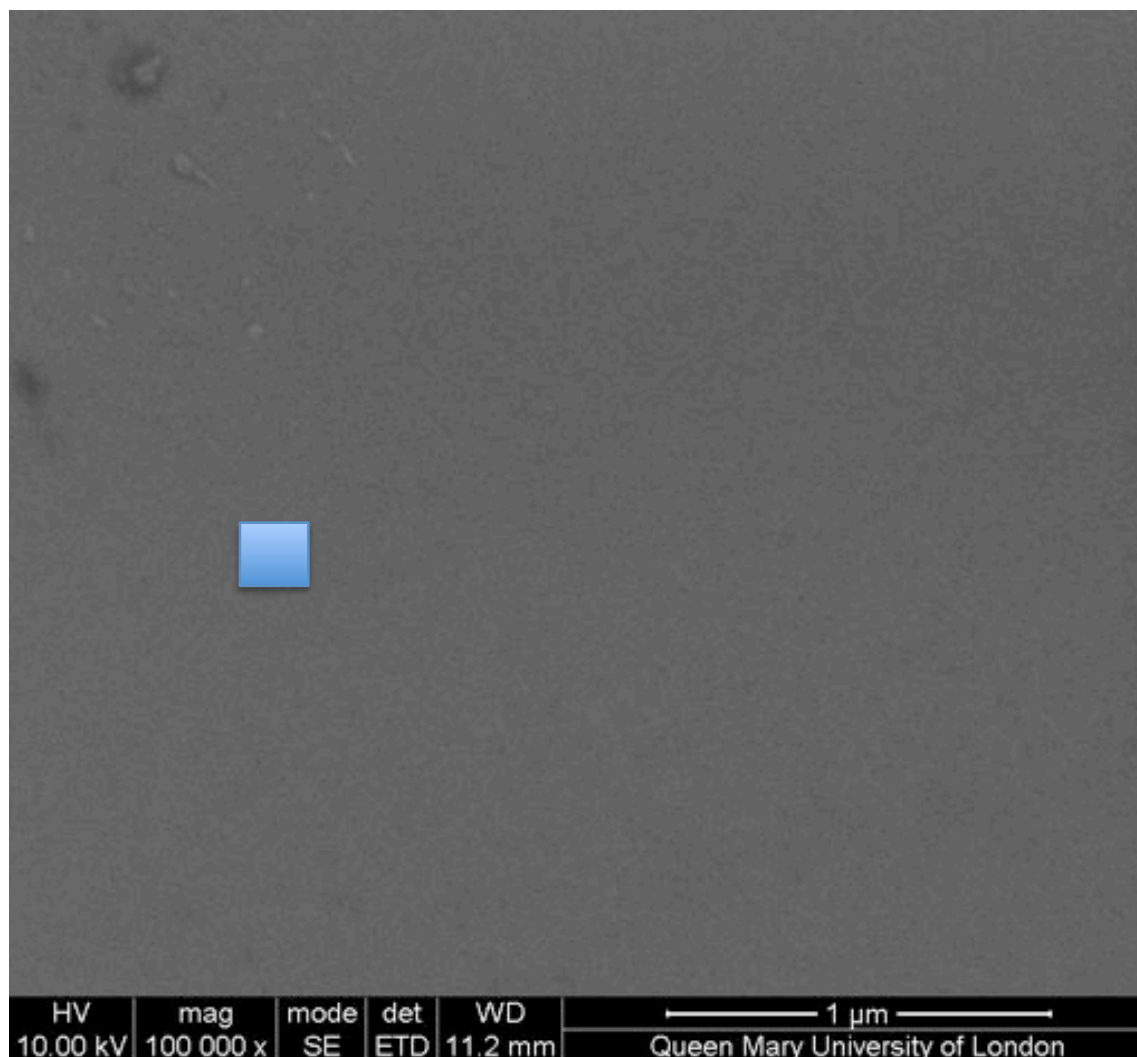
# Right side of the sample

Mostly featureless surface  
(what we expected to see).
