# "WHAT YOU GET" INJECTION & DUMP SYSTEM

### Outline

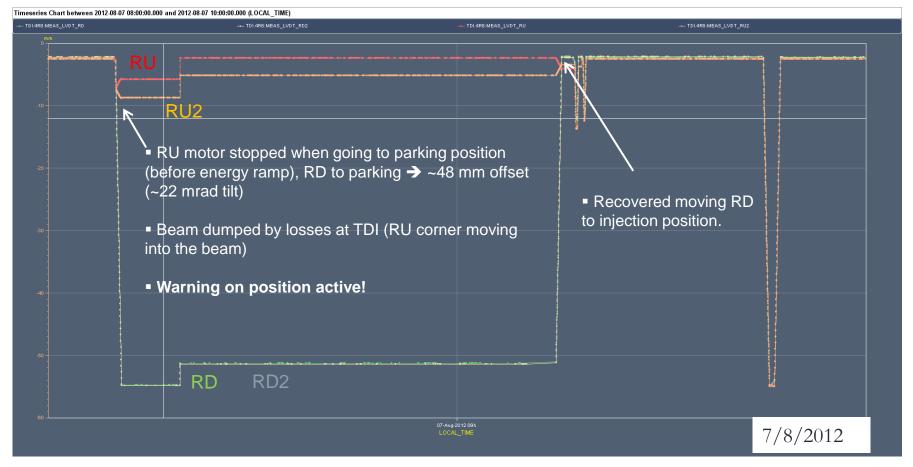
• Two spurious glitches on the RU end-switch when moving to parking (7/8/2012 and 8/8/2012) → switch active → motor stopped → huge tilt of the jaw (22 mrad – 11 mrad) → suspected plastic deformation

- Two spurious glitches on the RU end-switch when moving to parking (7/8/2012 and 8/8/2012) → switch active → motor stopped → huge tilt of the jaw (22 mrad 11 mrad) → suspected plastic deformation
  - Control module of the switch exchanged (9/8/2012)
  - TDI alignment re-checked and validated!
  - Maximum allowed angle of 5 mrad (check of the requested position and warning if bigger than specifications, low level control on position measured by resolvers and motors stopping if angle > 5 mrad)
  - Added a task in the sequencer to check TDI position before the energy ramp
- Left (upper) jaw stuck at parking position during the **25 ns scrubbing run**.

Hypothesis: **beam induced heating** + frequent **cycling** of the jaw from injection to parking position → **mechanical degradation** of the motorization system
  - Increased current to augment motor torque
  - Exchange of full motorization block for the upstream axis of the upper jaw (during TS4)

- Exchange of full motorization block for the upstream axis of the upper jaw (during TS4)

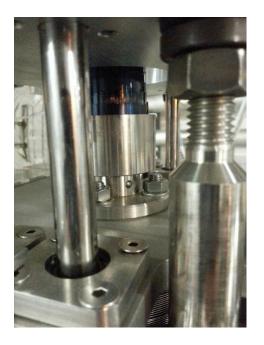
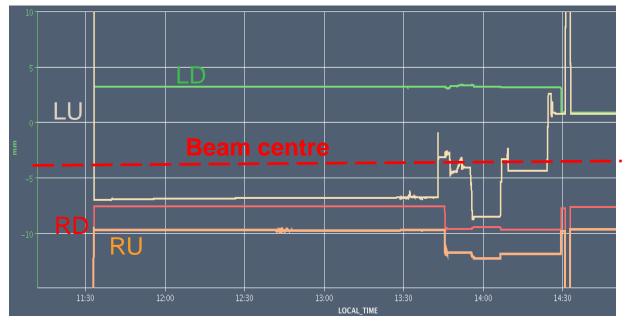
- Failure of the LVDT of the upstream corner of upper jaw (14/10/2012)
  - Moved controls to LVDT(2)
  - Position and energy interlock thresholds setup around the new LVDT → introduced an offset of ~200 µm between settings and LVDT readings
- While moving from parking to injection position (without beam) the LU side of **TDI** upper jaw fell across the beam axis onto the lower jaw (3/12/2012).

- While moving from parking to injection position (without beam) the LU side of **TDI** upper jaw fell across the beam axis onto the lower jaw (3/12/2012).

- LU LVDT drifted beyond inner dump limit when at injection position  $\rightarrow$  not possible to move the jaw to parking (11/12/2012)
  - Re-checked TDI alignment → defined new settings and thresholds. A total offset of
     530 μm between LVDT readings and settings persists

- Jaw put back into correct position plus hardware consolidation
  - Re-checked TDI alignment (both jaws) → no significant change in settings was measured but a further offset of 100 µm was introduce between LVDT and settings (closer to inner position interlock limit)

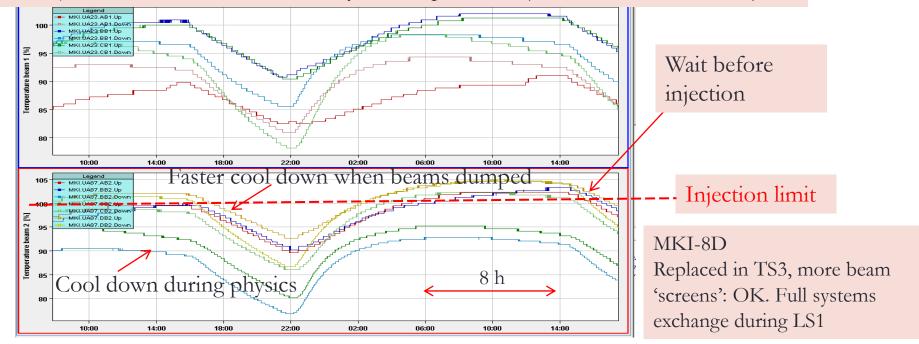
MKI injection kicker measured ferrite yoke temperatures (relative to SIS threshold)

- On about **10 occasions** required to wait > 1 hour for an injection kicker (normally **MKI8D)** to cool down
  - Happened after a series of long fills with efficient turn around to refill
- In **TS 3 replaced the hottest kicker** (MKI8D) with version with more screening wires: now amongst lowest measured temperatures.
- All MKIs to be upgraded during LS1 with more screen conductors
  - Don't expect any waiting time for kicker cool-down after LS1
  - See presentation B. Salvant

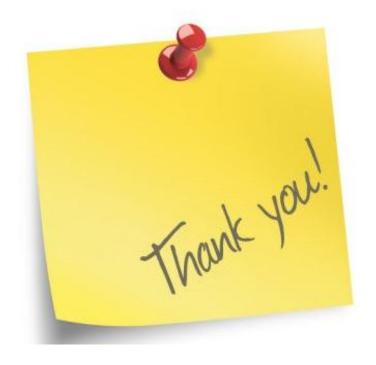
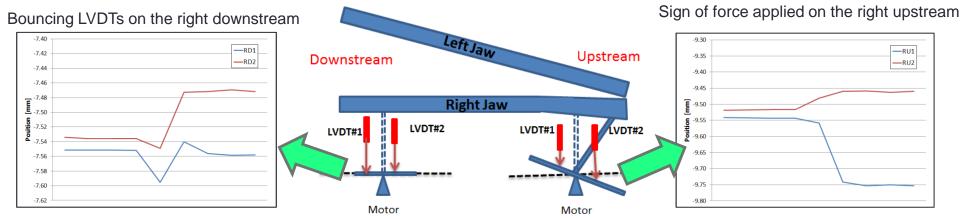
# Cotter pin problem on the TDI.4L2 LU

- > On the 3.12.2012, during a motion, the Left Upstream axis cotter pin "jumped out" from its position
- The LU first changed the moving speed and, at the end of the movement, fell down of approx. 30 mm
- > Signs of a suspected impact between the jaws at the upstream
  - ✓ LVDTs readings on the right jaw, "jumping" on the downstream, deformation on the upstream (200 μm for RU1 and 50 μm for RU2)
  - ✓ The vacuum level at the TDI raised up from 1.1E-8 to 4.2E-7 mbar
