# OPERATION AND FAILURES

23<sup>RD</sup> OCTOBER 2012

G. Spiezia, M. Brugger, M. Calviani, R. Garcia, J. Mekki, M. Pojer

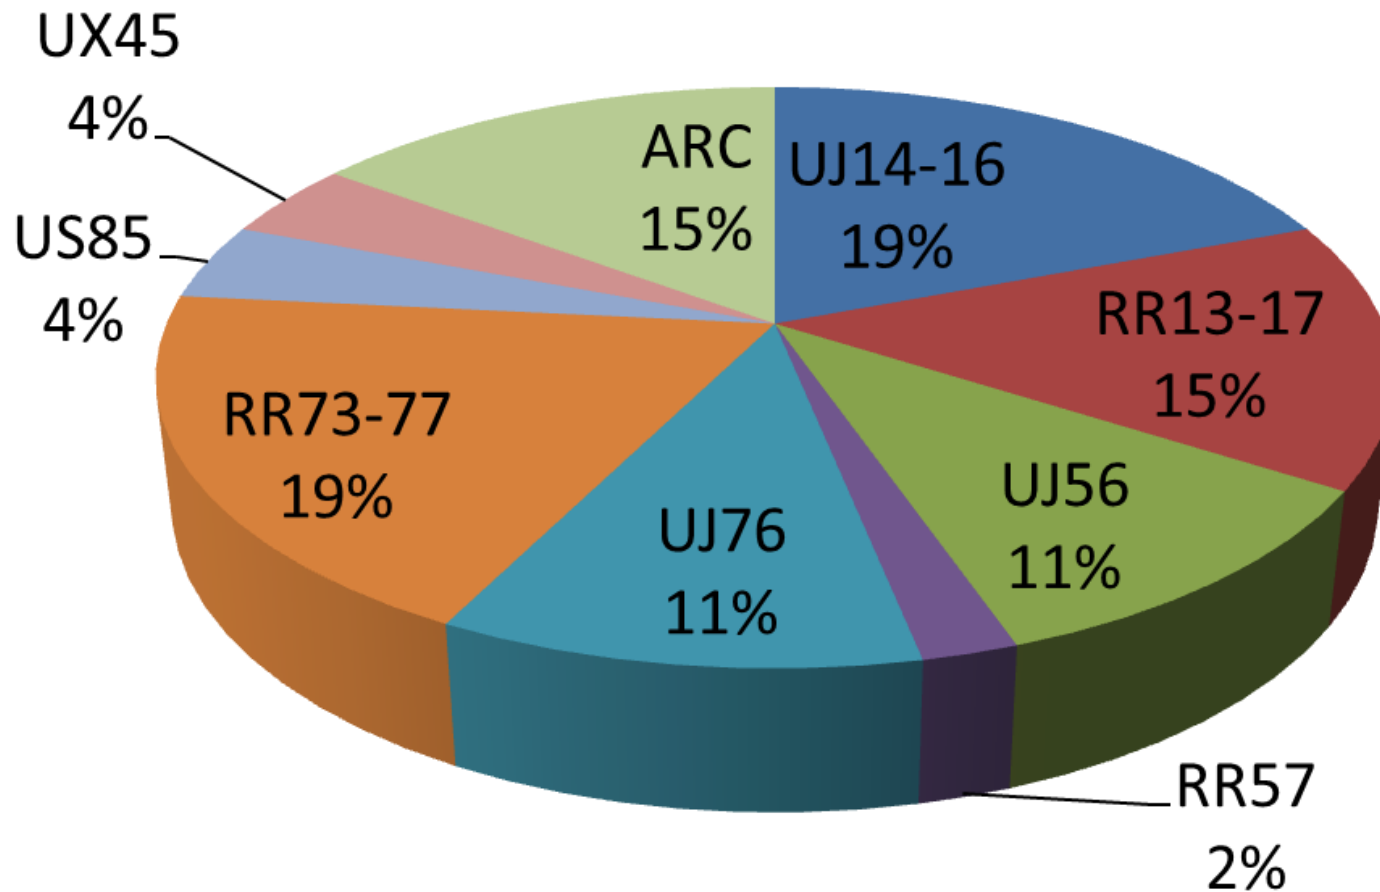
Confirmed Dump per Area

# Failures per area

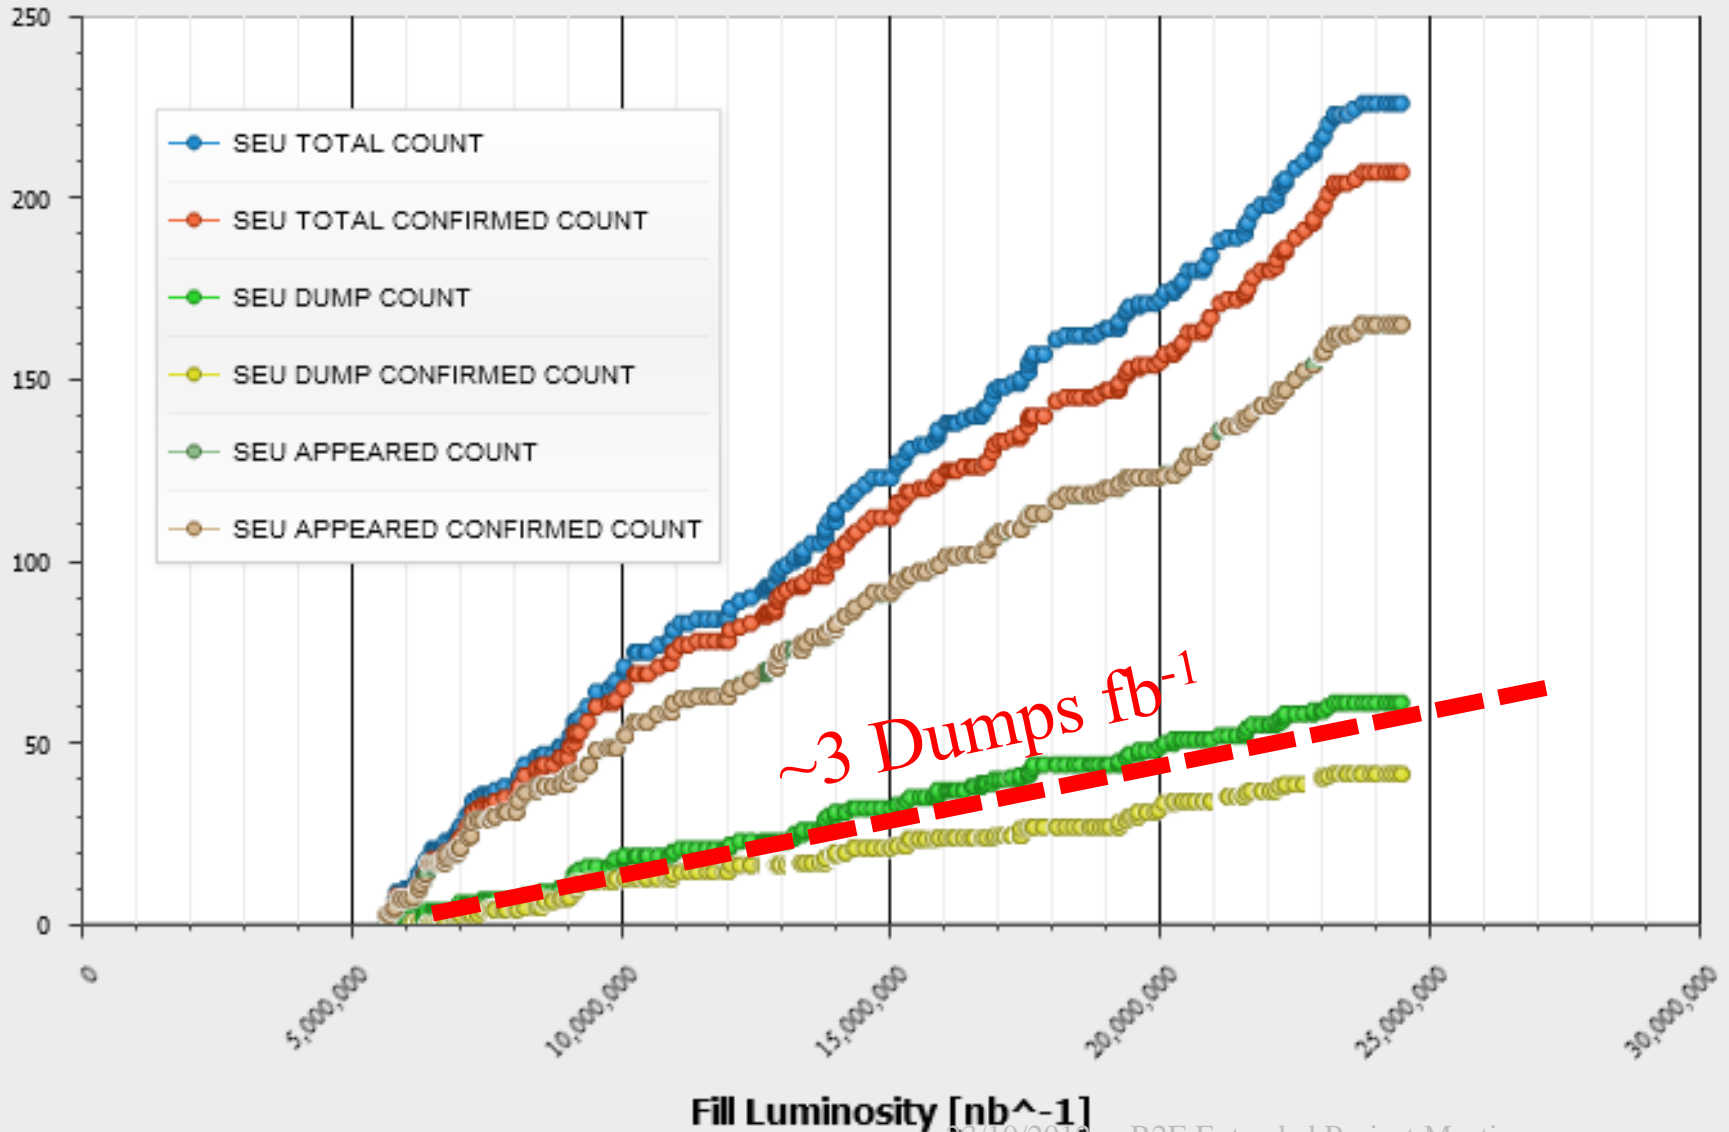
## SEU Failures vs Luminosity

- ❖ **2011:** ~70 dumps events
- ❖ **2012:** ~50 dump events
  - ❖ In Agreement with predictions
  - ❖ Effectiveness of the mitigation actions
  - ❖ Failure estimation for the next has uncertainty factors
    - ❖ Beam gas effect
    - ❖ Collimation losses
    - ❖ Equipment failure types not yet appeared
- ❖ **>LS1:** relocation and shielding
  - + new developments
