# The LHCb Silicon Tracker: Lessons learned (so far)

A. Vollhardt, Uni Zürich/Switzerland

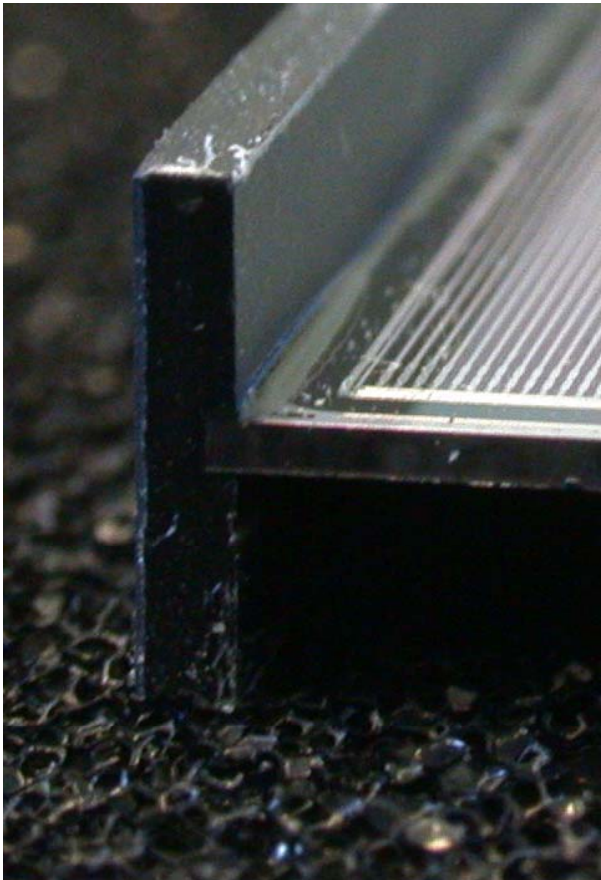
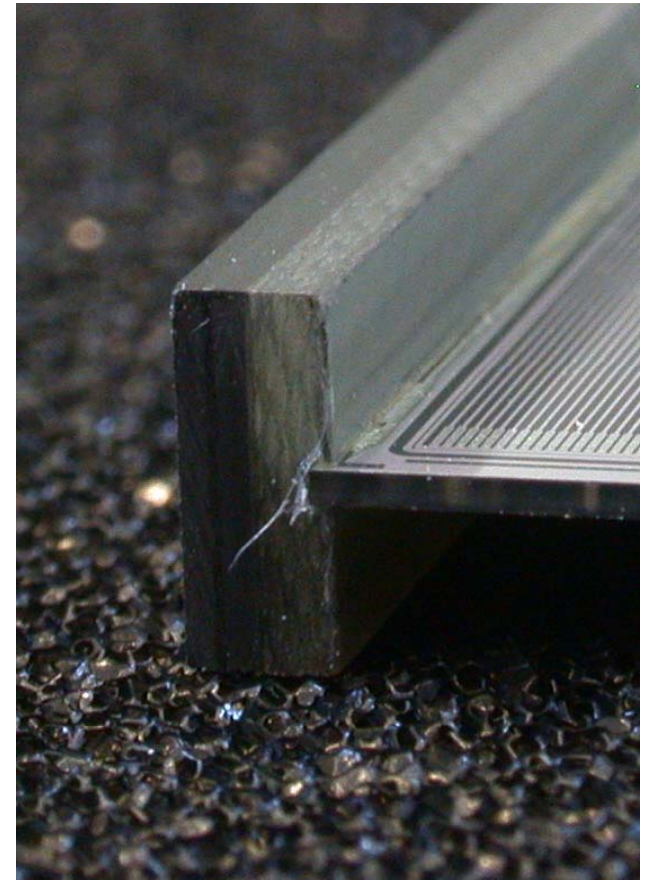
# GFK/CFK sensor rails

- Parylene coated CFK rails to support sensor modules
- Lot of bias voltage breakthroughs
- CFK fibers not 100% covered, shorting sensor backside (bias) and guard rings
- Fix: use GFK/CFK sandwich

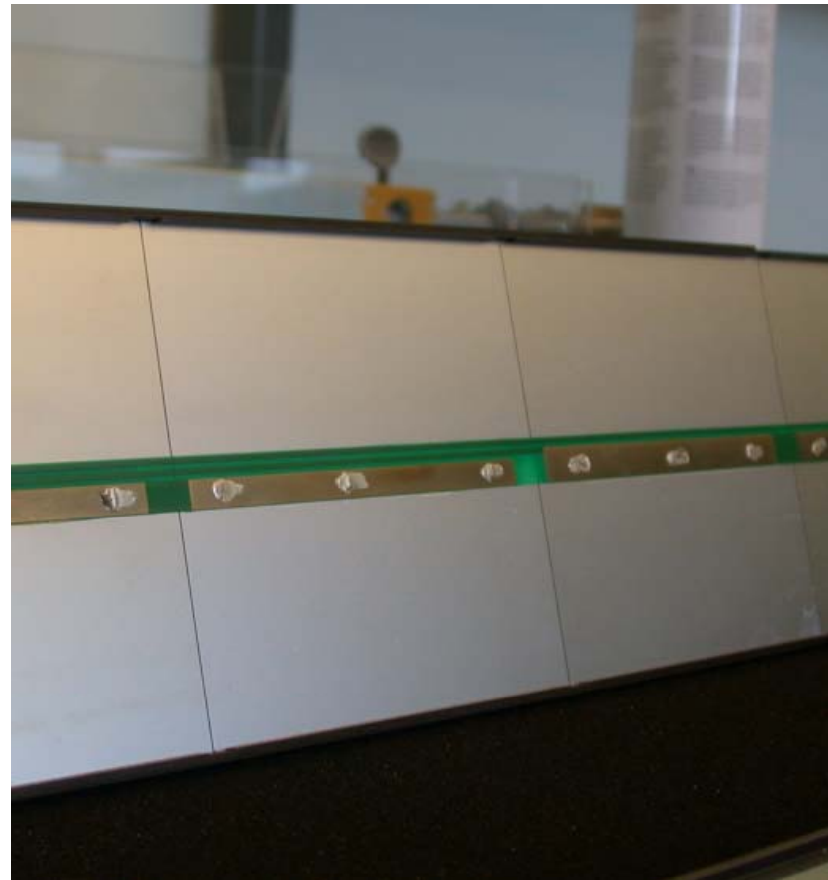
# Using conductive Glue

- Single compound silver glue (Ecolit) was used for connecting the sensor bias voltage on the back side and for grounding the kapton hybrid onto the copper ground plate
- The conductivity of the glue was decreasing over time -> bad grounding and unreliable bias connection
- Fix: Grounding was soldered  
Bias connection was bonded and sealed with glob-top

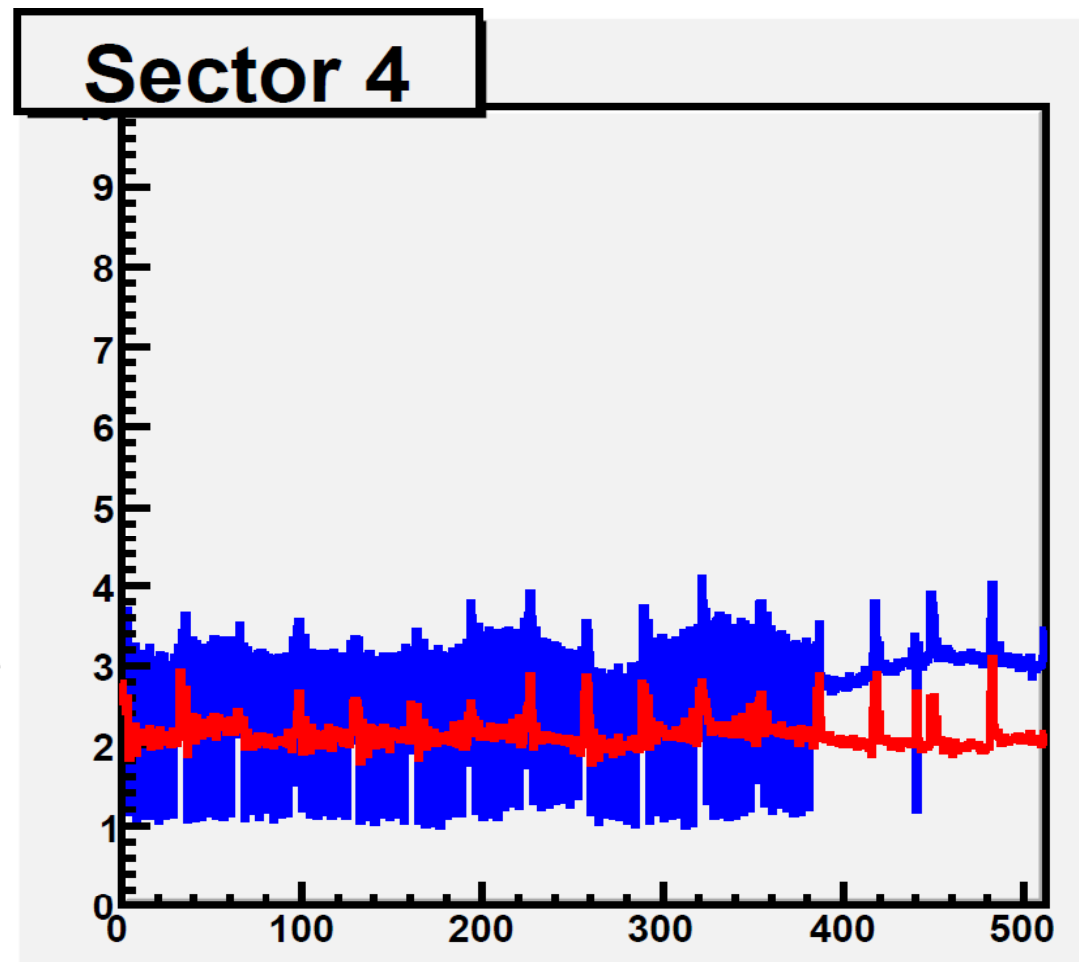
# 4<sup>th</sup> channel problem

- Strange pattern seen after some weeks: low noise on every 4<sup>th</sup> channel
- Ca. 320 bonds in total (concentrated on 5 readout hybrids)
- Problem not seen in multiple burn-in tests in Lab (incl. few dozen temperature cycles)

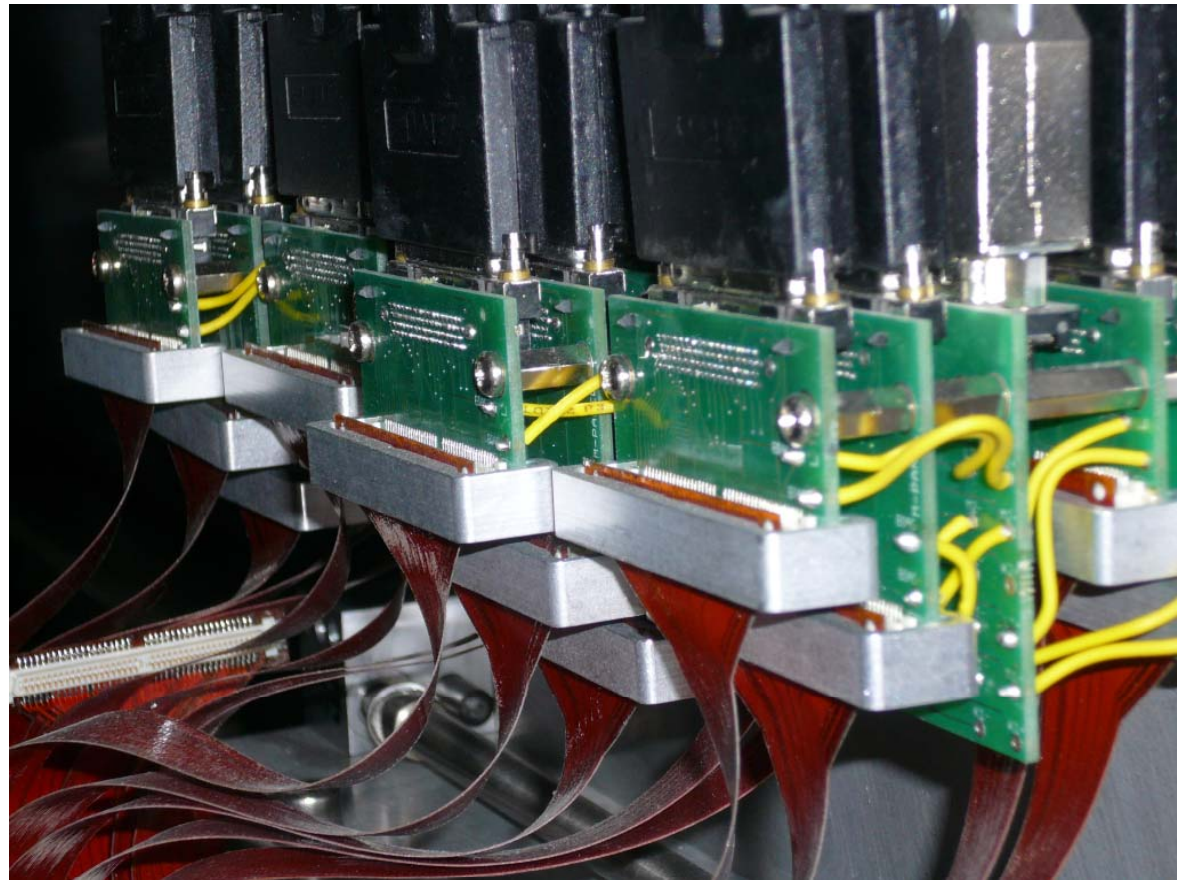
# High-Density connectors

- 80-pin connectors for insulation wall feedthrough
- One cable per readout hybrid, carries all signals/power/bias
- Kapton tension puts torque on mating interface, which can lead to unreliable contact
- Fix: Aluminum clamps to prevent connector rotation

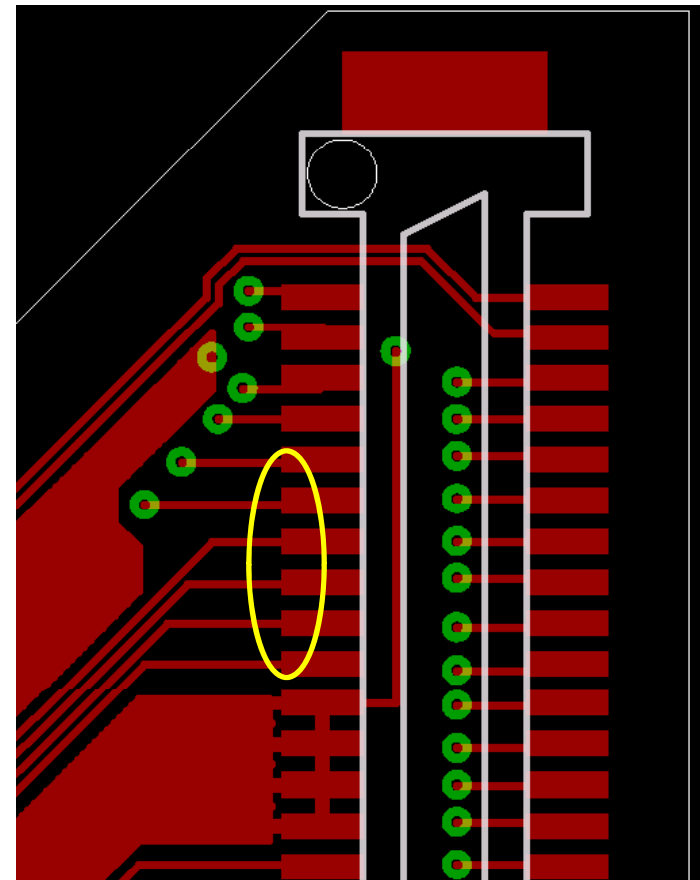
# Kapton Flexcables

- Kapton Flexcables have open traces (6-7 cables of 280)
- Reason: hairline cracks at transition of solder joint to copper trace (solid-flexible)
- Almost impossible to repair, exchange is only option
- Lesson learned: keep trace wide beyond solder pad for some mm before thinning trace for the long run

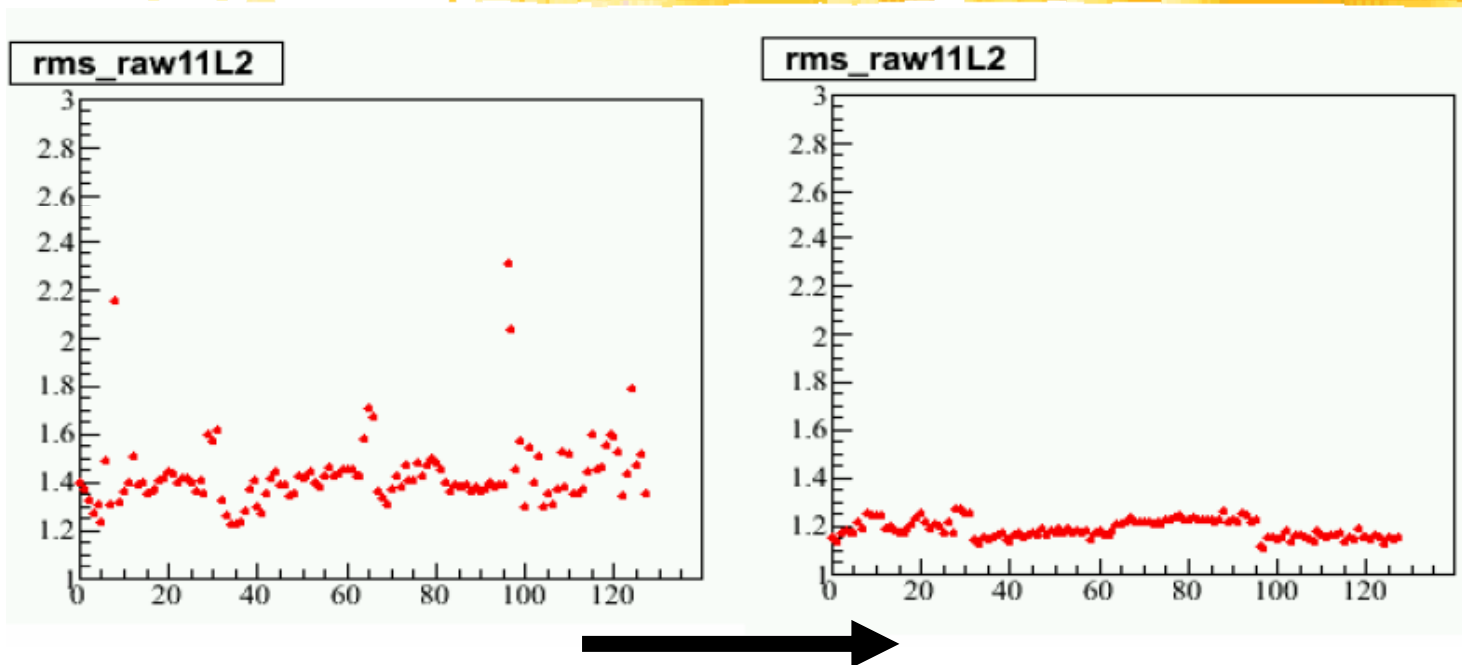
# Hunting noise: The ADC frequency response

- Analog input bandwidth of ADC 'changed' between 2001 and 2002 from 100 MHz to 1000 MHz
- Lowpass filter for out-of-band noise rejection missing!
- Fix: Adding 18 pF on an empty SMD pad did the trick...

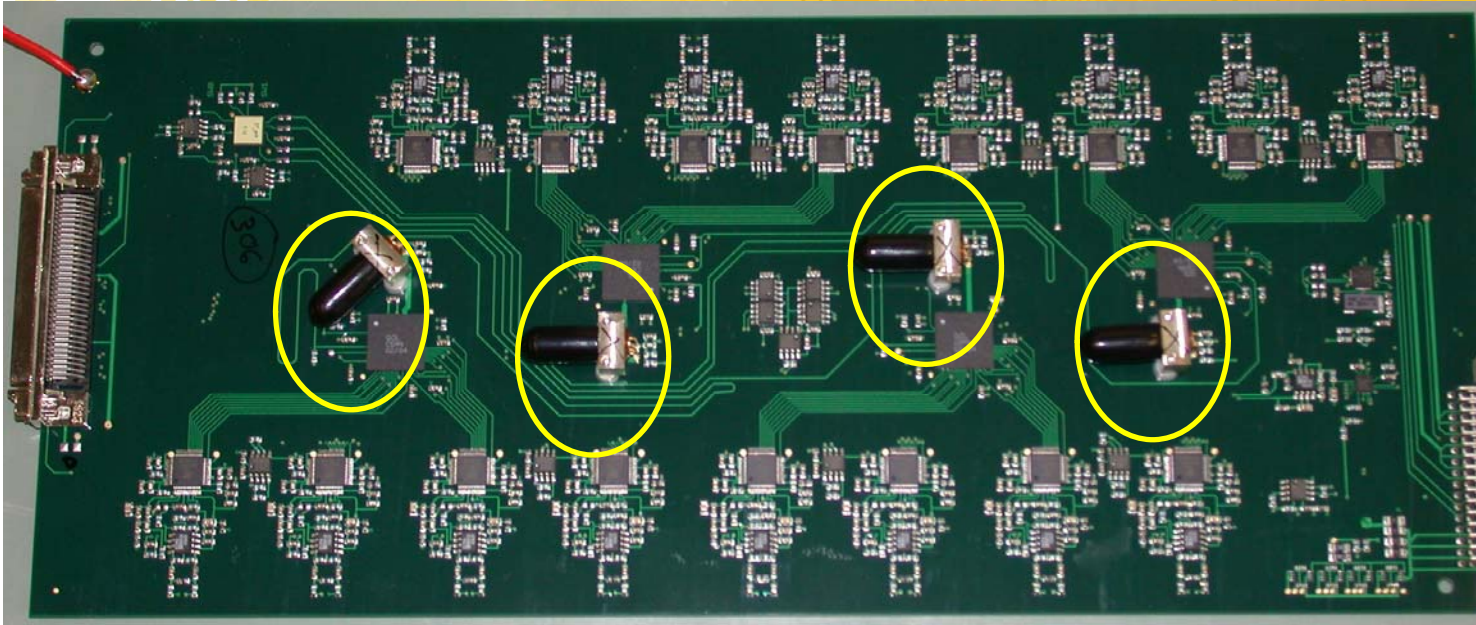
# VCSEL Diodes

- Symptom: 30 % of laserdiodes with too little output power
- Preproduction diodes were hand soldered, Main production was wave soldered.
- Increased heat flux through fixation screws resulted in partial de-alignment of VCSEL diodes inside receptacle.
- Fix: find and exchange out-of-spec diodes.

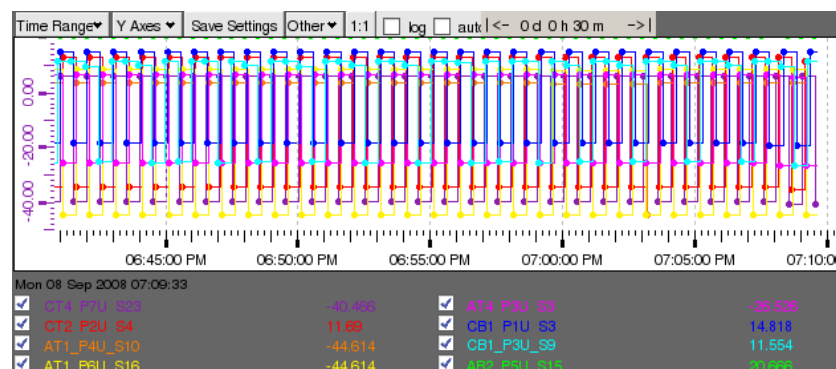
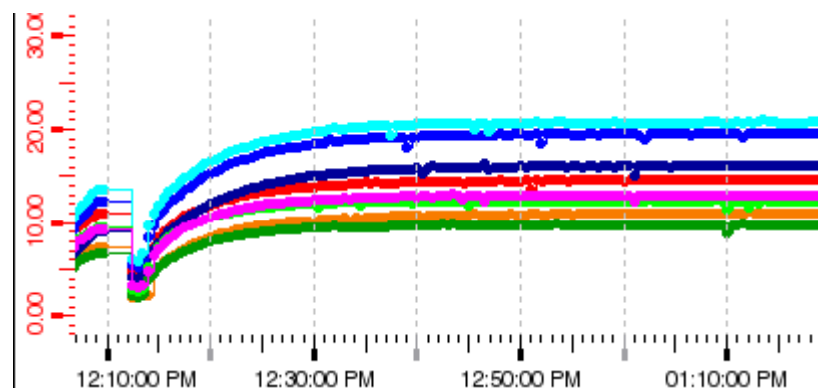
# Oscillating temperature readout

- Strange Temperature oscillations seen, traced back to DCUF slow control ADC
- Problem: voltage divider ratio for measuring regulator output designed wrong ( $>2.5V$  at DCUF input)
- Cause: voltage drop of cable calculated incorrectly
- Fix: change divider ration to reduce ADC input voltage

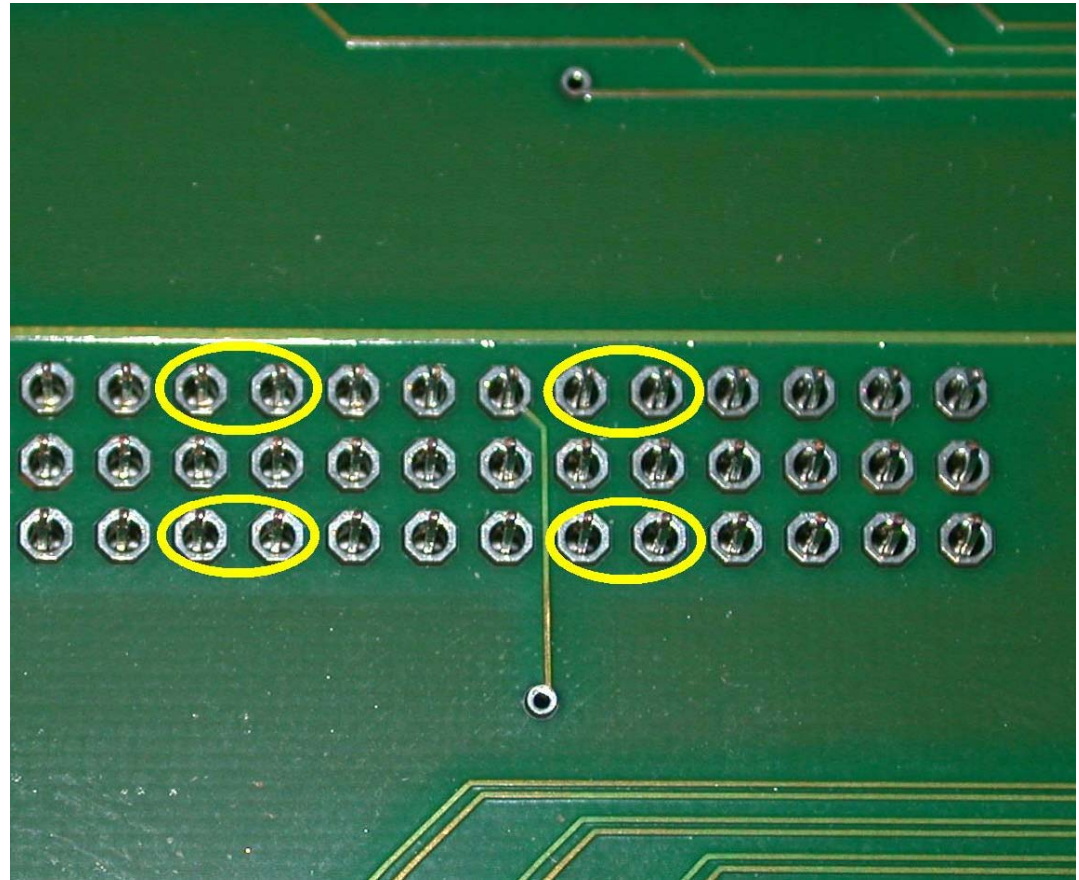
# Pressfit Connectors

- Pressfit technology used for Box backplane connectors (DIN41612)
- Part of the pins got bent during delivery, rework by company
- Pin loses tension/reliability/contact
- Fix: all pins resoldered by hand

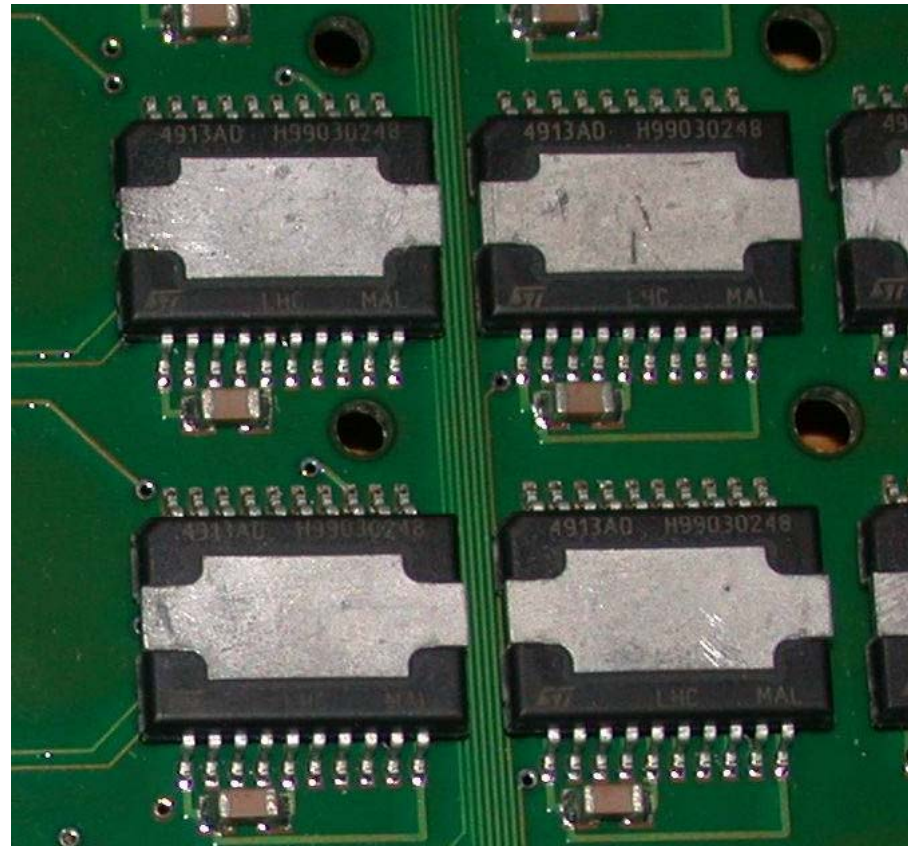
# Voltage Regulators

- All voltage regulators tested in test setup (24h burn-in)
- Some regulators failed to deliver rated current (1 Amp)
- Regulators signaled over-current condition
- Fix: Exchange of regulators (ca. 30 of 864)
- Was partially traced down to influence of long cables between regulator and load (8m) which were not part of the testsetup
- Still not completely understood

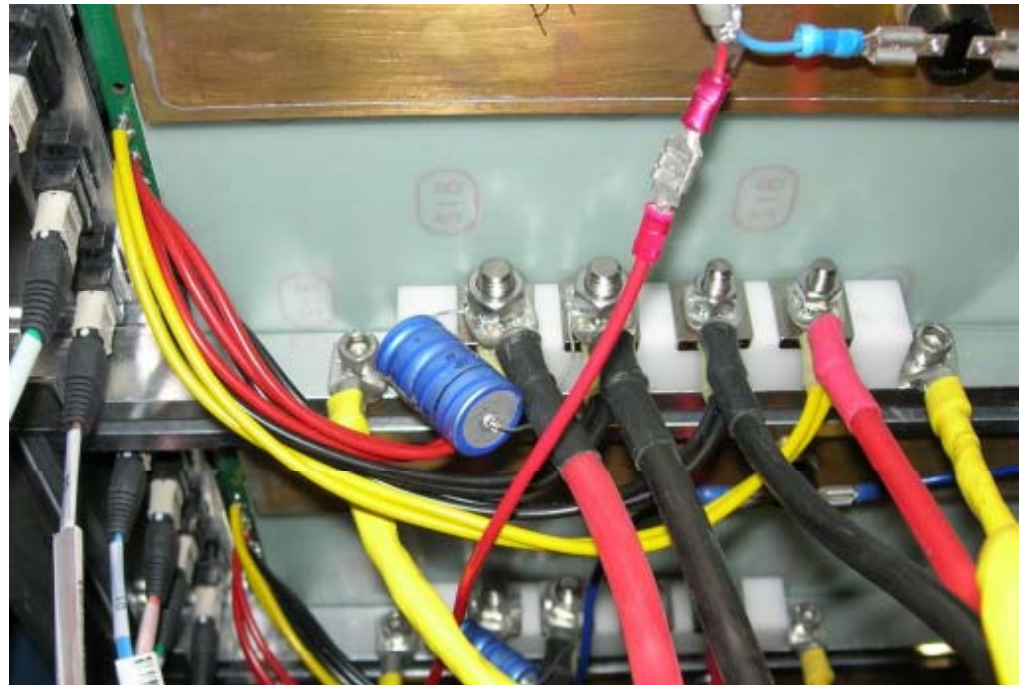
# Power line oscillations

- Symptom: some frontend electronic boxes draw less current when switching to max. L0 trigger rate compared to idle.
- Cause: power supply oscillations on the MARATON output going to the electronic Boxes (35m line length) (3Vpp @ 6V/20A !)
- Fix: add 1000uF electrolytic capacitor directly at low voltage terminal of electronics box

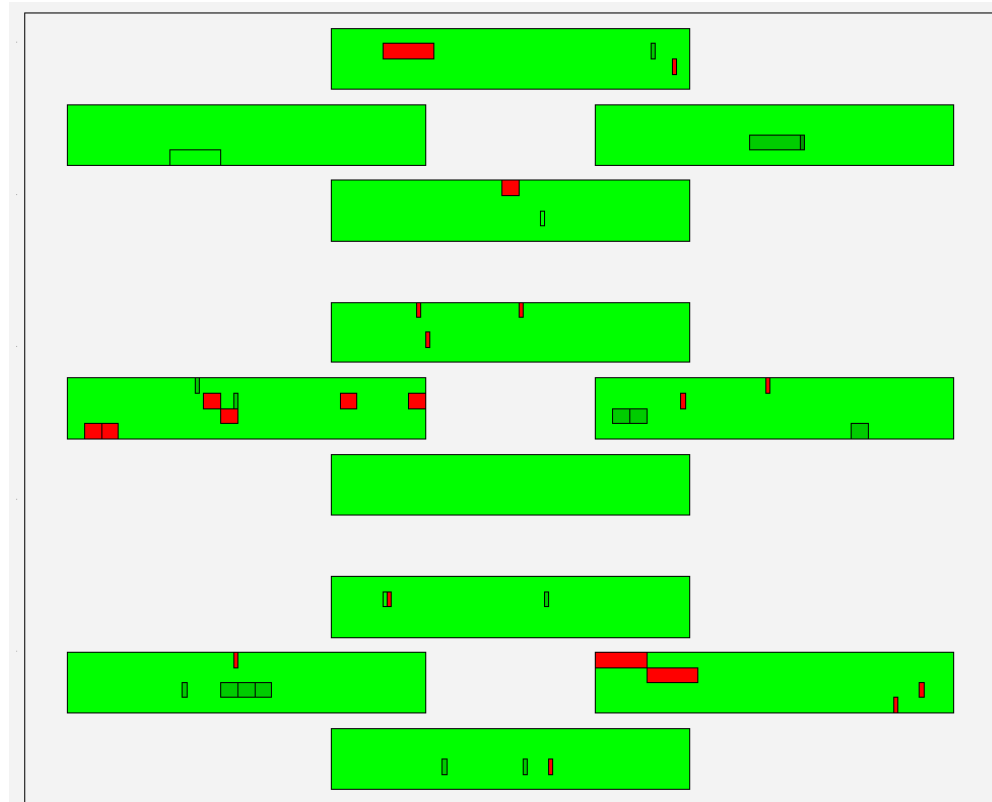
# Current status IT

various problems:

- broken cables
- broken fibers
- weak VCSEL diodes
- broken Digitizer Boards

Could not be fixed yet due to inaccessibility of IT stations compared to TT

All to be fixed in next shutdown!
