# The LHCb Silicon Tracker: lessons learned (so far)

## Abstract

The LHCb Silicon Tracker is part of the main tracking system of the LHCb detector. It covers the full acceptance of the experiment in the Tracker Turicensis (TT) in front of the dipole magnet and the innermost part in the three Inner Tracker (IT) stations downstream of the magnet. We report on final elements of the production, the installation and commissioning process in the experiment. Focusing on electronic and hardware issues we describe the lessons learned and the pitfalls encountered. First experience of detector operation is presented.

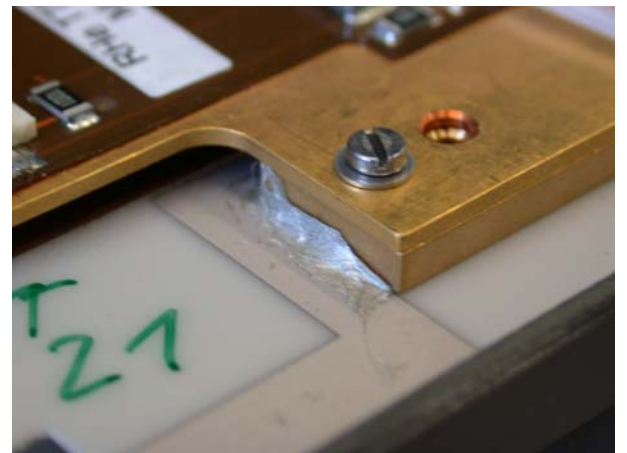
Conductive glue was used to connect the grounding of the TT readout hybrid to the cooling block of the sensor module and for the connection of the biasing voltage on the back side of each silicon sensor. While initial testing showed a good connection, older prototypes suffered from high glue resistances. The reason is due to the inability of the silver glue to stop the oxidization for the underlying aluminium [5]. In addition the grounding of the readout hybrid suffered from thermal cycling (Fig. 2). It was therefore decided to change the connection procedure for these locations. The grounding of the readout hybrids was changed to a screwed solder lug. As no soldering is possible on the back side of a silicon sensor, the bias lines of the Kapton supply cables were bonded to the sensor followed by a glob-top seal to protect the bond wires.

Figure 2: Breakup of silver glue after thermal cycling

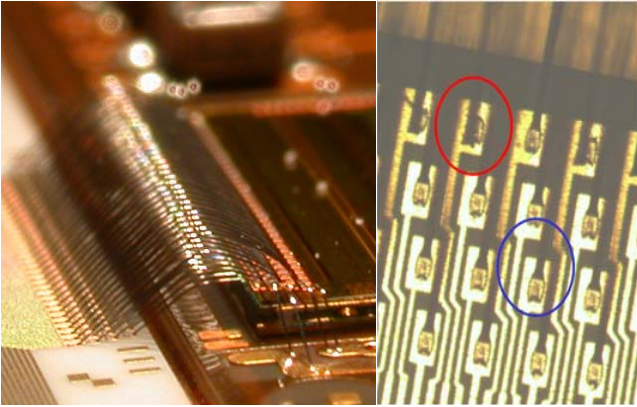
A problem that was discovered very recently concerns the wire bonds at the inputs of the Beetle front-end chips. As shown in Fig. 3, these are executed in four bond-rows to match the four-fold staggered input pads of the Beetle. A few weeks after the installation of the detector modules in the experiment it was found on six out of the 280 installed readout hybrids that a significant number of bonds in the inner-most of these bond rows were broken. Nothing similar had ever been observed in the extensive burn-in tests that each module had to pass during its construction and that were designed to reproduce conditions in the experiment as closely as possible. As of now, we have no explanation for this effect, investigations are ongoing.

Figure 3: 4-fold staggered bonding (left) and comparison of good vs. bad bond connections (right)

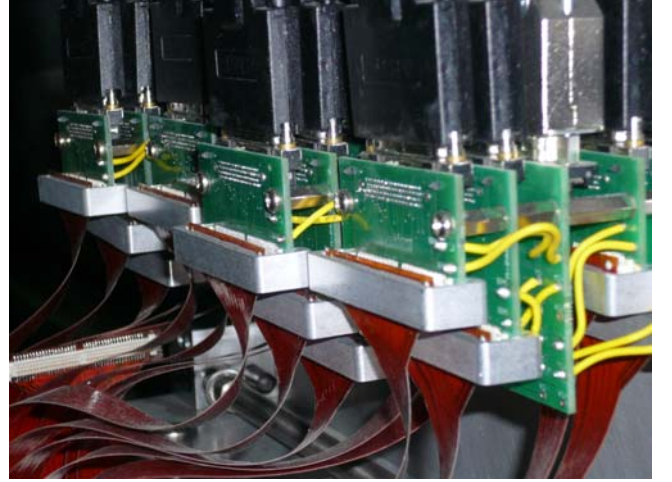
Each readout hybrid requires a single cable connection only, where all necessary supplies and signals are provided. An 80-pin high-density connector was chosen which connects on the Beetle readout hybrid inside the cold volume and to small patch panels outside. Due to the mechanical layout, the inner ends of the cables are guided by small gaps in the main cooling plate. Therefore no torque applies to this mating interface. As space is very limited on the outside between the feedthrough and the patchpanels, the cables had to be bent in tight radii to be mated to the patch panels. The resulting torque led in several cases to unreliable electrical connection between mated high-density connectors. To ensure a mechanical fix of this mating, milled aluminium clamps were

Figure 4: machined aluminium clamps for securing the high-density connectors

designed which could be applied to the patch panel stack and improved the connection (Fig. 5).

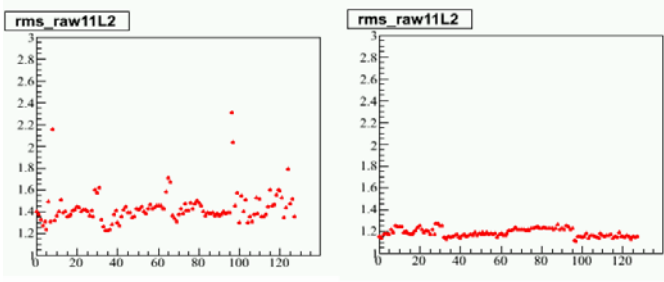
In early laboratory tests, a non-flat noise distribution within a analogue readout frame was discovered. As this distribution was persistent even without any attached readout chip, it was traced back to have its origin inside the Digitizer Board itself.

Figure 5: Comparison of raw noise without filter (left) and with filter (right)

In addition to the sampling rate, any ADC has a specified analogue bandwidth. Usually, this bandwidth exceeds the sampling rate to enable ‘undersampling’, i.e. to digitize a signal with a frequency larger than the sampling rate. To limit the amount of noise at the input of an ADC, a lowpass filter with a properly dimensioned cutoff frequency has to be used. While an early datasheet of the used ADC cited an analogue bandwidth of 100 MHz [6], an updated version listed a bandwidth of 1000 MHz [7]. Tests have shown that a 70 Mhz lowpass, which could be easily added to the existing layout, was sufficient to restore the required flat noise distribution (Fig. 6). This lowpass filter was fitted to all Digitizer Boards prior to installation in the detector.

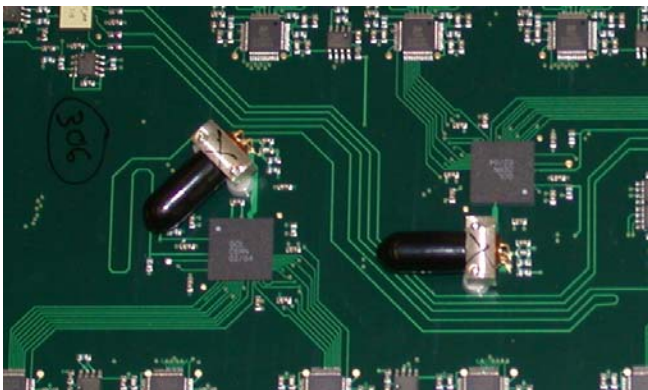
Figure 6: VCSEL diodes with receptacle next to GOL serializer

During reception tests of the production Digitizer Boards, 30 % of the VCSEL diodes were determined to be outside of the optical power specifications. Tests performed by the vendor confirmed a misalignment of the VCSEL diodes inside the metal receptacle. This problem was traced to the soldering procedure of the diodes, which were wave soldered. As the diodes were already fixed to the board via their screws, a large amount of heat was transferred through them into the receptacle which led to the weakening of the glue holding the

diode in alignment. As the preproduction boards were hand-soldered, this problem did not show up during the first batch of boards. A repair of these diodes was not possible and therefore all boards had to be screened and the defective diodes were individually replaced.

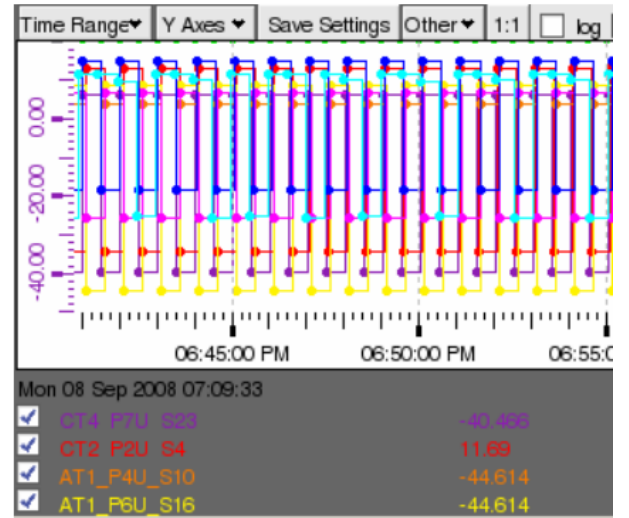
Each Beetle readout hybrid features a PT1000 resistive thermometer, which can be read out by its associated Digitizer Board. This is done via a DCUF slow control ADC [9]. After installation of the Service Boxes in the detector, all ADC readouts showed an oscillating odd-even behaviour (Fig. 8).

Figure 7: oscillating values from the DCUF slow control ADC

The source of this behaviour was determined to be an overvoltage condition on one of the other ADC input channels. An incorrectly dimensioned resistive divider resulted in an input voltage of 3.8 V, which is beyond specifications for a 2.5 V powered ADC. Once this resistive divider was corrected the DCUF readout worked as designed. The change of dividers has only been done for some Digitizer Boards corresponding to selected locations in the detector as this problem was understood only very late in the commissioning process. As these are non-critical readings, the dividers will be changed over time during normal maintenance and board replacements.
