ACCELERATOR R&D WORKSHOP DRESDEN

1.6 mA upgrade –
thermal (and other) problems
during high current cw operation

Rico Schurig
schurig@hzdr.de

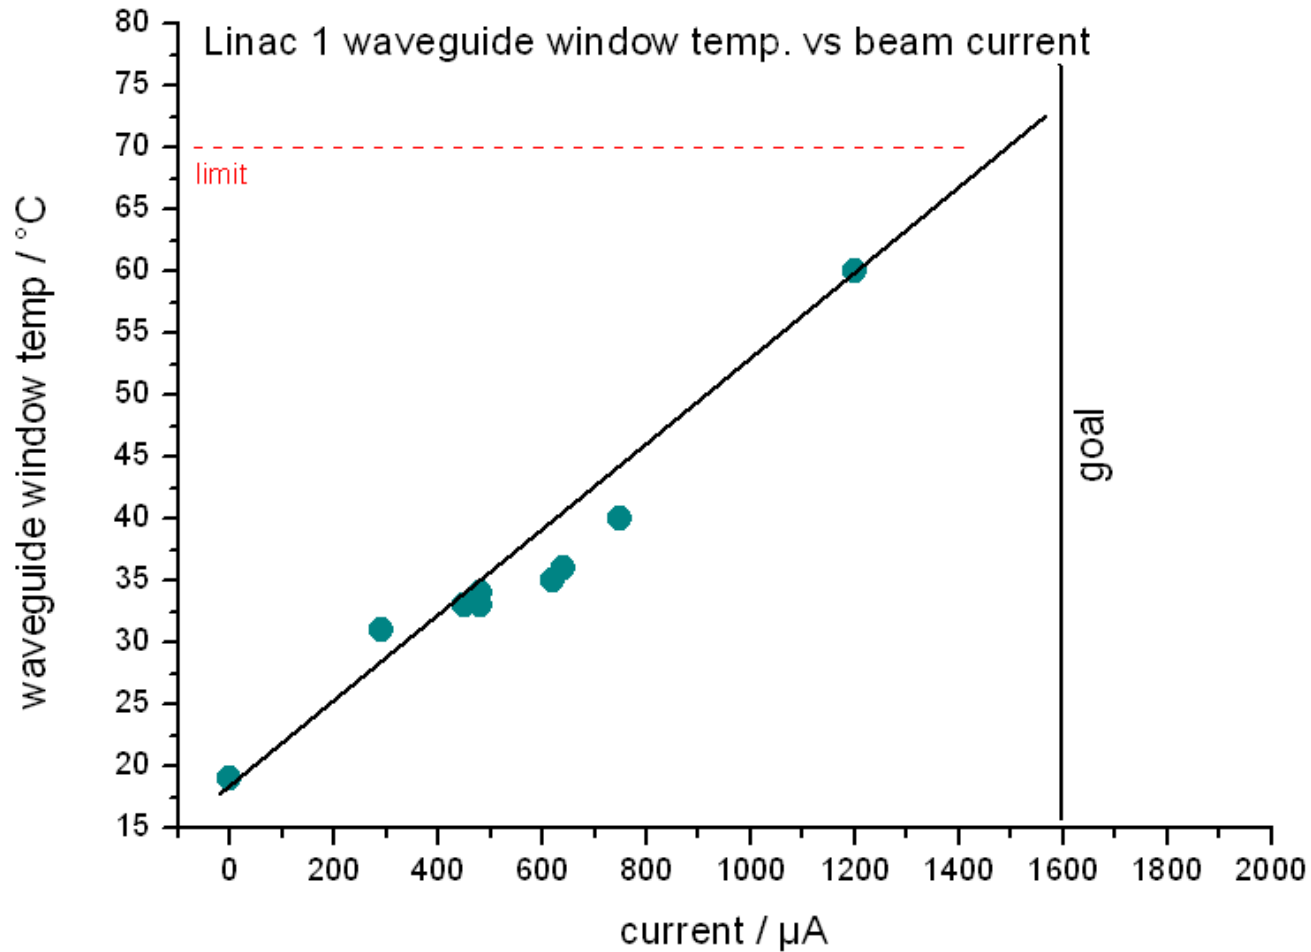
warm waveguide window – what temperatures do we reach?

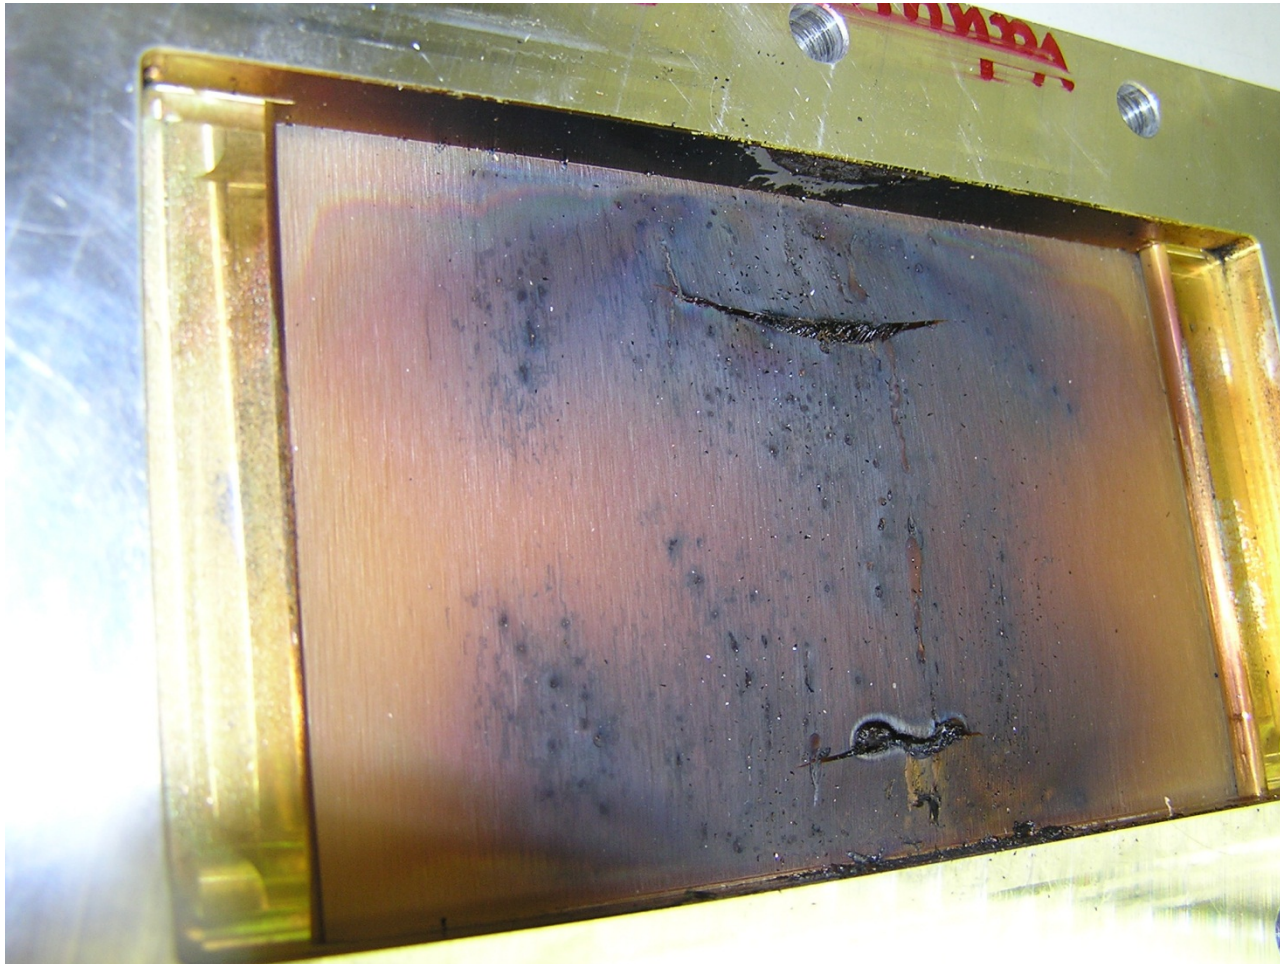
warm waveguide window – what temperatures are safe?

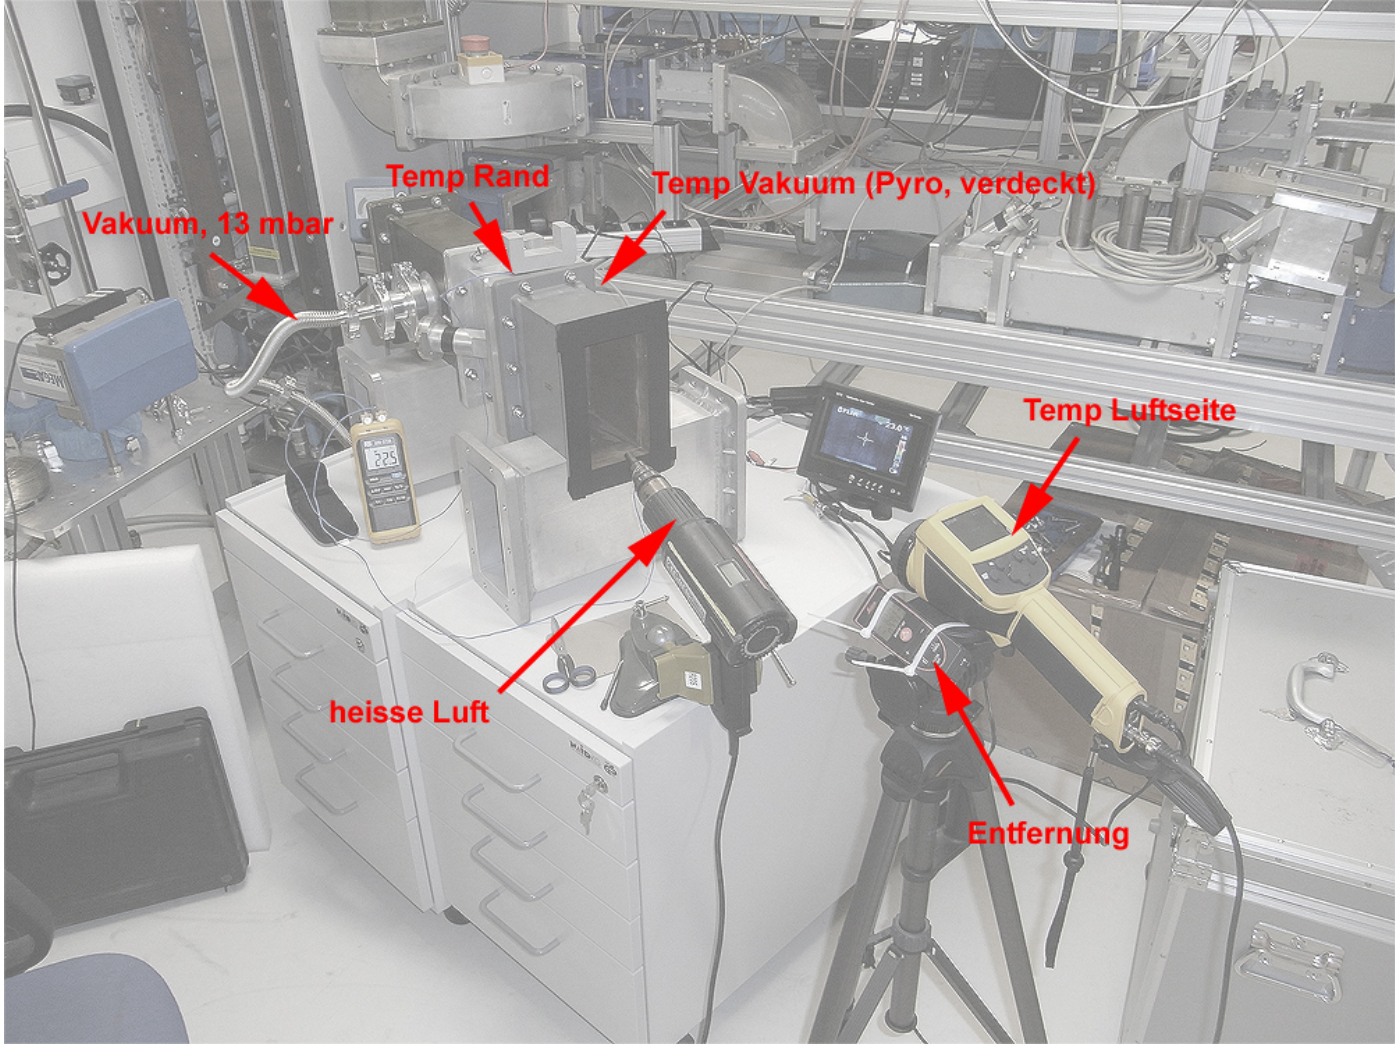
warm waveguide window – what Temp is safe?

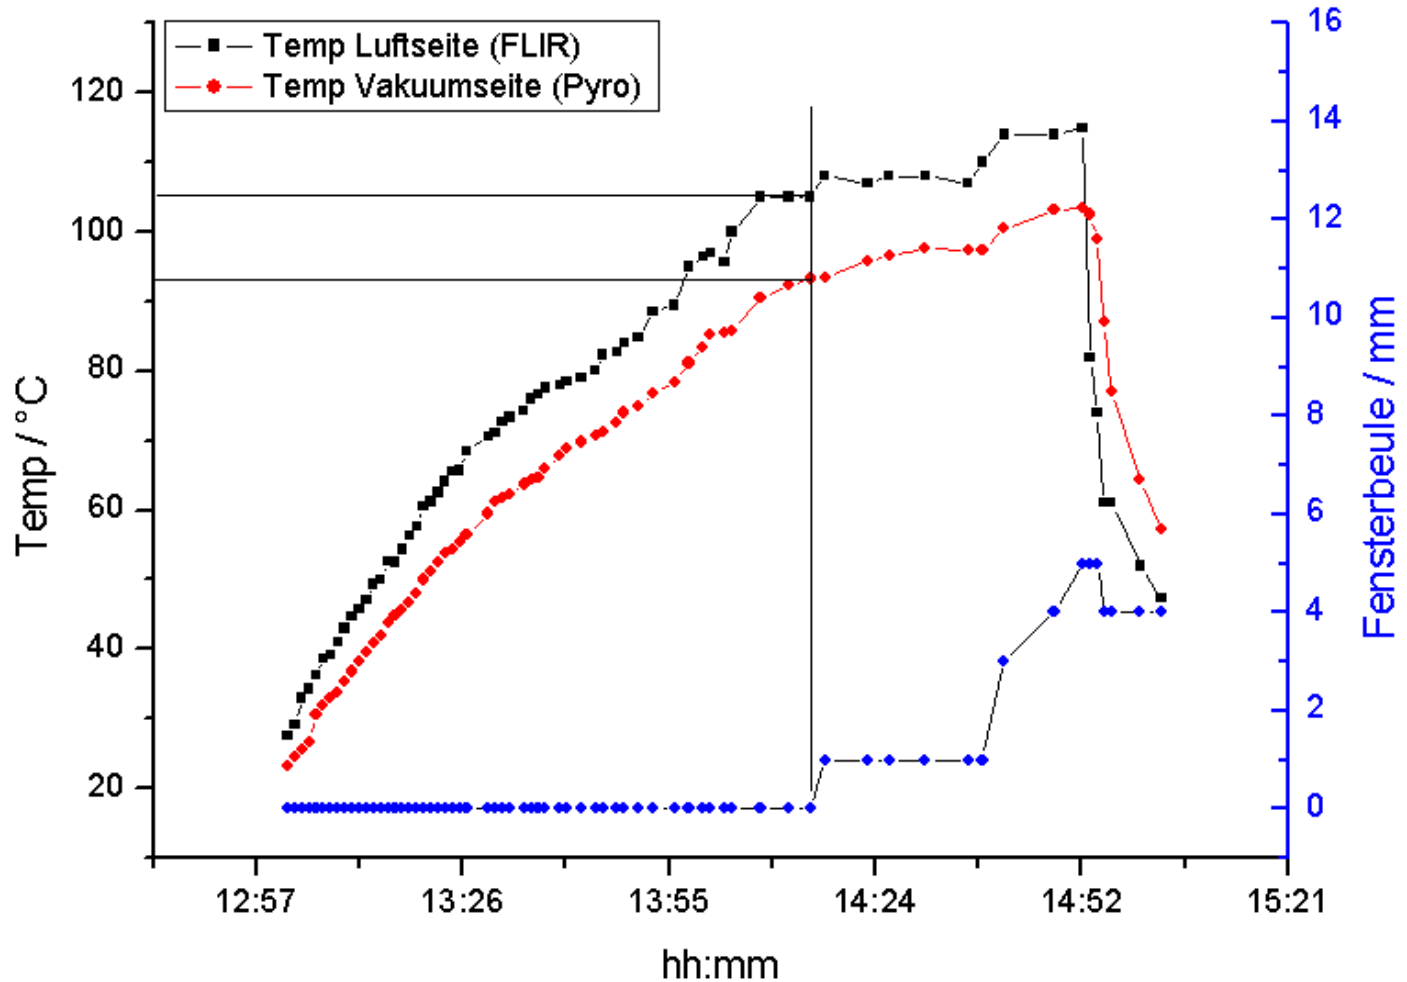
warm waveguide window – above 90 °C window is bending

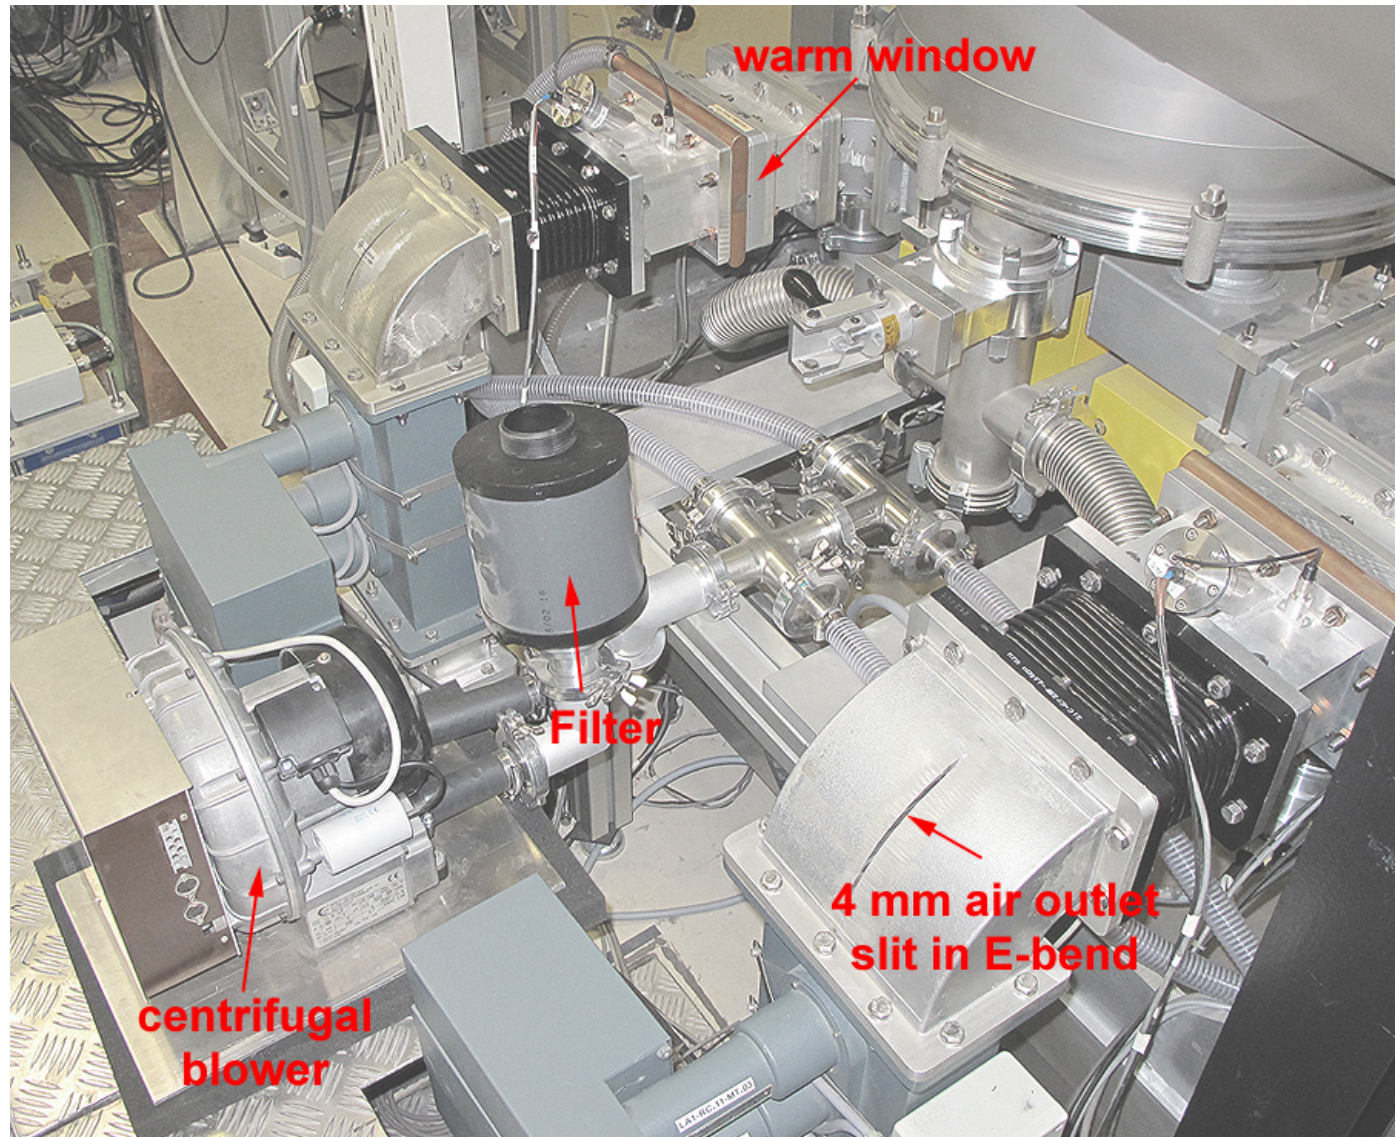
Cooling at LA1:

- filter is important
- 150 l per min flow
- slits in E bends

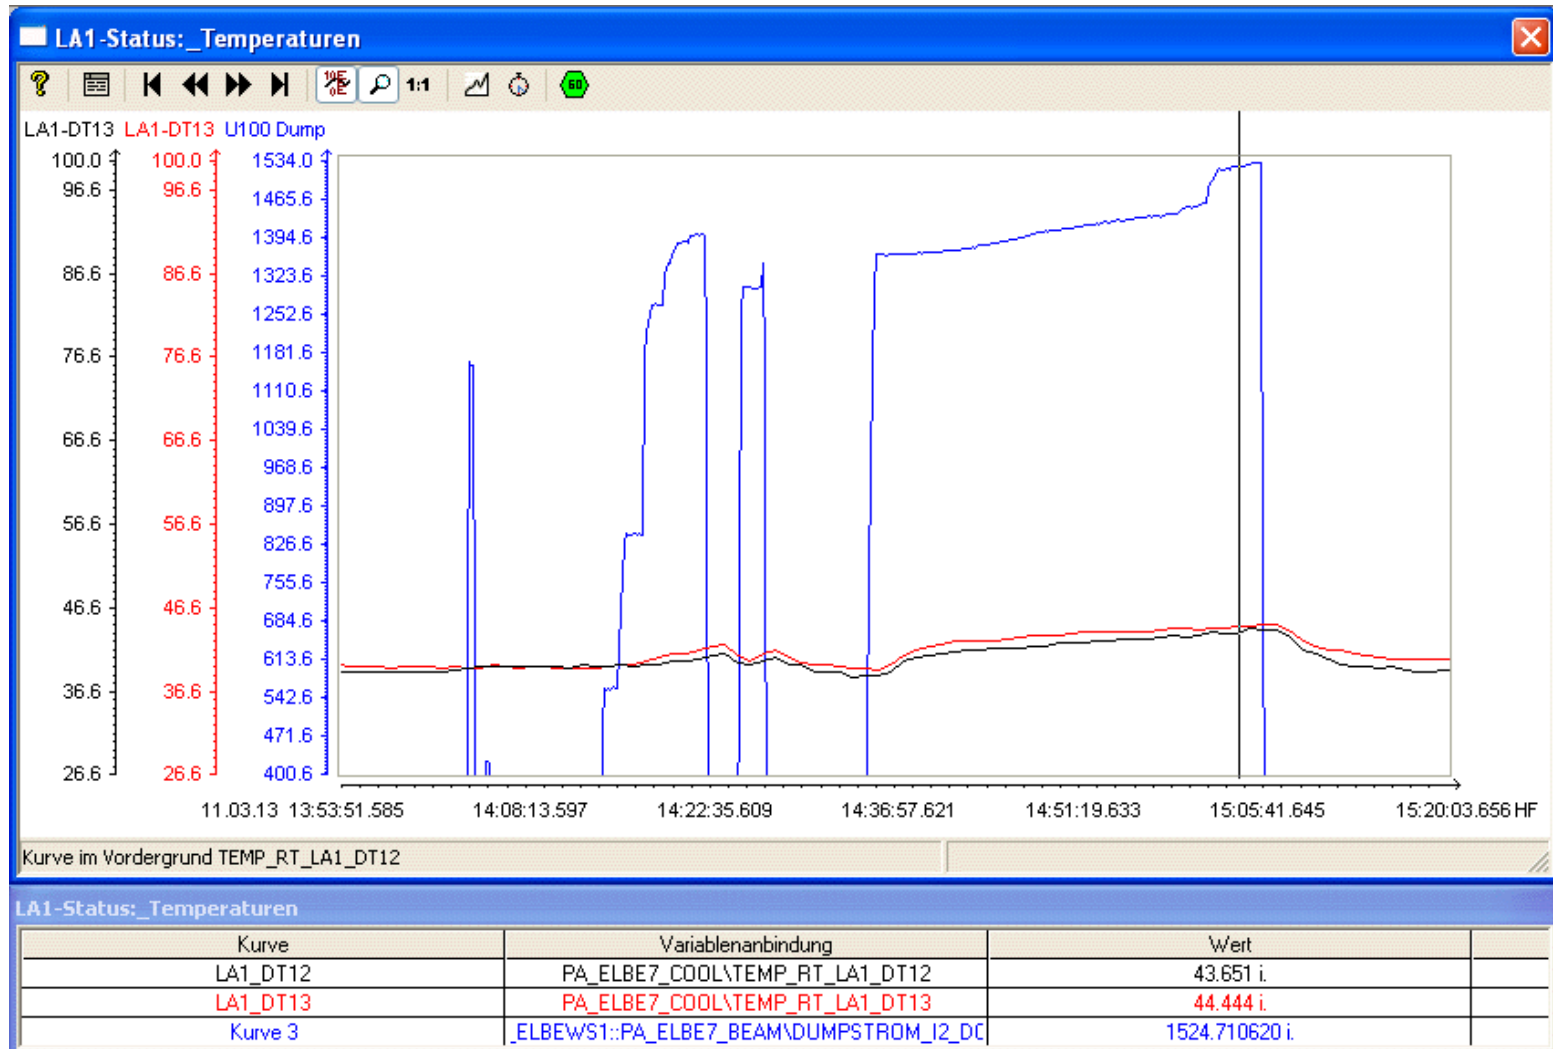
warm waveguide window – with cooling no problem any more

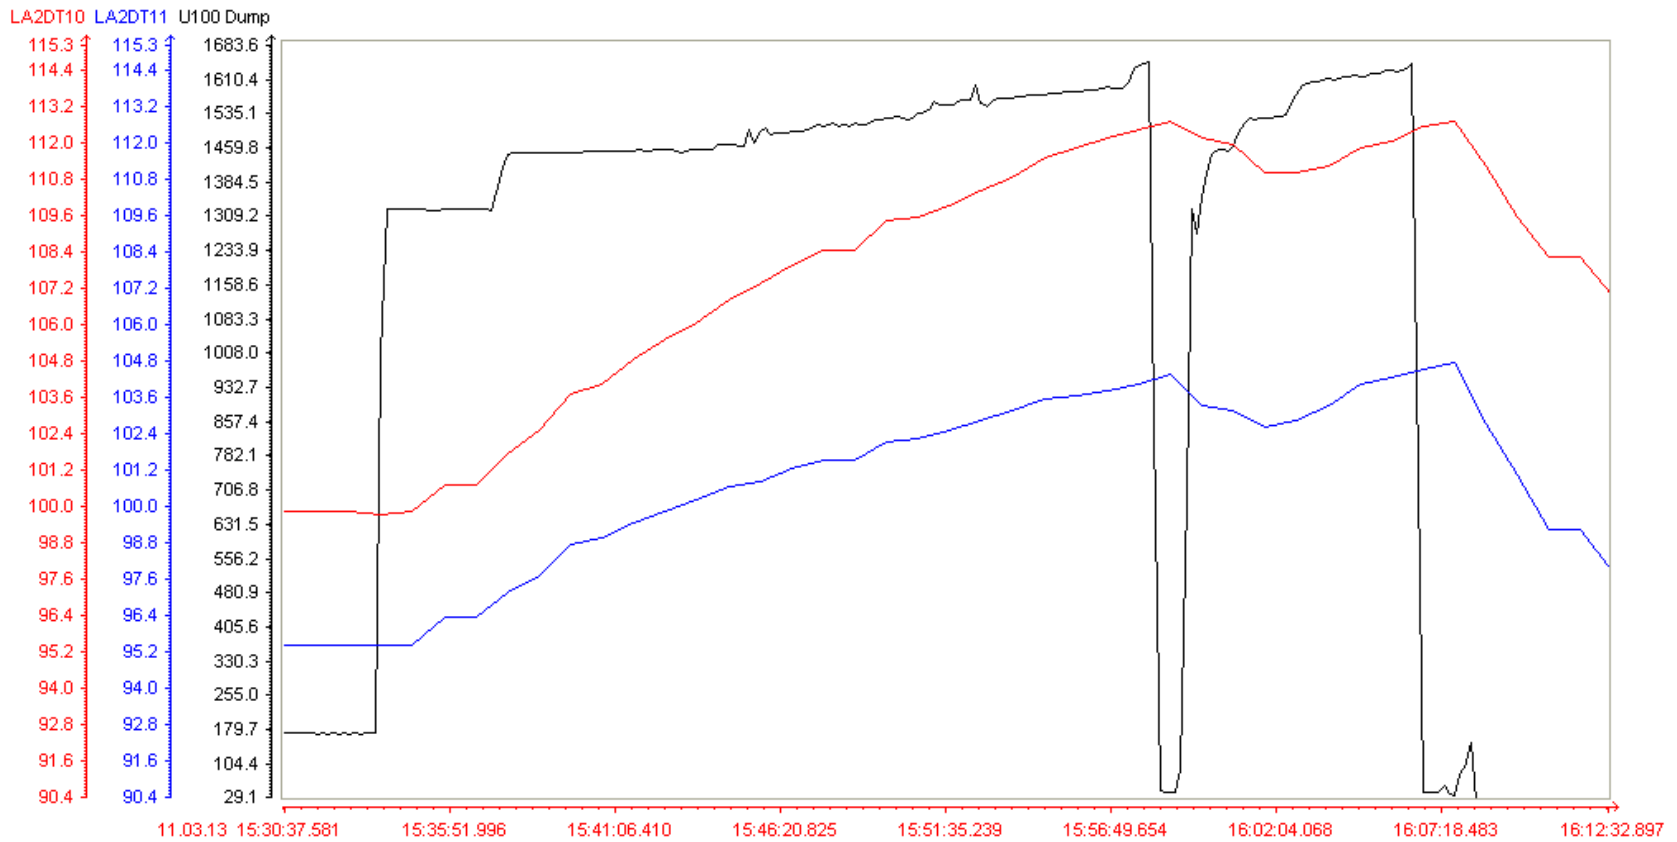
cold coax window temperatures

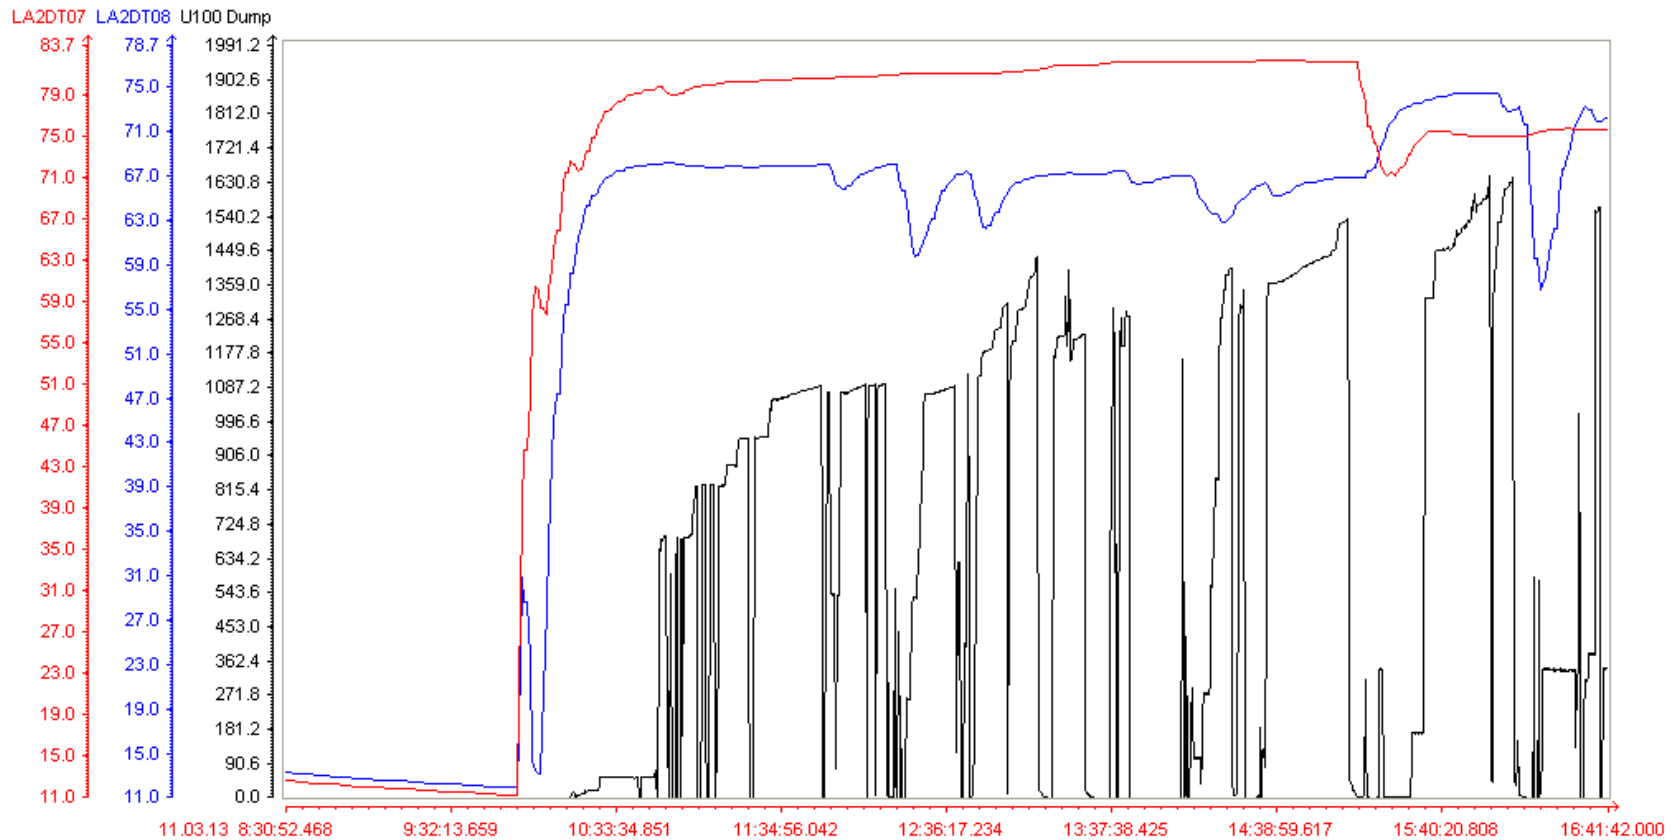
HOM coupler temperatures

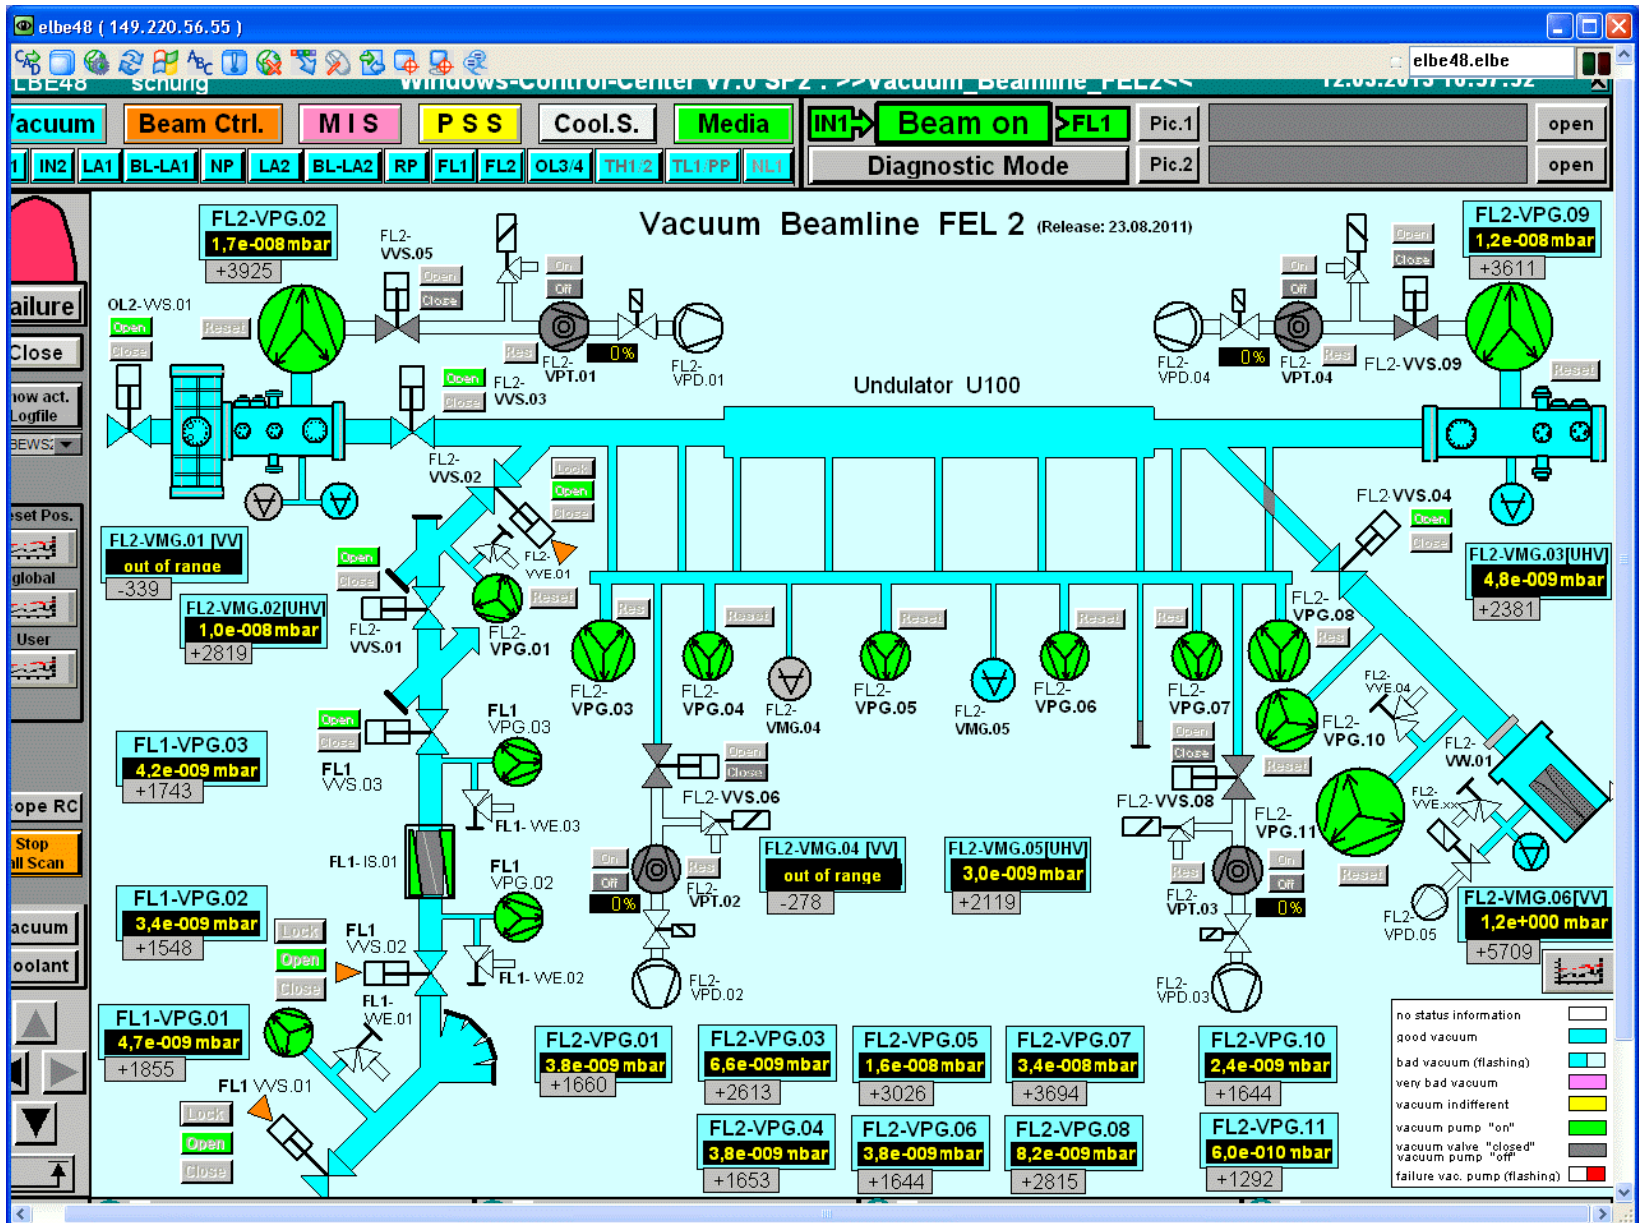
Problem Beryllium window:

- separates $10E-9$ (particle free) beamline from $1E-3$ dirty dump vacuum
- abt. 300 W are dumped in the window
- with FEL on (dE) some horizontal beam distribution, but no vertical
- broke several windows, expensive!
- probable solution: wobble beam on the window to spread heat load

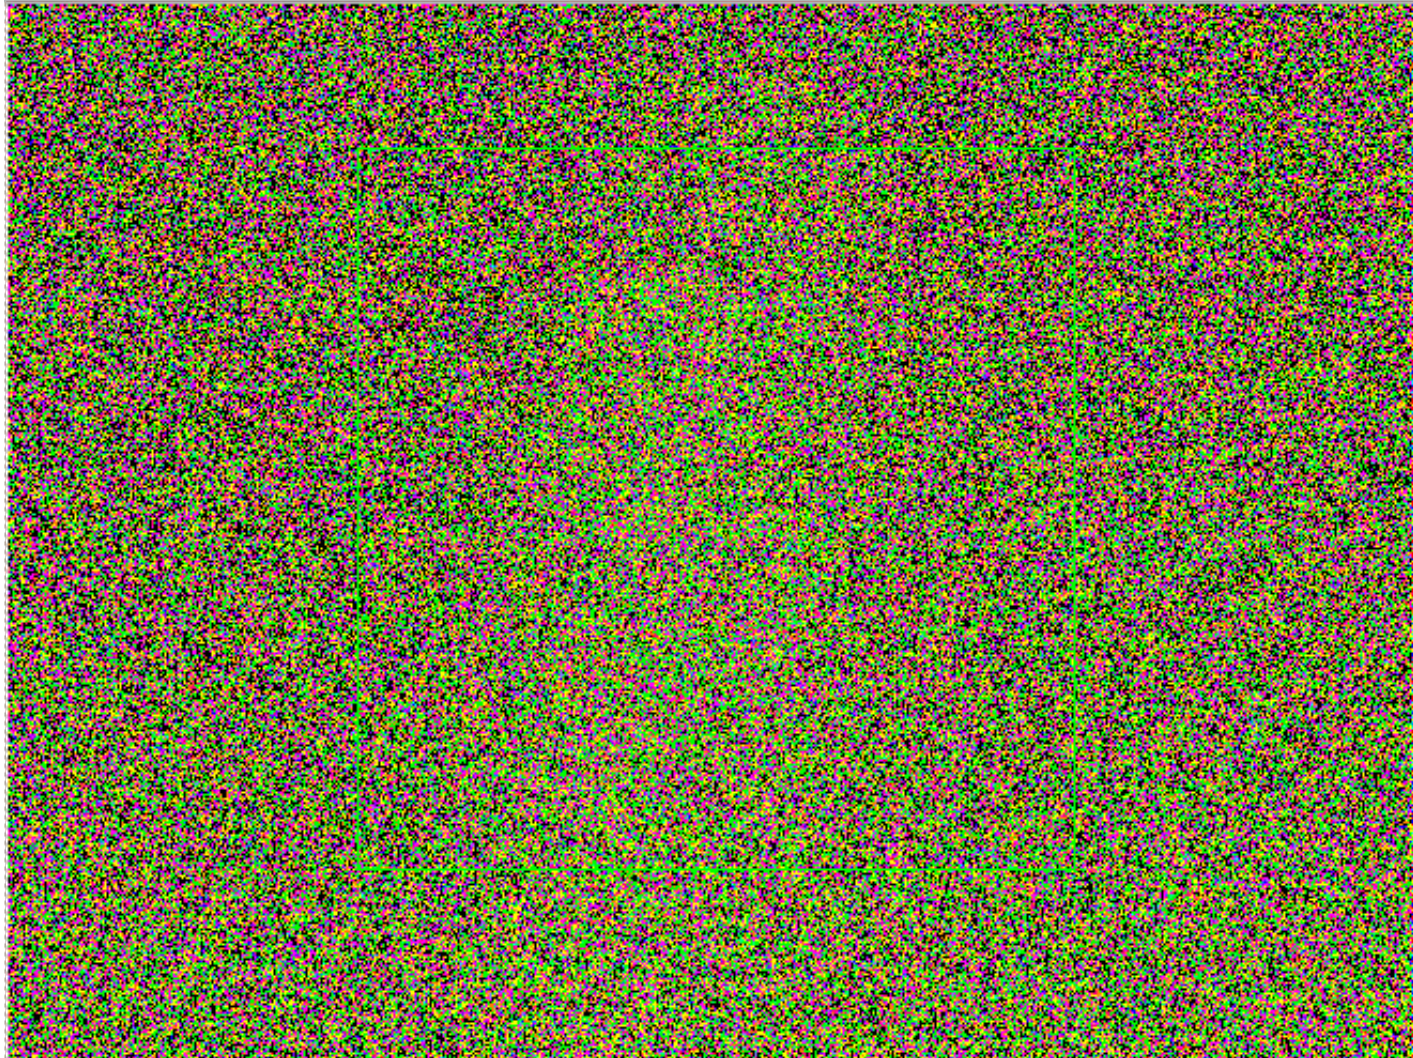
Be dump window beam wobbling

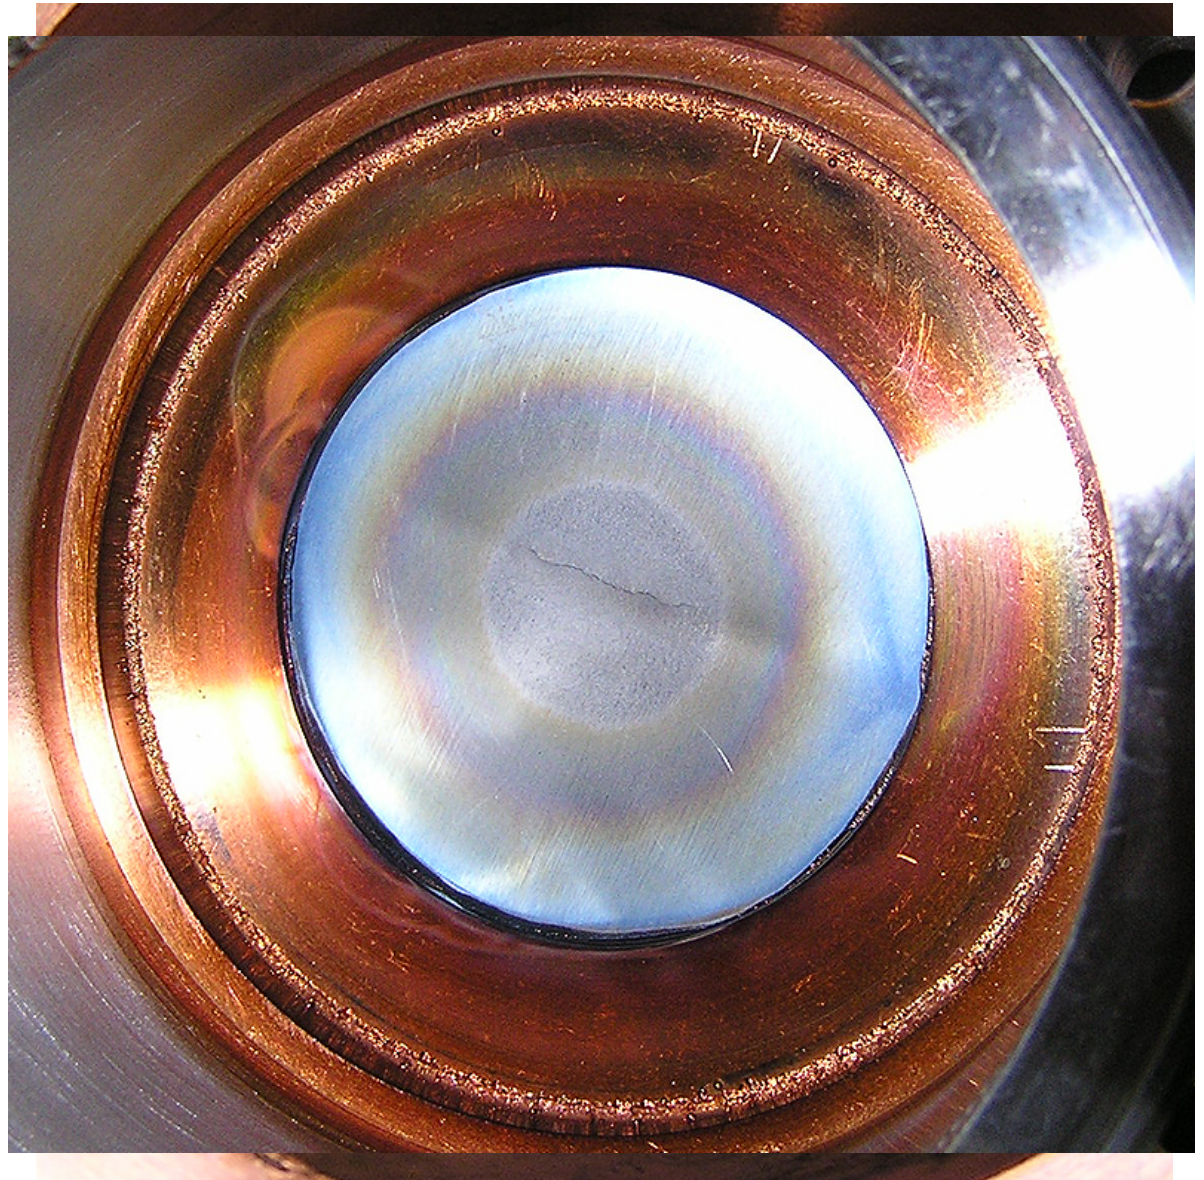
another broken
Be window
