MTTR and Spare parts for the LHC BACKBONE (TS/CV)

G. Peon, J. Inigo-Golfin TS/CV

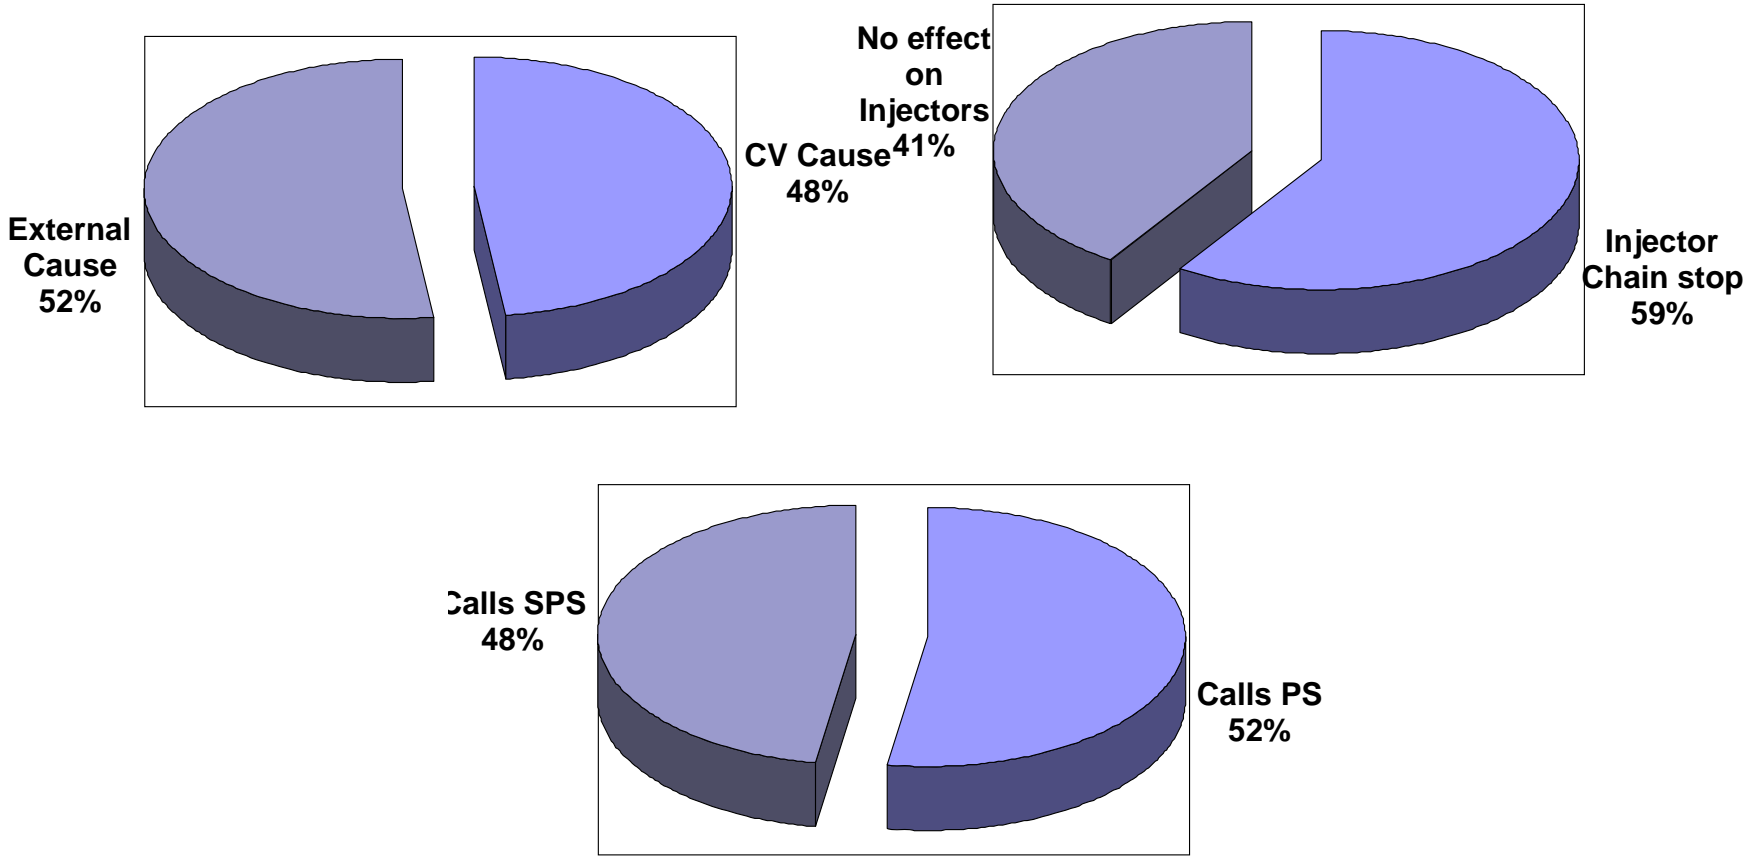
Major Event Summary - Charts

- In the last 3 years 27 major events, with:
 - grand total of 120 hours lost and an overall MTTR of 4.4 hours
 - the 13 MERI due to CV total 73 hours, with an MTTR of 5.7 h
 - water leaks from users account for 17.5h, with an MTTR of 3.5 h
 - unauthorised manipulations of CV systems during run account for 11.2h, with an MTTR of 2.8 h
 - control problems (HW & SW) account for 21h with an MTTR of 4.2 h

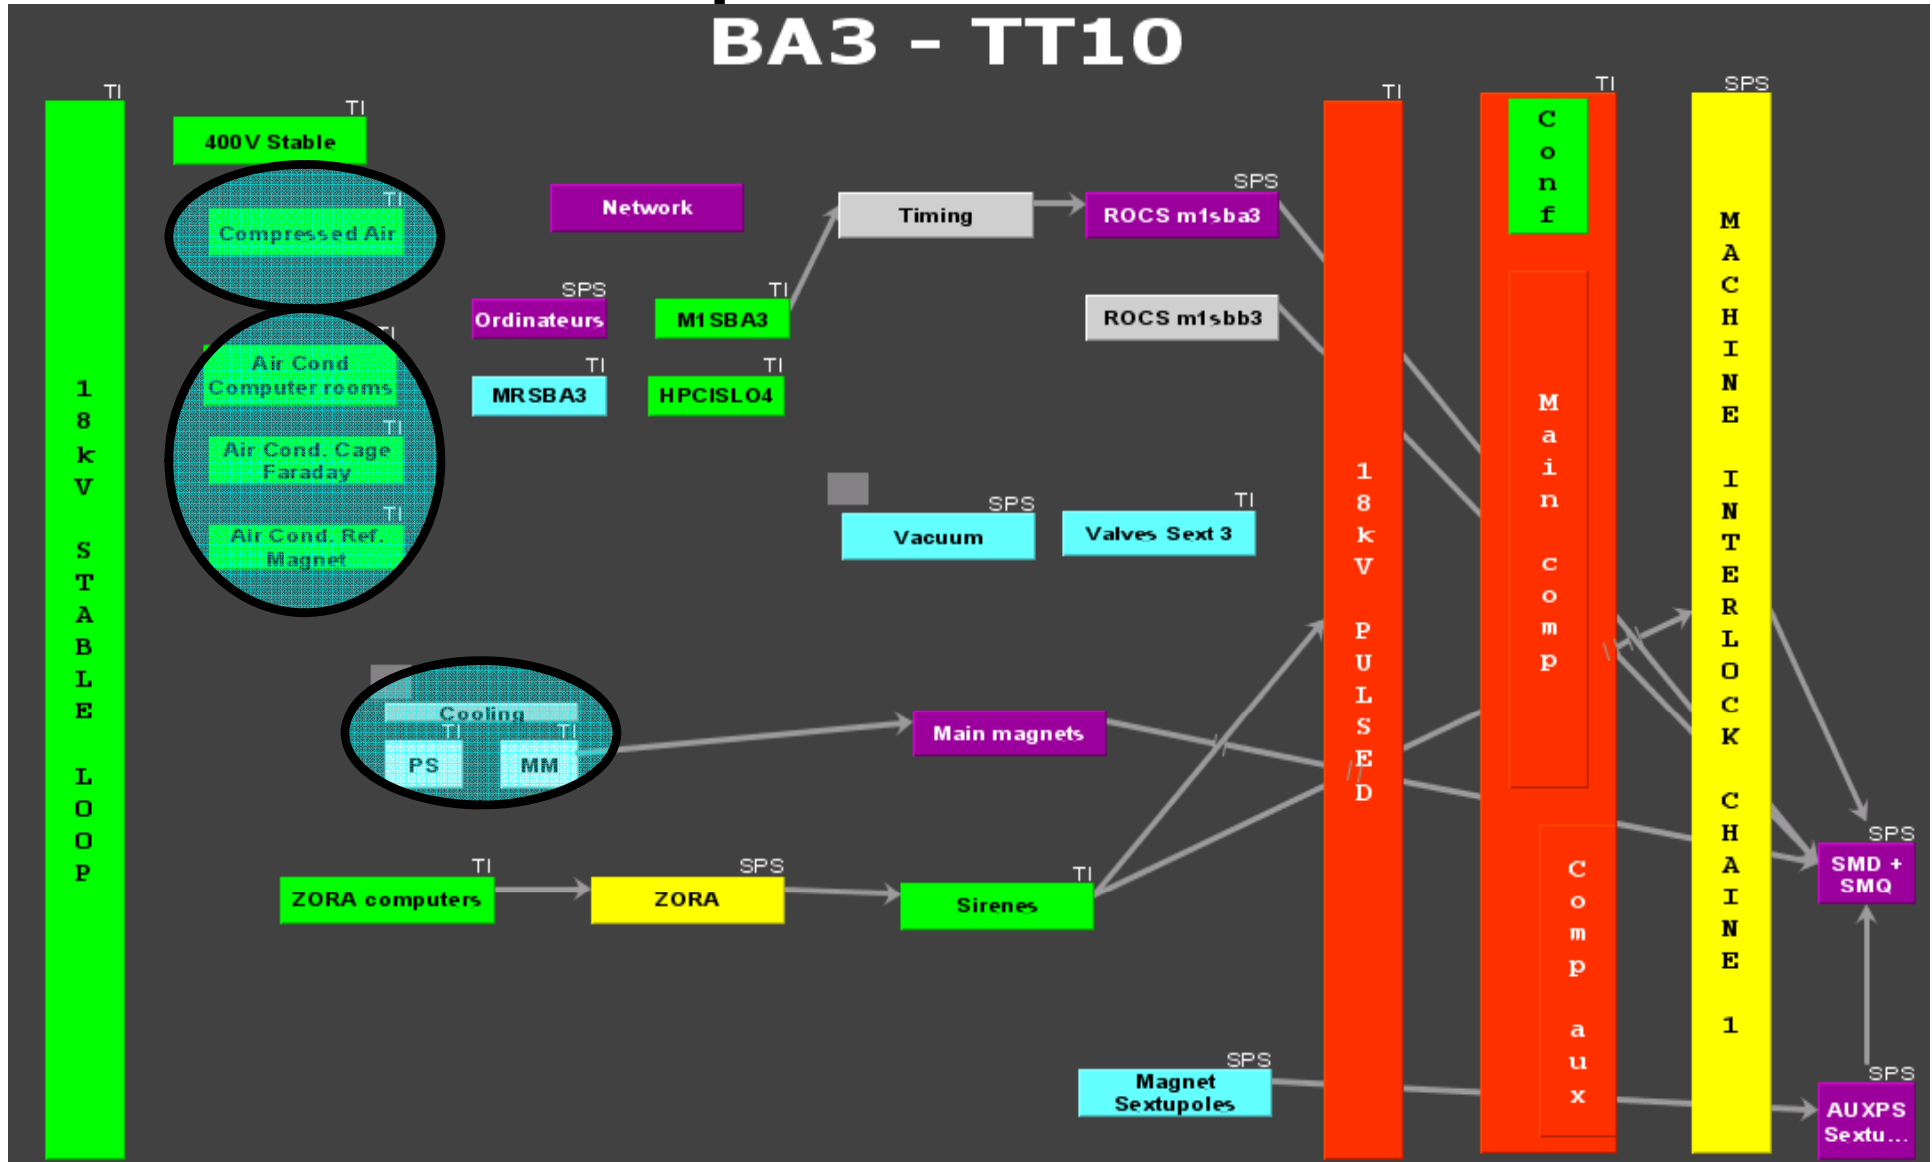
BA3 - TT10

Identification	Critical element	Remedy
BA3 and BA5 compressed air production	Not enough back-up	Add a compressor in parallel
Filter in demineralised water circuits without by-pass	Motorised valve at the outtake of the pumps and another for by-pass	Keep servomotors in store
BA2 demineralised water	Common expansion vessel: a leak in TT20 circuit would stop SPS	Add a expansion vessel separated for that circuit
