Overview of the main events related to AT equipment in the LHC injector chain for 2007

P. Strubin, on behalf of AT Department

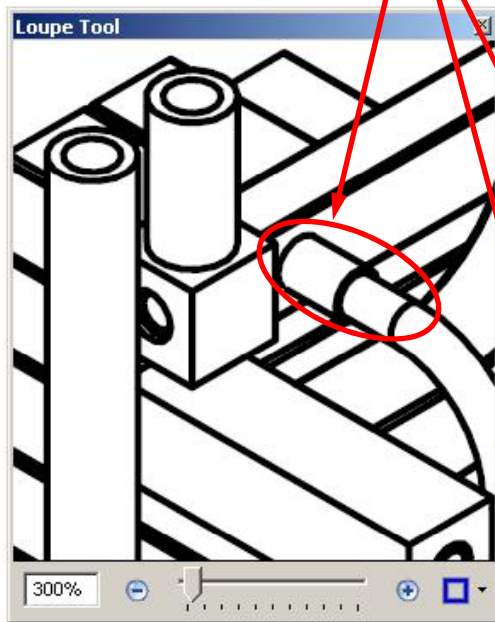
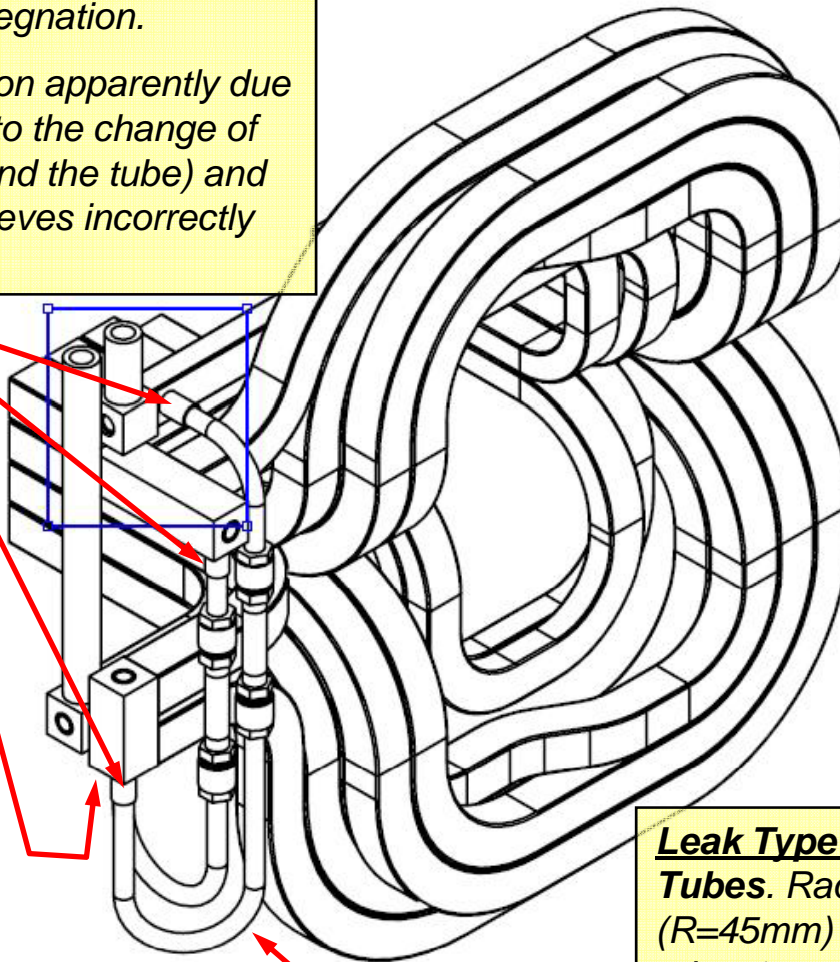
LEAK Type 1 On straight copper tube junctions. Copper tubes are brazed on a short thick sleeves. These sleeves are brazed to the coil conductor prior to coil impregnation.

6 cases of leaks in 2004. Erosion apparently due to bad design (turbulence due to the change of diameter between the sleeve and the tube) and also due to bad fabrication (sleeves incorrectly brazed or incorrectly inserted)

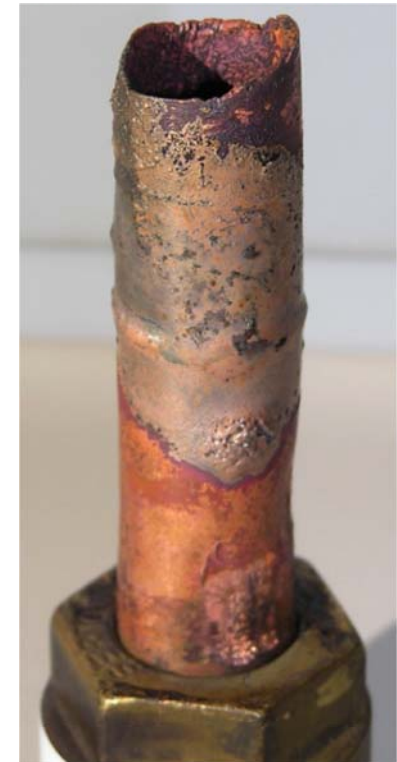
Leak Type 2 on U-shape Copper Tubes. Radius too small ($R=45\text{mm}$) for the diameter of the tube. 1 case of leak in 2004. Erosion apparently due to bad manufacturing (inclusion ?, dent?)

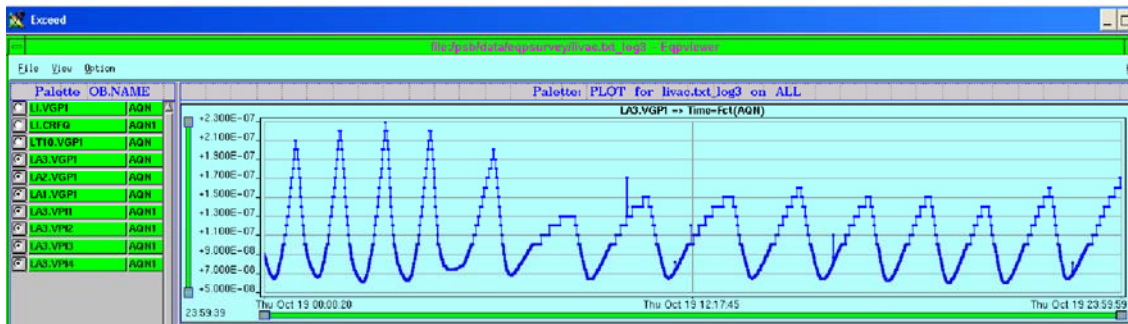
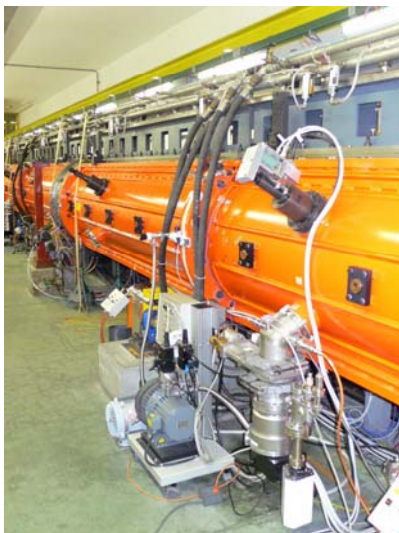
- Systematic consolidation during 2006-2007 shutdown (1)
 - Pressure instability on the tanks
 - A polymer skin was poured around the flange where the largest leak was located to create a differential vacuum
 - The « sliding » feet were lubricated

Pressure now stable in the 10^{-8} mbar range, independent from the temperature of cooling water, **no longer any RF trips**

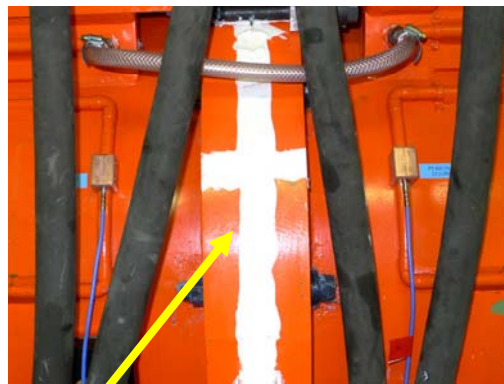
Resin poured and polymerised in situ (TS-MME)

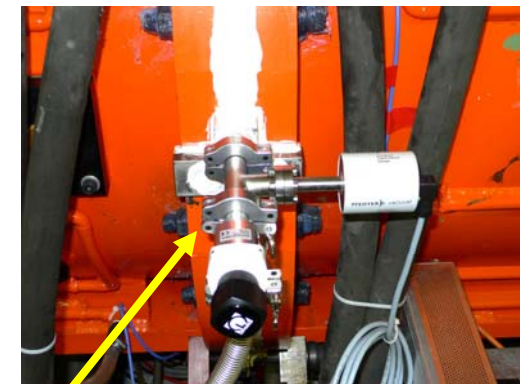
Differential pumping: outside pressure around 2-3 mbar

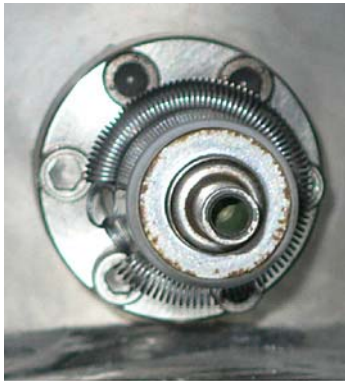
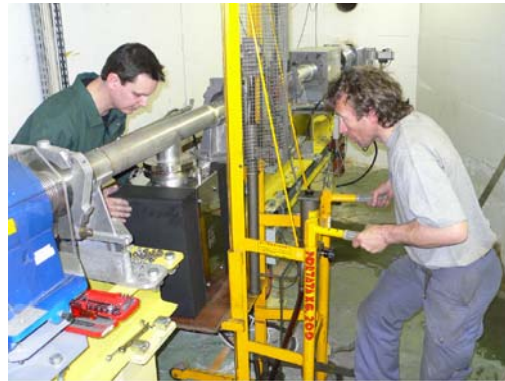
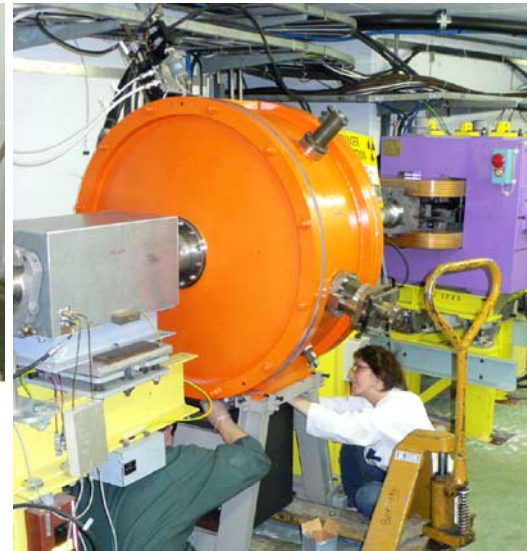
- Systematic consolidation during 2006-2007 shutdown (2)
 - Various items on the LT10 transfer line
 - Replacement of ion pumps with corroded HV feedthrough

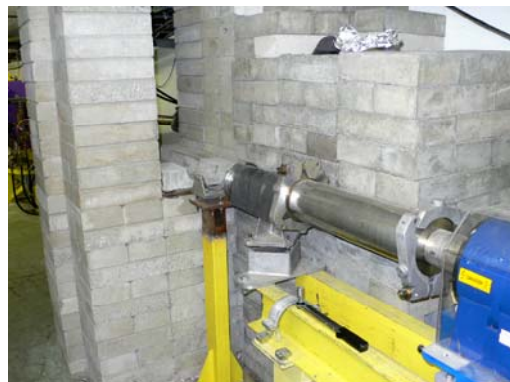
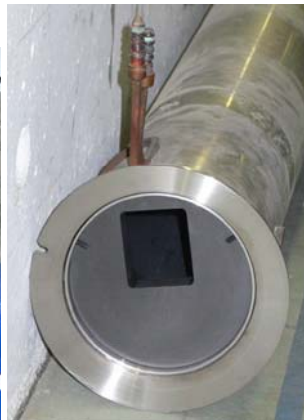
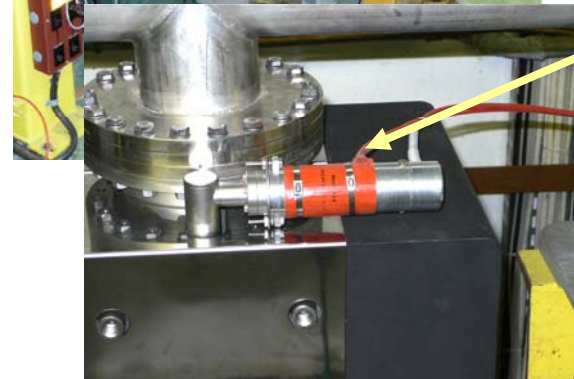
Replacement of leaking vacuum chamber (corrosion)

Heating collars added to avoid moisture

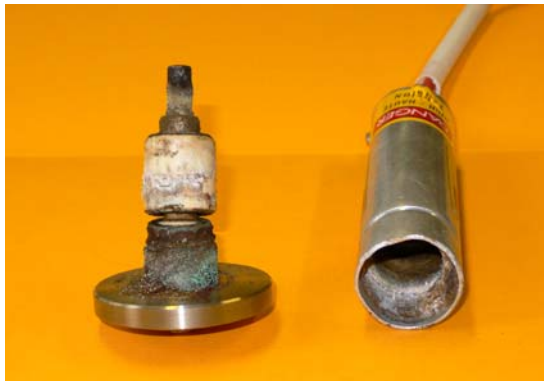
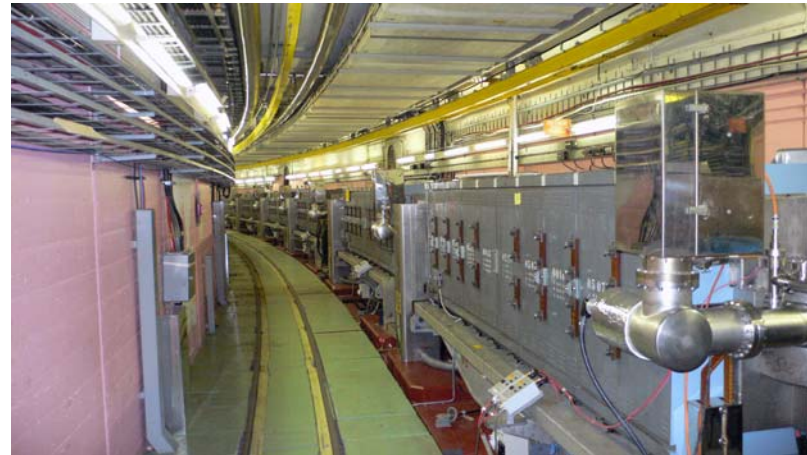
- Corroded ion-pump feedthrough
 - Severe corrosion

- Rapid survey of all PS pumps did not show any other case

Systematic inspection of the feedthrough and connector of every ion-pump in the PS is ongoing during this shutdown

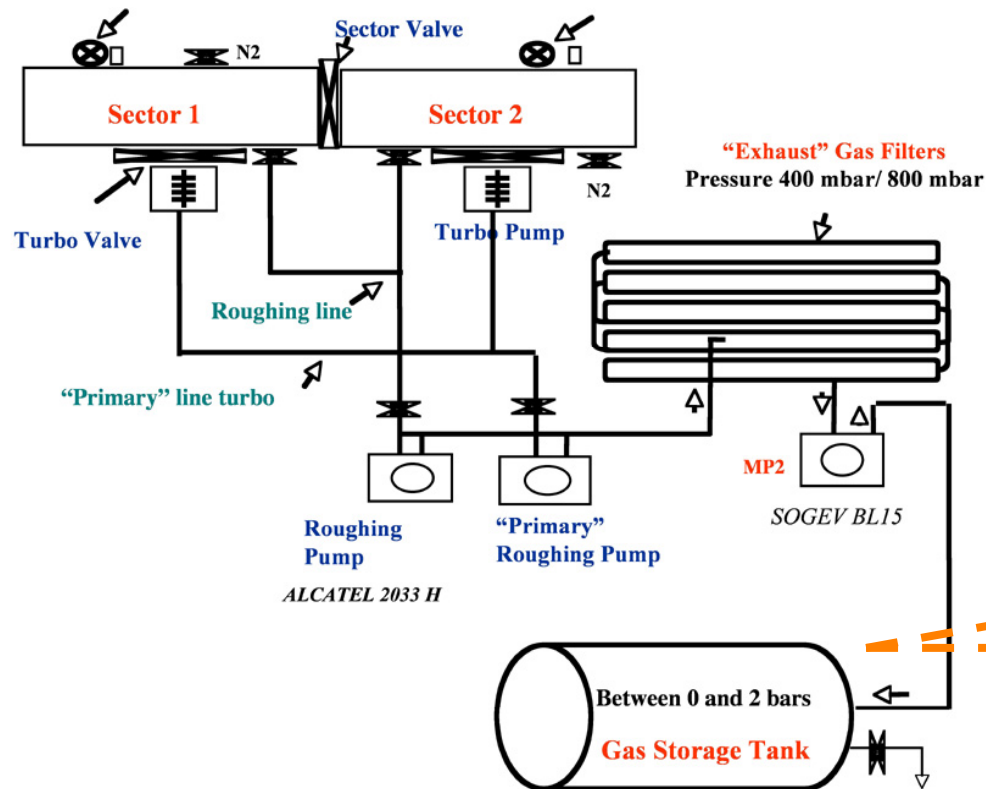
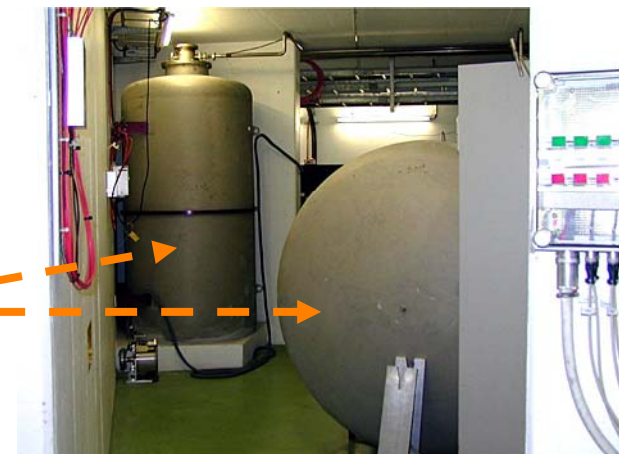
- Most important incident on gas recuperation
 - Was the consequence of an intermediate status of the vacuum system to prepare the installation of the RFQ, which masked a leak on the Faraday cage that developed during this period.
 - Stopped data taking for about 1.5 days

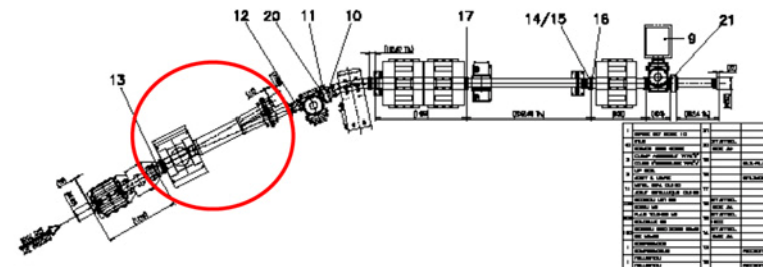
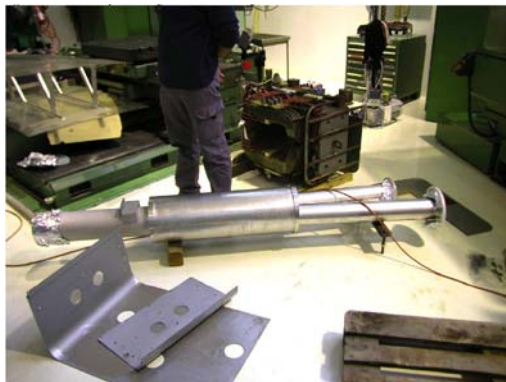
- Magnet BHZ12 had to be replaced in extraction line DE0
 - Ground fault developed as a consequence of coil damage
 - Cut out the "Y" chamber

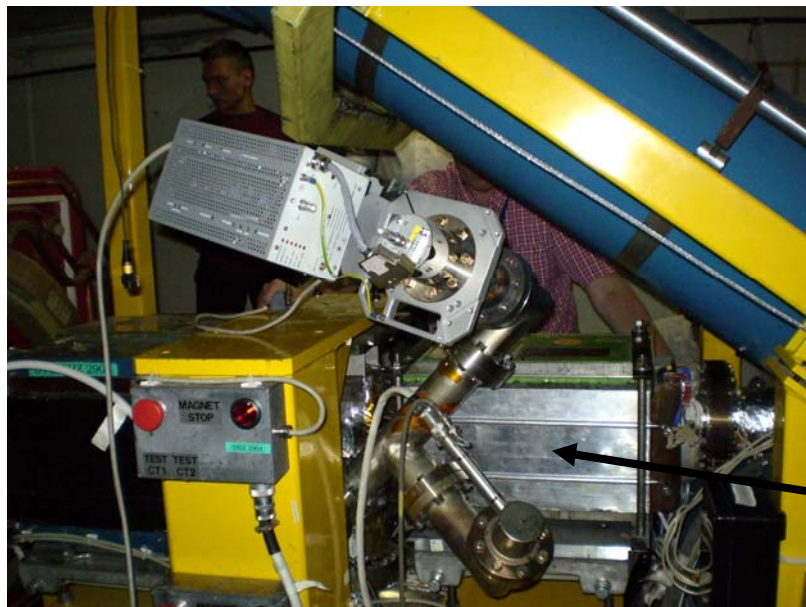
Magnet to replace

- Magnet DHZ2908 had to be replaced
 - Required to vent the vacuum sector
 - AT-VAC took the opportunity to replace a faulty ion-pump feedtrough
 - Because of the need for bake-out, the total down-time was around 10 days (10 to 20 September)

New layout of the magnet installation will avoid to open the vacuum system if a new fault develops on the magnet

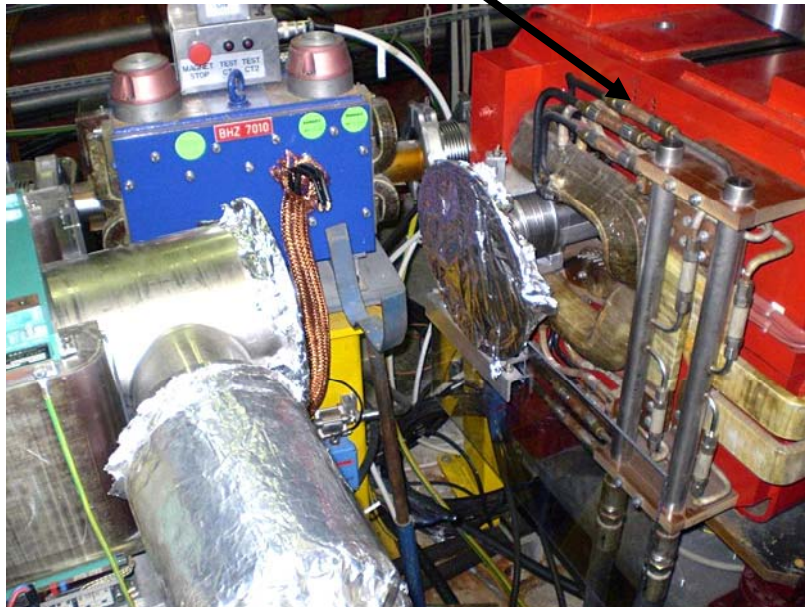
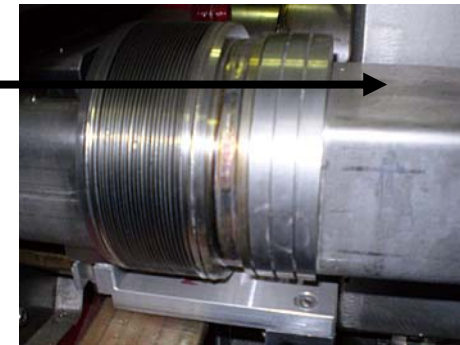
Magnet to repair

- Water leak on QFC54
 - Identified during the repair of DHZ2908
 - Repair could wait for the shut-down
 - Implies heavy mechanical work
 - Vacuum chamber is welded to septum 58

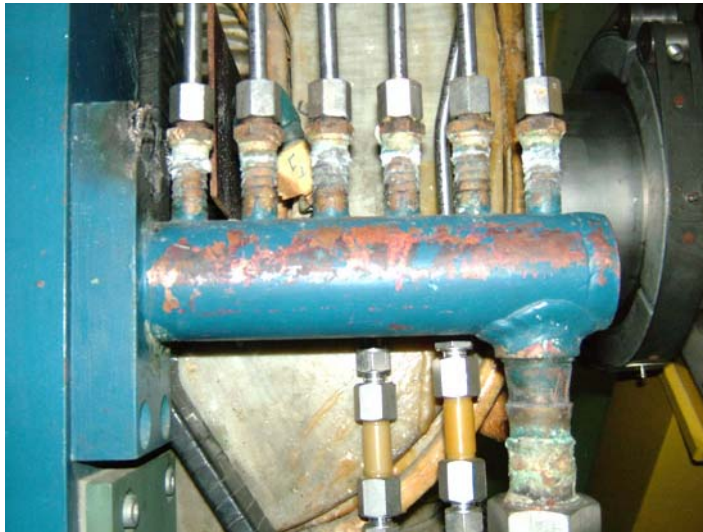
- Example of a cooling manifold in ISOLDE
 - Water leak found in ISOLDE on a cooling water manifold

A new manifold was made from stainless steel and installed into the machine. Due to the irregular positions of the connectors the manifold could not be made from a drawing but only by copying the original, which had to be removed from the machine.

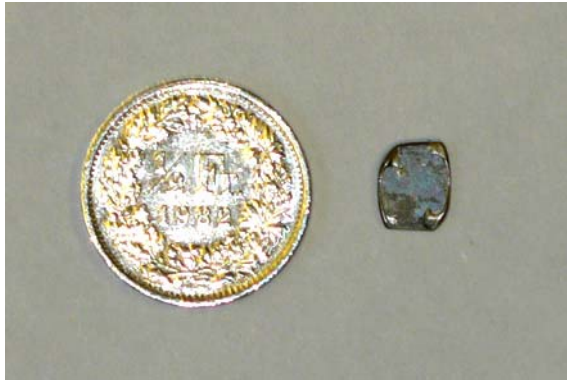
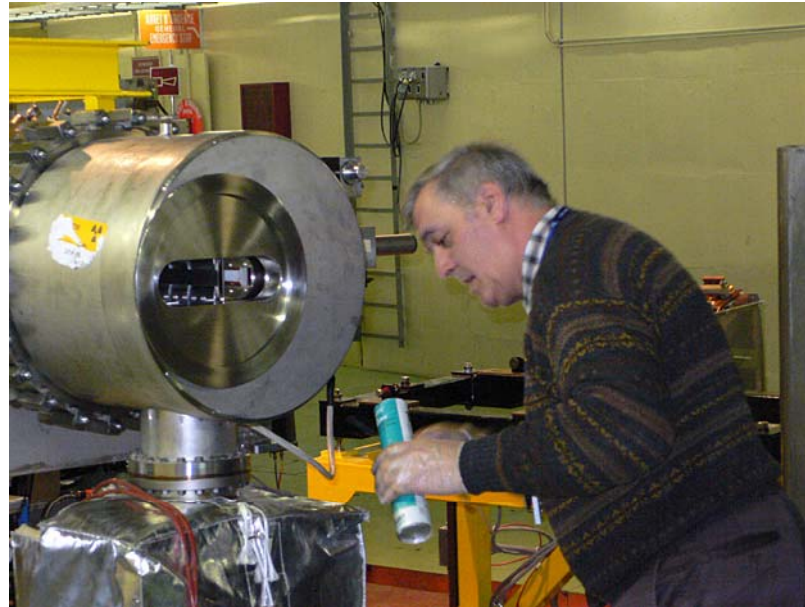
- Debris in a kicker
 - Found at the end of the 2006-2007 shutdown
 - Could have stopped operation if not detected then

- AT-VAC encountered difficulties when closing a large (330 mm) flange with a non-standard seal
 - Had to use an expensive Helicoflex™ joint

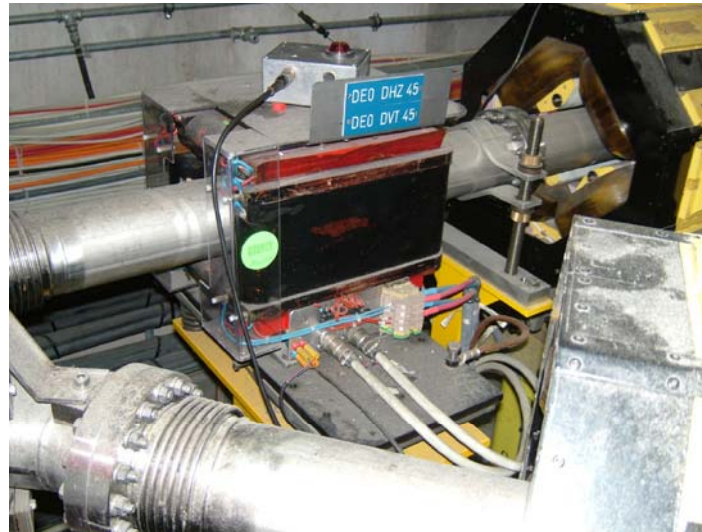
- The equipment is not always the culprit!
 - Example from AD:
 - Interlock on DHZ45 corrector in DE0 line
 - Traced back to an unplugged cable
