Korean GEMs tests

Christopher Armaingaud

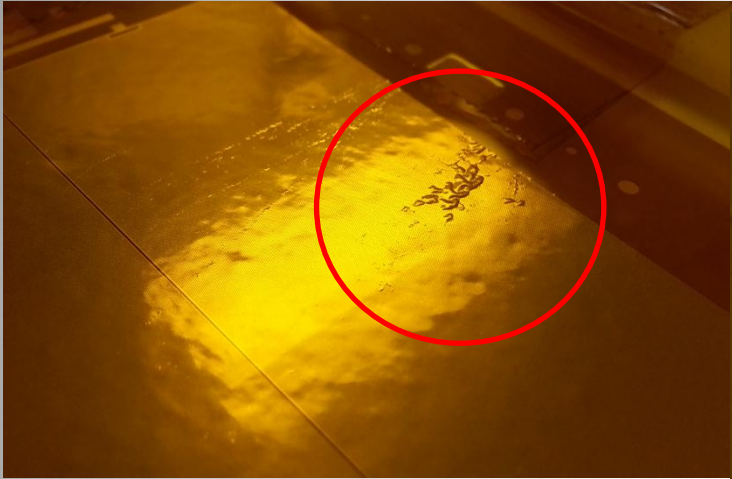
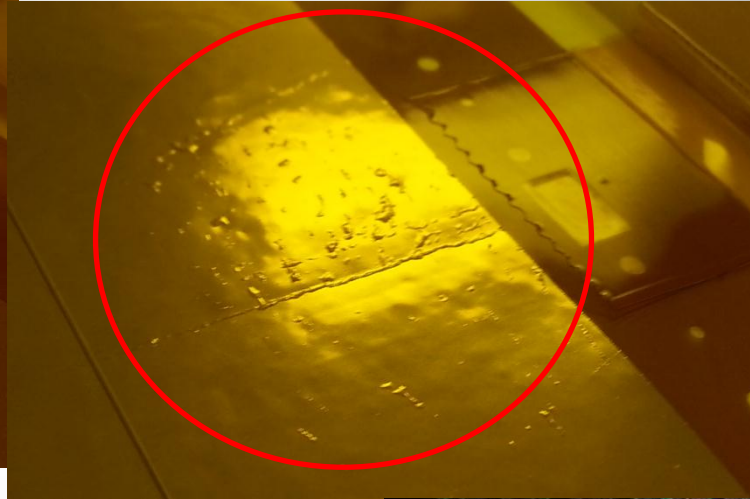
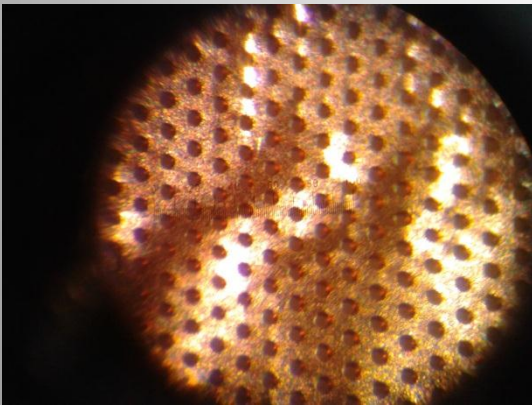
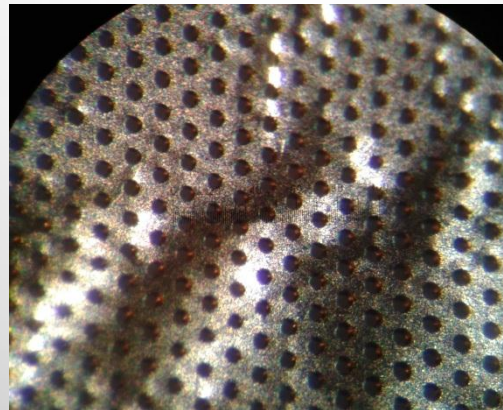
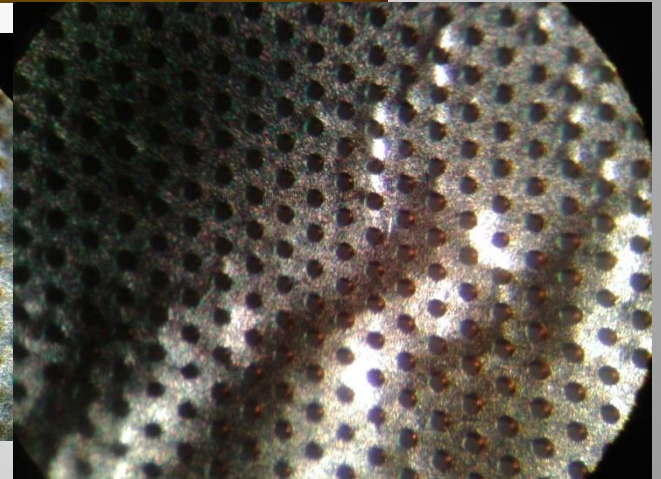
Visual inspection

- We need an industry to produce GEMs in high quantity.
- We receive 4 GEM foils from Korea.
- The last step of cleaning was missing, which induced many discharges from all the sectors.
- They have been cleaned in Rui De Oliveira's workshop then the behavior seems ok.
