# 4Rod Crab Cavity in SM18

March 28, 2013.

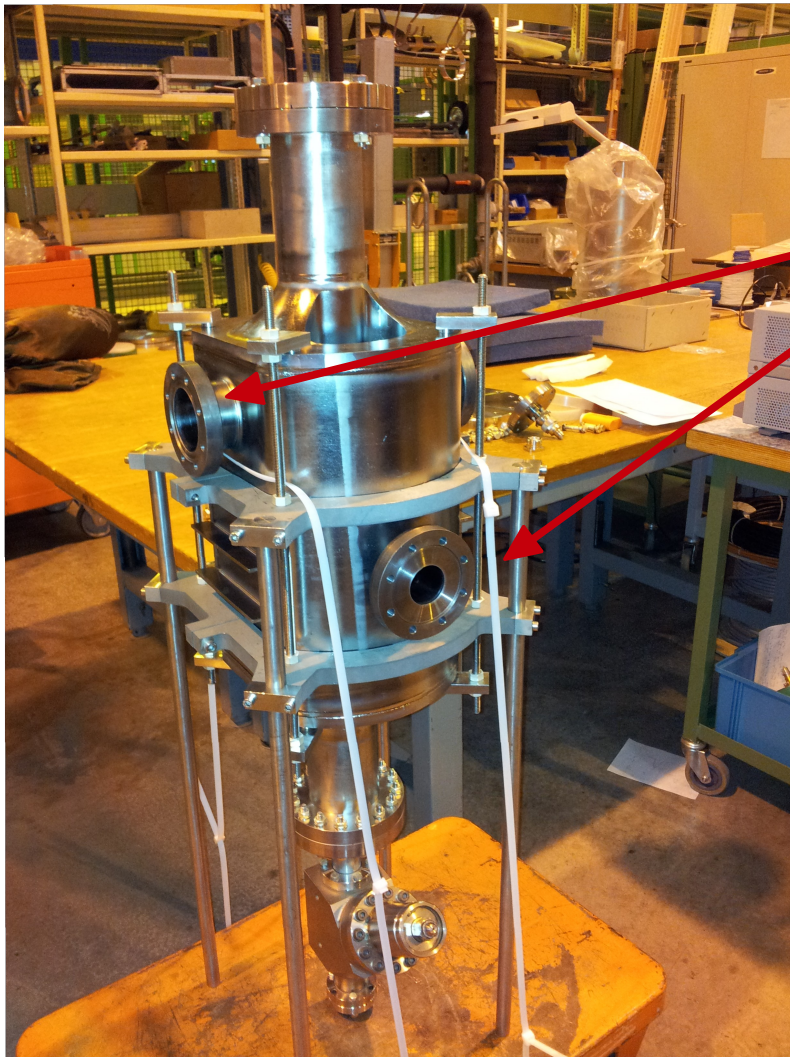
3 Flanges DN63  
NbTi (Cu Seals)

Leak from  
flange below

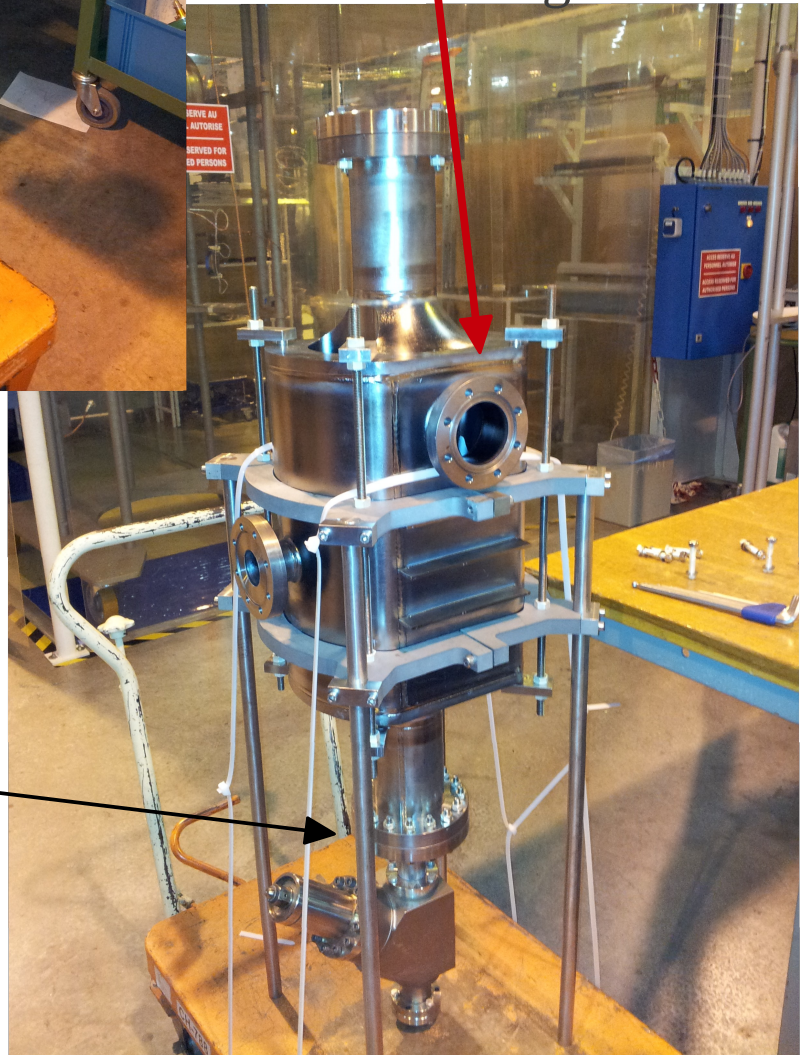
2 beam pipe  
flanges in SS

PickUp Coupler Flange (Little dent at  $\sim 270^\circ$ )

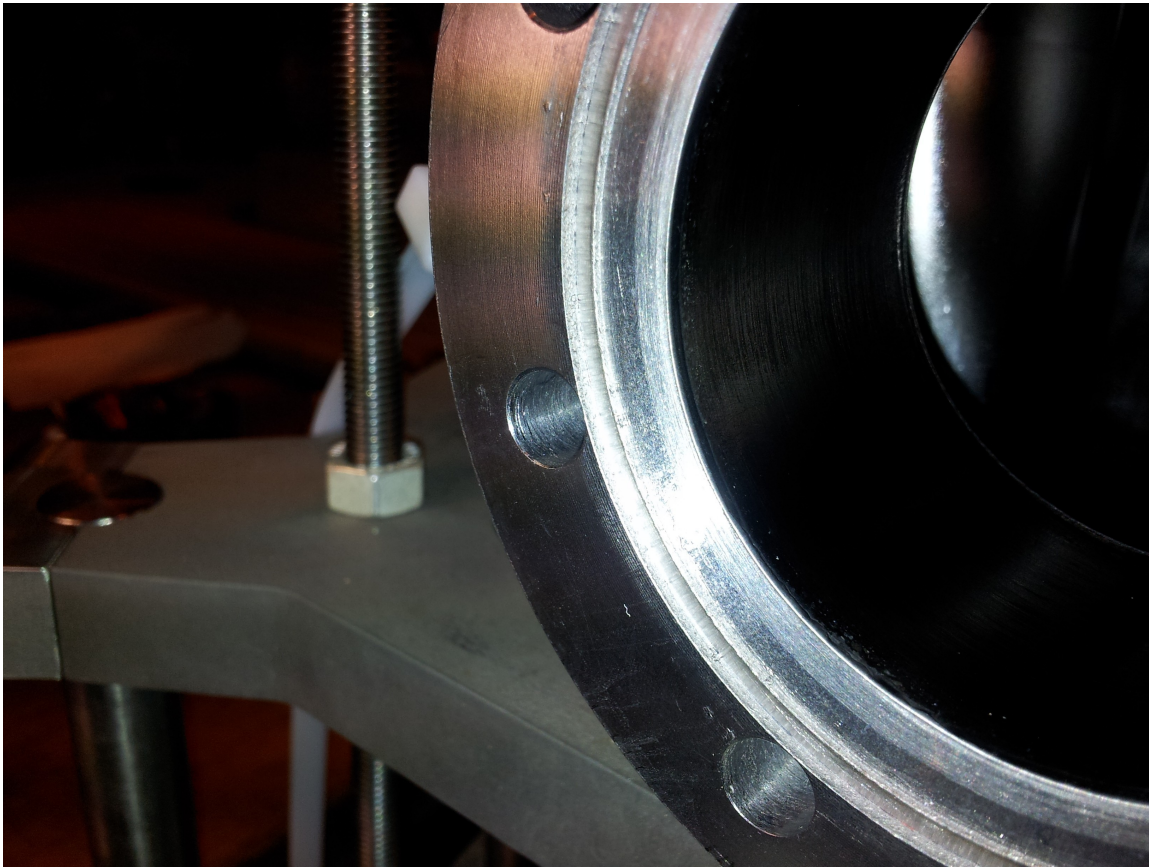
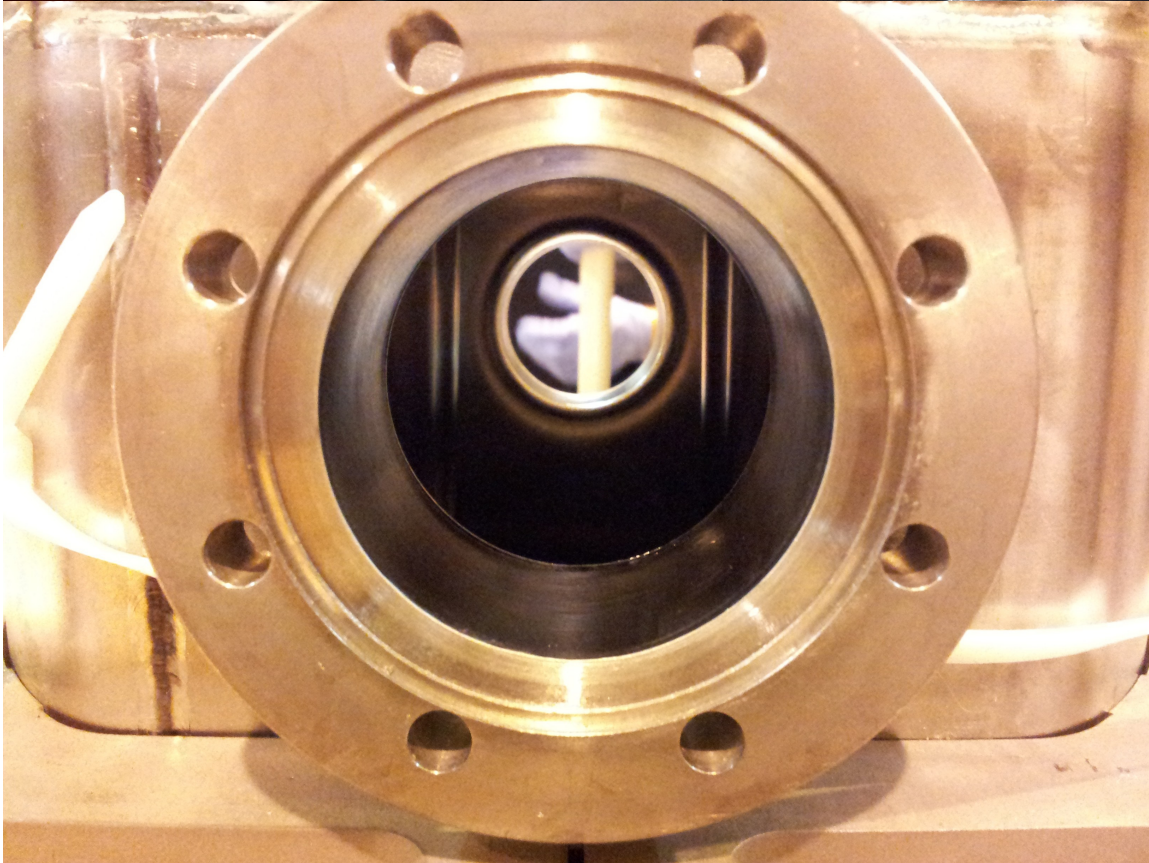
Blank Side with no Coupler  
(Leak identified with the brown trace with LN2)

Repaired one of the External Blank Flanges where the leak was found. Leak tested in LN2  $1.7 \times 10^{-10}$  mbar.

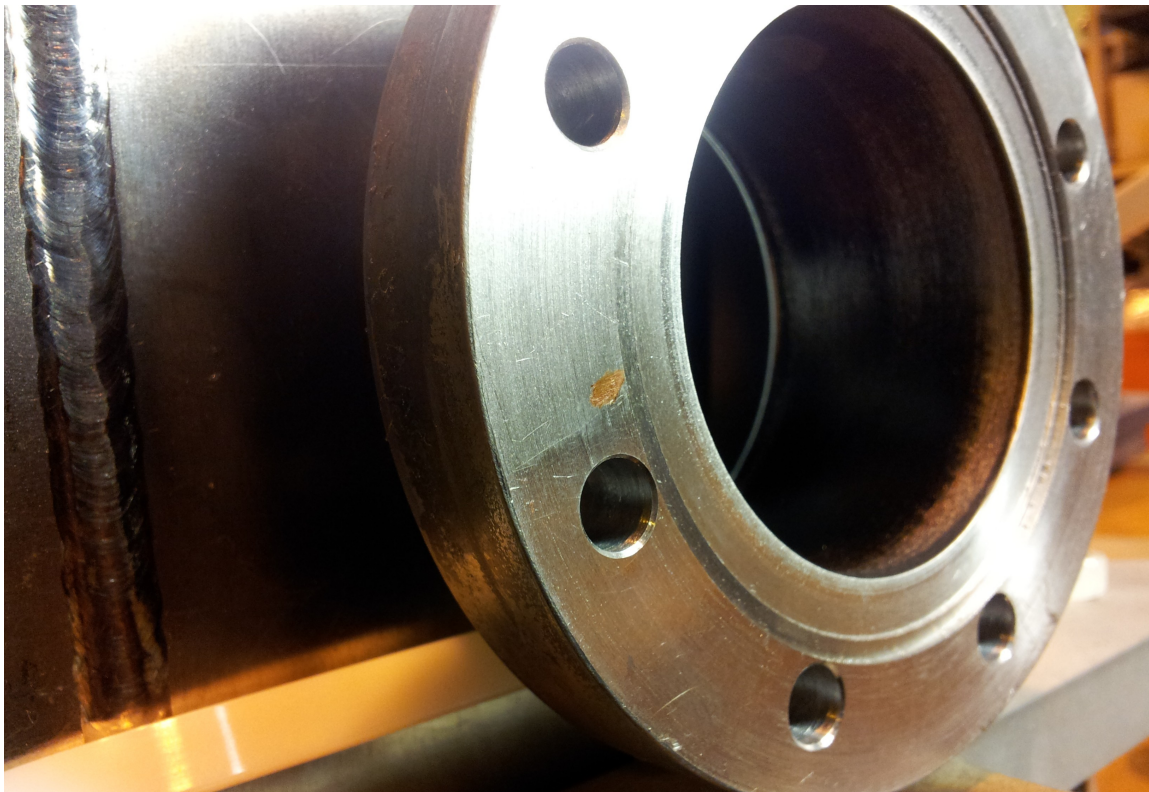
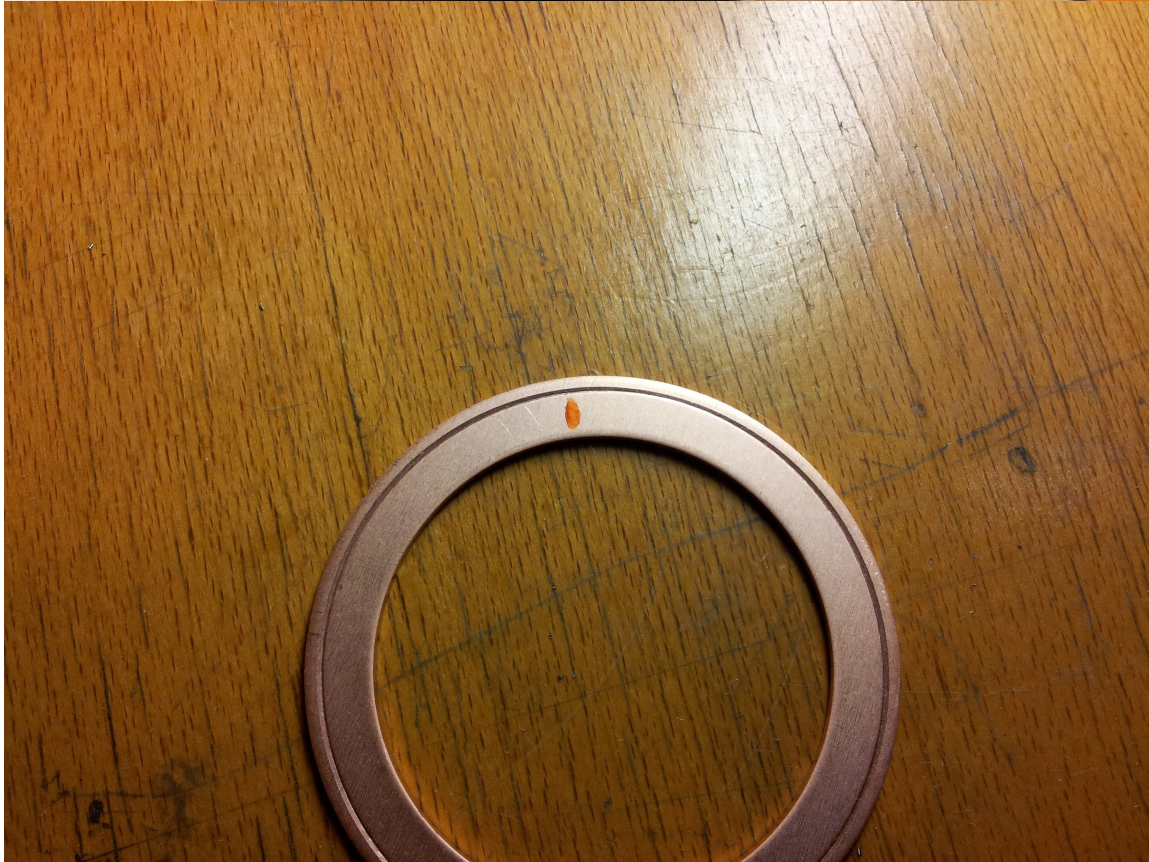
Power Coupler Flange (probably best of the 3)
