# Failure mechanism and consolidation of the compensation bellows of the LHC cryogenic distribution line

K. Brodzinski<sup>1</sup>, P. Cruikshank<sup>1</sup>, J.L. Fournel<sup>2</sup>, L. Tavian<sup>1</sup>, N. Veillet<sup>3</sup>

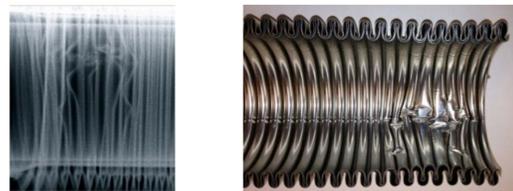
The X-rays of the suspected interconnection confirmed visually deformations on header C bellow. The X-ray and photo of later removed bellow are presented in Fig. 2a and 2b.

Fig. 2. (a) X-ray of first leaky bellow;  
(b) photo of the first leaky extracted bellow.

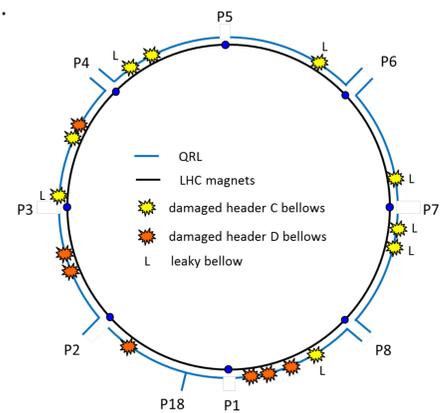
After complete warm up of the machine for long shut down period the performed X-ray campaign confirmed damage and repair necessity on 16 compensation bellows – see Fig. 3.

Fig. 3. Repartition of damaged compensators

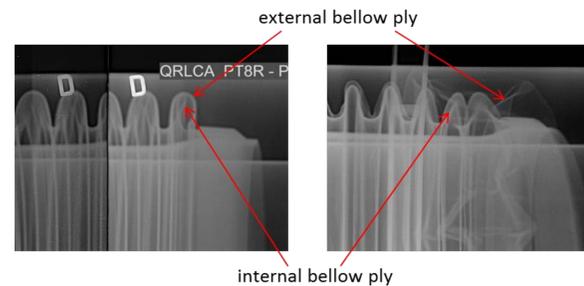
After the long shut-down warm-up the situation required full investigation and understanding the problem origin. The detailed analysis of the X-rays confirmed clear damage of the bellow plies – see Fig. 5.

Fig. 5. X-rays of damaged compensator plies.

This finding led to presume that during three years of operation some bellows faced with the helium tightness problem into the inter-ply volumes. The metallurgical analysis confirmed existence of a crack on the double weld between the plies extremity and the flange – see Fig. 6.

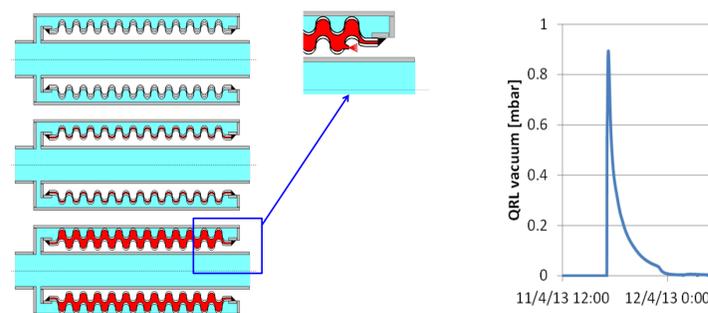
During warm up the supercritical helium trapped in-between the plies did not have enough time to escape via the micro leaks. The increasing inter-ply pressure led firstly to bellow deformation and secondly to creation of traversing leak from helium to the vacuum volume. Visual representation of the damage sequence is presented in Fig. 7. The effect of the helium discharge from the inter-plies volume to the vacuum was visible on vacuum pressure monitoring and is shown on the graph in Fig. 7.

Fig. 7. The bellows damage sequence with the insulation vacuum pressure evolution.

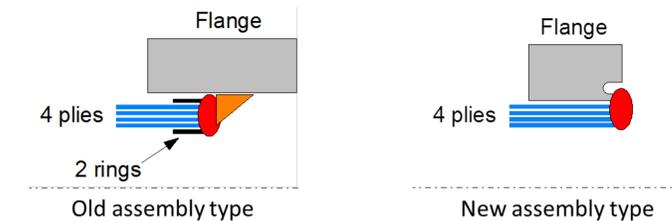
Fig. 8. The modified assembly procedure for new type of spare bellows.

- The new spares have modified flange shape and weld between the plies extremity and the flange – see Fig. 8. The new design allows welding of the 4 plies in one passage.
- The other modification is to keep only one ply tight (on the helium side) and all other plies are perforated to create ventilation holes.
