# Quality Test of the KLOE-IT GEM foils

*Danilo Domenici  
on behalf of the KLOE-IT group*

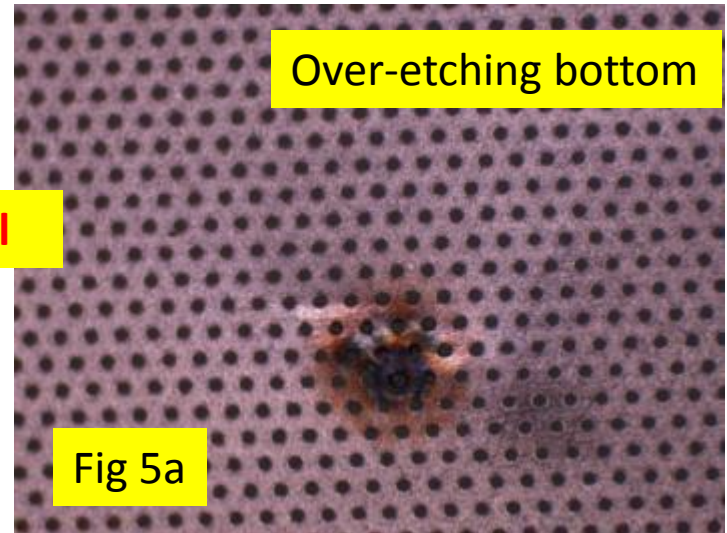
Rejected foil

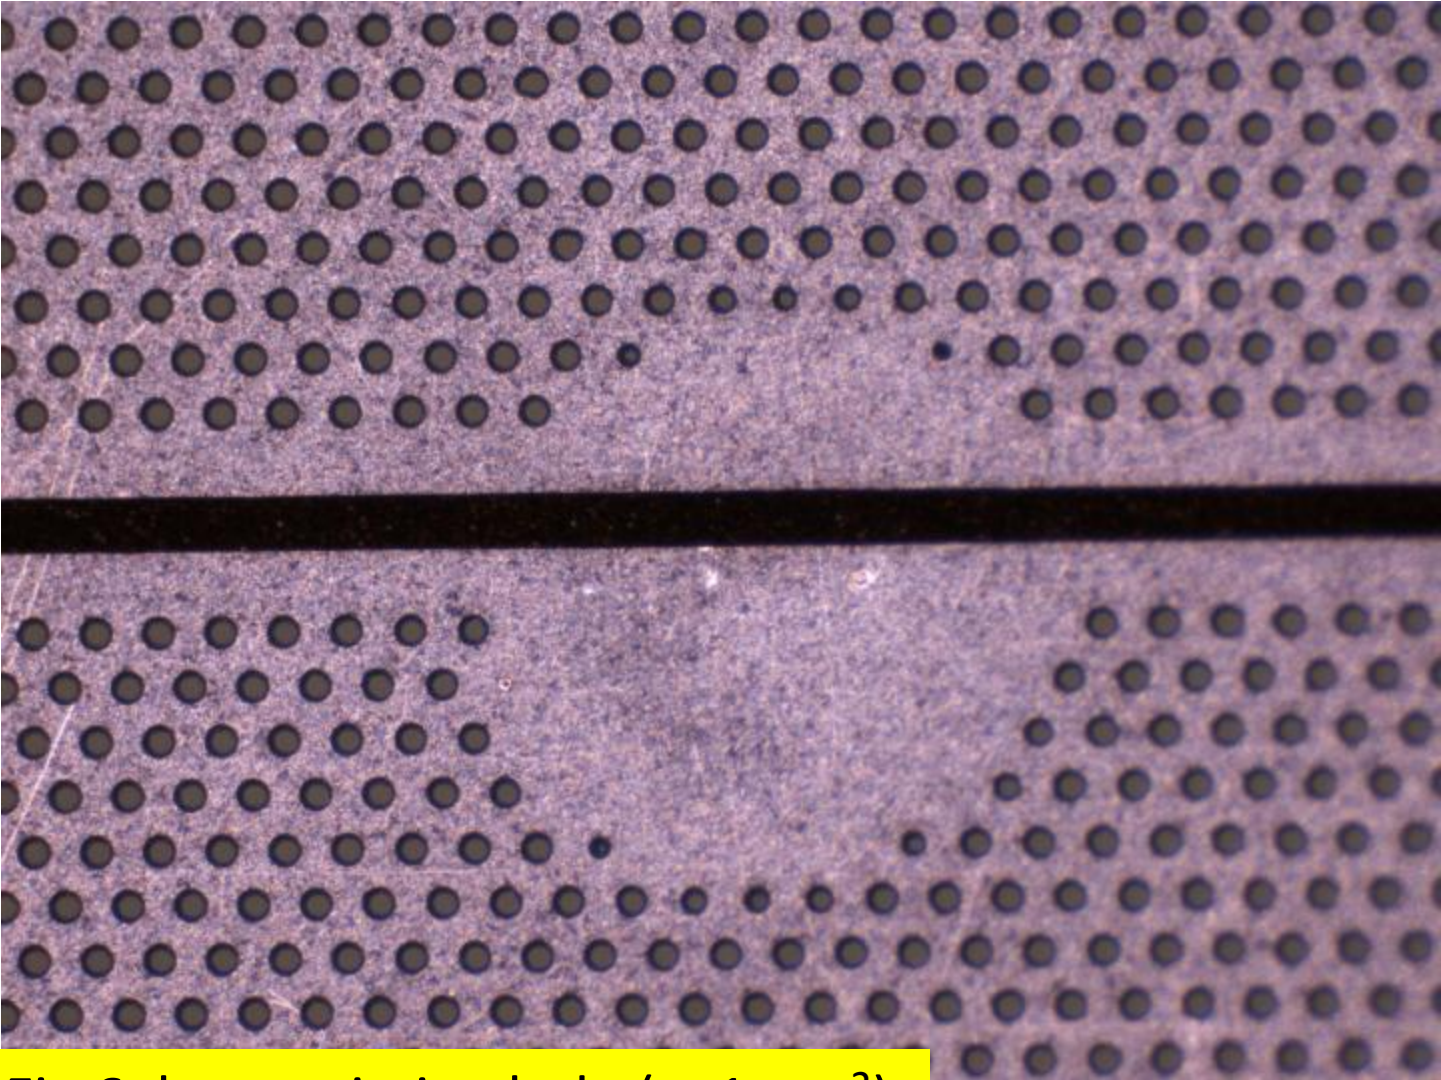
Fig 6: large missing hole (  $\sim 1\text{mm}^2$  )

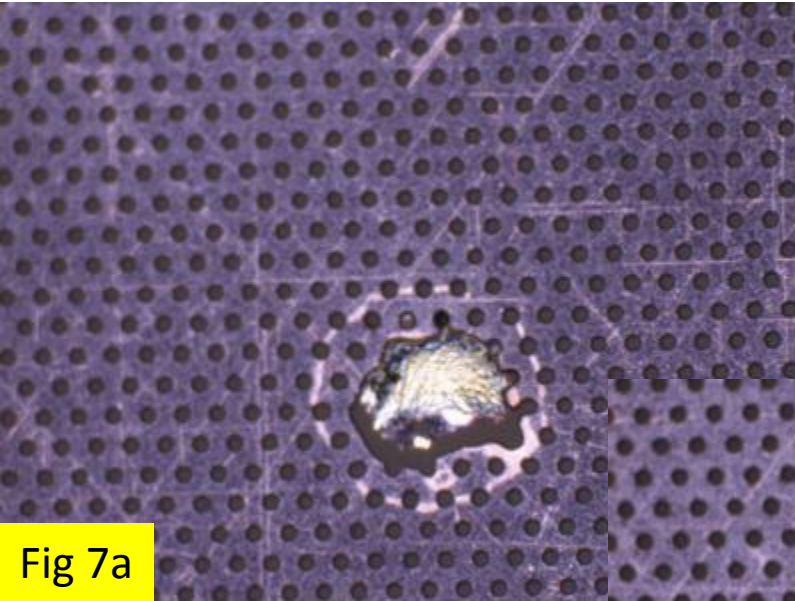
Fig 7a

Typical heavy “over-etching” with residual bottom copper film, leading to continuous discharges (all on the same foil!)

**Rejected foil**
