# Quality control experience with foils of the ALICE TPC prototype

### Piotr Gasik (TU München)

#### for the ALICE TPC Collaboration

RD51 Collaboration Miniweek 22-24.04.2013, CERN

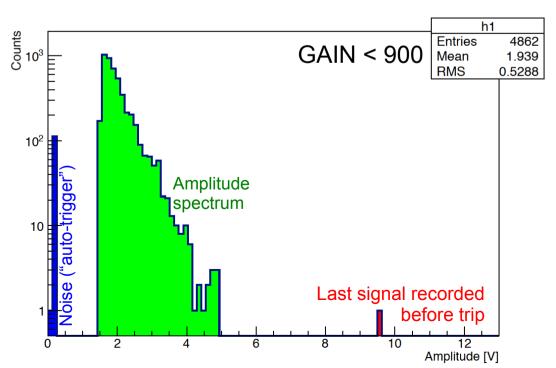
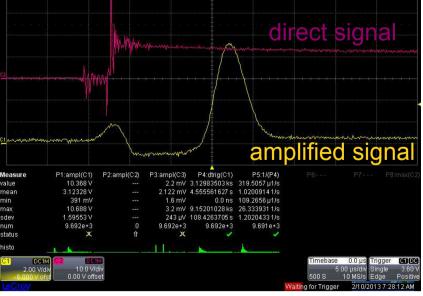
#### Example of the last signal before trip

#### 23 trips occurred

- 20 at lowest "IBF" settings, 2 at "standard", 1 while ramping up
- 21 with beam, 2 without \_
- No correlation found with beam conditions
- All included G1
- 1<sup>st</sup> trip already while running with 10 kHz coll. rate
- 7 shorts developed! •
  - 1 x GEM1; 3 x GEM2; 3 x GEM3; —

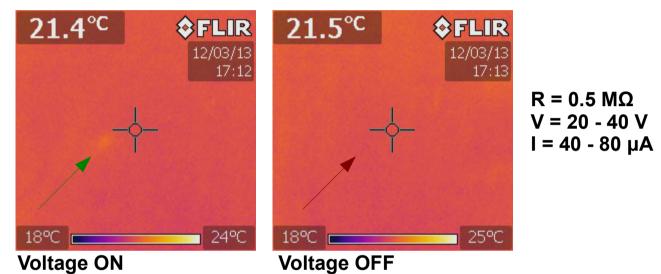
### Short identification

- Search for suspicious places (discharge spot)
- Identification:
  - Thermographic camera

• Irregular shape of inner hole  $\rightarrow$  black pieces (carbon?) sticking out

Here, in addition, light color pieces found nearby (photoresistive?)

• Final identification: discharge/explosion while burning with high current (see next slides)

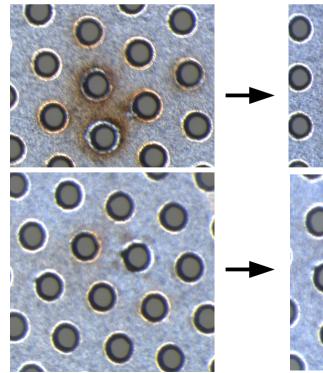
#### **Burning with high current**

- Resistance change (>30 MΩ) after applying 20 30 V ( $I_{LIMIT} = 1 2$  A)
  - usually "explosion" of short seen
  - more carbon in hole after burning procedure
- Leakage current "re-appear" with higher voltages,
  - usually trip around 50V (R<sub>LOAD</sub> = 0)
  - "re-produce" a short with  $R_{SHORT} \simeq 1 k \Omega$
- Procedure repeated several times per short → result always the same

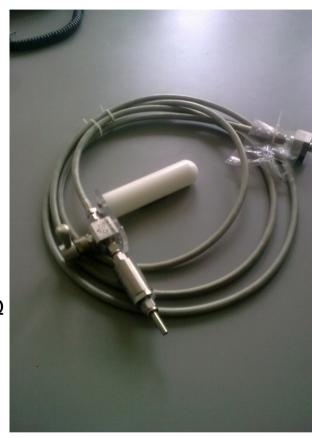
#### **Cleaning with CO<sub>2</sub> particles**

- While fast decompression of  $CO_2$  solid micro-particles are created
- Cleaning procedure  $\rightarrow$  several "shots", from close distance
- High pressure (high flux) leaves an imprint on the foil
- Hole seems to be cleaner, carbon is not visible
- Starting point:  $R_s = 9.3 \text{ k}\Omega$
- Resistance of the short increases after each cleaning: 3.5...10...18...>30M\Omega
- Ramping up  $\rightarrow$  leakage current **decreases** after each cleaning
  - after 9 "shots",  $I_{leak} = 0.7$  nA at 100 V (with  $R_{LOAD} = 100 \text{ M}\Omega$ )
  - usually  $I_{LEAKAGE}$  < 0.5 nA at 550 V

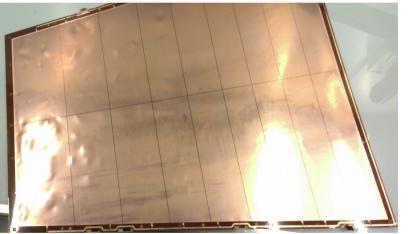
#### **Ultrasonic bath**

- 2 foils (2 x 3 shorts) were treated this way
- Holes visibly cleaner
- 3 out of 6 sectors were cured
  - Leakage currents I<sub>LEAK</sub> < 1 nA at 550 V (R<sub>LOAD</sub> = 100 MΩ)

- After bathing and drying parts of the foils, which were dipped in liquid, are wrinkled
- Drying (24h in 60 °C ) didn't help
- Effect enhanced by stretching?

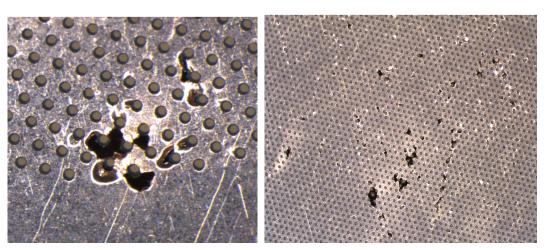
- TOP Copper layer was destroyed in many places
- In most of those places one can observe that copper was "different" there: scratches, light reflected differently
- Micro defects in raw material?
- Effect of stretched and framed foil?

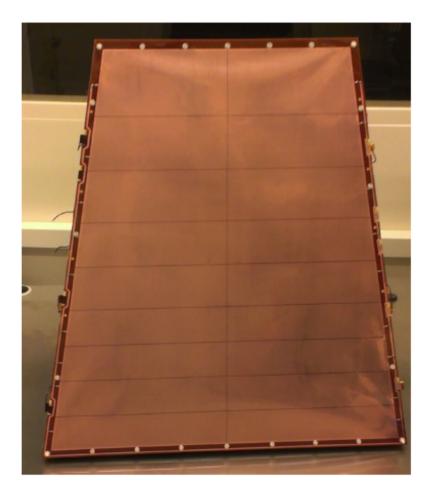
#### GEM-stack mounted on IROC-Alubody

- After mounting, "wrinkles" appeared near parallel edges of trapezoid.
- Wrinkles on the foil may result in inhomogeneities in the gain.
- Current method of fixing the foils seems to be not sufficient and will be improved.
