Safety in the Data Center

HEPIX – University of Michigan

Tony Wong—Brookhaven National Lab

Rack Tip-Over Accident

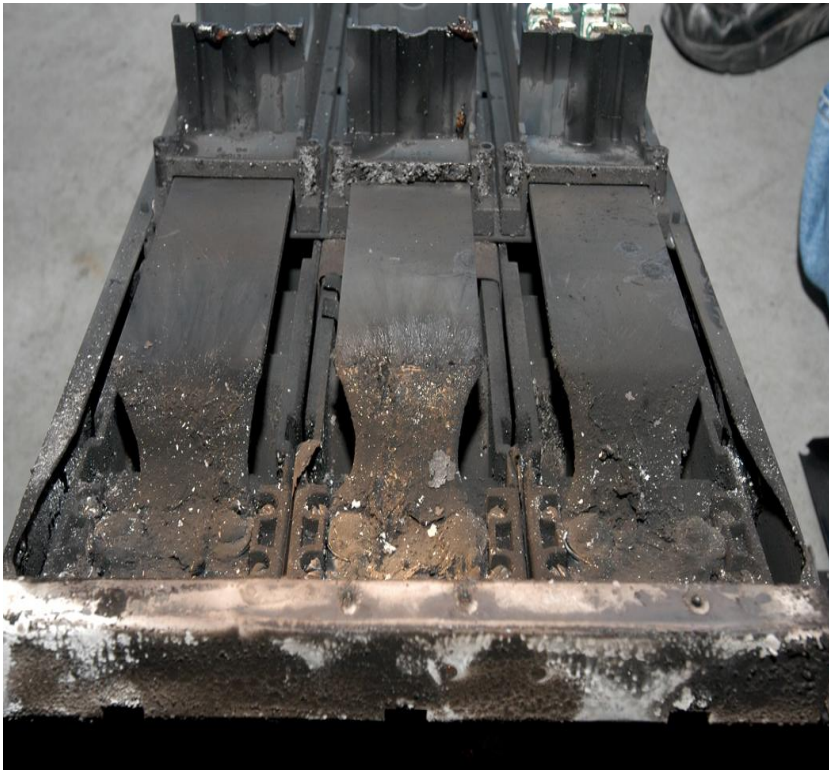
Damaged Switch

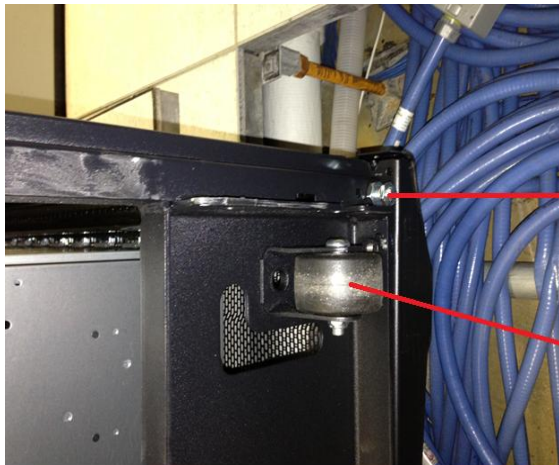
- Rack fell on its front face during installation procedure on Sept. 30, 2013
- **No one injured**
- Safety officers notified within 2 hours of accident (BNL internal requirement)
- Since servers are loaded from the front, we could not even remove servers one by one and then attempt to lift up the empty rack – **full rack weighs over 1000 lbs (454 kg)**
- Severed power cables underneath raised floor and damaged nearby CRAC unit
 - No water leak in damaged CRAC unit
 - Power cables not energized – no electrical hazards

Fallen Rack

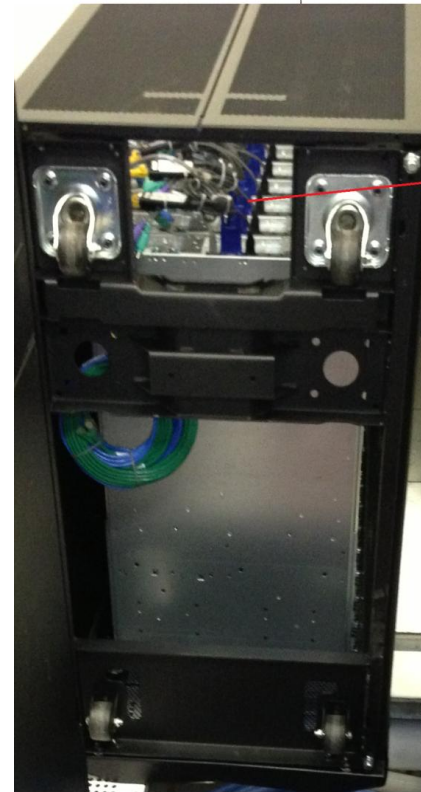
Adjustable Leg

Wheel

Opening for power and signal cables

- Typical of how accidents normally occur—a sequence of conditions that culminated with the incident
 - Tile in front of rack removed to access power and network cables
 - Rack wheels not immobilized
 - Tile in front not replaced after cables are fetched or adjusted
 - Two staff maneuver rack forward and falls into open hole

- Administrative and engineering measures
 - A 3rd person assisting
 - Modified training for data center operations
 - Work plan (permit) in advance
 - Immobilize rack wheels when nearby tiles are removed
- Understand best practices in the field
 - Contacted rack manufacturers
 - Discuss with peer institutions
 - Further measures possible to mitigate contributing factors or conditions that cause accidents

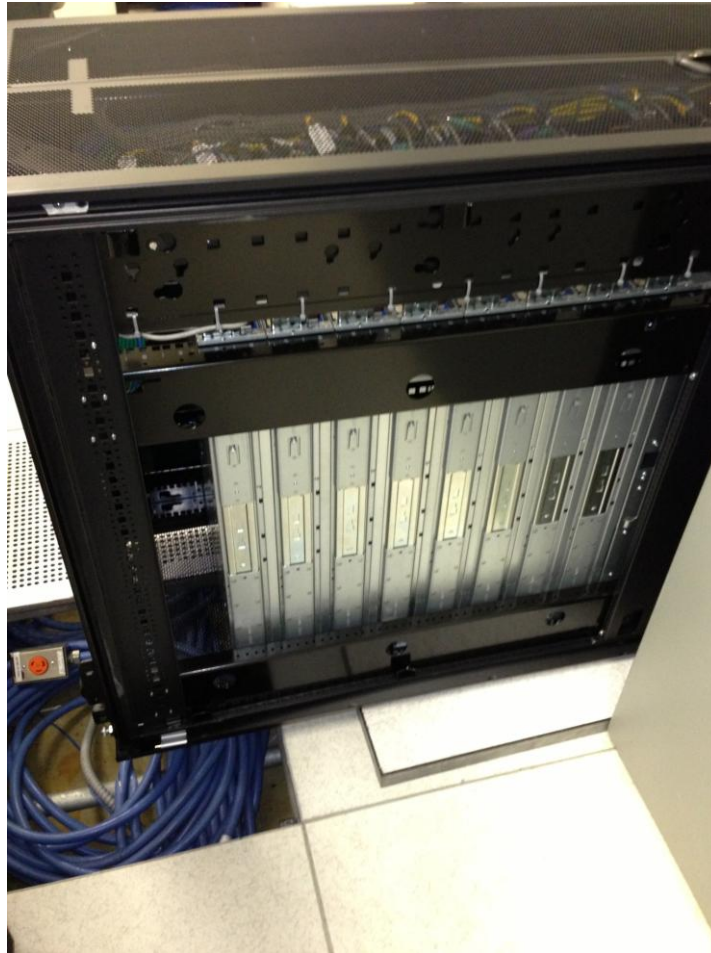
Fallen Rack

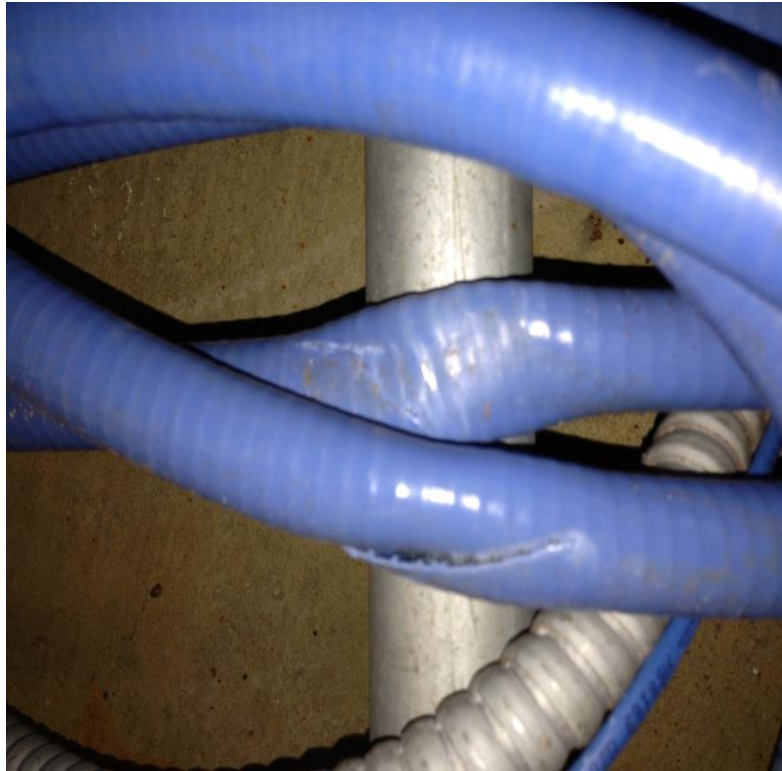
Damaged Power Cable

- Three power cables replaced on Oct. 14 – delayed energizing of PDU
- All rack installation interrupted ~3 weeks until investigating was completed and remediation procedures were approved on Oct. 21
- Remediation must be auditable – increase in paperwork and more time-consuming (see next slide)
- Internal discussion on hiring external, qualified helpers
- Procedures still in the process of being formalized and implemented
- A review of safety procedures will occur in 3 years (part of remediation)

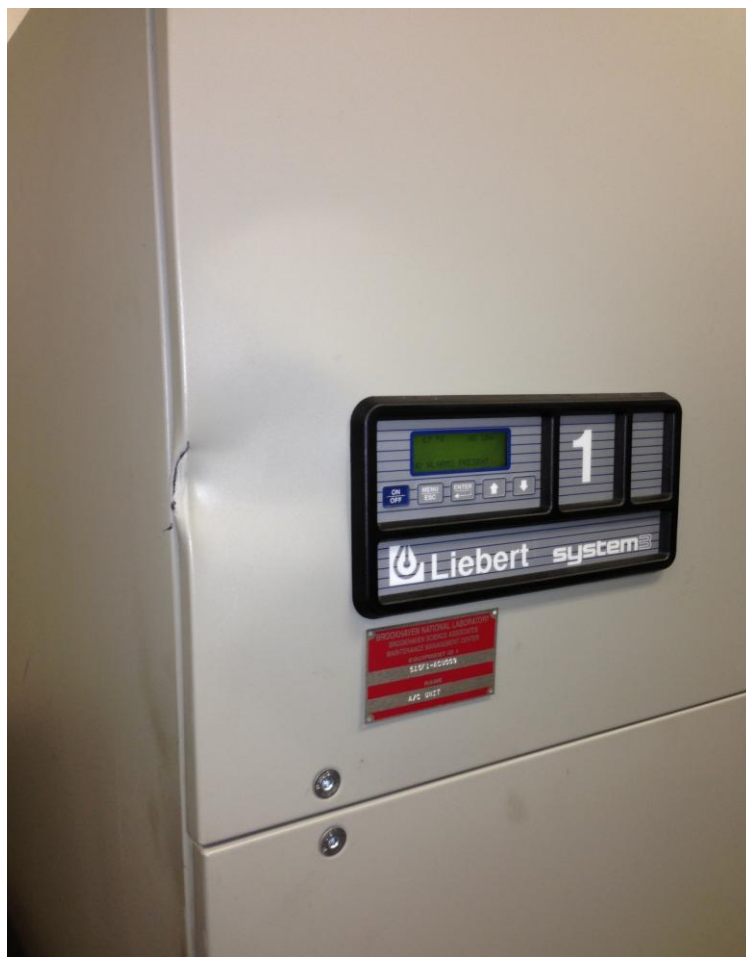
Damaged CRAC Unit

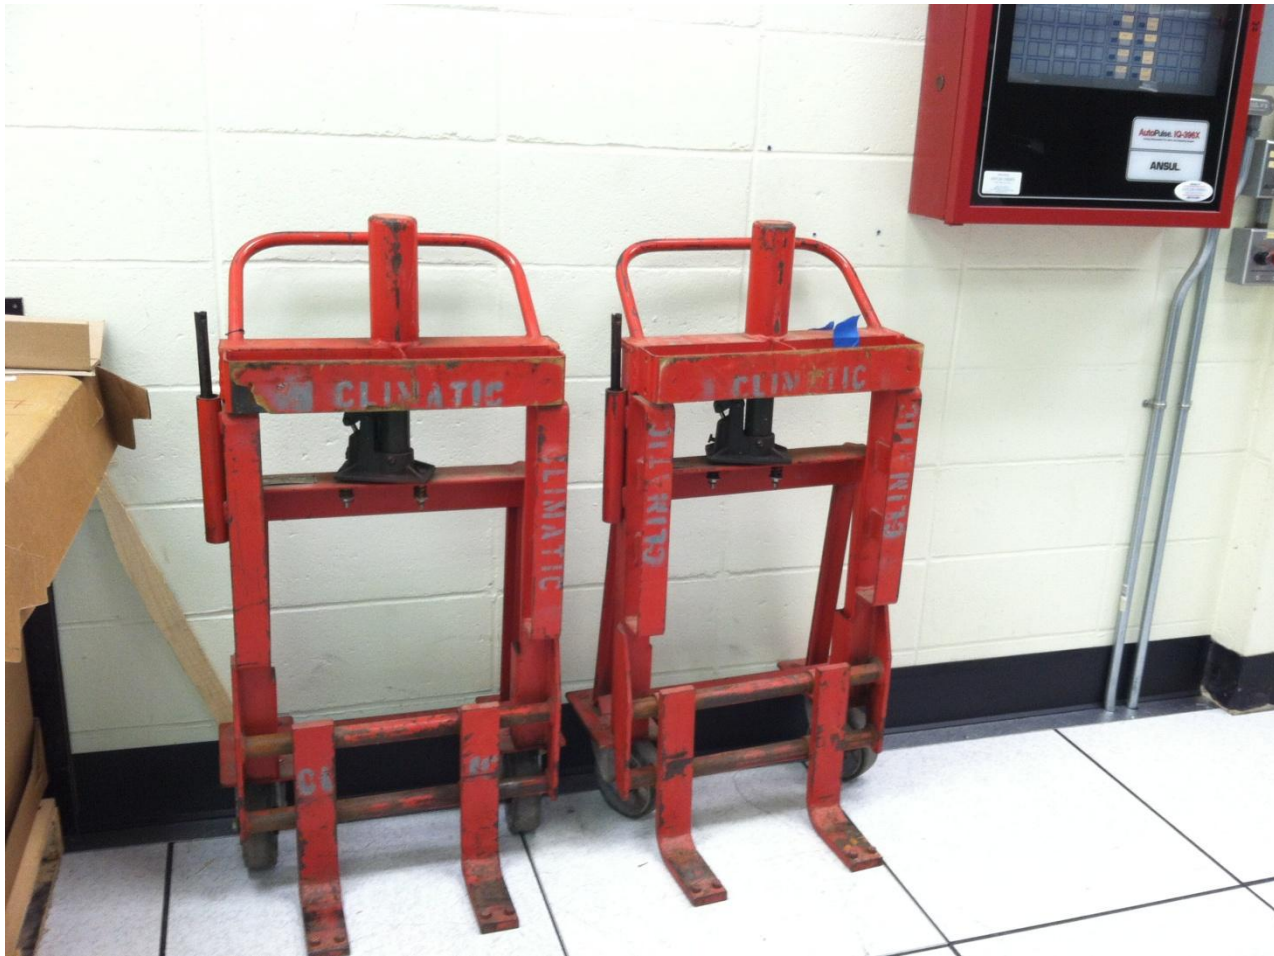
Hydraulic Jacks

- Rack raised up with specialized equipment
 - Hydraulic jacks
 - Crane
- Detailed physical inspection ensued
 - Rack front door damaged beyond repair – discarded
 - One hot-plug disk was re-seated
- Extensive tests so far find **NO DAMAGE** to any of the servers
 - Fully loaded rack worth ~US\$100k
 - Warranty still valid
 - Mitigating factors
 - Rack slid down slowly due to open hole and CRAC unit took some of the momentum away
 - Raised floor only 12 in (30 cm) high, not deep enough for impact to cause significant damage

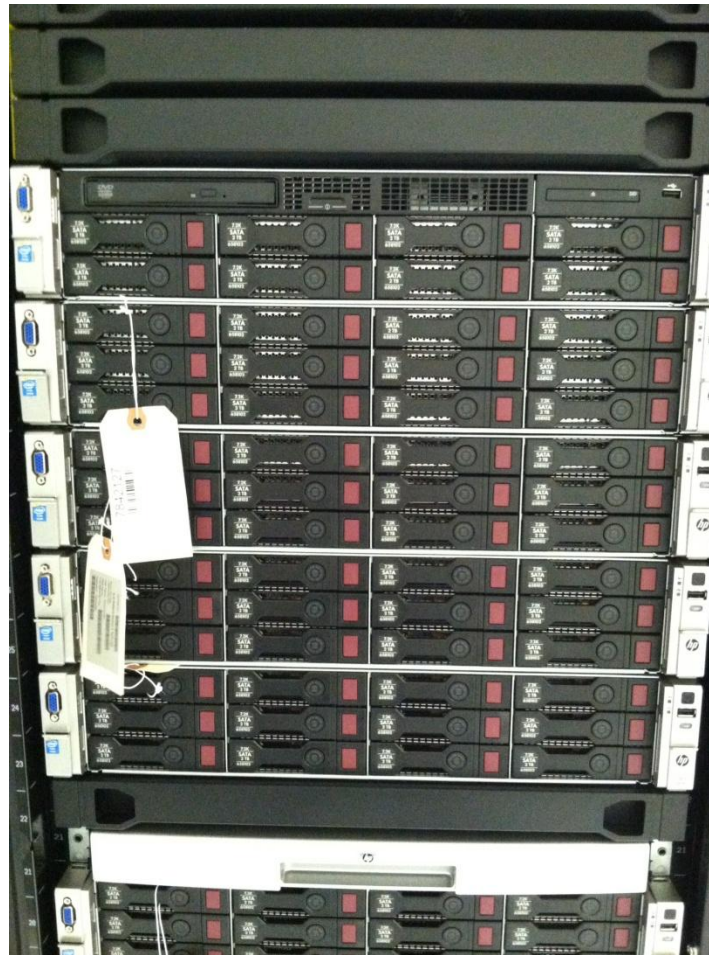
Undamaged Servers
