Crab Cavity Tests

R. Calaga, HiLumi Meeting, Nov 13, 2013

Summary:

All 3 prototype cavities built by Niowave Inc. in bulk NiobiumSurface treatment and first tests completed1 very good result, 2 moderate results and retreating to recover performance

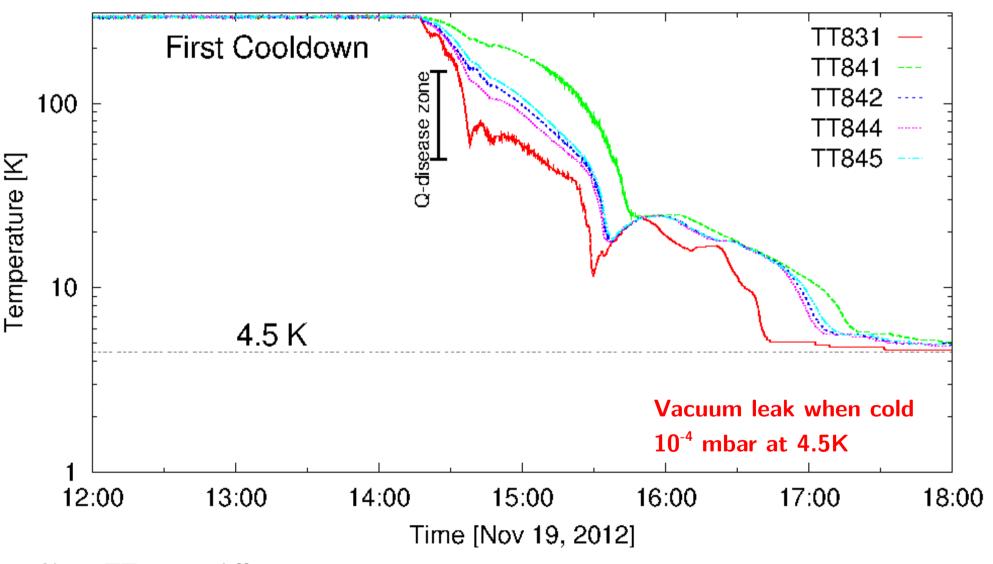
1^{st} Cool-down

Q-disease zone (150-50K) \rightarrow Approx $\frac{1}{2}$ hr

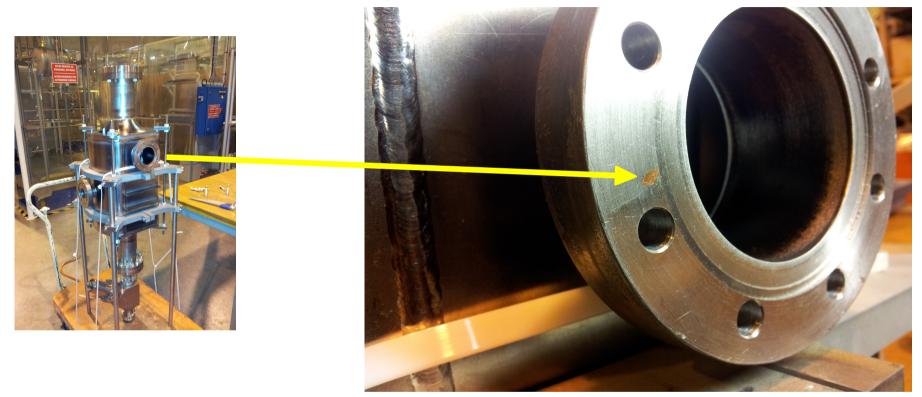
Leak Check & Repair

Leak test with LN2 & Helium gas

Apart from the NbTi flanges, the rods themselves are porous!

All NbTi flanges with irregular knife edges repaired Final light chemistry of 20mm + HP rinsing 2^{nd} RF tests in Sep 2013 \rightarrow Vacuum leak persists but better $\sim 10^{-7}$ mbar

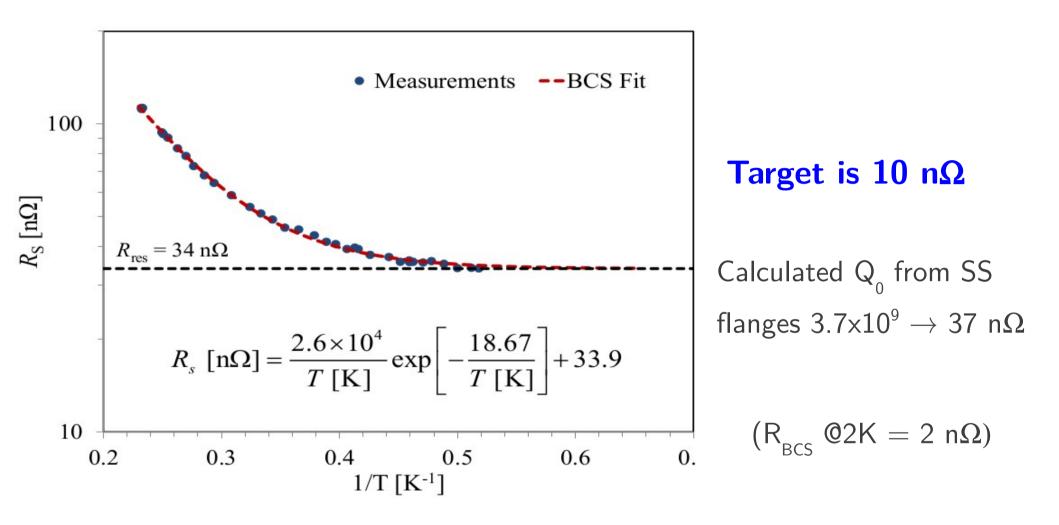
Achieved fields: $V_{T} = 7.0 \text{ MV }!!$ $E_{p}=75\text{MV/m}, B_{p}=131\text{mT}$ Achieved $Q_{0} = 4.0 \times 10^{9} (35n\Omega)$

Low field multipacting easily processed did not reoccur

The slight higher residual resistance either due to acid contamination or stainless steel flanges

Future tests pending funding, perhaps use Nb coated SS flanges

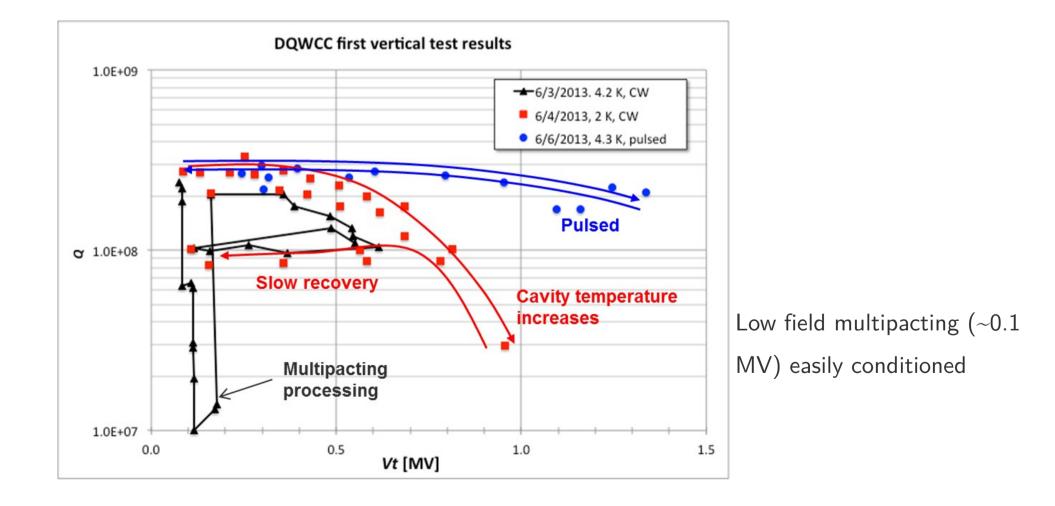
DQW 1^{st} Test

1st test with poor results due to improper HPR

Q is low, ~3×10⁸ (independent on the temp, expected 8.5×10⁹)

No Q-disease or not due to SS flanges

CW mode 0.96 MV (thermal load), pulsed mode reached 1.34 MV (200 W amplifier)

2nd Treatment at Argonne
Light BCP -40 μm
2 rounds of HPR due to contamination
Next test on Nov 19, 2013
