PSB dump endoscopy

30th May 2013

Alba Sarrió on behalf of EN-STI-TCD

AIM OF THE ENDOSCOPY

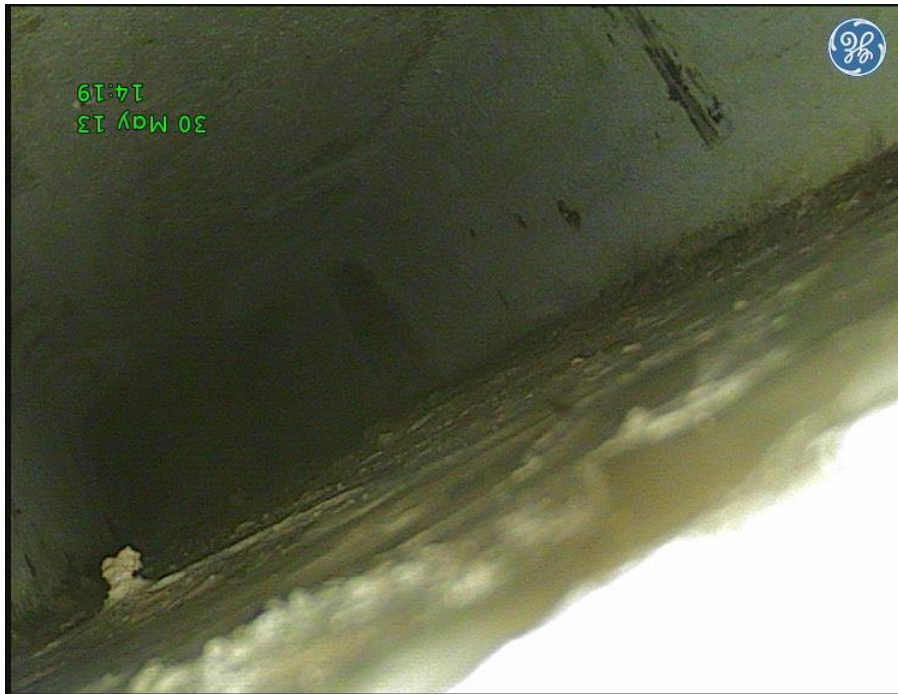
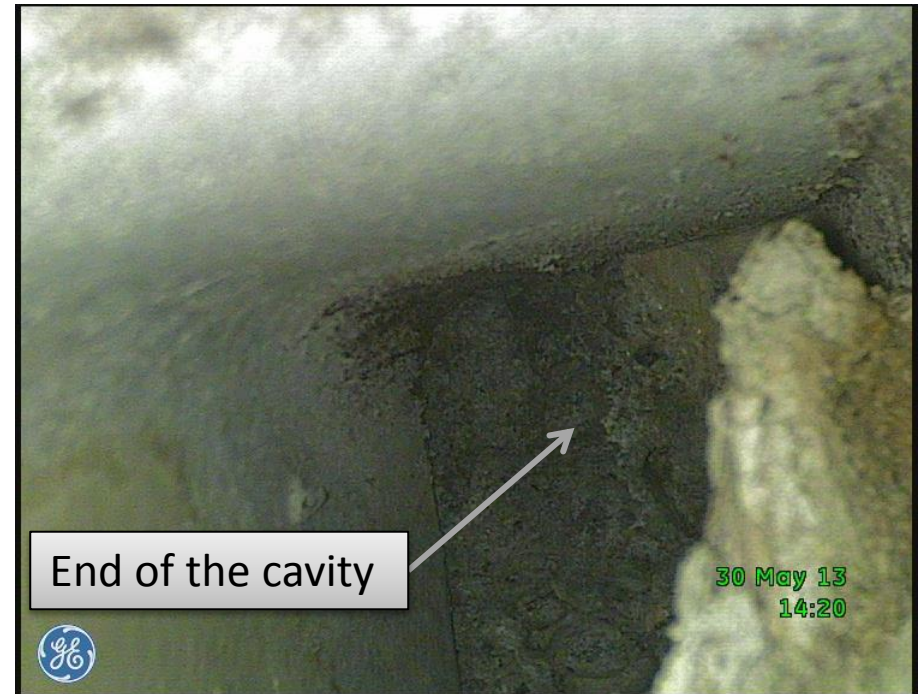
Conclusion: the rail is in one piece, in very good state and it reaches the end of the cavity

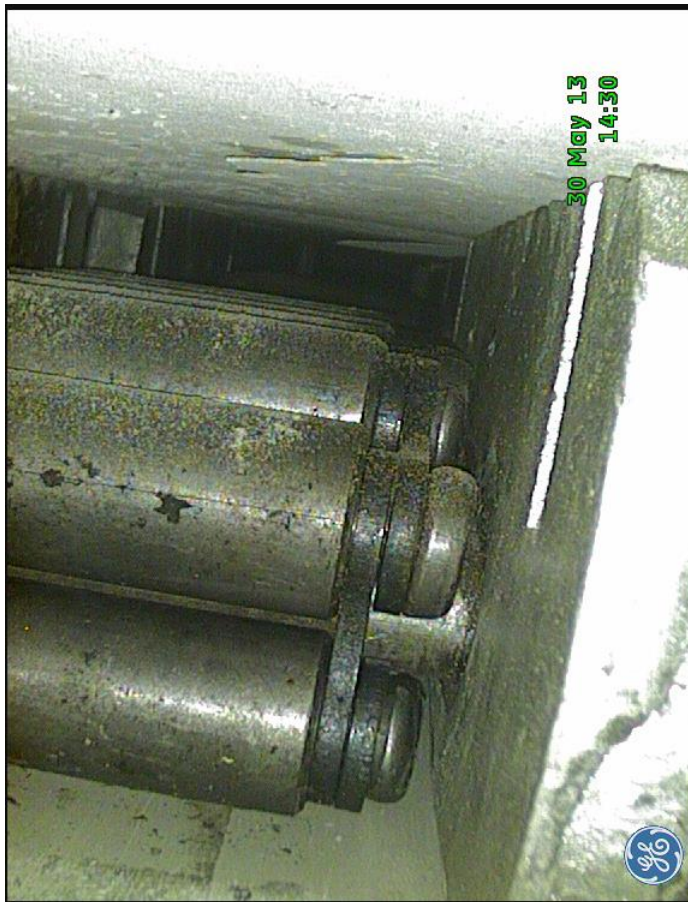
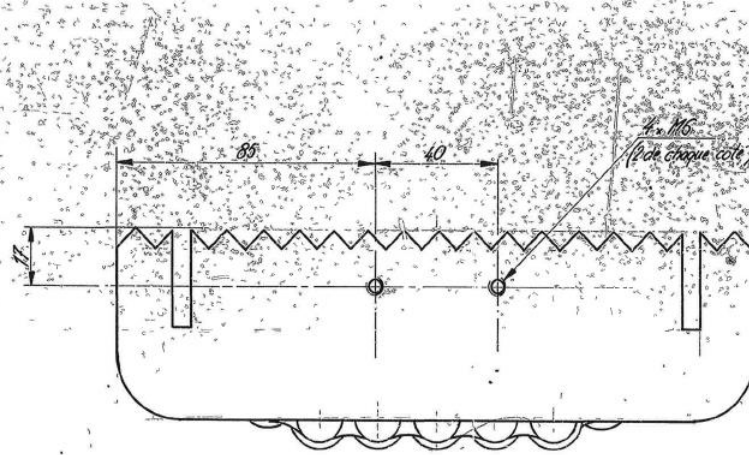
The technical drawings are accurate.
The rollers are in good state.

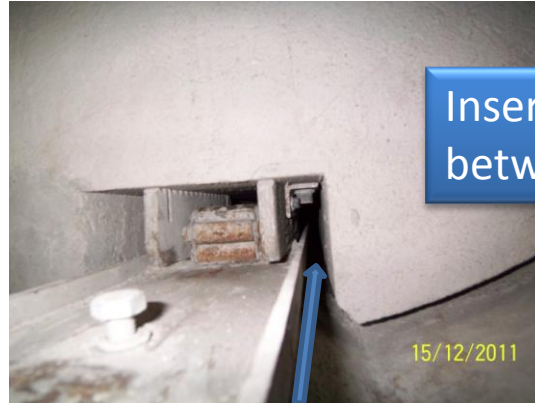
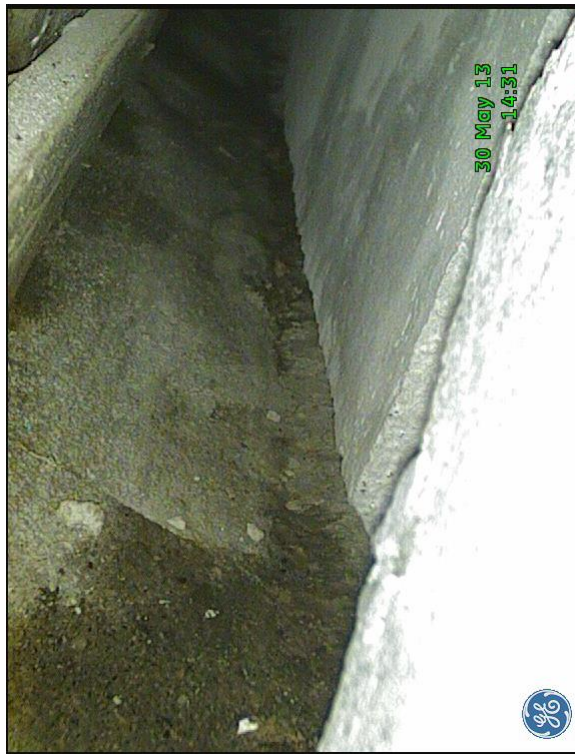
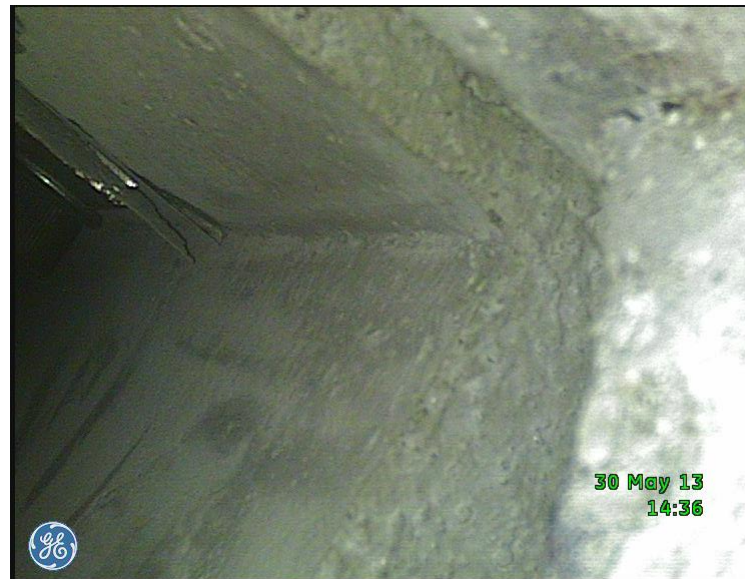
The lower part of the cavity is in good state, as well as the side of the rail

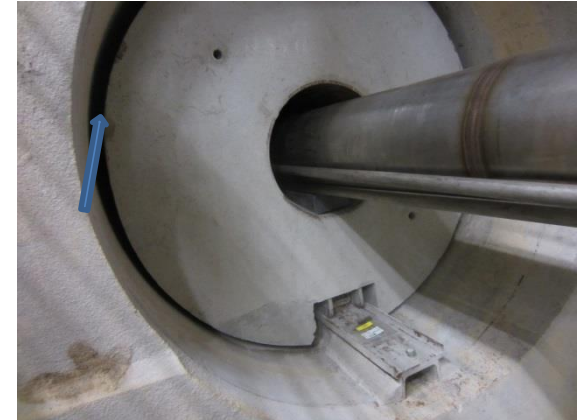
The outer part of the blocks is in good state and the 4th and 5th blocks are aligned

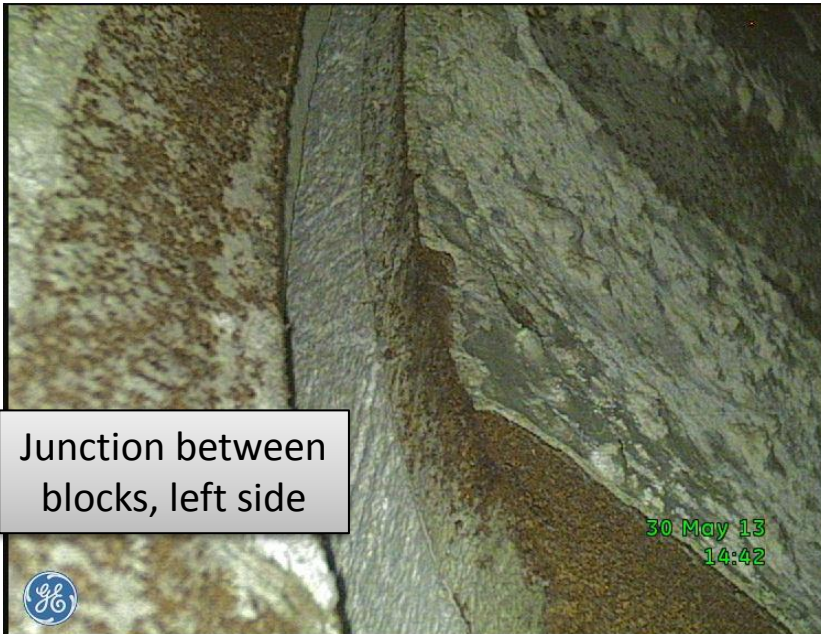
Junction between blocks, left side

5th block inner $\varnothing <$ 4th block inner \varnothing

Conclusion: the blocks are aligned outside but not inside

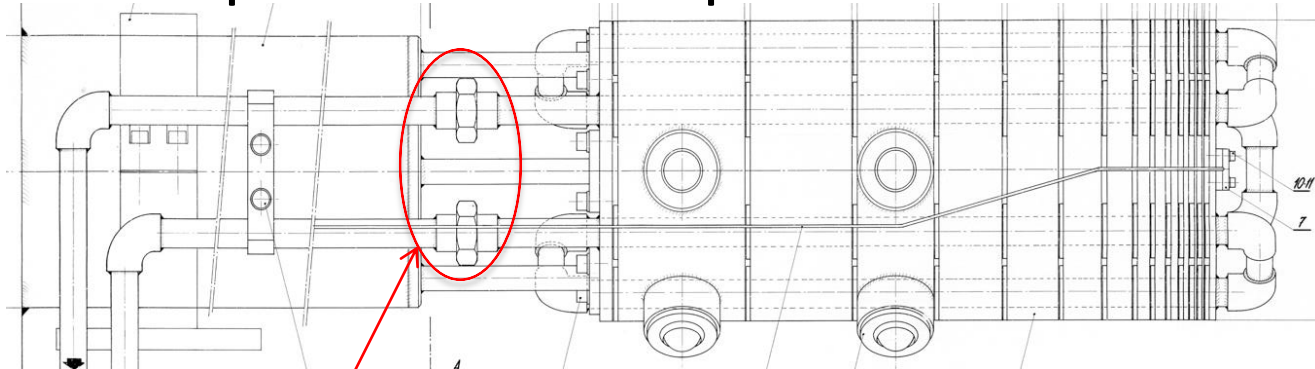
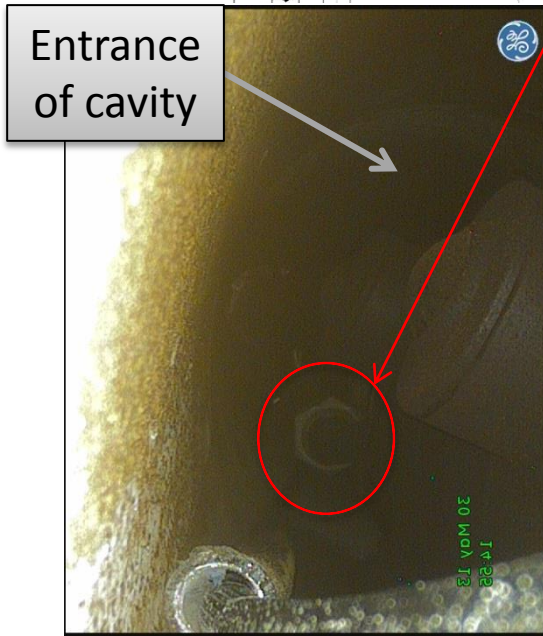
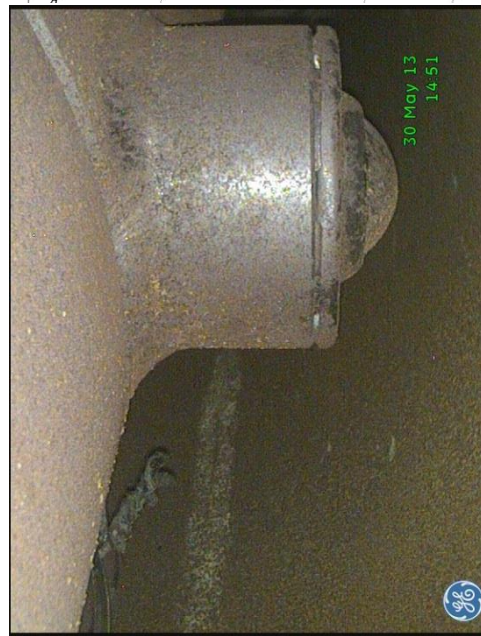
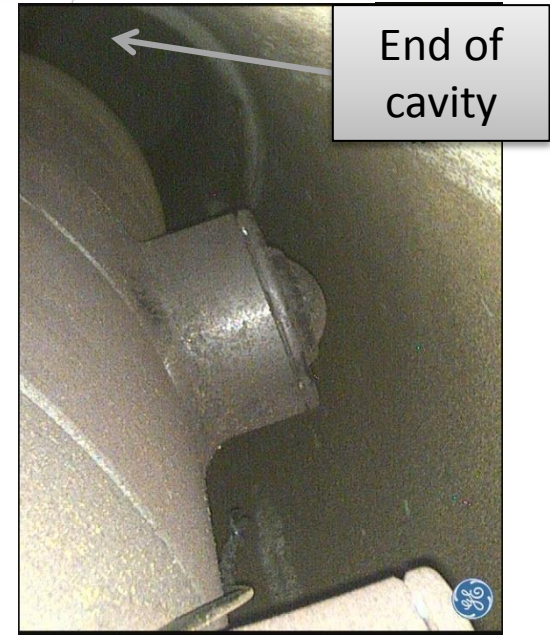
The dump's supporting balls are in good state, so are the cooling pipe connections

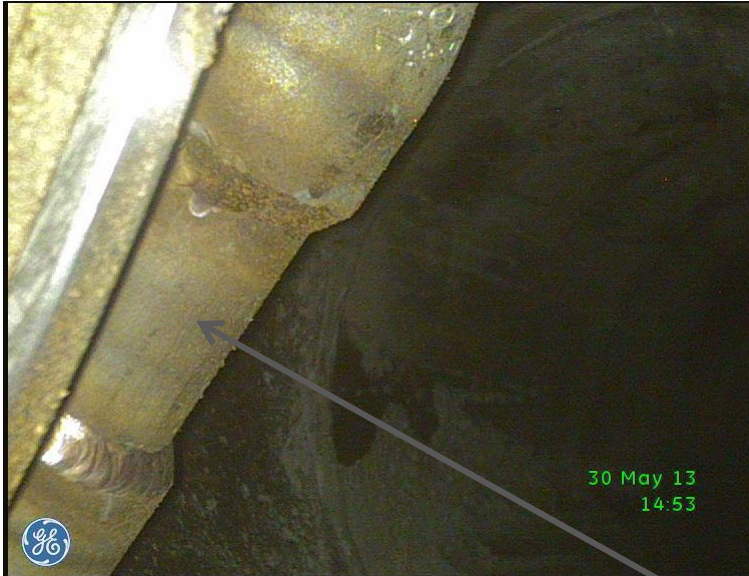
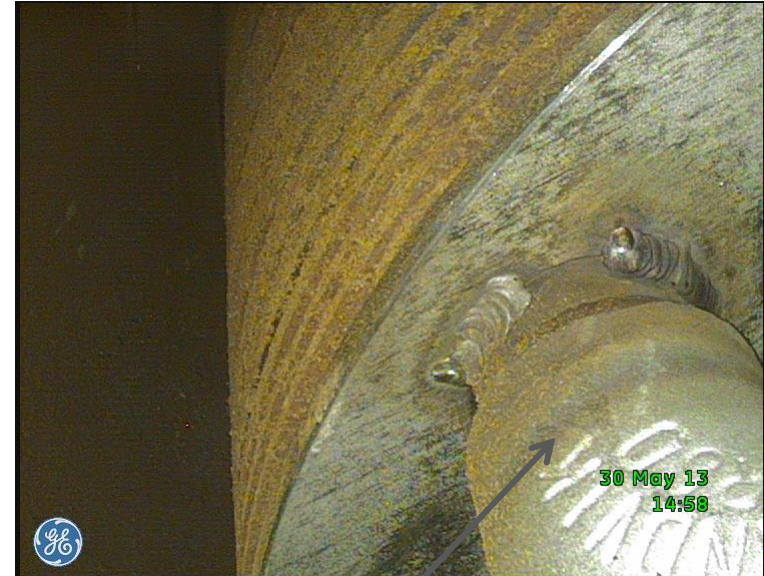
water connections (cooling system)

The water connections are in good state

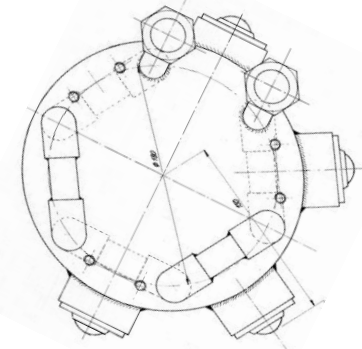
Actual position of dump

Conclusion: the dump is rotated 60 ° counter-clockwise

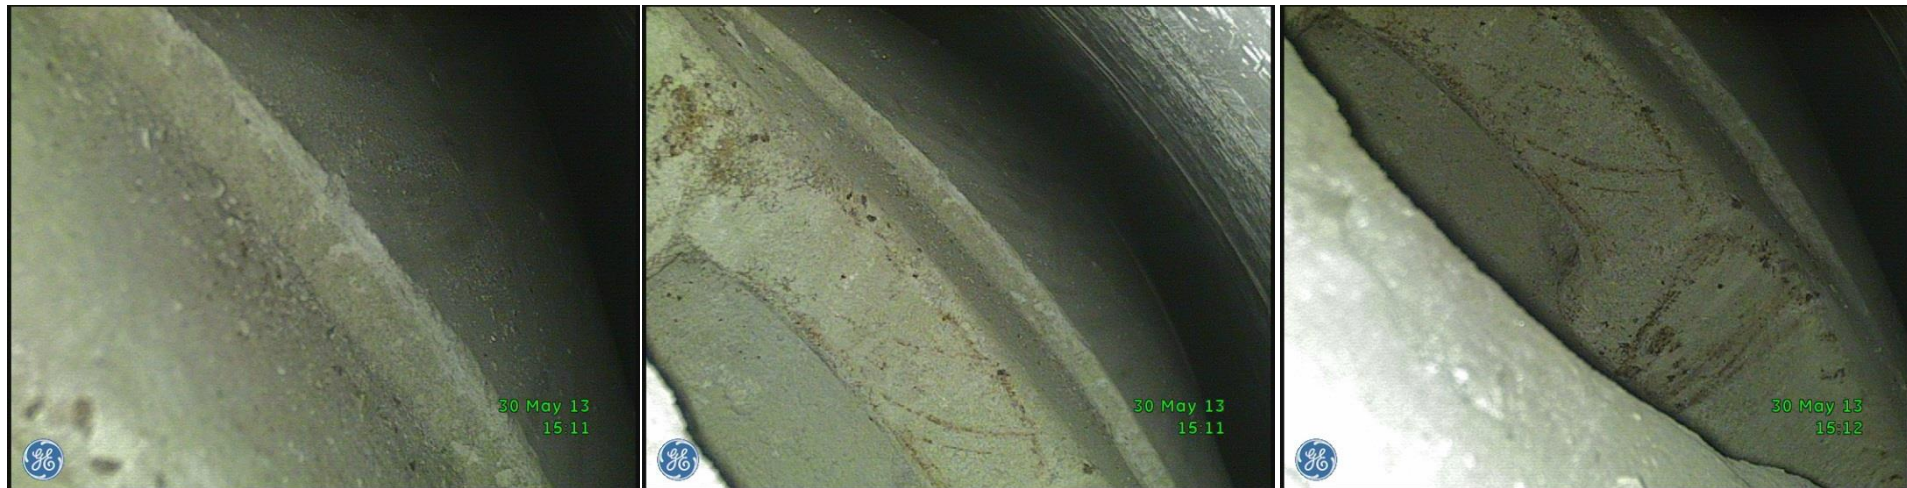
Conclusion: the blocks have a lifting point in their upper part
