# Vacuum incident on MKB - Implication on HV performance and tests foreseen

MPP meeting

Viliam Senaj, 25/10/2013

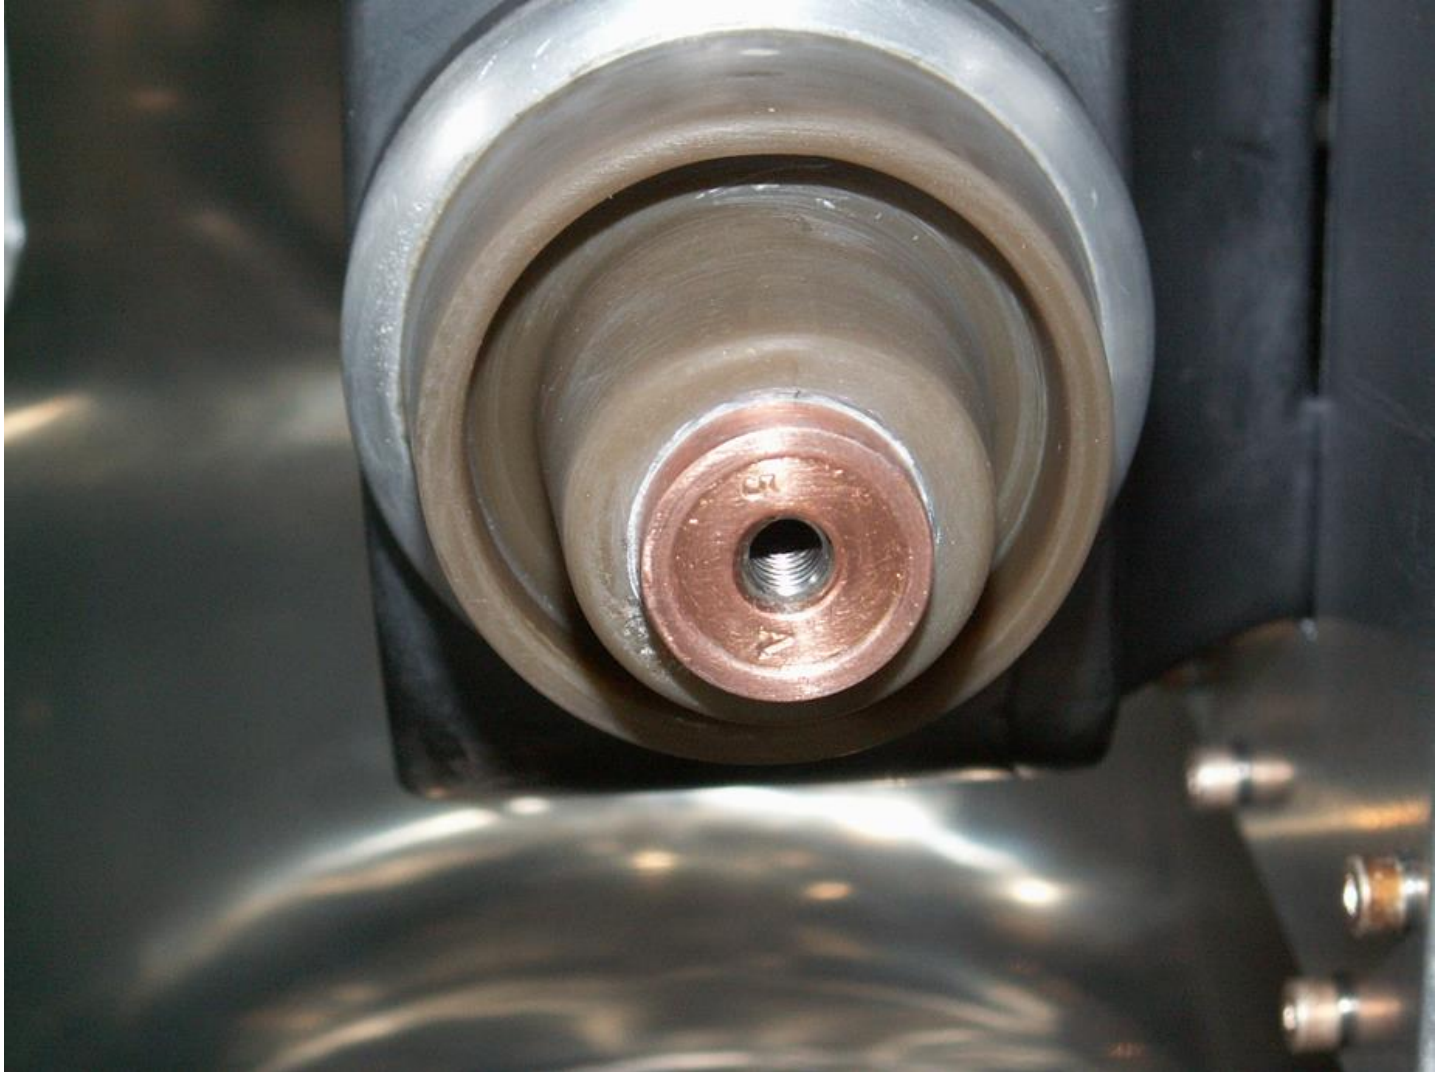
# Coil contact

- Potentially risky places in case of Al pollution:
  - Tank HV feedthrough
  - Coil contact (HV side)
  - HV conductor spacer
- All risky places visually inspected (with some access limitations)
- Coil in short circuit mode and hence no possibility for DC conditioning
- Careful pulse conditioning with slowly increasing voltage and vacuum activity surveillance (~several weeks).
- As good vacuum as possible ( $< 10^{-6}$  mbar for full voltage) = lower risk of sparking and higher sensibility to a vacuum activity. Presently  $\sim 3.5 \times 10^{-6}$  mbar; sputtering pumps off (?)
- Vacuum gage reading on recently installed tank not included into VAC application yet; Interlocking? Request submitted.
