LS1 Status Report

LS1@LHCC

Frédéric Bordry

25th September 2013

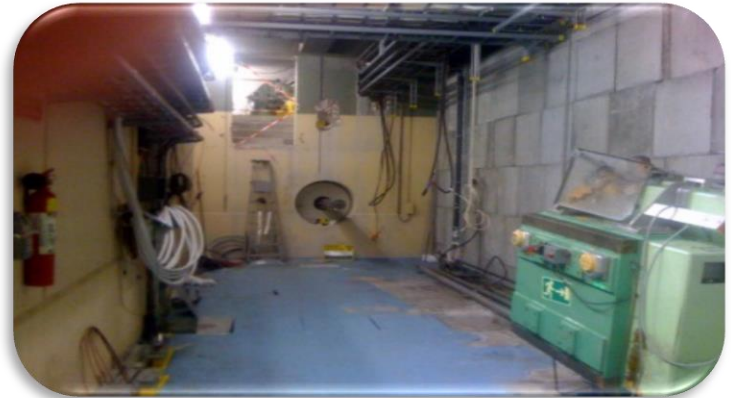
Beam dump replacement

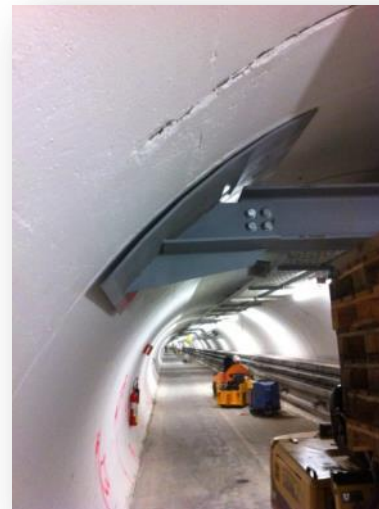
TT10 – vault repair

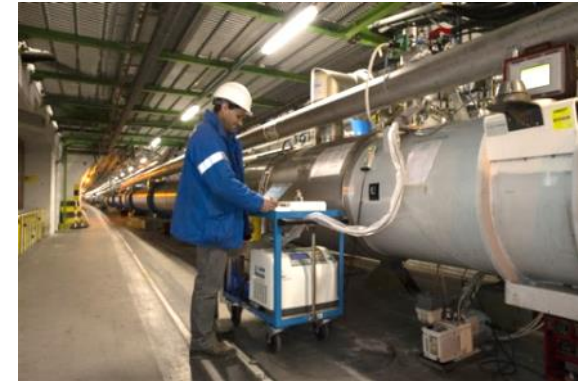
QRL S45-Subsector B: Q15R4

Internal helium leak

Suspected condensed air

Damaged corrugations of

- all C-line compensators inv
- #3 found damaged (Q15Ra)
- additional X-rays of #3 B, D,

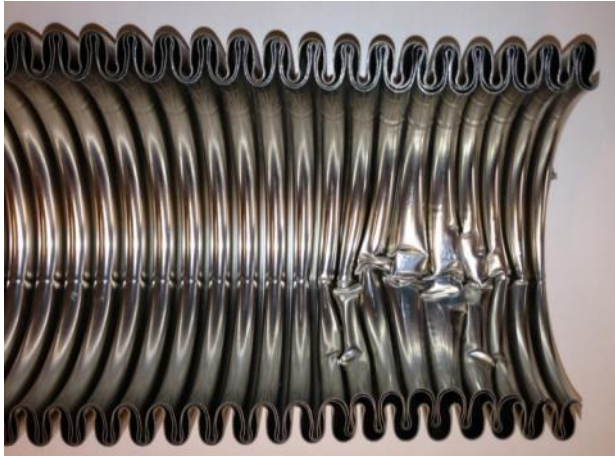
Internal ply damage (S45, 14R4)

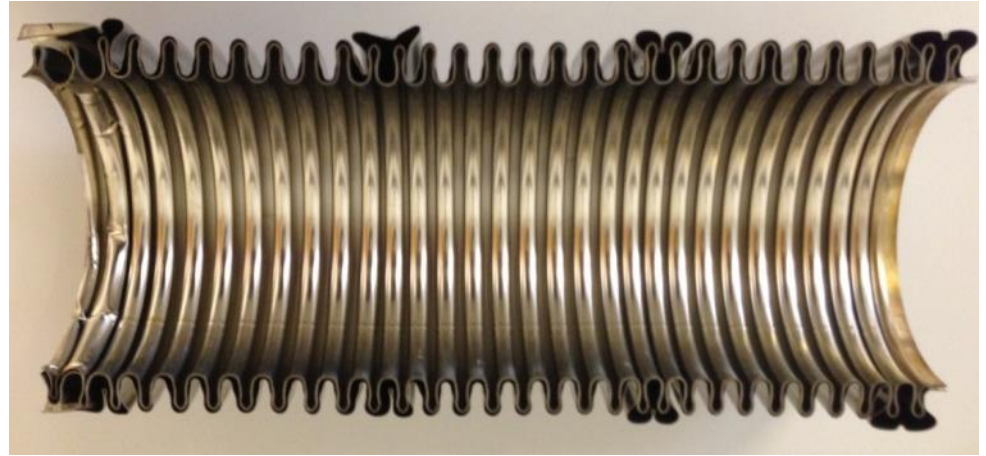
External ply damage (S78, 10R7)

DN100 multi-ply bellows compensators (4 plies of 0.3 mm)

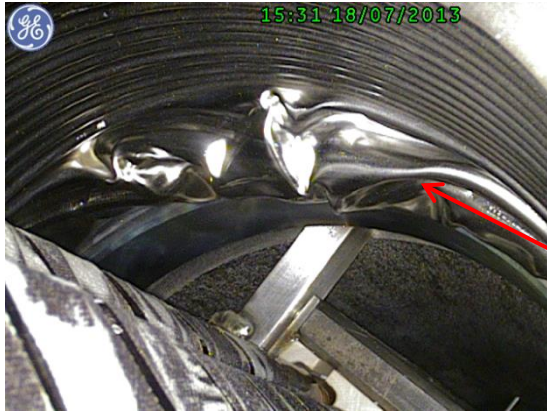
DN120 multi-ply gimbal bellows
(2 plies of 0.2 mm); Identical failure process identified

DFBAK upper gimbal (Sector 5-6)

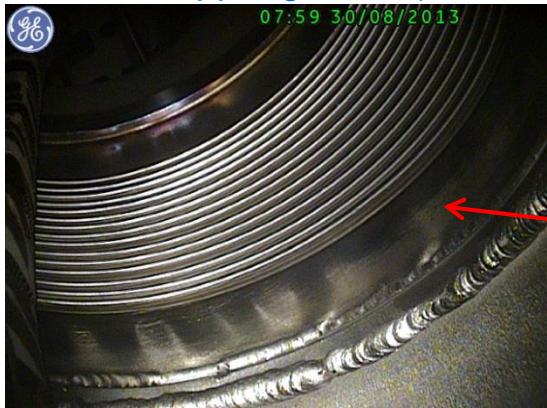
DFBAF lower gimbal
(Sector 3-4)

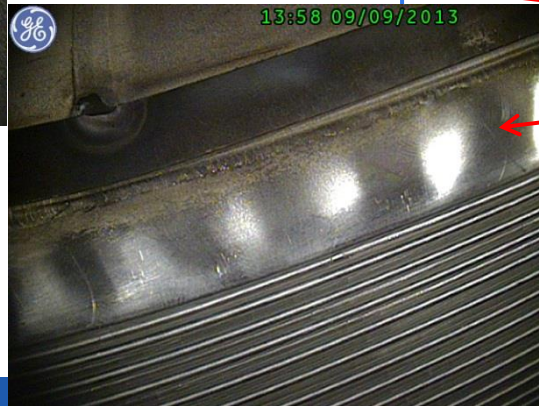
DFBAI lower gimbal
(Sector 4-5)

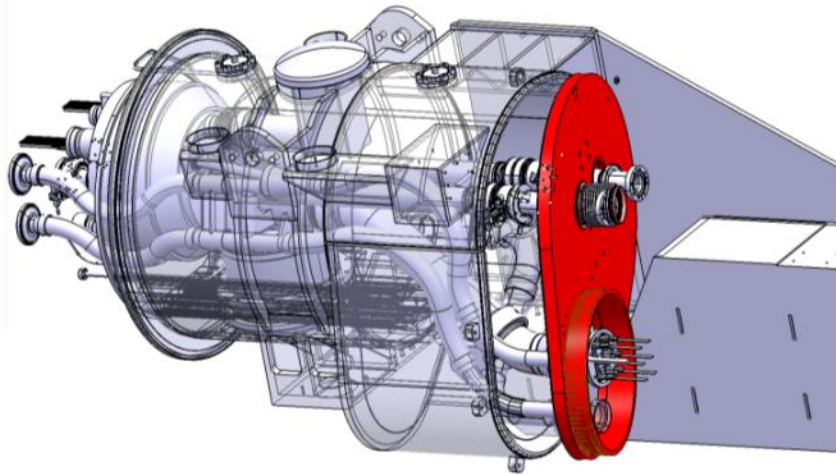
In situ access by cutting the end door: possible solution

Gimbal patching
(Rigid assembly)

- Very limited space to cut/weld the door
- Cutting and welding of beam pipes to be done in very difficult position
- Leak tests of beam pipes?
- Extreme very difficult work positions
- Safety to be assessed

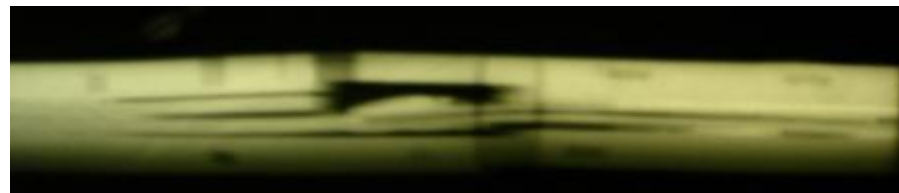
Sample 2A right (43 $\mu\Omega$)

R-8 measurement : top ten outliers
