RF Related Issues Encountered during over 15years of Operation of SPring-8

Shigeki Sasaki,
SPring-8/JASRI

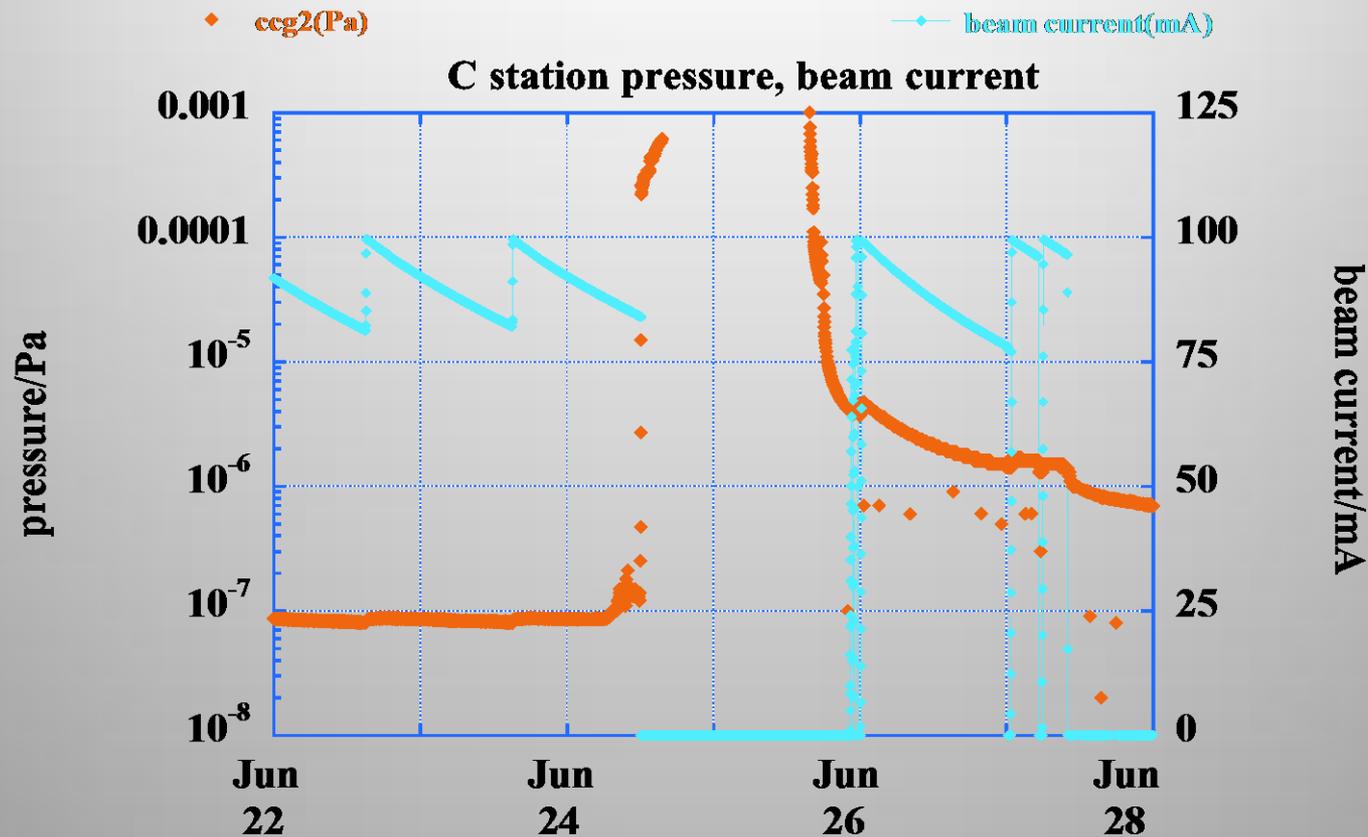
water leak into vacuum from SR absorbers in 2001

- sudden pressure rise → beam abort
- main component of the gas = H₂O
- water leak from absorber_2
- replace with spare
- 36 hour of down time

2001: Water leak from the absorbers for RF cavities to the vacuum area

SR lights pass the cooling channel and the chemical reactions with copper and the oxygen occurred, and the copper was eluted
Absorber wall thinned and finally the water leaked through holes

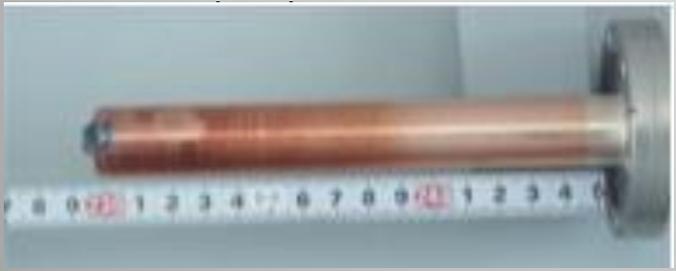
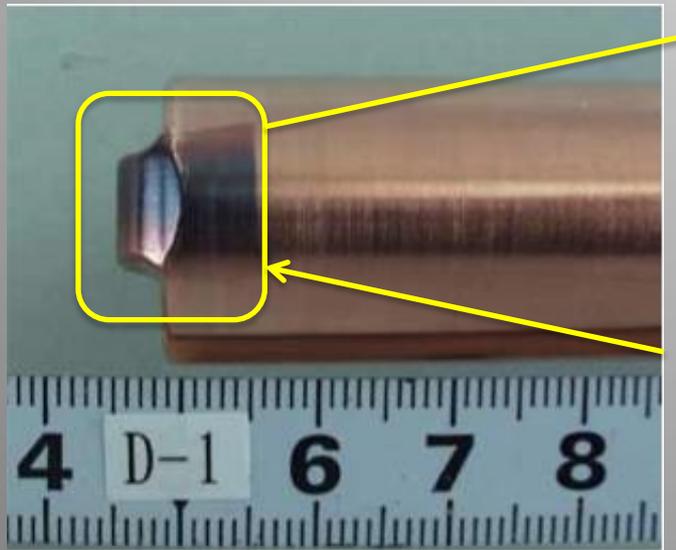
SR pass through the cooling water

OFHC+H₂O+SR → corrosion?

Absorber No.	Power density
1(Cav#1-#2)	2.55kW/cm 2
2(Cav#3-#4)	1.60kW/cm 2
3(Cav#7-#8)	1.06kW/cm 2

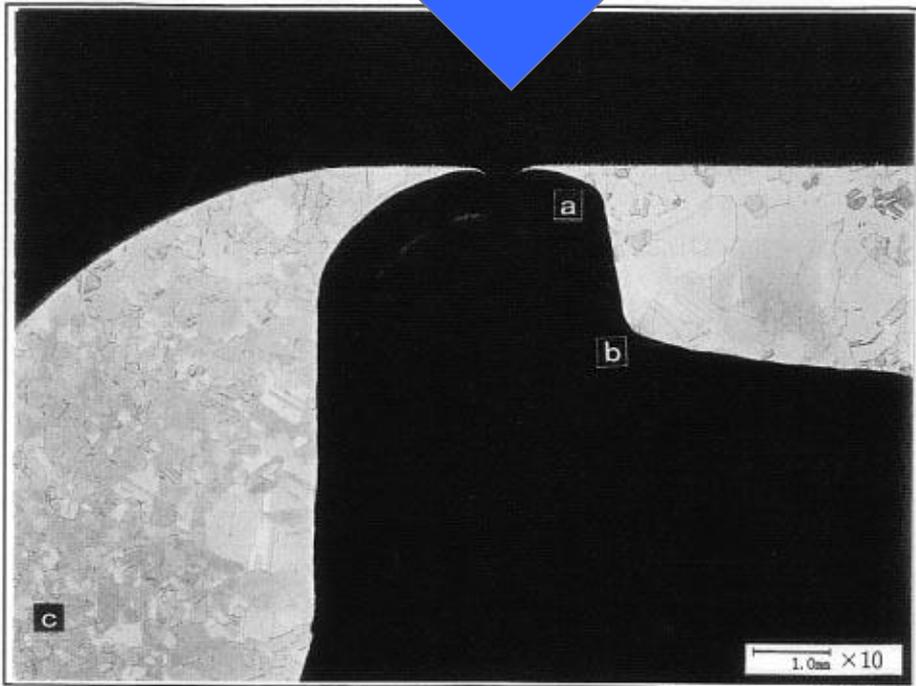
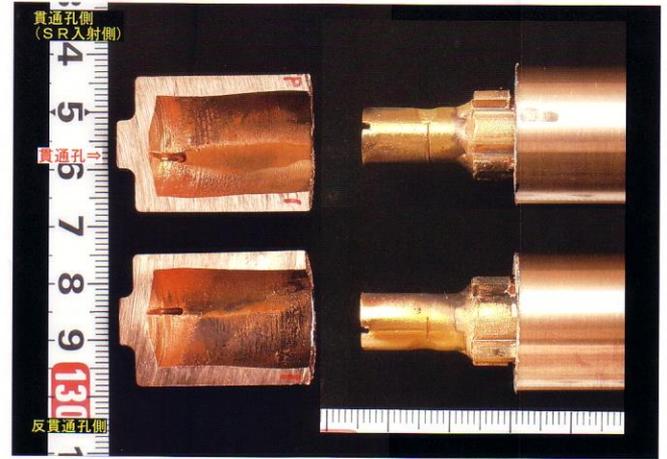
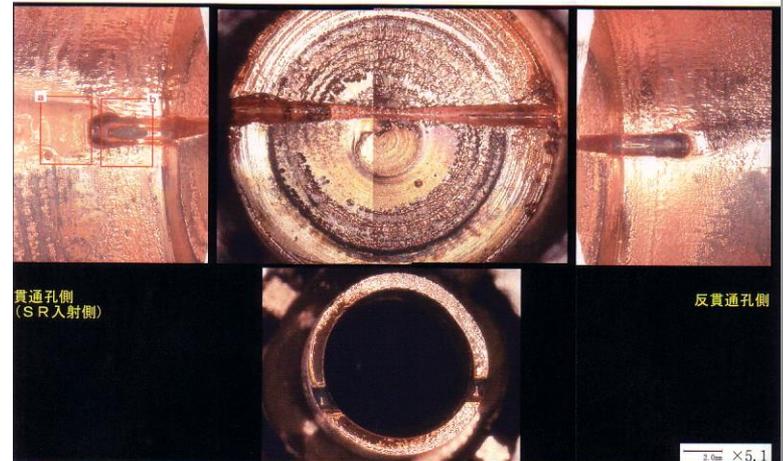
損傷全体

(SR入射方向↓)

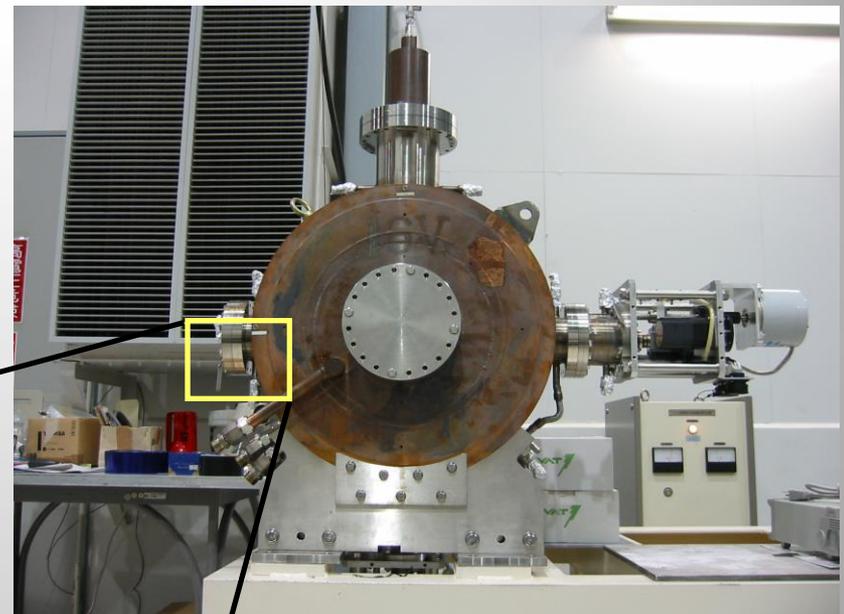
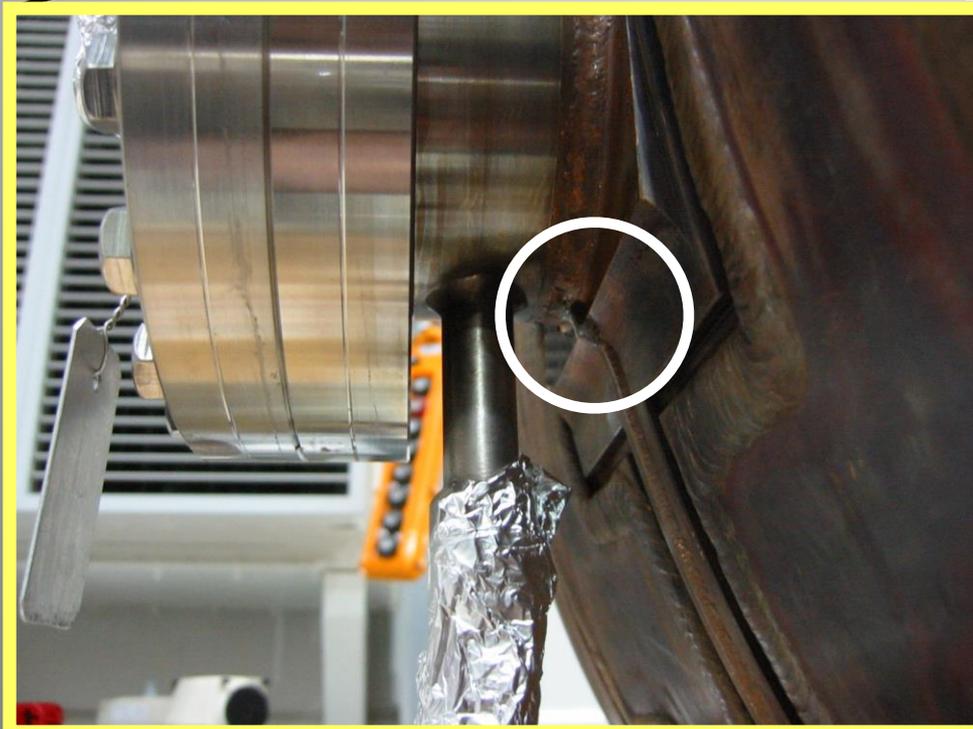
leak part of a
cavity

- vacuum leak from 3 cavities (electron beam welding type)
in the summer 2002 : temporary treatment with vac-seal
- manufacture 8 cavities with diffusion welding (- Jun 2003)
- High power test (Apr. – Jun. 2003)
- installation, tuning, putting into operation (Jul. – Aug. 2003)

vacum leak from the joint part of
tuner port junction with electron
beam welding

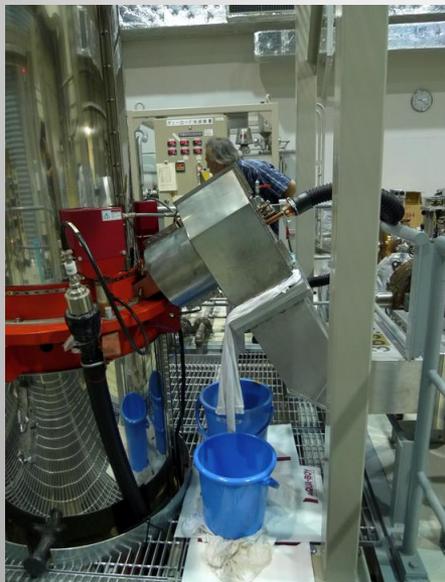
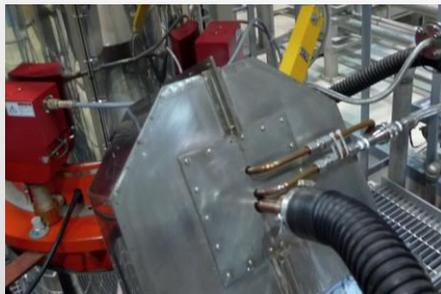
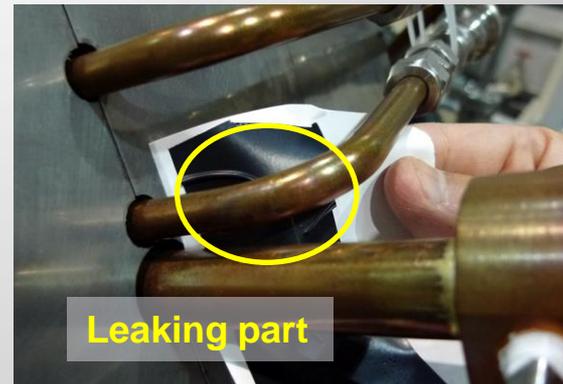
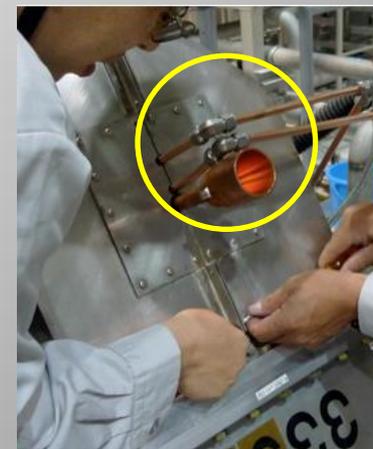
2010-11: water leak from the cooling pipes of klystron output windows

The water flow was more than necessary
(10L/min \rightarrow \approx 3.3m/s, \varnothing 8-mm pipe)
Water hit the pipe wall at the corner like point of
the piping configuration

The flow was lowered to the adequate level
($<$ 1.5m/s)

Some of the pipes were replaced
Klystrons were replace one by one

The water pipes were
replaced with angle joints
turning parts of the cooling

This part is hard to be repaired
Klystrons were replaced one by one, if the pipe
swellings were found before occurrence of leak

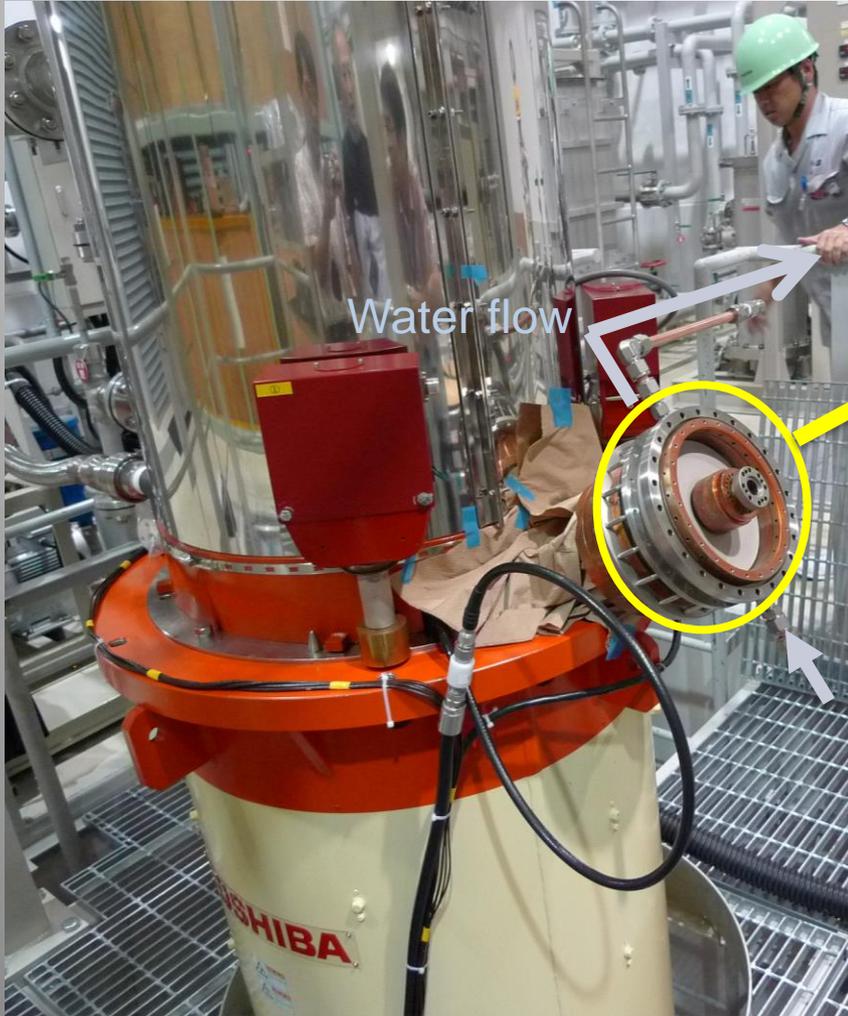
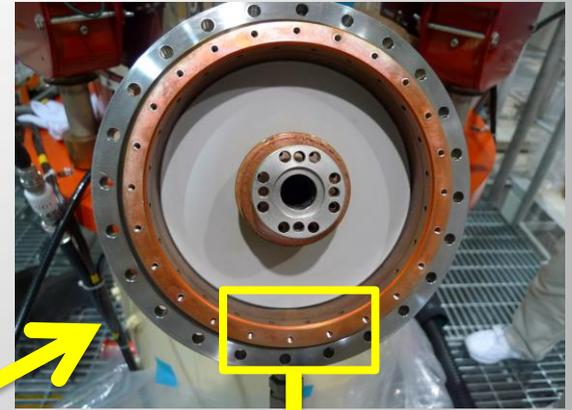
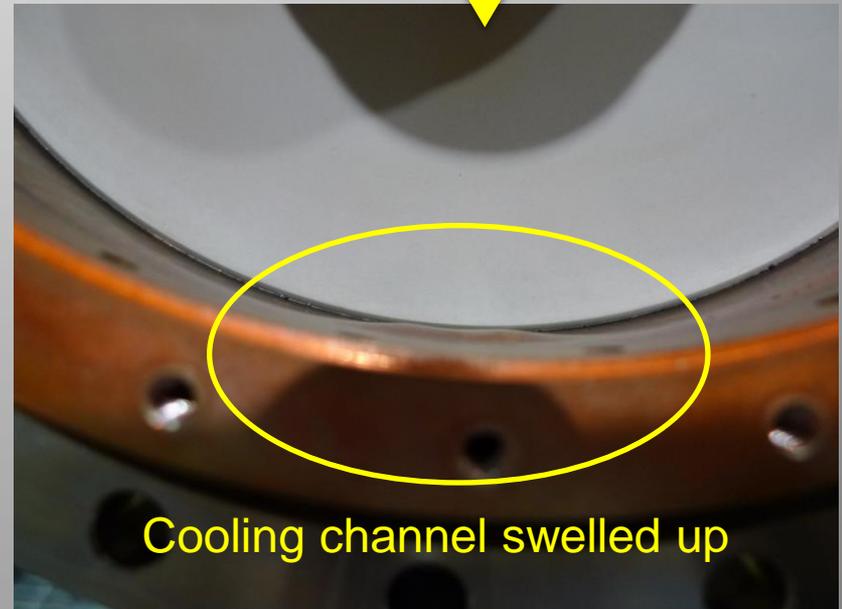
Aug.17, 2010: A pinhole was found at the output window of Bst klystron.

Aug. 20, 2010: Turbid water flowed from the cooling channel of the klystron when the cooling channel was disconnected for replacement of the klystron

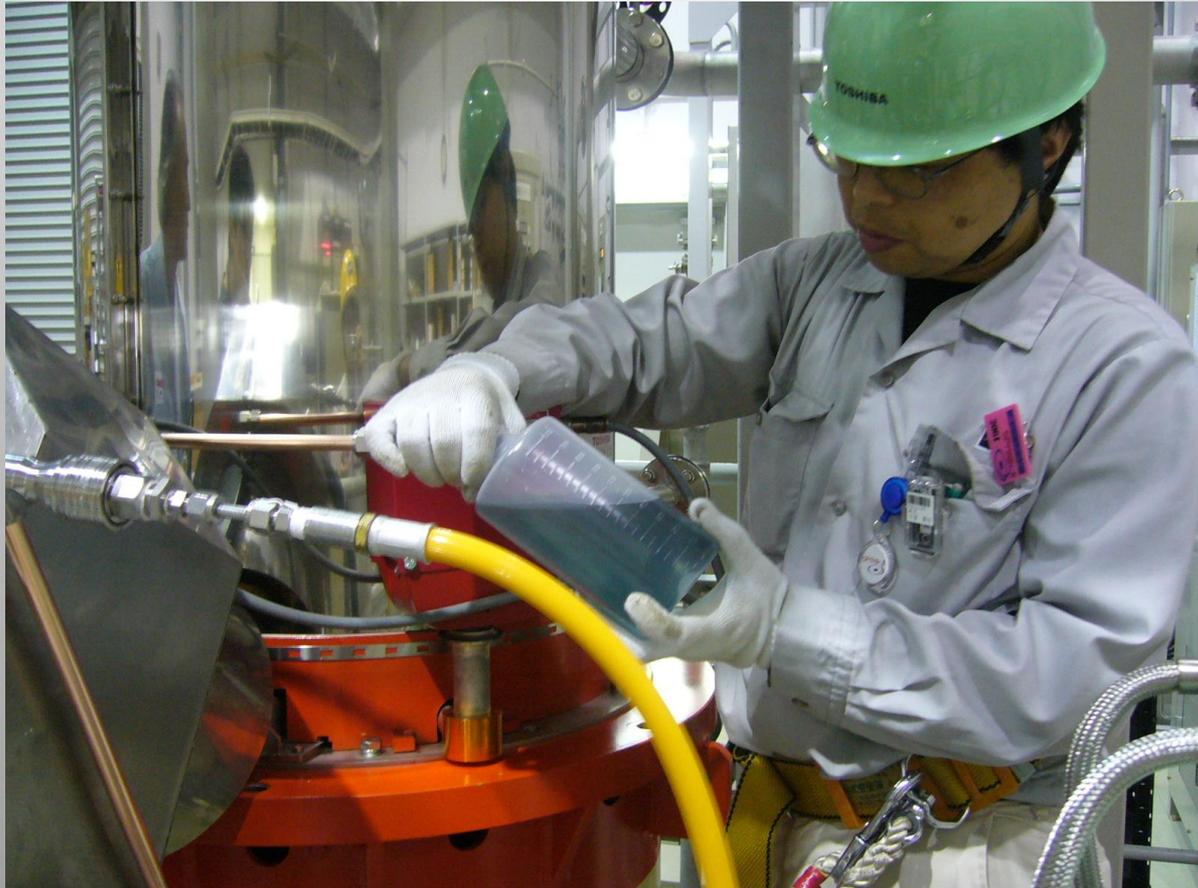
possibility of oxidation during the shutdown
after the circulation of cooling water stopped

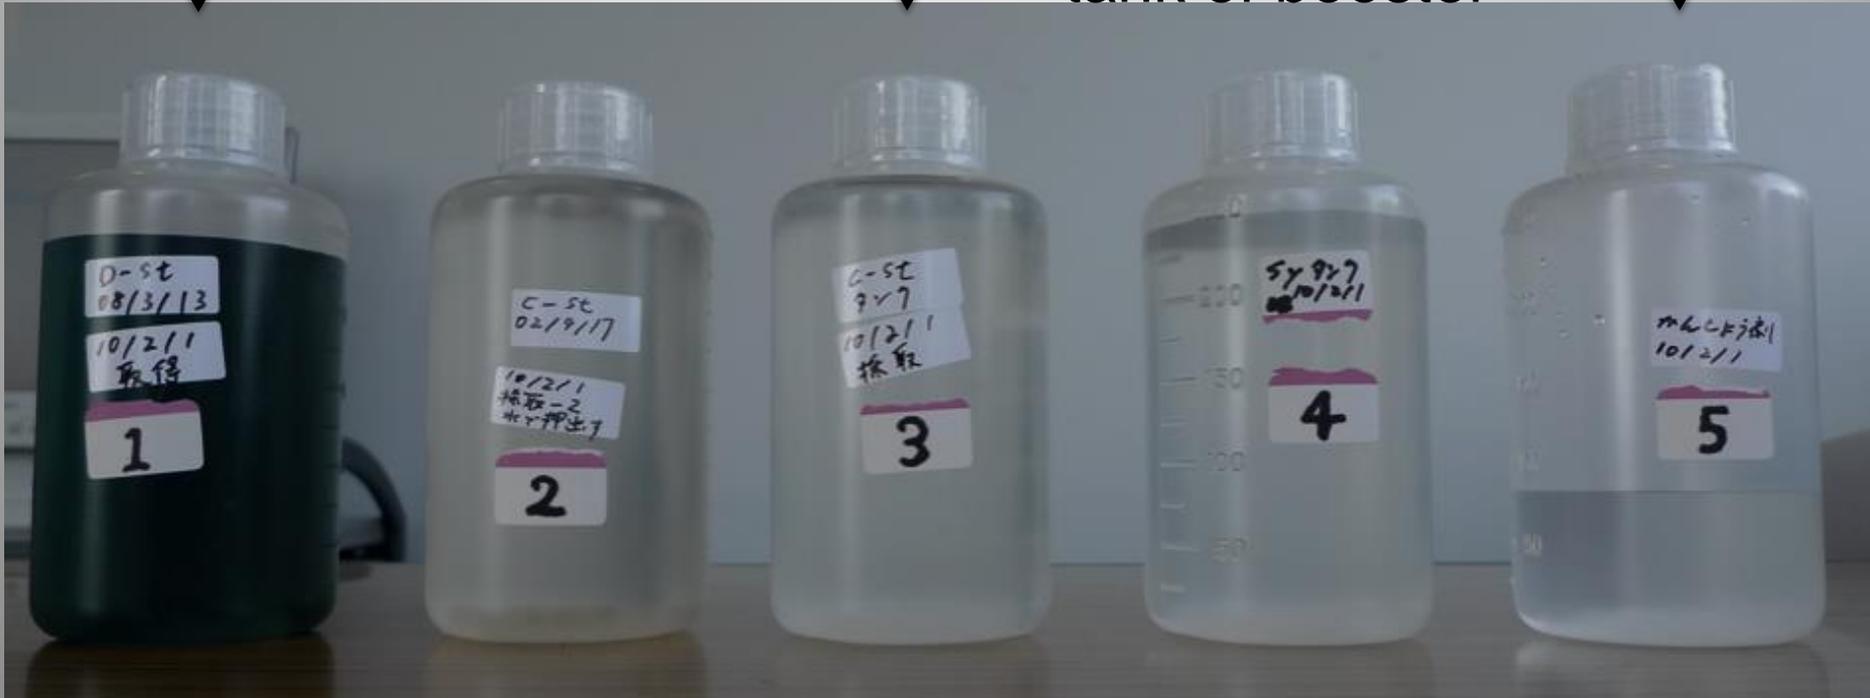
water in tanks are clear.

water in one of stocked klystrons is suspended

does not depend on the period of storage

quantity of No1 sample water was small? air coexisted? was not filled with water?

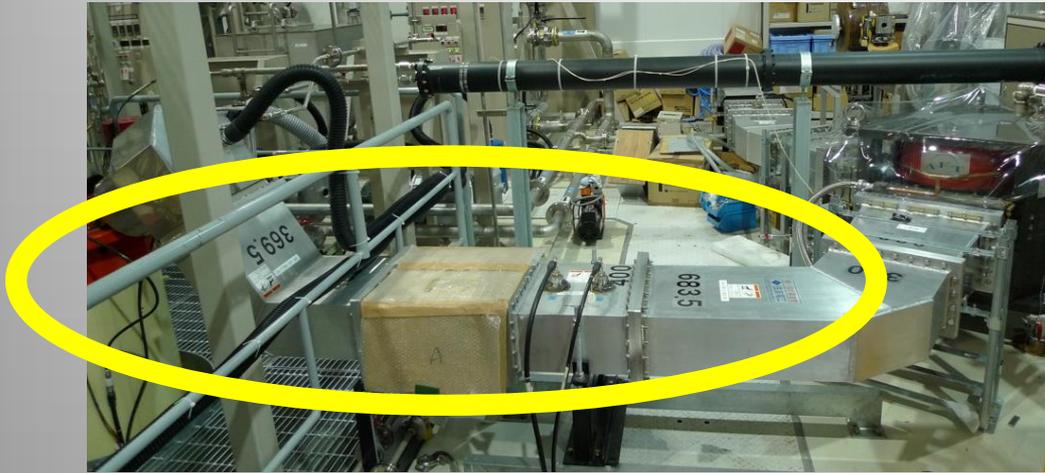
Water leak from output port of a klystron (Ast No.2), in 2011

water stood whole the area of the wave guide

Apr/11 : Interlocks

Cathode voltage failure, anode over current, repeated klystron arcs

possibility of water leak from RF window, made appearance check without finding a leak halt operation of A-2 klystron

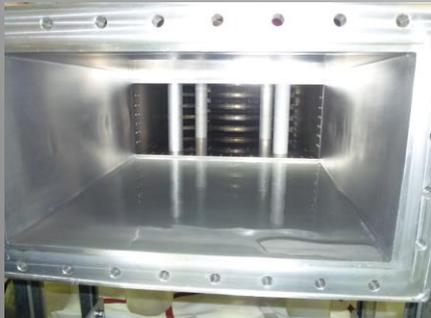
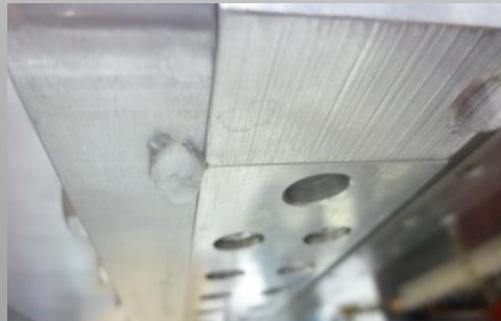
detected leak at the joint part of the circulator
a small step at the entrance of the circulator
→ circulator no exposure to water

Water leak from waveguide connection part of the circulator

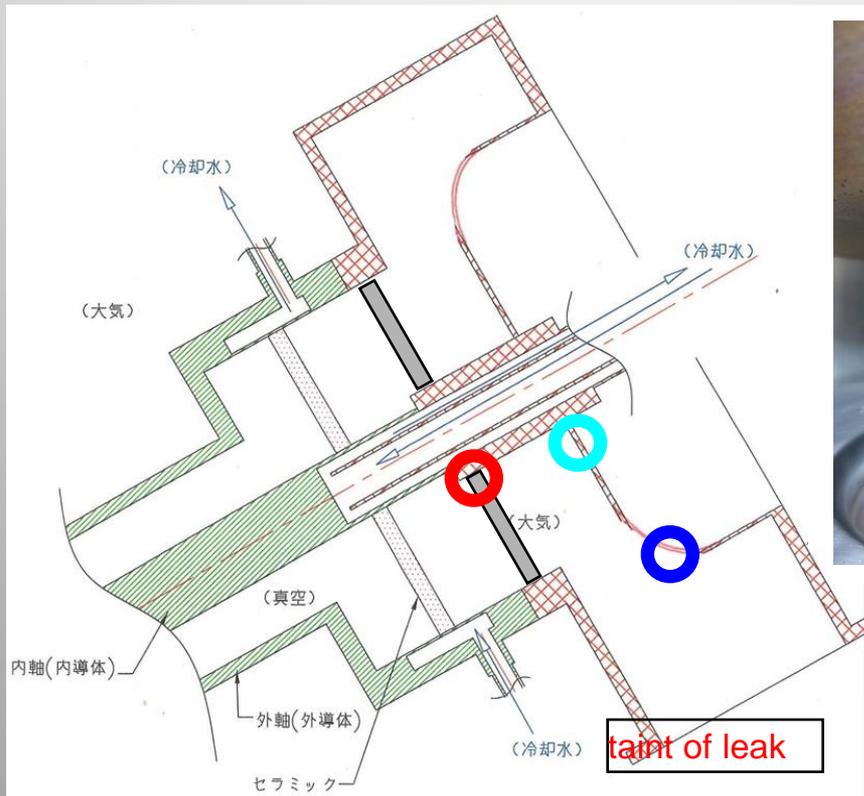
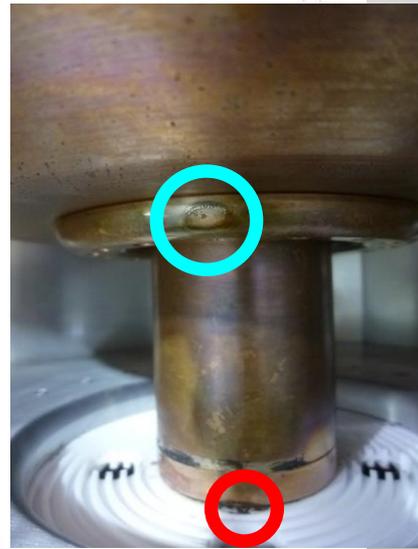
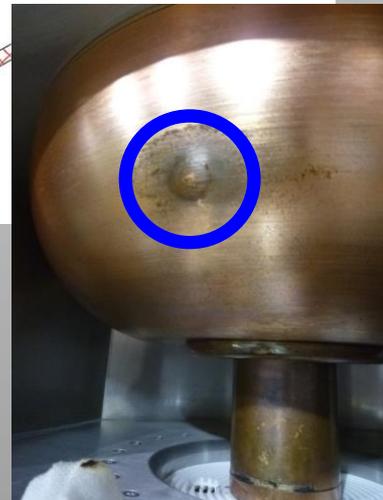
disconnect the wave guide and inspect inside
could not identify the leak source between the klystron and the circulator
stop supplying water to the window
→ stop leak
concluded leak from the output window part

Replace the klystron
brazing part of the inner conductor of the
coaxial structure
