Paul Scherrer Institut Markus Schneider

Status of the rf-system for the high intensity proton accelerator facility at PSI

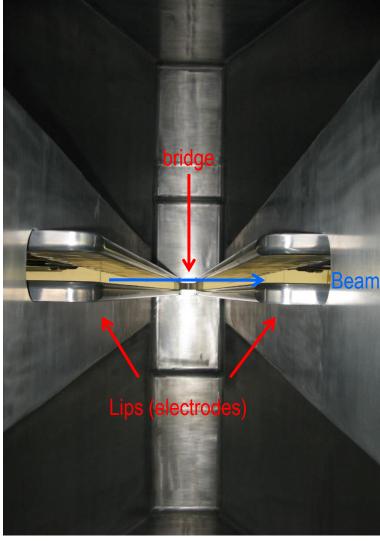
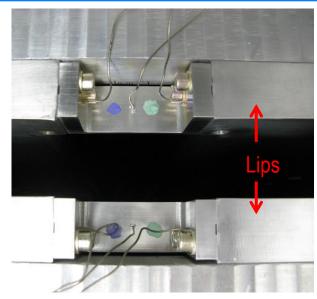
### **Bridge between lips of Resonator**

Inside Resonator 2 towards center of cyclotron

Bridges with thermocouples

Arcing during power tests  $\Rightarrow$  bad contact

Bridges are getting to hot redesign

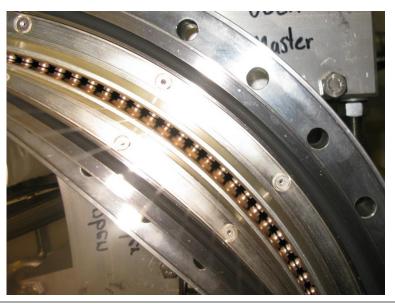
#### Gold plated tuner after power tests

Gold plated tuner was tested under power. Final tuner design in production. Assembly summer 2014

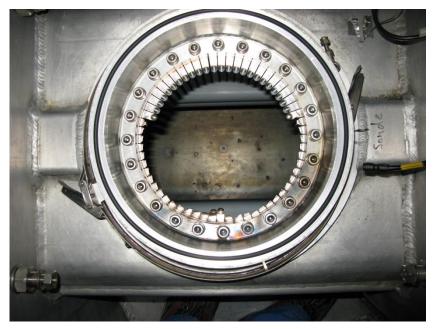
25. September 2013 Called in: Problems to get flattop cavity on nominal voltage

Many events on probe at coupling loop  $\Rightarrow$  Status of ceramic at coupling loop ??

Burned finger contacts at cavity opening for coupling loop

Venting the machine for change of coupling loop, but.....

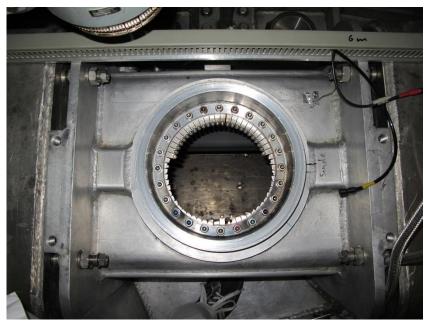
- 27. September 2013 Finger contacts and coupling loop replaced Conditioning of cavity at about 480 kVp gap voltage start of getting events on probe at coupling loop Over night run at 300 kVp
- 28. September 2013 450 kVp for short time, event on probe at coupling loop after that only 200 kVp achievable.  $\Rightarrow$  venting the machine and inspection of coupling loop

2nd time burned finger contacts

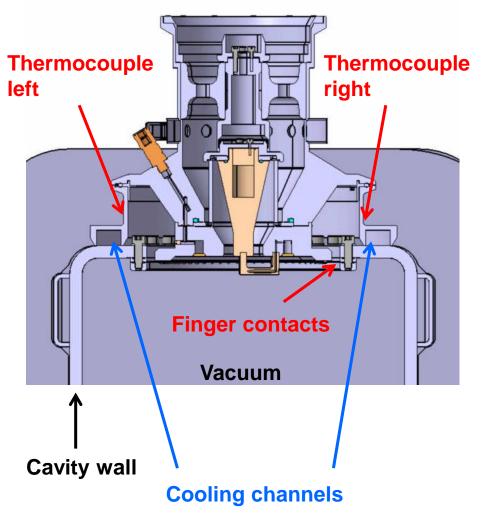
Cross-section of coupling loop on flattop cavity

Temperature rises on right side faster than on left side of coupling loop. This matches to the arrangement of the molten finger contacts.

Change of main magnetic field of cyclotron has an impact on temperature on the right side of the coupling loop !

Last set of finger contacts installed. New coupling loop installed. Cooling channels checked for sufficient cooling.

Installation of two Thermocouple close to finger contacts.

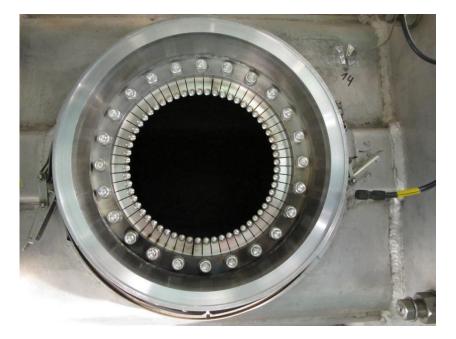
11. November 2013 temperature rise on coupling loop  $\Rightarrow$  take out coupling loop

Oil found under cavity  $\Rightarrow$  oil leak on hydraulic tuning system ?

Finger contacts intact, but hanging down

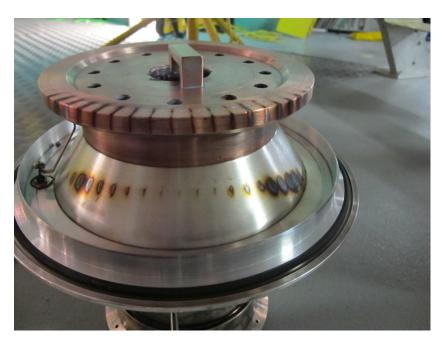
Shadows on coupling loop

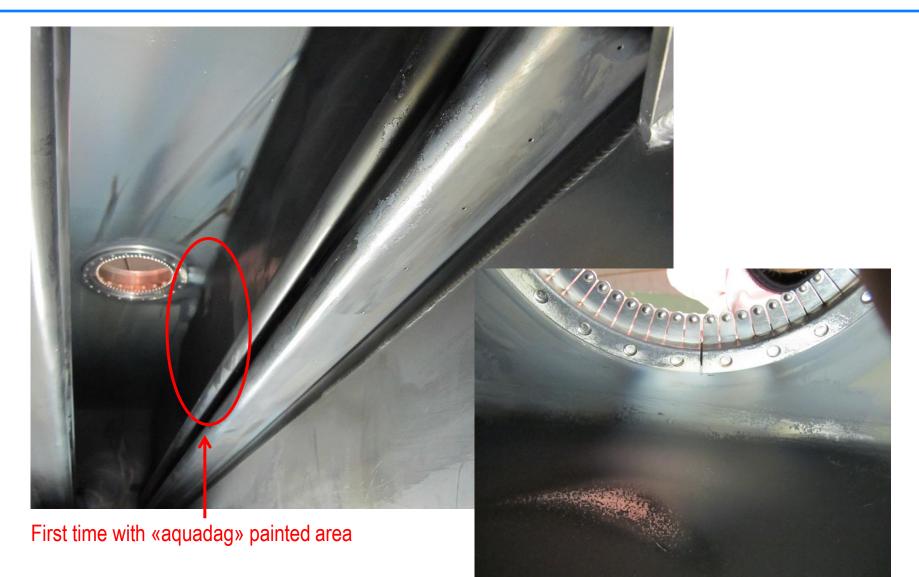
## Inspection of flattop cavity

Again spot on cavity wall close to coupling loop

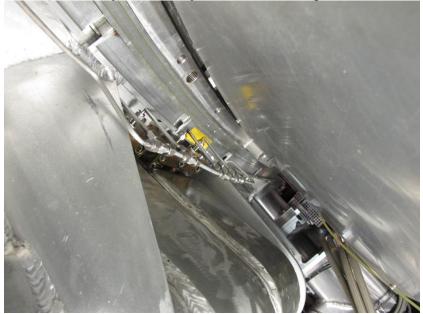
#### Clamp with hydraulic system for tuning

Hydraulic bellows replaced on oily clamps Old bellows are bent and stretched

But no oil leak found

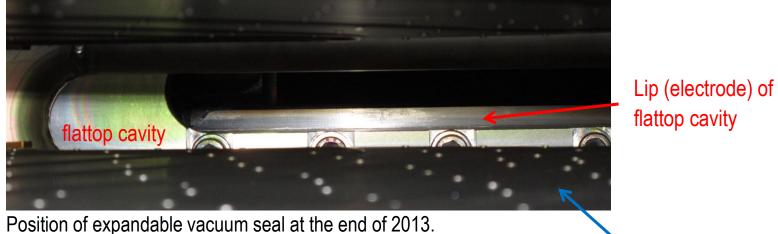
## View through sector magnet 6 toward flattop cavity

Lifted position of expandable vacuum seal after shutdown 2014

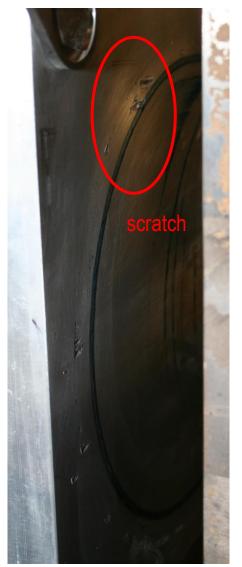
Cavity surface for vacuum seal

Vacuum leak on lifted expandable vacuum seal.

Viton O-ring on cavity side replaced by glued square – ring from chloroprene elastomer  $\Rightarrow$  lifetime in this area unknown (radiation)

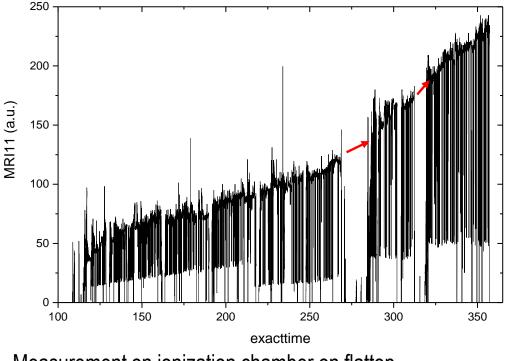
Measurement on ionization chamber on flattop cavity during 2013

Still same behavior in 2014 since shutdown

- Have a closed look on temperatures on cavity (new interlock system already installed)
- Further measurements with ionization chamber
- Planing or polishing of cavity surface for vacuum seal to get ride of scratches. For this action cavity has be take out of cyclotron and bunker. ⇒ task for shutdown
- Improvements on expandable vacuum seal to avoid scratches on surface of cavity (rf-shielding ?)
