Power Converters Availability for post-LS1 LHC

TE-EPC-CCE

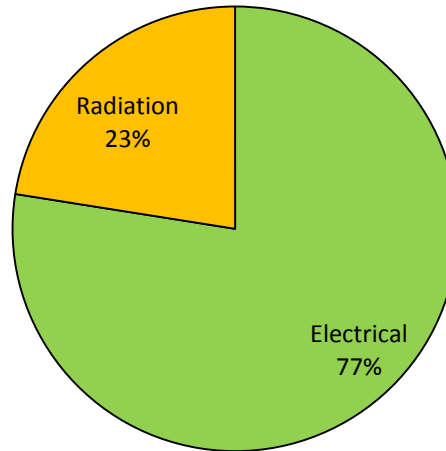
Failures due to radiation

Date	Title	Area	Event type	Caused by SEE	Beam dump	Equipment	HC fill
08/11/2012	PC SEE Problem: 15h in RR53 AC-DC of 600A	RR57	hard SEE + Access	YES	No	PC 600A Aux. Supply	3272
08/11/2012	SEE fault on 120A	RR53	soft SEE + Access	YES	Yes	PC 120A	3272
30/10/2012	Power converter	RR73	hard SEE + Access	YES	Yes	PC 600A Aux. Supply	3240
27/10/2012	another SEE on PC	RR13	hard SEE + Access	YES	No	PC 600A	3231
26/10/2012	Trip of RCBXV3.R5 (power converter)	UJ56	hard SEE + Access	YES	Yes	PC 600A Aux. Supply	3223
23/10/2012	Trip of power converter RQT12.R1B2, dump	RR17	hard SEE + Access	YES	Yes	PC 600A	3212

600A Power Converter (14/15 events)
 Single Event Burnout of an AC-DC power supply
 Detected in the R2E Project framework and fixed by TE-EPC-LPC

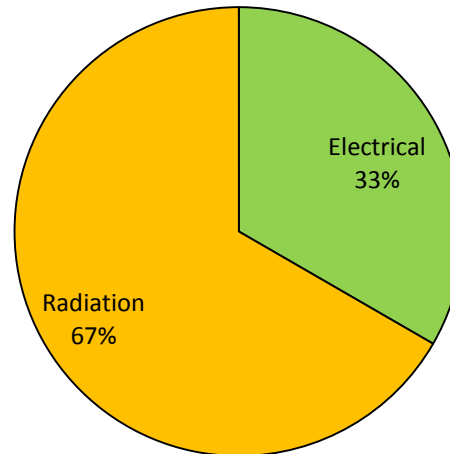
Failures due to radiation

Date	Title	LHC point	Area	Event type	Caused by SEE	Beam dump	Equipment	LHC fill
27/10/2012	Power Converter SEE	Point 7	UJ76	soft SEE	YES	Yes	PC FGC COD	3231
03/10/2012	FGC problem on 60A	Point 6	ARCs	soft SEE	YES	No	PC FGC COD	3128
07/09/2012	Power converter	Point 5	UJ56	soft SEE + Access	YES	Yes	PC FGC Generic	3036
08/08/2012	FGC Problem on 18L1	Point 1	All	soft SEE	YES	No	PC FGC COD	3142
22/07/2012	Power converter	Point 4	ARCs	soft SEE	YES	Yes	PC FGC COD	2870
17/07/2012	Power Converter	Point 5	ARCs	soft SEE	YES	No	PC FGC COD	2852
28/04/2012	Power-Converter RPLA.28L8.RCBV28.L8B1	Point 8	ARCs	soft SEE	YES	No	PC FGC COD	2565
19/04/2012	Power-Converter RPLA.18R7.RCBV17.R7B2	Point 7	ARCs	soft SEE	YES	No	PC FGC COD	2534
16/04/2012	FGC problem on RPLA.18R7.RCBV17.R7B2	Point 7	ARCs	soft SEE	YES	No	PC FGC COD	2520
10/04/2012	Power-Converter RPHGB.RR17.RD2.R1	Point 1	RR17	soft SEE	YES	No	PC FGC COD	2498
