MICE Target Mechanism CM38 – Napa Valley

P J Smith on behalf of the MICE target team

Target Mechanism

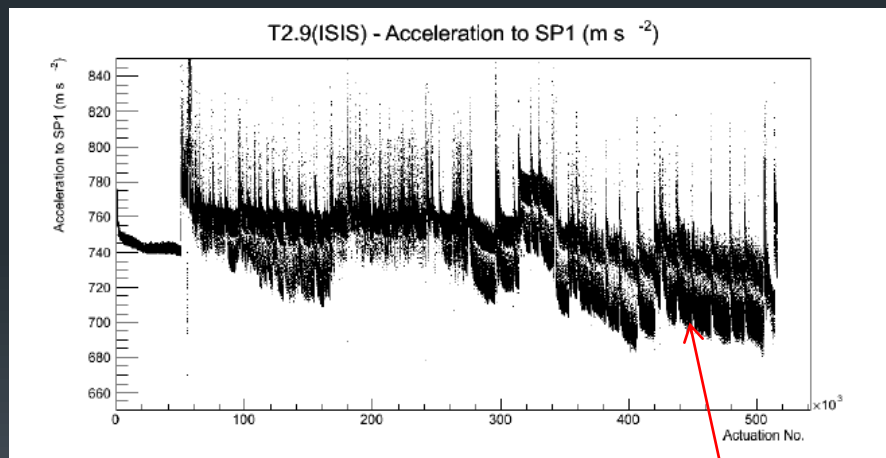
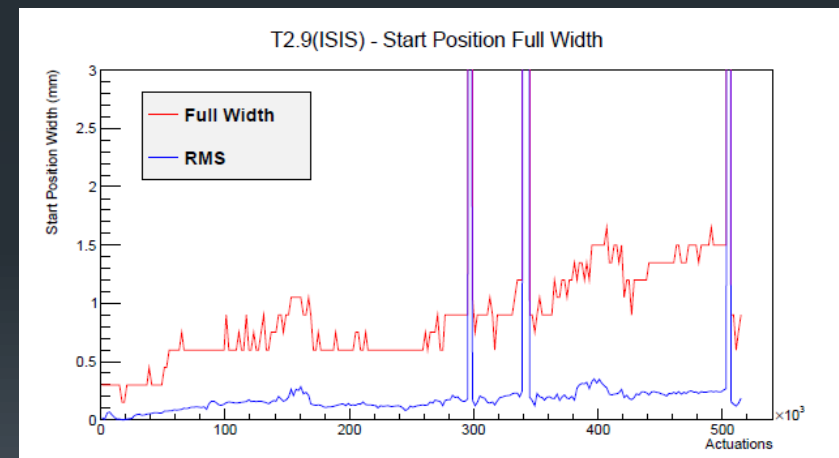
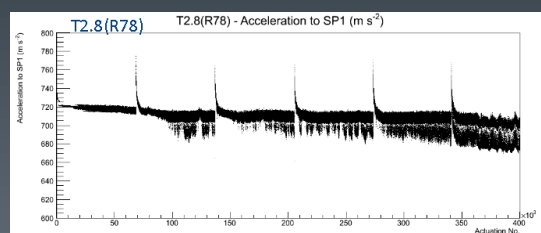
This change to a double band structure is typical during wear

T2.8 - In R78 ran for 1m (500k shown)

The start position is one indicative measure of wear. We like to see the full width <1.5mm.

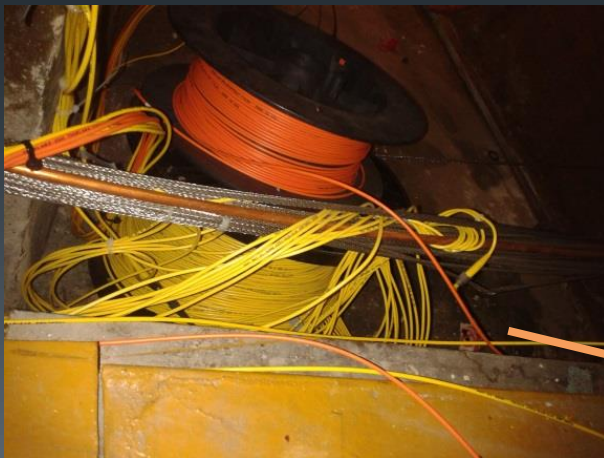
The cables did not follow the prescribed route and consequently there was a significant excess of cable that was left stored underneath the dipole just behind the target.

Excess fibres stored underneath the dipole behind the target. This is not what it was planned to look like!

- 1) A critical case for re-installing the fibres as per the original plan – the plan deviated significantly in the synch.
- 2) That there should be twice as many fibres laid as are required to give a significant number of spare channels in case of accidental damage to the fibres .

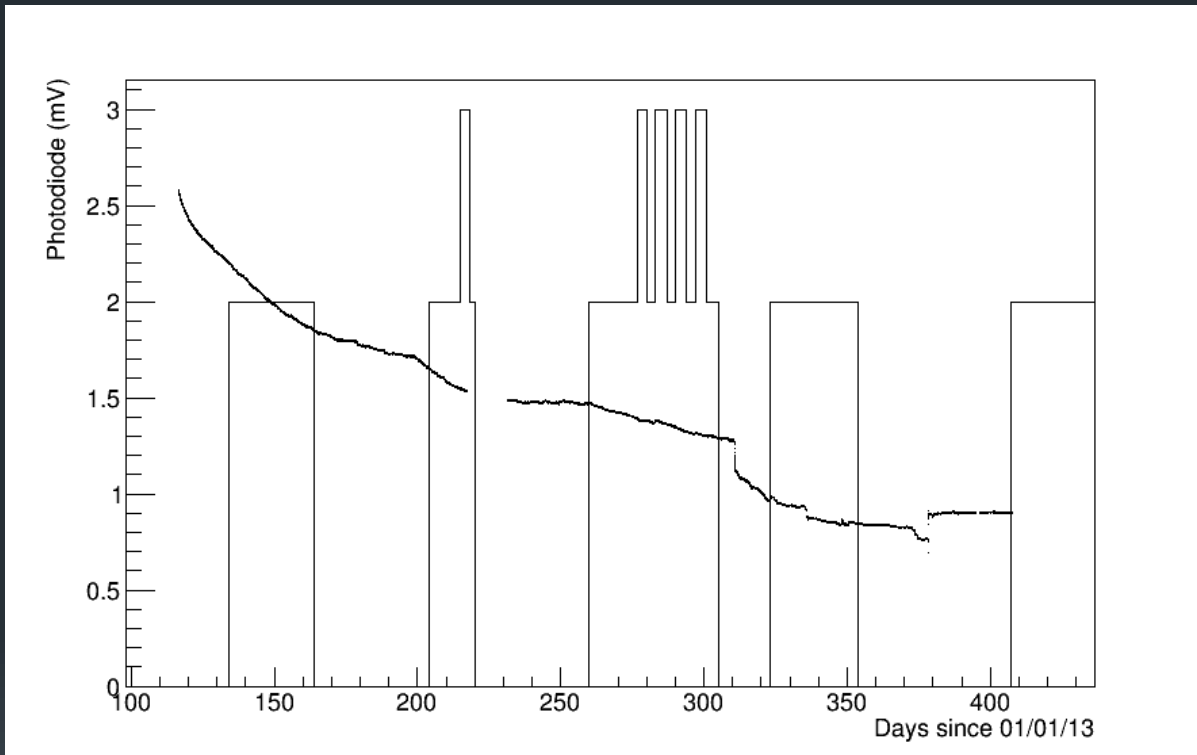
Loopback Test results: Still Running. Loopback is at the end of the long fibre runs and does not include patch cables at synch end.

The cause in the drop of the signal over time is unclear. Not necessarily rad damage but justifies the need to monitor signals.

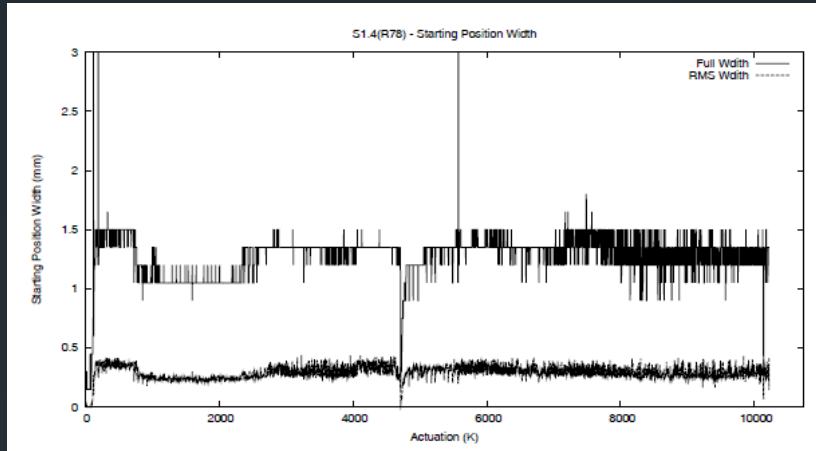
Starting position for the target remained consistent throughout the run.

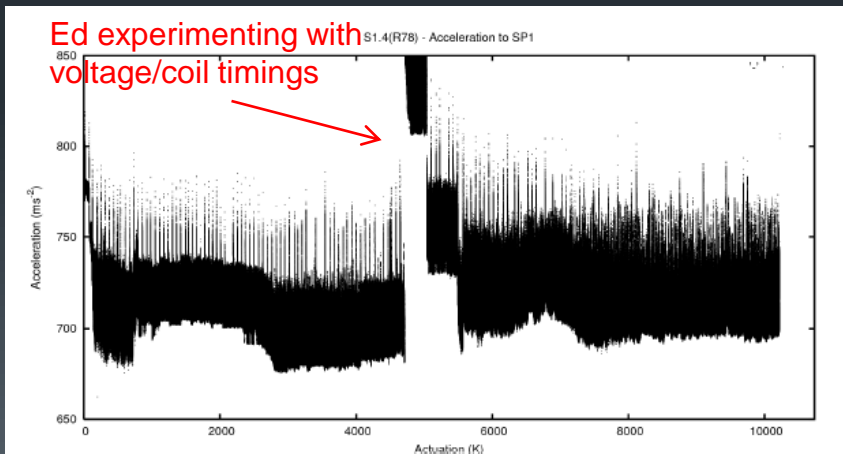
Acceleration broadens slightly but it looks consistent. (Perhaps it even improves with age like a good wine!)

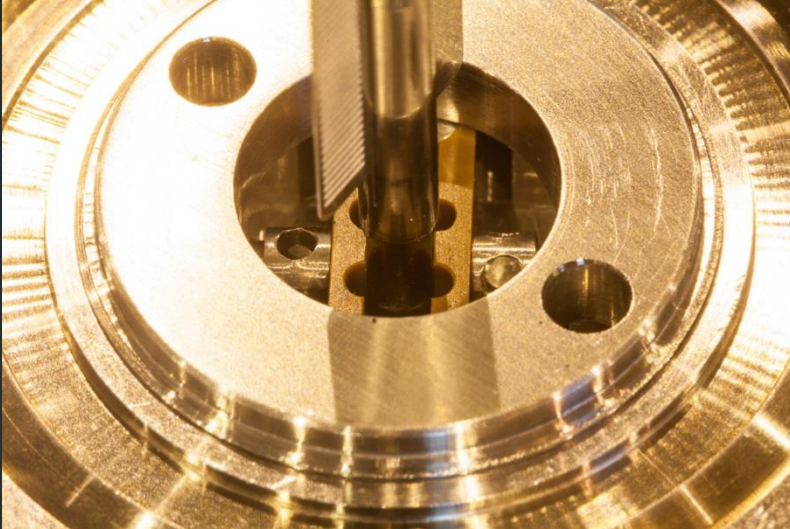
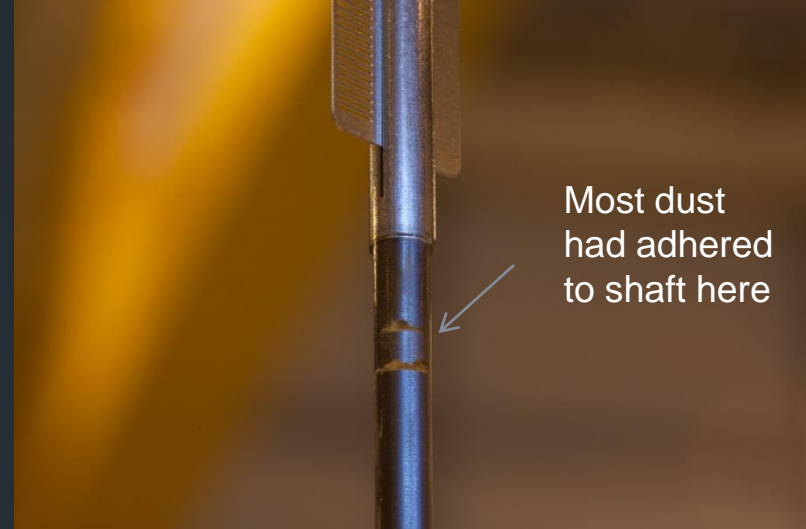
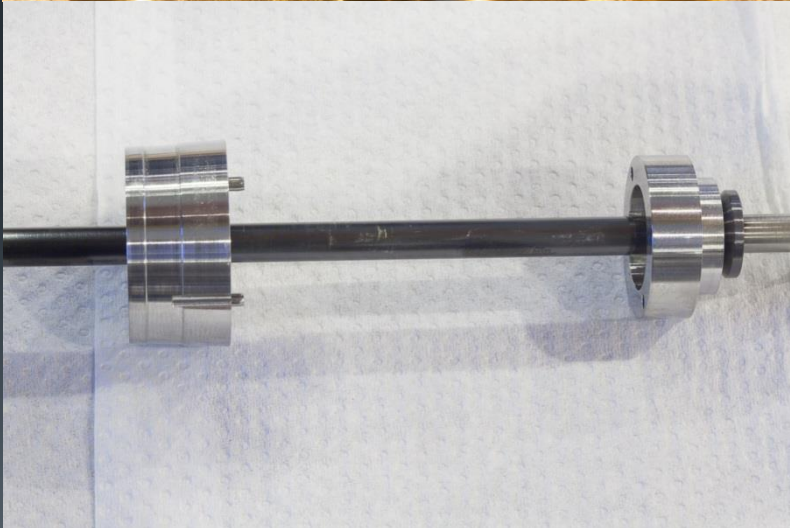
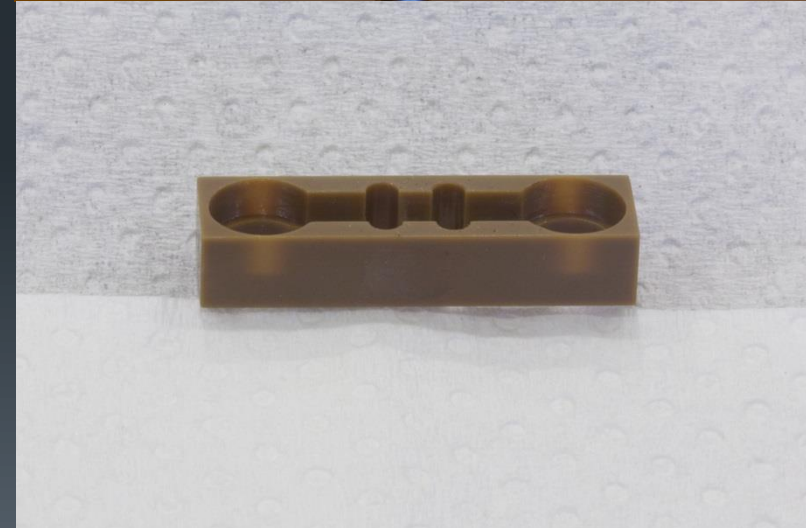
10 million actuations. Very Clean. No migration of any dust below the mechanism. Important milestone and if repeatable has implications for operations.

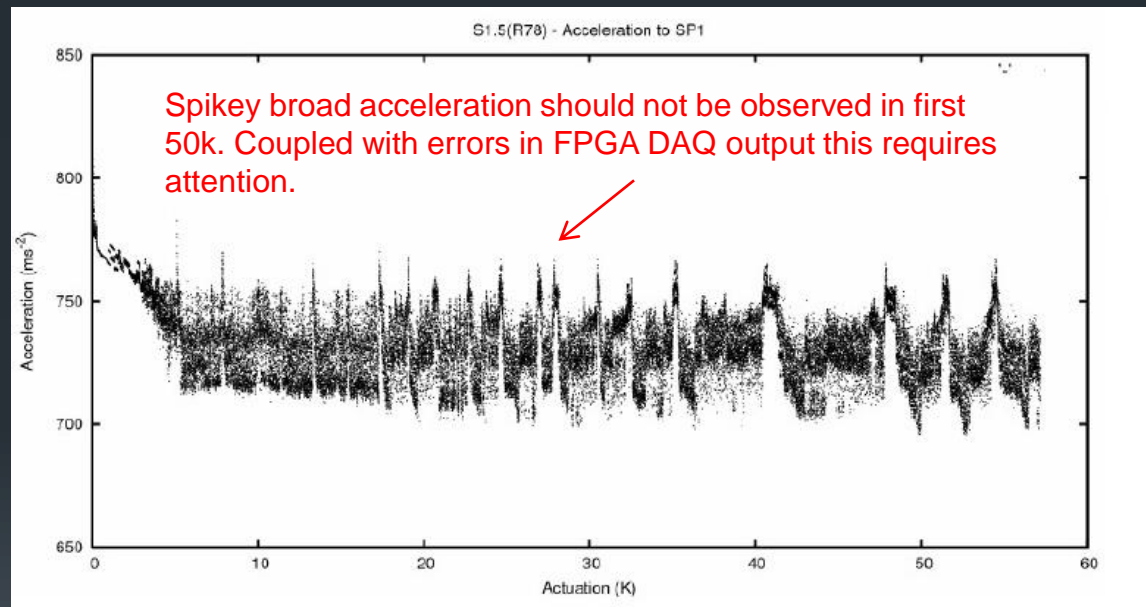
On the basis of the success with 1.4 we refurbished the target and set it running again in late Jan 2014. However, from the DAQ data it was clear that something is not quite right with this run. Stopped at 750K.

We disassembled the target on 19/02/2014 to take a look but nothing obvious was found. The target was refitted with new bearings and is now running again. Too early to draw any conclusions.
