Elettra Booster Power Converters Refurbishment

"A Year-Long Challenge"

R. Visintini

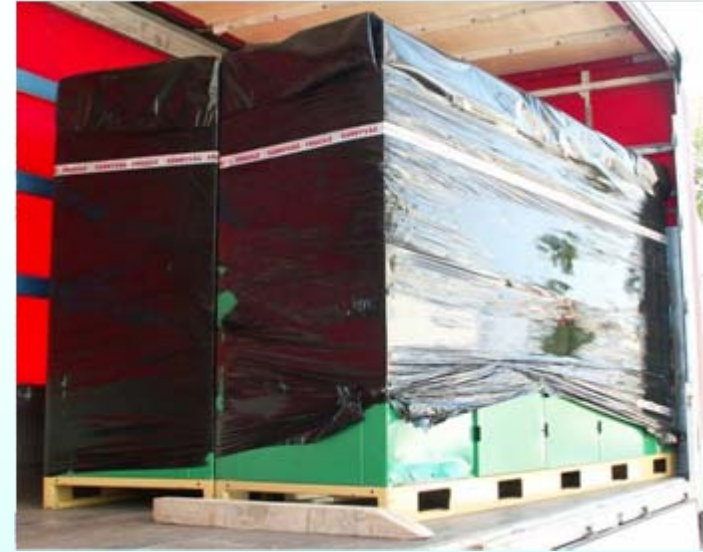
...damaged due to transportation!

- A dedicated shipping was not chosen
- Insufficient protection for a multiple carrier shipping - the cabinets were loaded and unloaded on trucks at least three times.
- Damages both outside and inside the cabinets

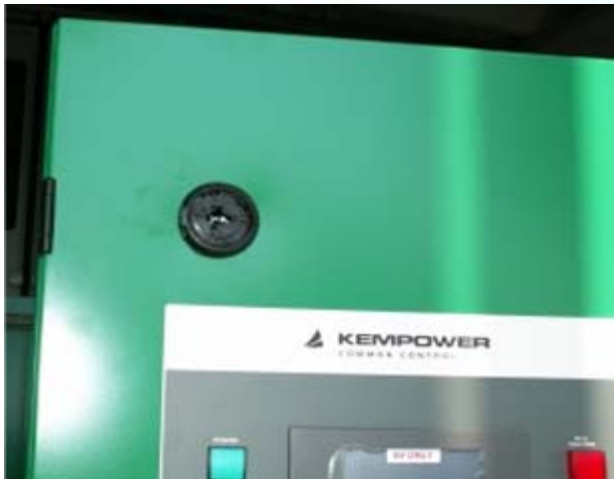
Broken CB Handle

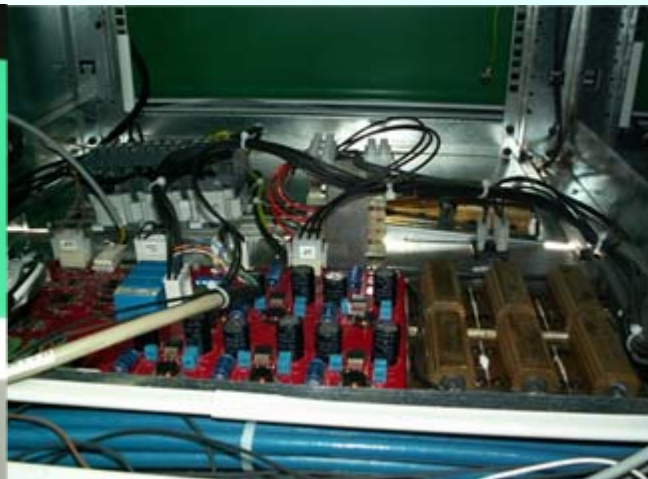
Bottom plates lifted up

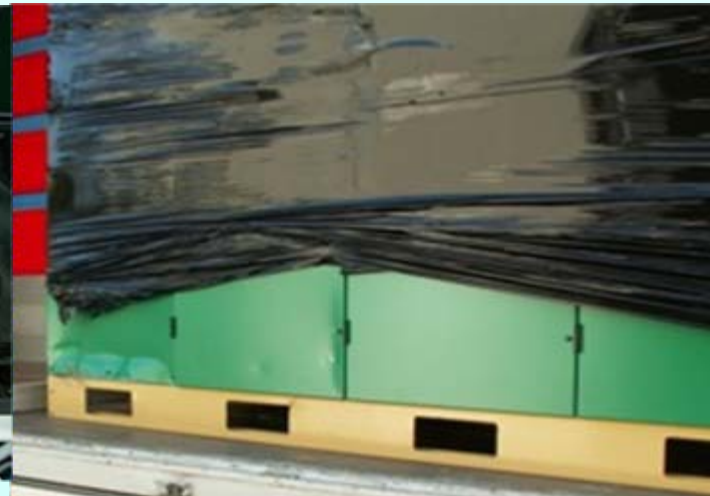
Bumps & scratches on sides

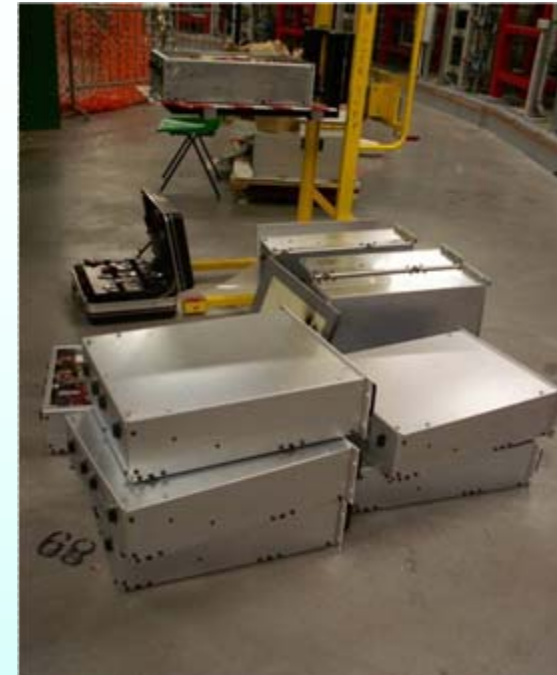
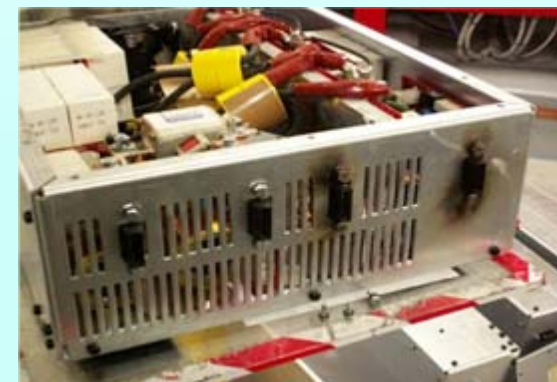
Status - Major Faults on Dipole PC

- During normal operations at 2.0 GeV a large number of output modules (a.k.a. DC/AC) on one Dipole Power Converter went in fault (April 17th, morning).
- First attempt to put the PC operational - removing the apparent cause and replacing the broken units - failed: more units damaged.
- Still investigating on the real causes of the failure:
 - ❖ Spurious turn on of IGBTs in the same leg of conducting ones
 - ❖ Wrong PWM pattern due to EM noise that influences the FPGA inside the control cards
 - ❖ ...
- Similar fault occurred again after the (scheduled) intervention of Kempower following the Refurbishing Program

- Moved the magnets' connections to the still working converter and put the loads in series → peak current limited to 1 GeV
- Operate the Booster at 1.0 GeV, trying to inject into the SR and then ramp the SR to the final energy

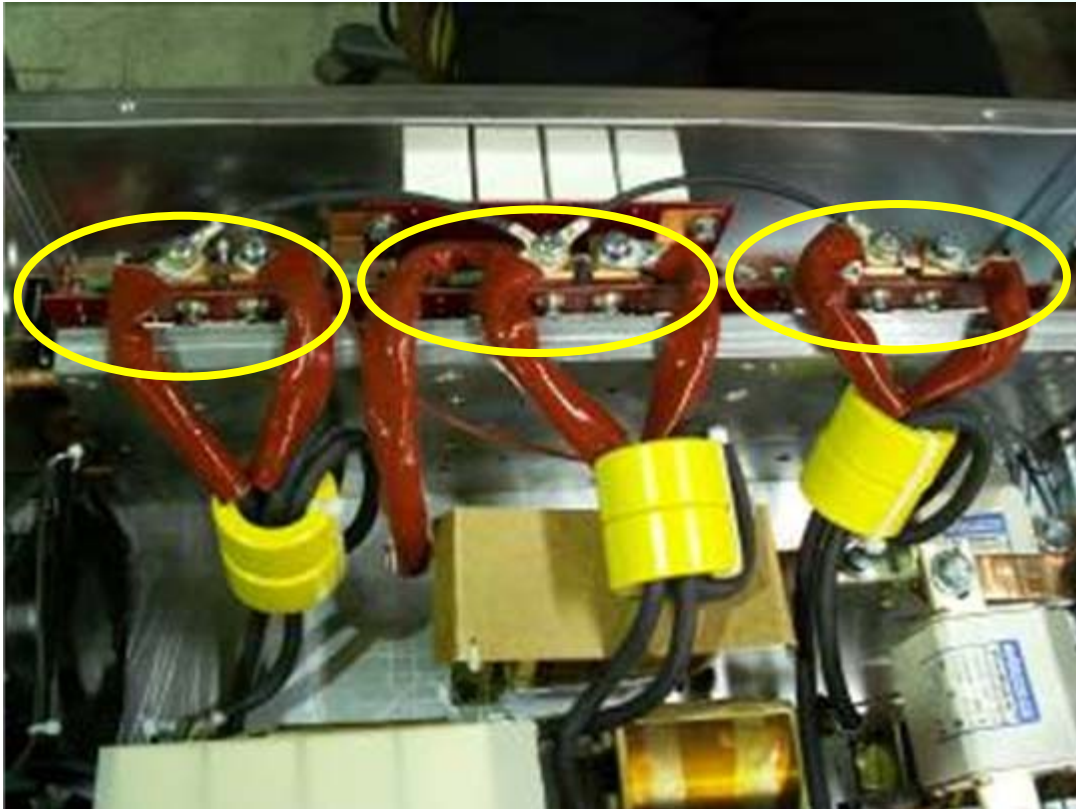
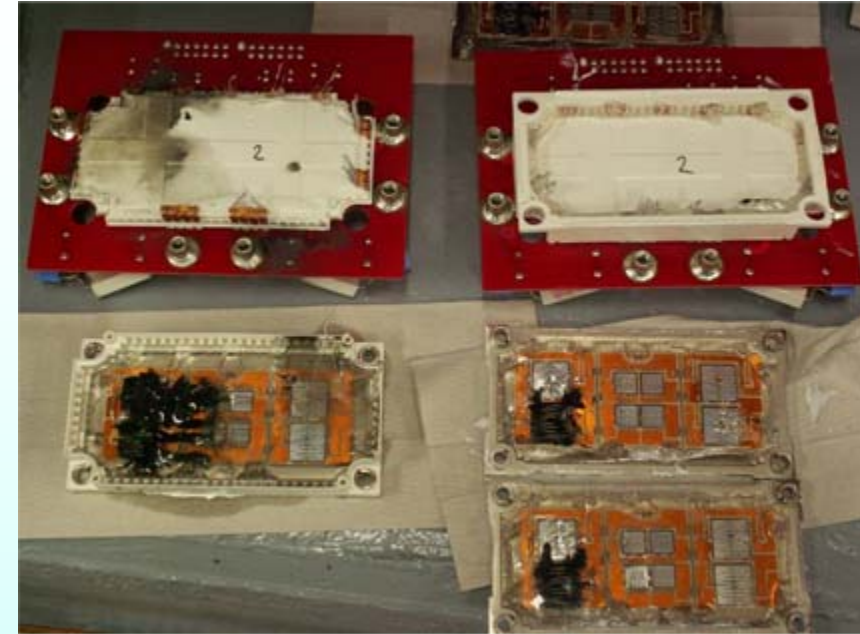
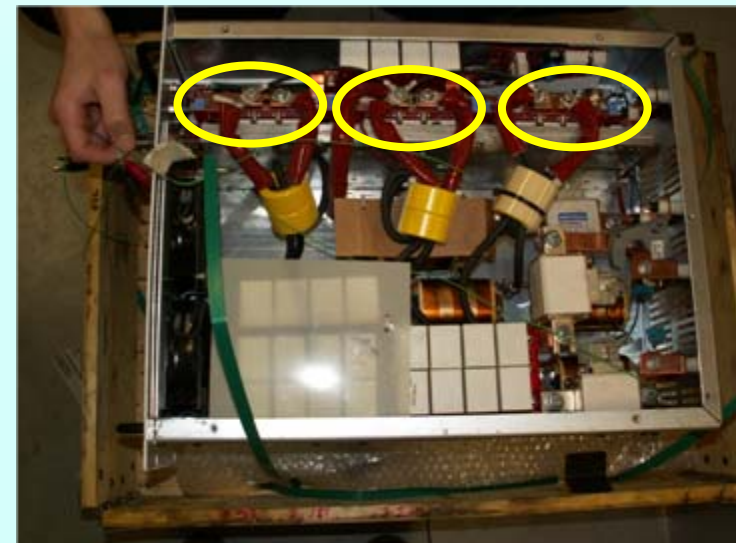
Status - Damages to IGBT modules

DC/AC Unit

- Three IGBT modules (full H bridge, 1200V/150A) in each Unit
- All IGBT modules are dead
- Apparently, the faults tend to occur to the Lower Section in the same Dipole cabinet.
