High Quality Power Supply (HQPS) experience at ESRF

POCPA Workshop 19-21th May 2008 Trieste Elletra

The European Light Source

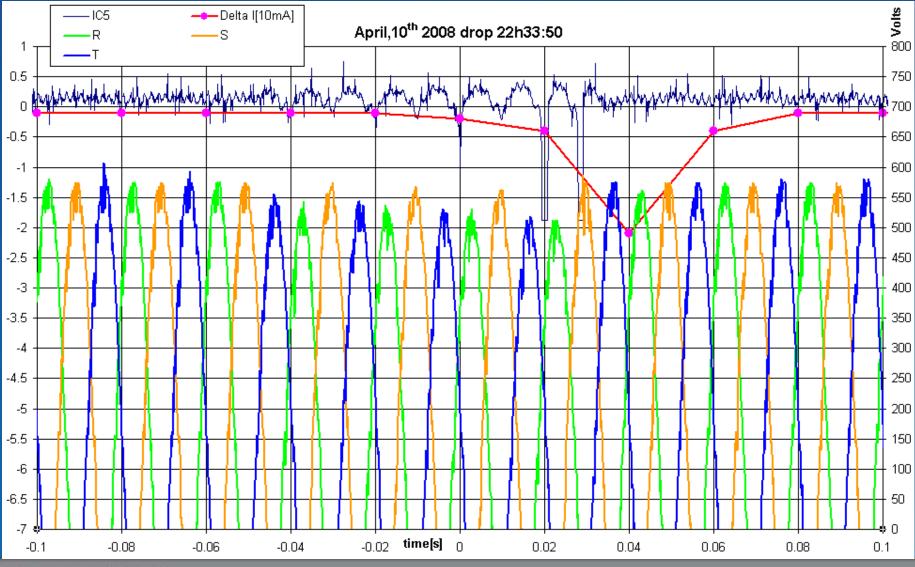
The effect on the QD6 Thyristor rectifier

- Display Window								
	10/04/08 22:33:50.06 Phase 1 Phase 2 Phase 3								
RMS Value	9850.4 17	780.9 1821	19.1						
Frequency	49.9	19.2 50	.0						
1	Drop Duration : 100 ms								
Cancel									
20kV level	V1	V2	V3						
read	19850	17780	18219						
nominal	20350	20250	20360						
Drop level [20k∨] -2.5%	-12.2%	-10.5%						
400Vlevel	S[orange]	R[green]	T[blue]						
read	562	512	518.8						
nominal	575	575	581						
drop	-2.3%	-11.0%	-10.7%

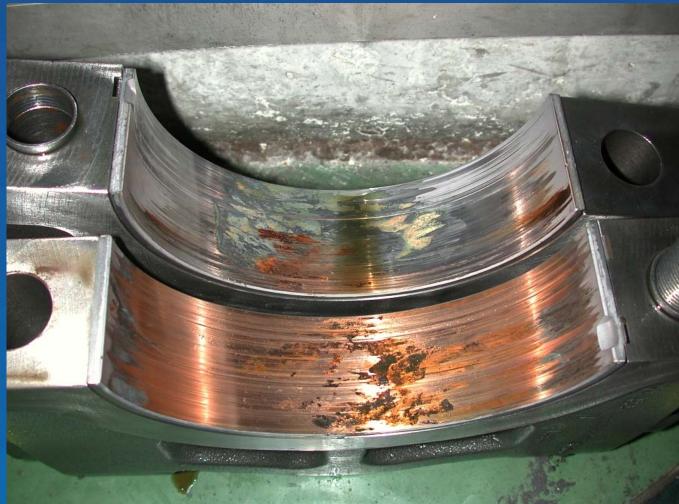
Damages after 7 years of operation

Bearings damaged On all crankshafts Of the 10 diesel Engines.

Causes under legal Considerations: Oil quality, vibrations of accumulators and magnetic field induced by remote clutch

After 4 years of Procedure no evidence: Decision to change the system

The system was **repaired each year** before the stormy season. (~ ready in April each year) Lot of effort has been financially engaged. (~ 2 millions Euros) No collaboration from the manufacturer put the ESRF in a situation to invest into a new system.
