LEAK DETECTION AND REPAIR IN THE ACCELERATOR COLUMN

LEAK DETECTION AND REPAIR OF VACUUM IN THE ACCELERATOR COLUMN

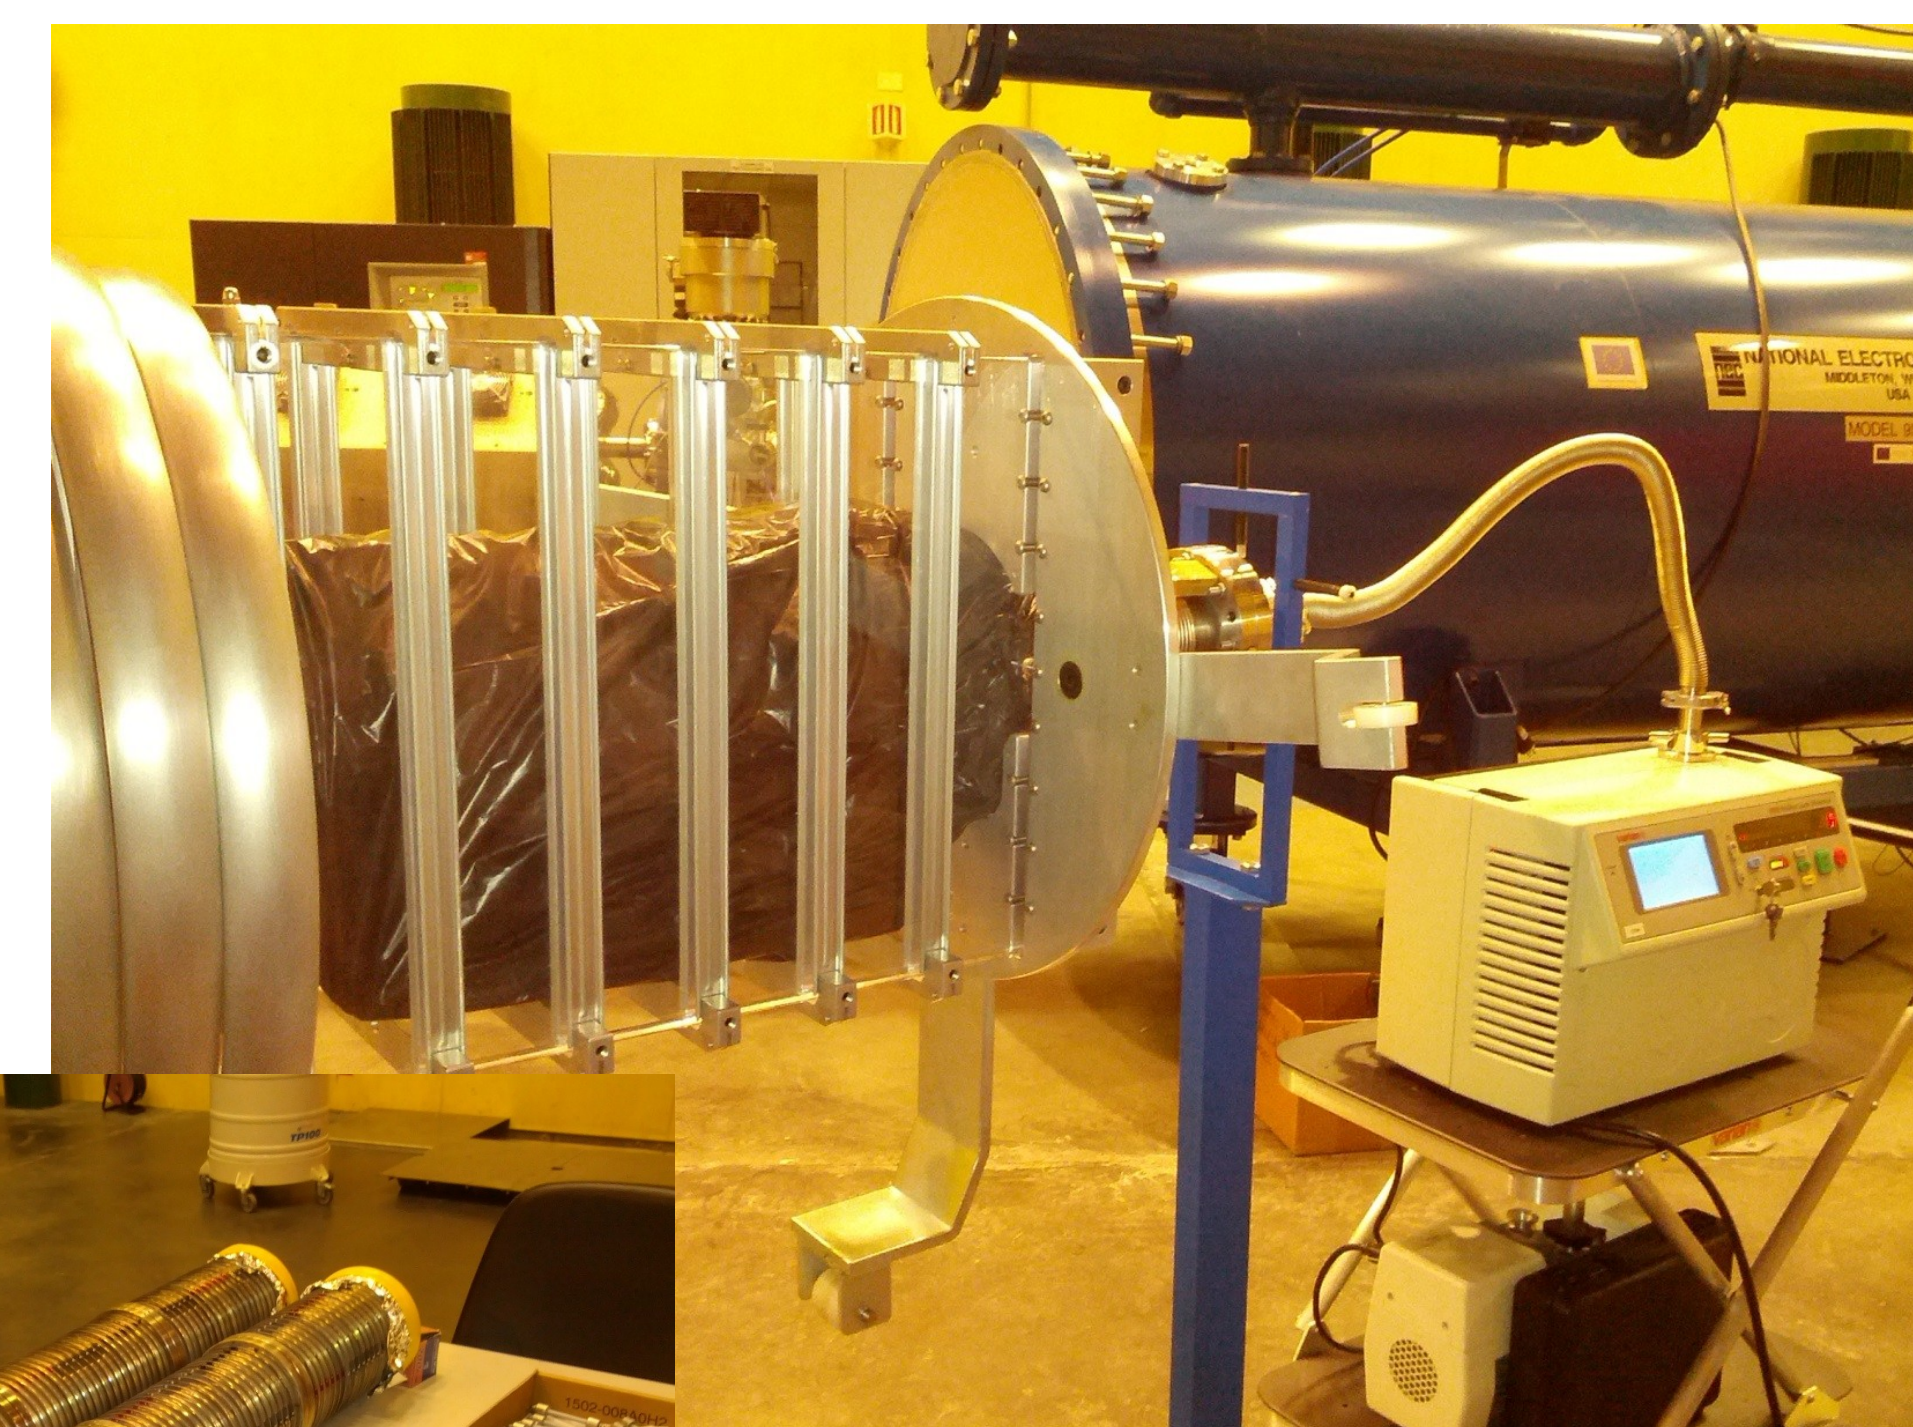
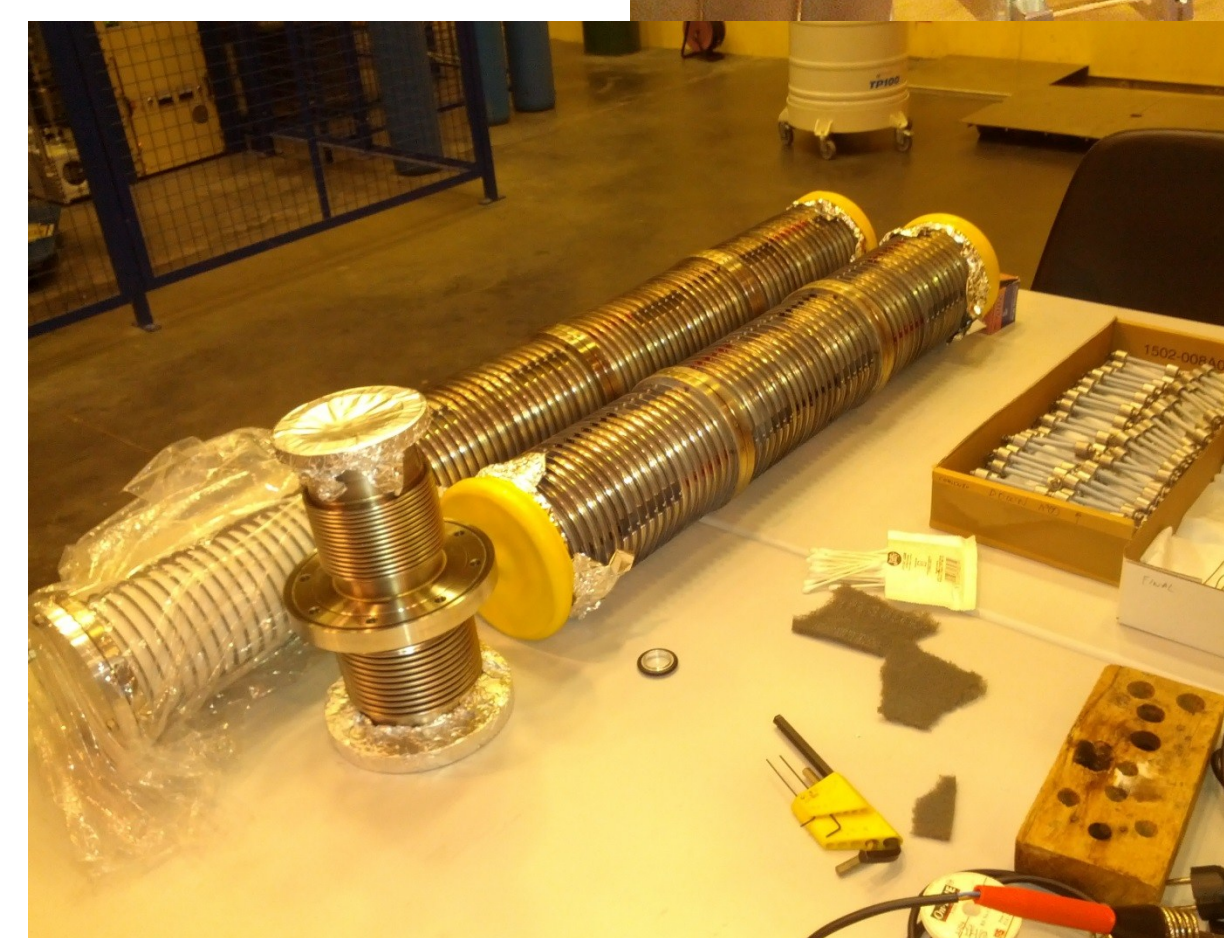
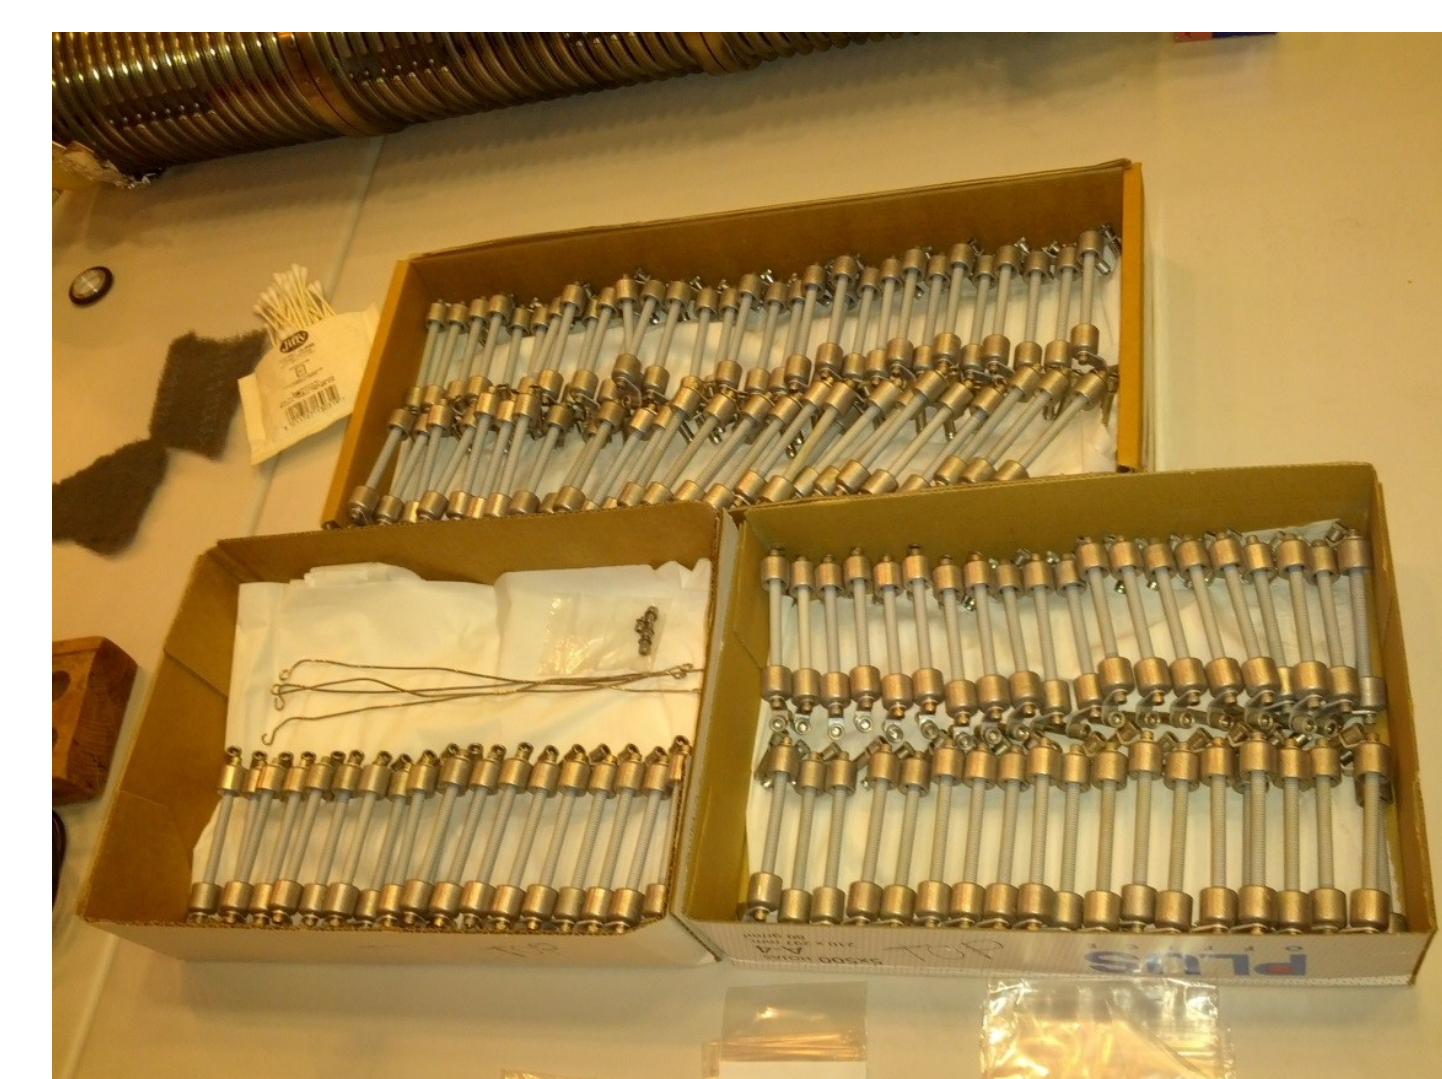
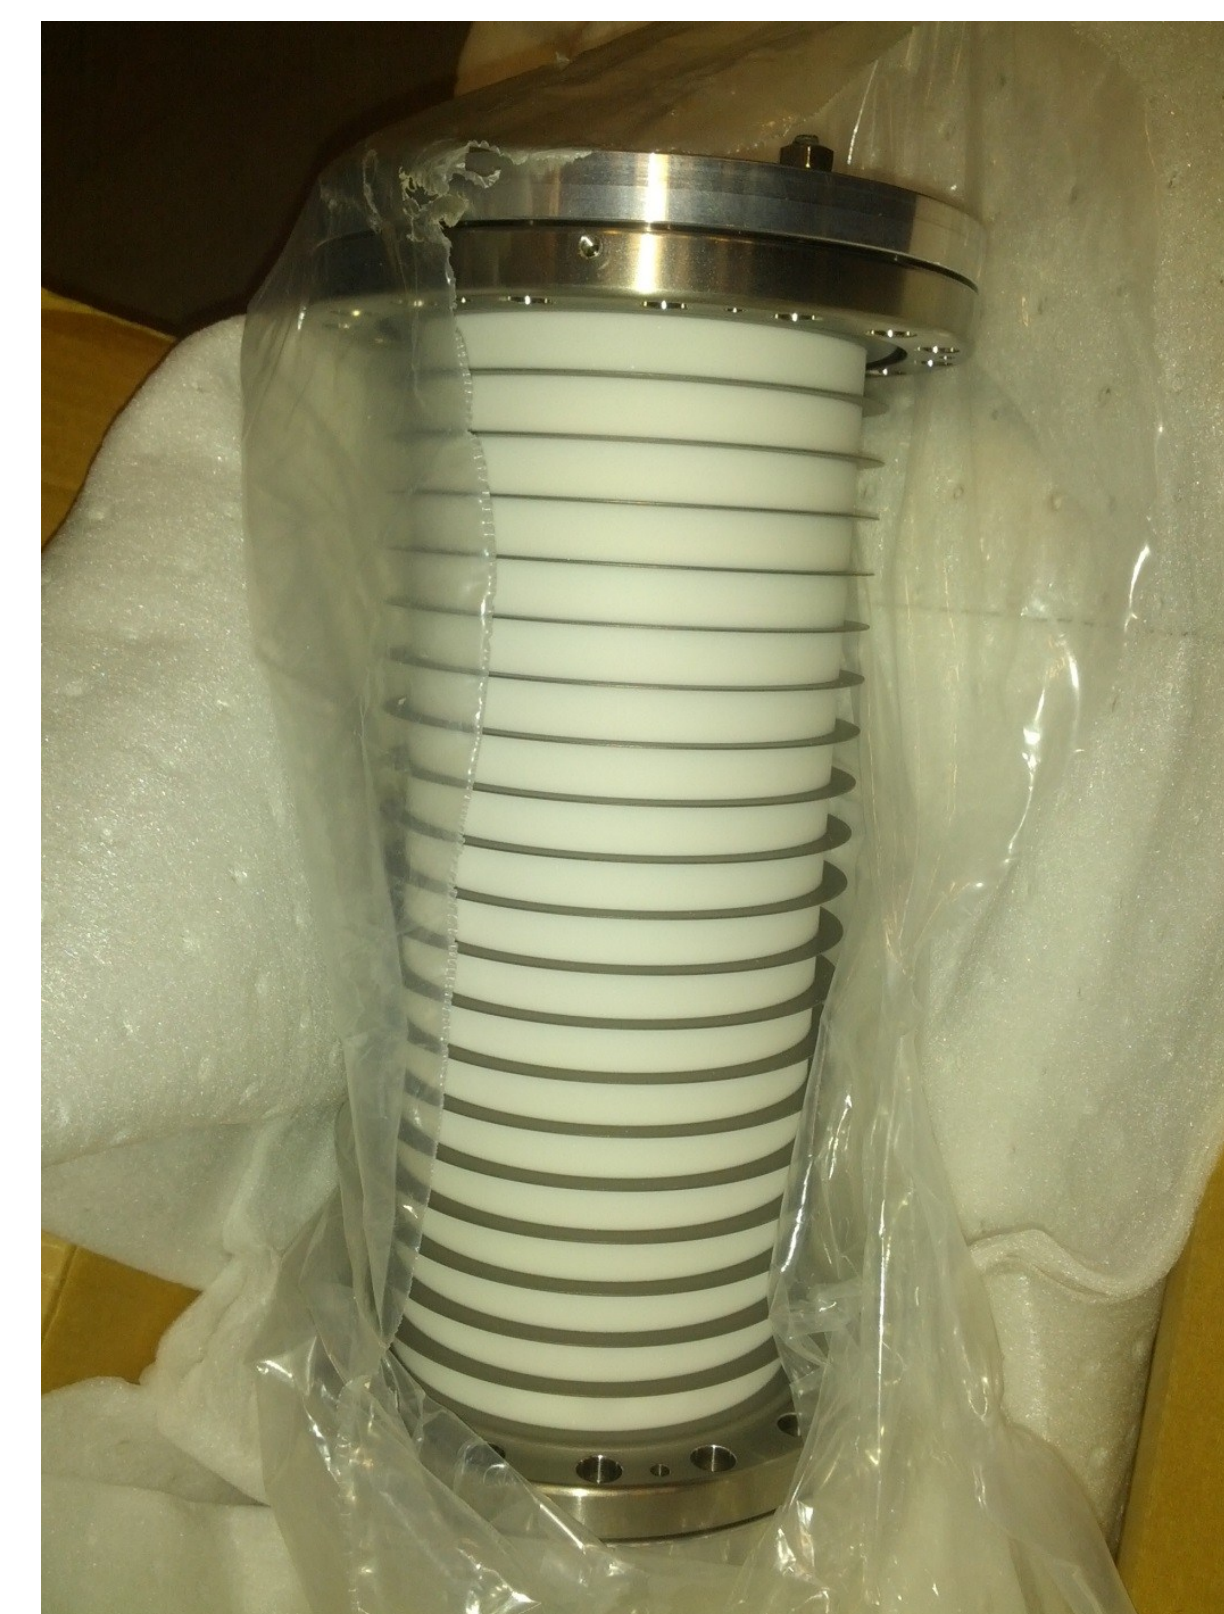
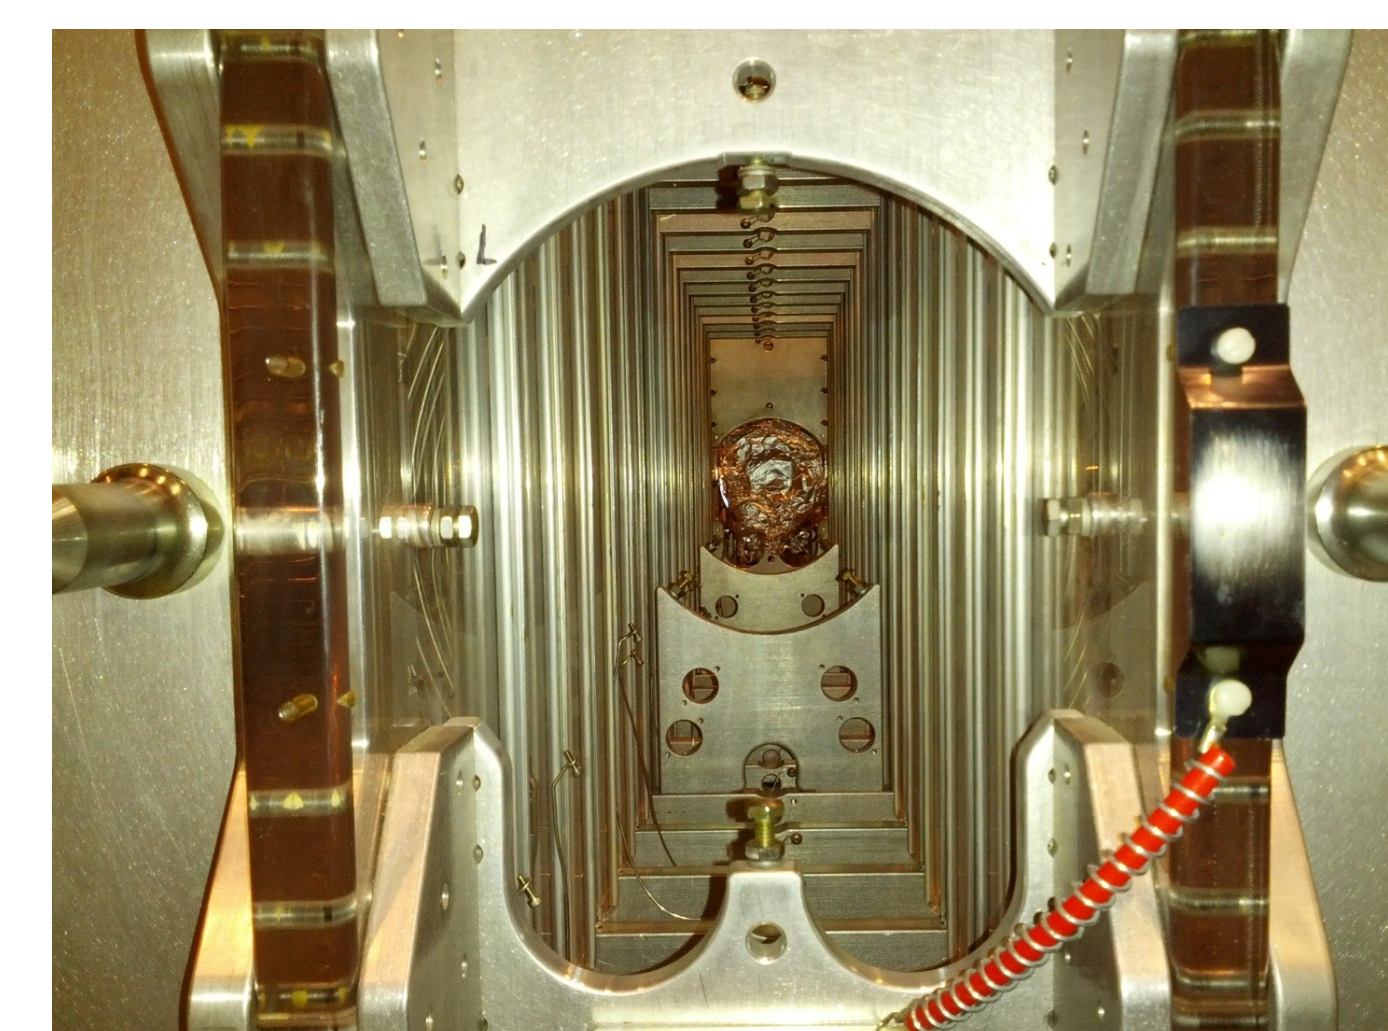
The vacuum started deteriorating inside the tube after a spark. It was found out that residual gas inside tube was SF₆. The pressure of SF₆ tank was decreasing, the maximum voltage was 2.3MV

Hunting of leak: Leak detection just after the tank opening. A leak detector was connected to the low energy terminal. The procedure employed was same as conventional leak detection. Accelerator tubes were sprayed with helium. The leak was very small, the leak wasn't detected.

We had to disamble the low energy column. We had to look for the leak in each tube.

The leak was detected in second tube of low energy column.

Tube replacement is a very hard job and requires many fore preparations. So the damaged tube was replaced with a new accelerator tube.

During the same installation time alignment of the machine was taken care. Again leak checking was done and the tube was baked properly. The tank was closed again and was conditioned for about four days. today the terminal can reach its maximum voltage stably(3MV).
