# CDF silicon cooling: problems and recovery

- I will not talk..
- The CDF silicon detector cooling system
  - The leak
    - Investigation
    - Repair
- Status

*Ignacio Redondo*

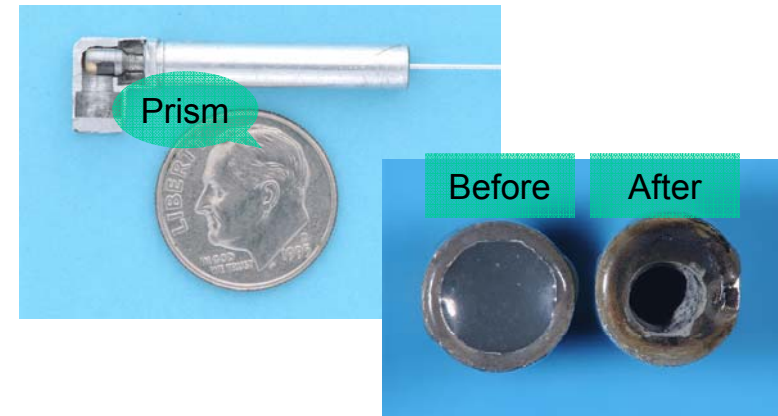
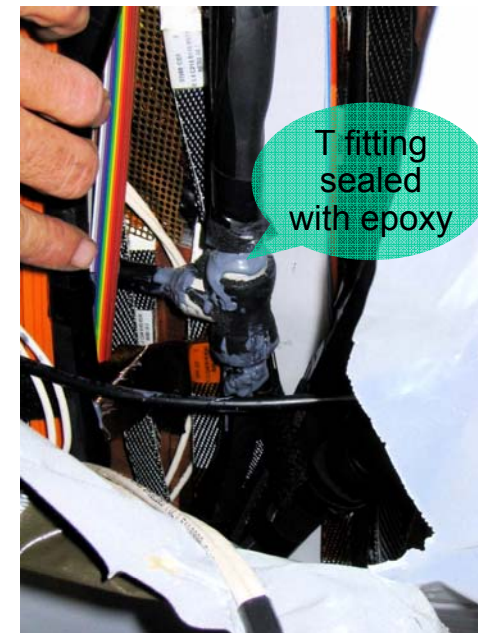
### Blocked ISL Cooling Lines

- Problem: cooling insufficient to switch on parts of ISL
- Reason: 12 ISL cooling lines (~1/3) blocked by glue (discovered after installation)
- 2002: 11 lines successfully opened by strong laser (not trivial: work with borescopes, shoot laser around corner with prisms)
- Reprise in 2006:
  - Cause (2002): 2 prisms got stuck in cooling lines during retraction
  - Effect (2006): Insufficient cooling to these compromised lines due to air leak in the system

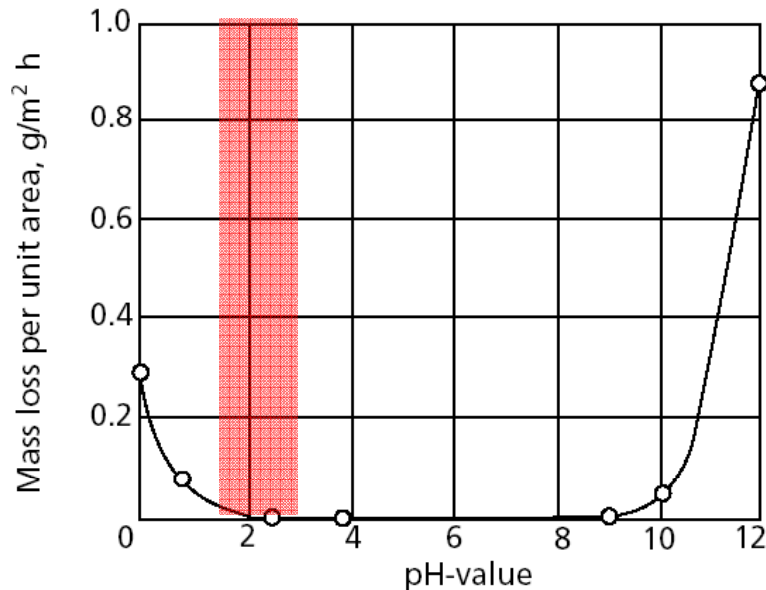
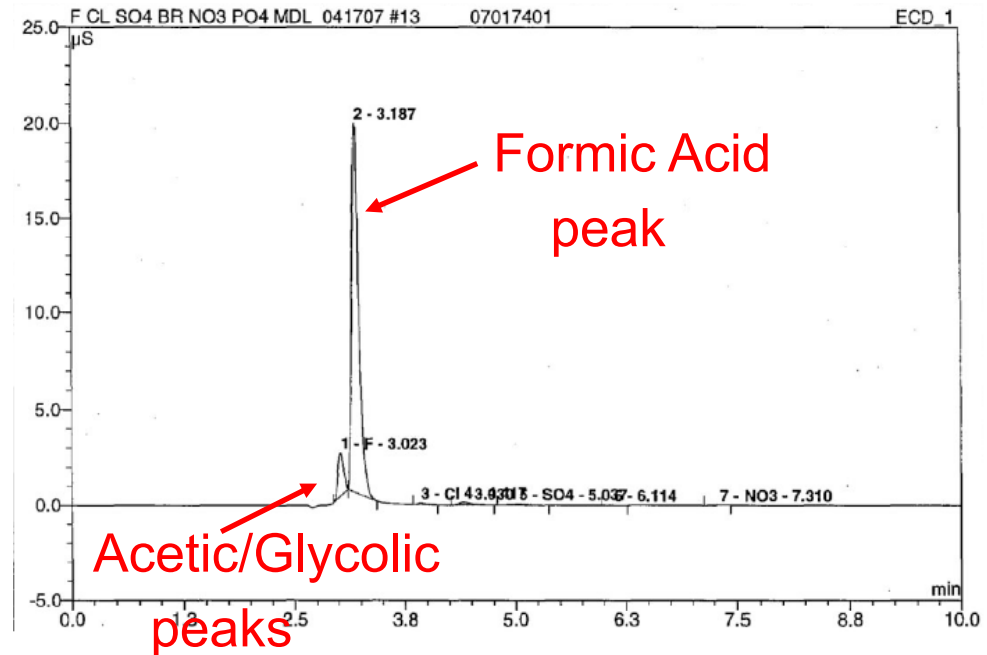
- No significant concentration of inorganic ions
- Glycol can oxydate into carboxylic acids, similar process to wine turning to viniger.
- Ion chromatography analysis shows carboxylic acids, mostly

formic acid as source of the low

- Al vulnerable to corrosion below pH 2 because Alumina becomes soluble
- Corrosion resistance is alloy-dependent:
  - Heat affected zone in 6061-Al welds (ISL portcard rings) most sensitive
  - 1100-Al test sample (pipes cooling the sensors) shows no corrosion or mass loss

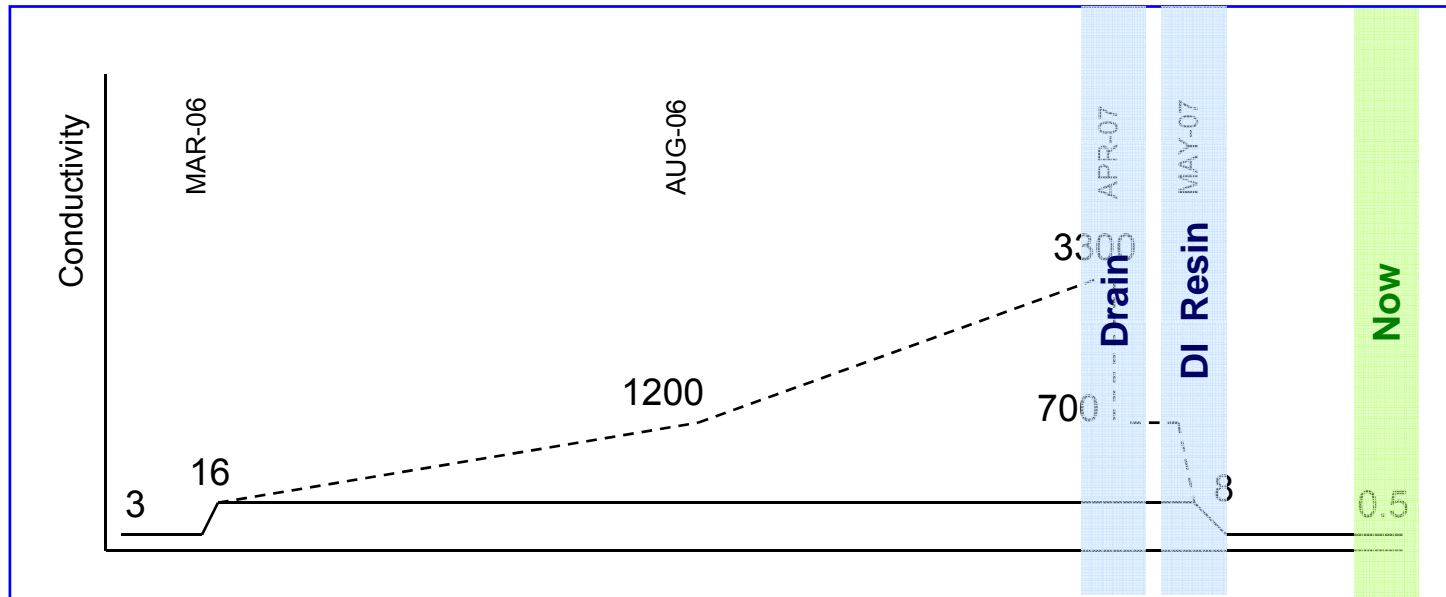
## Conductivity history

- March 2006 ISL conductivity went out of range of the inline conductivity meter
  - Dashed line shows the estimated behavior of the conductivity
  - Numbers show measurements performed by external labs
- e-valves failures in February – March 2007.
- pH was only measured on March 07: ~ 2 (between gastric acid and lemon juice!).
- **Problem was aggressively attacked!!!**

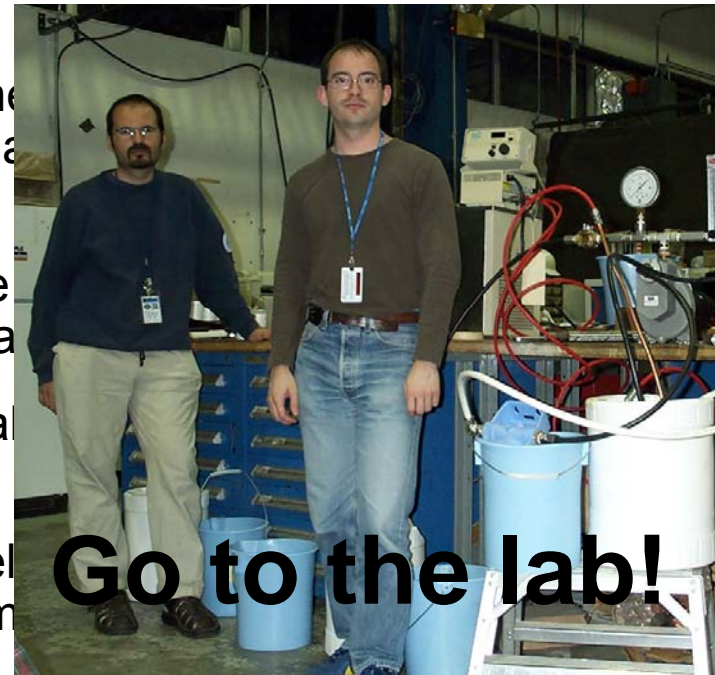
- In March 2007, pH of the ISL cooling system was **1.9** and the conductivity **3300  $\mu\text{S}/\text{cm}$** .
- Treating the coolant with **chemicals** was **discarded** without a complete risk assessment.
- Diluting and/or draining the system was the desired coolant quality. This option would drain the system.
- 16 h access was requested to perform the work contained in the system and replace damaged components.
- The piping system was divided operationally and each section was drained.
- Around 3 – 4 barrels (55 gallons per barrel) of coolant were removed from the system. Glycol was almost completely removed from the system.

**Conductivity = 700  $\mu\text{S}/\text{cm}$**

**pH = 2.8**

- But the operation had to be repeated several times (~5) to reach pH > 4

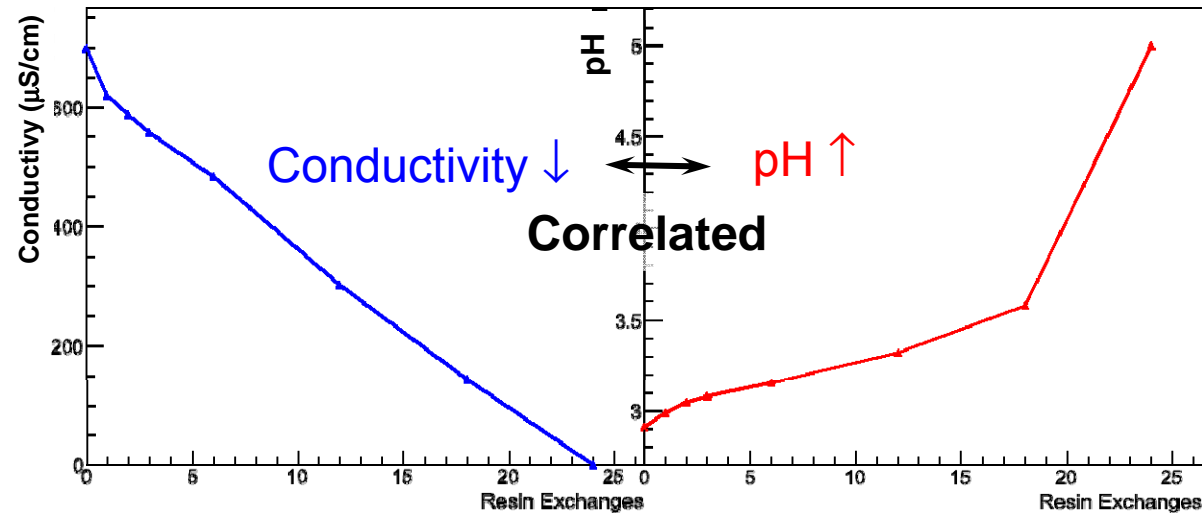
- We used a setup with 1/100 of coolant in the system to emulate the effect of the dionizing resin on the ISL system.

- Our tests in the lab showed that at pH ~ 2, the resin worked perfectly.  
**But samples not only had a decrease in conductivity, pH also increased.**
- Obtained a prediction of the quantity of resin needed to get the desired pH and Conductivity.
- We used a larger resin bed to decrease conductivity and increase pH.  
Values obtained were:

**Conductivity = 8 μS/cm**

**pH = 4.5**

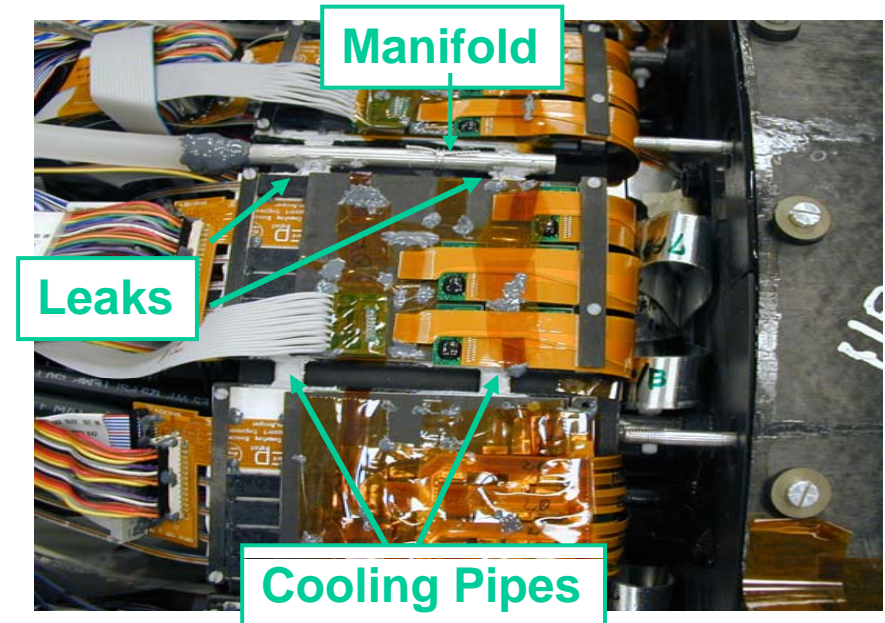
- Coolant was successfully neutralized by draining (to 700  $\mu\text{Si}/\text{cm}$ , pH 2.8) and de-ionizing with resin (to 8  $\mu\text{Si}/\text{cm}$ , pH 4.5).
- Degradation on West portcard flows stopped after pH was increased.
- No additional flow problems observed in ladder lines.
- But...
- **Welds of the aluminium rings which cool the optical transmitters (portcards) had already corroded.**
- Since the system is sub-atmospheric, leaks result in lower flows. In May flow was too low to operate the portcards.

**Since May and up to the shutdown in August we were not able to operate East ISL/L00 (affected 300 pb<sup>-1</sup>)**

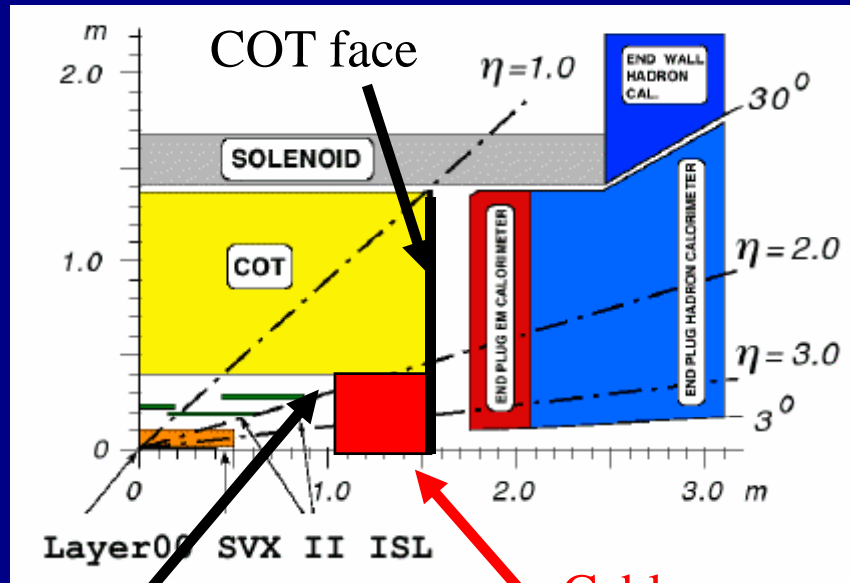
Portcard ring

- Manifold - AL 6061-T6, 0.7 mm wall, 127 mm long tube 6 mm ID
- Cooling Rings - AL 5052, 5 mm wall, oval tubes (21 sided)
- Welded - either 5356 or 4043 filler
- Inner surface area: 0.12m<sup>2</sup>
- Fed by Cilran (Silicon) tubing from COT face
- Impossible to access from outside, isolated by volume full of cables, ~60cm in z.
