LHC insulation vacuum system: consolidation activities and leaks followup during the first LHC long shutdown

Jaime Perez Espinos on behalf of all contributors to LHC insulation vacuum (TE/VSC, AL4030 and ICIT)

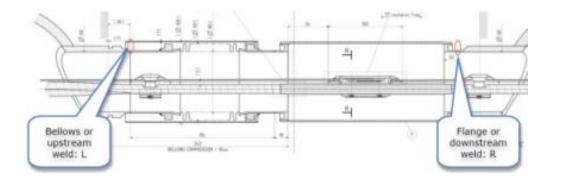
Known leak: s. 3-4

Error in strategy and Quality Control!!!

Leak location (inner surface; before cutting)

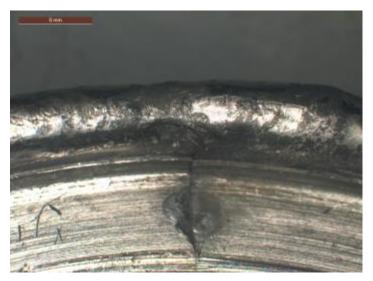
Details: crack, lack of fusion, segregation, cold drops

Detail inner surface: Porosity

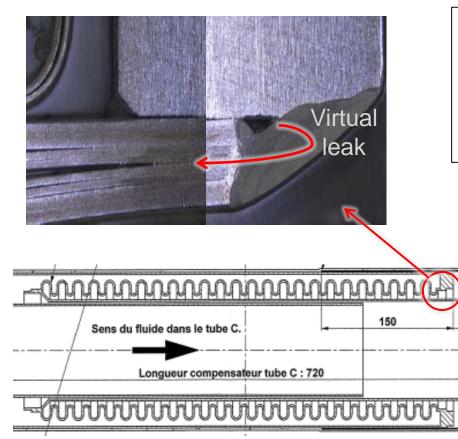
QRL, lines C & D (internal leak)

Failure process: filling of the inter-layer space with time (3-4 years of operation) \Rightarrow Pressure increase of the inter-layer space during warm-up leading to the compensator collapse

Compensator damaged: DN100 multiply (4 plies of 0.3 mm)

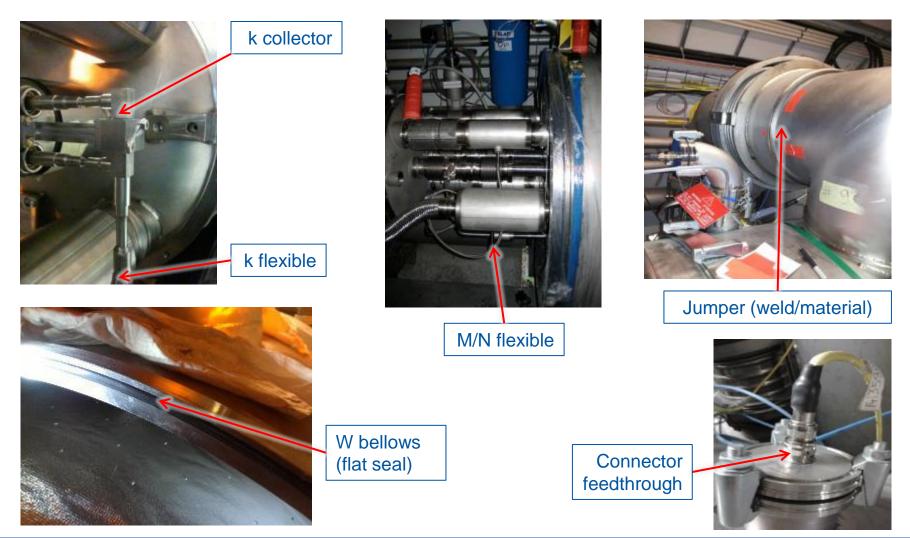
Other leaks

No accessibility to vacuum

weld \Rightarrow pump-out or isolate

space between enclosure

and support structure
