LHC's injector chain:

# Vacuum activities during LS1

Jose A. Ferreira Somoza on behalf of TE-VSC-IVM  
team

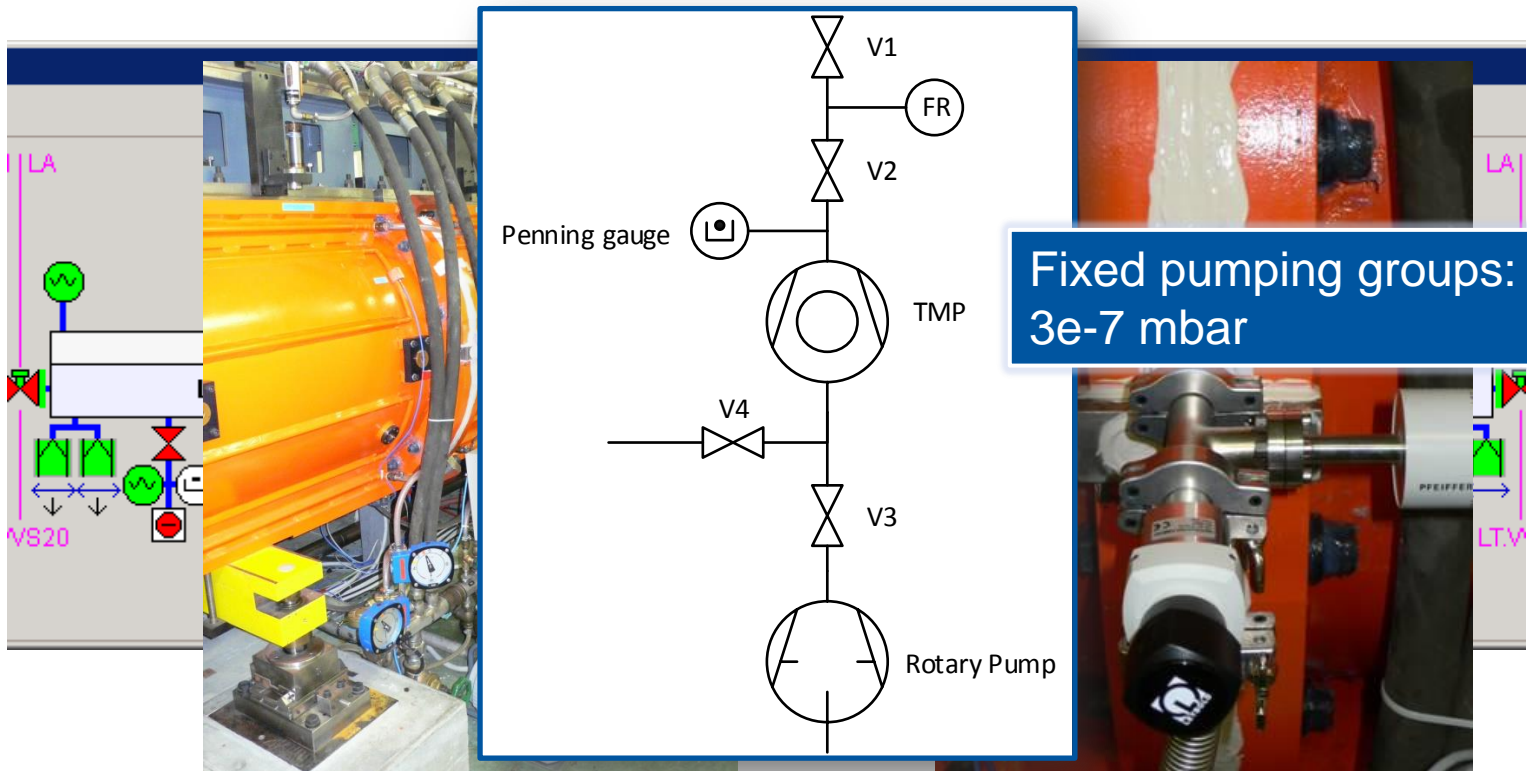
- 2xVPIs in tank2 of LINAC2 lost

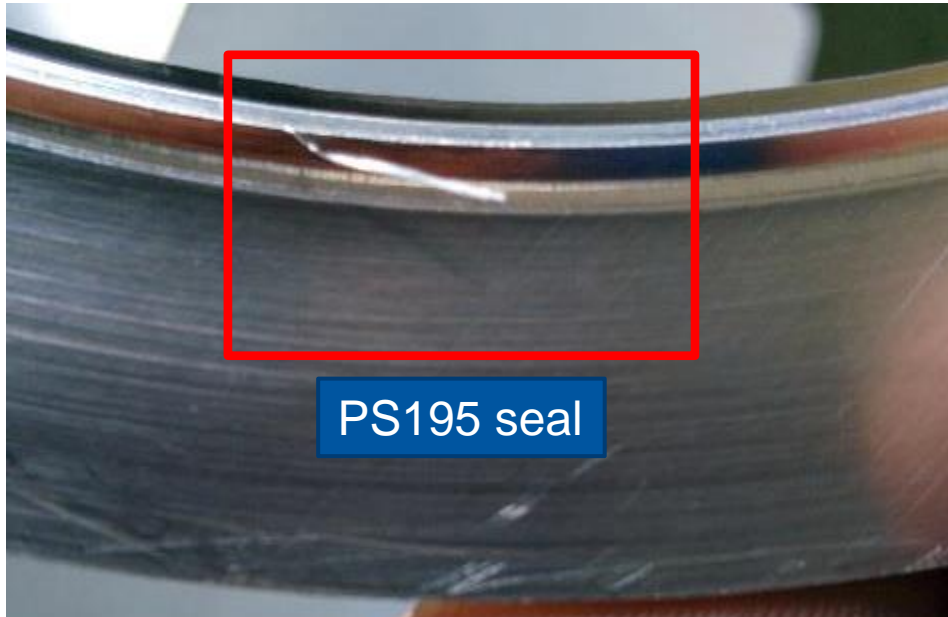
Dust from fiber glass (insulation)

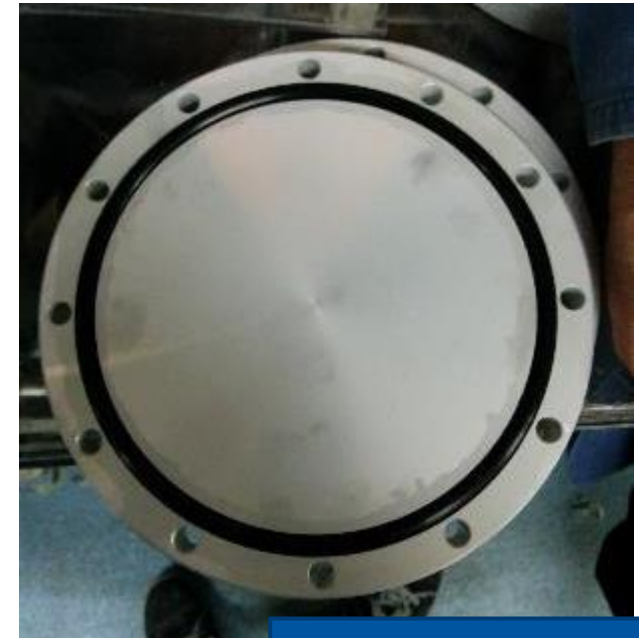
Low quality o-ring
