OTHER NON-SOLVED NC ACROSS THE LHC RING AND POTENTIAL IMPACT ON PERFORMANCES

V. Baglin, CERN, Geneva, Switzerland

Abstract

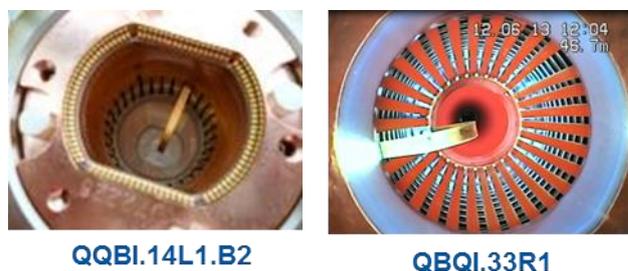
One of the most critical equipment of the cryogenic vacuum system is the plug-in-module, PIM. These components are non-conform since the installation of the LHC. The first non-conform PIM was found by chance at QQBI.26.R7 in August 2007 after the warm up of sector 78. The origin of this NC has been traced back to a NC during manufacturing which was not properly documented and followed-up. Two bending angles of the RF fingers of the PIMs are out of tolerances which, as a consequence, might lead to buckling during warm up. In particular, the QQBI type PIM (interconnect quadrupole-dipole) are the most critical. A systematic check is therefore mandatory once the PIM temperature is higher than 120-130 K. Possible means of checks are RF ball test, tomography, x-ray and endoscopy. Moreover, a systematic repair of the PIM is done when magnets are consolidated [1]. For LS1, in parallel to the arc repair, the PIMs located at the arc extremity: QQBI.7R and QBQI.8L were consolidated. Today, after LS1, 13 % of the PIMs are consolidated *i.e.* 456 out of 3443. All RF-ball tests were ok before cool down. As shown in

Figure 1, after the arc warm up, 2 PIMs were found buckled: in the arc 81 and the arc 12. It must be noted that the arc 12 was already warmed up in 2009. Therefore, systematic check of the PIM is needed even if an arc was already warmed up.

Figure 1: The two PIMs which were founded buckled following the LHC arcs warm up after Run 1.

For LS2, if the consolidation strategy remains unchanged; no significant impact of this NC is expected. However, it must be remembered that, any warm up above 120-130 K during technical stop, (E)YETS or long shutdown will requires inspection to ensure proper operation of the LHC.

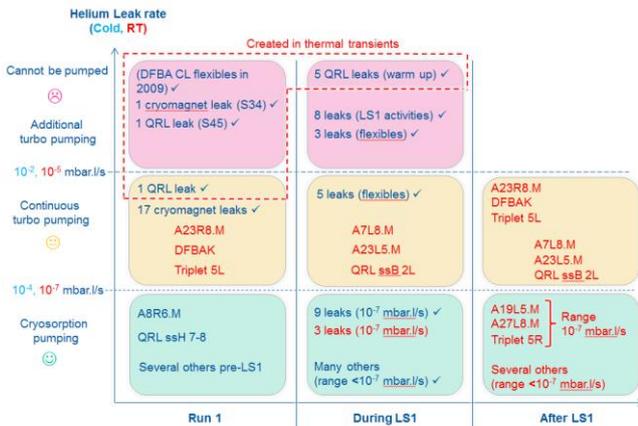
The 7 major leaks, which were created during thermal transient, were repaired during LS1. In s34, the repair of line M in the cold mass circuit of A27L4.M was done. In s45, the repair of the QRL line C of subsector B was achieved with the support of TE-CRG. The leaks in the QRL due to multiply bellows failure were repaired and managed with the support of TE-CRG.

As shown in Figure 2, the machine operated during Run 1 with several leaks above 10^{-5} mbar.l/s. Such large leak level required the use of additional turbo pumping. After LS1, most of the leaks are in the range 10^{-8} - 10^{-7} mbar.l/s which can be managed by simple cryosorption pumping. Only 6 leaks are in the range 10^{-7} - 10^{-5} mbar.l/s but can still be managed by the fixed turbomolecular pumping system. It is worth underlying that several leaks ($>10^{-7}$ mbar.l/s) were created during LS1 due to collateral damage. Fortunately, these leaks could have been repaired. To this date, the vacuum insulation system behaves as expected.

Figure 2: Time classification of leaks observed in the vacuum insulation system

During technical stops or long shutdown, any thermal transient occurring during quench of warm up will increase the risk of major leak. For LS2, several leaks will need to be repaired (IT5L, DFBAK, A23R8.M ...).

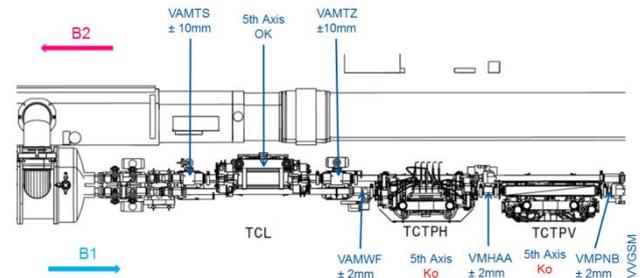
In the current layout, the TCTs are installed between TAN and D2. In these recombination areas, the systems

are very tight and the integration is very difficult. This is the case in particular in LSS 1 and 5 where the 5th axis is condemned. As shown in Figure 3, the vacuum system needs to accommodate the presence of sector valves, collimators, mask and BPMs. This can only be done by using connecting module not compatible with the 5th axis movement of the TCTPH and TCTPV.

Figure 3: Schematic layout of the TAN-D2 area in C4L5 (courtesy Y. Muttoni EN/MEF).

In order to restore the 5th axis functionality, a new layout including new position of TCTs and new interconnecting modules (to be designed and procured) has to be validated.

The implementation of this new layout must take place by YETS 2015, consequently, interventions in vacuum sectors A4L1, A4R1, B4L5, B4R5 must be planned. In the meantime, the collimator system cannot afford the risk to damage the TCTs limiting accordingly the machine operation.

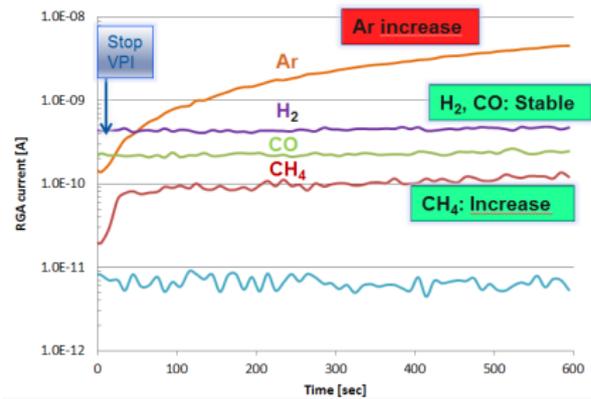
Figure 5 show a typical signature of internal leak. Once external leak have been eliminated, the complementary pumping system is switched off (in this case an ion pump). NEG is then the only remaining pumping system which does not pump noble gas and hydrocarbons. With time accumulation, if an internal leak (composed by air molecules) is present, Ar increase with time. The level of the internal leak can also be estimated from this measurement.

Figure 5: Typical signature of an internal leak (courtesy G. Cattenoz TE/VSC).

Two equipments, installed in the LHC ring during LS1 exhibit large internal leaks level: BQSV.5R4.B1 and TCSP.4L6.B2 with $5 \cdot 10^{-7}$ and $6 \cdot 10^{-7}$ mbar.l/s leak rate respectively. If needed, these equipments might be upgraded during LS2.
