FOCUS COIL STATUS

FC 1 @ CM39

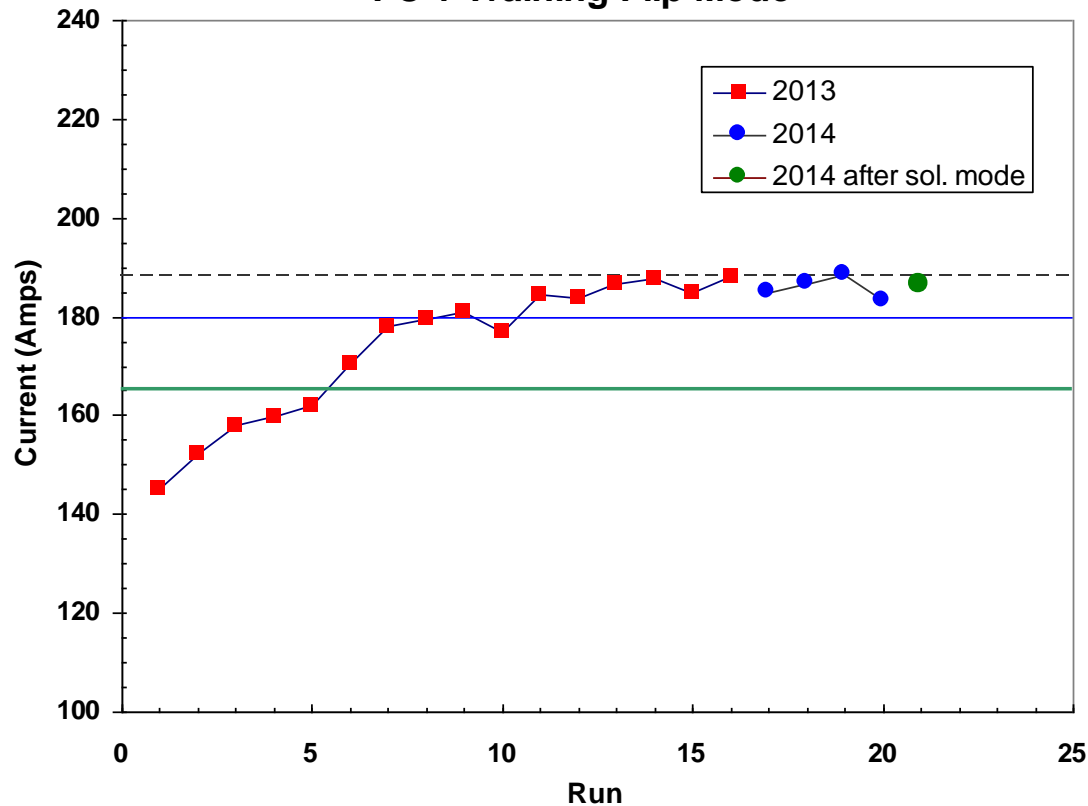
FC 1 Training Flip Mode

Remembers its training

Stable at 180 Amps for 24 hours

May have to de-rate for Step IV to ~ 165 A (a guess)

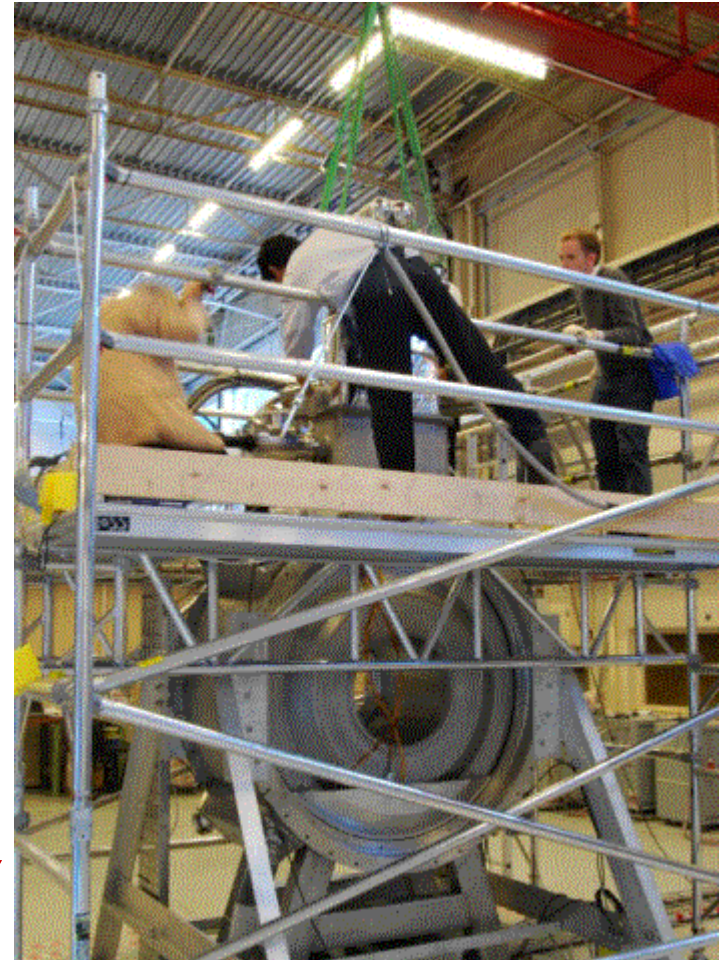
FC 2

- **FC 2 arrived end October 2013**
 - **Connected**
 - **Pumped down**
 - **Started to cool with cryocoolers**
- **Three faults:**
 - **Faulty temp. sensor**
 - **He leak**
 - **Worse when cold**
 - **Thermal shorts**
 - **Couldn't cool cold mass...**
- ***Returned to manufacturer in January***

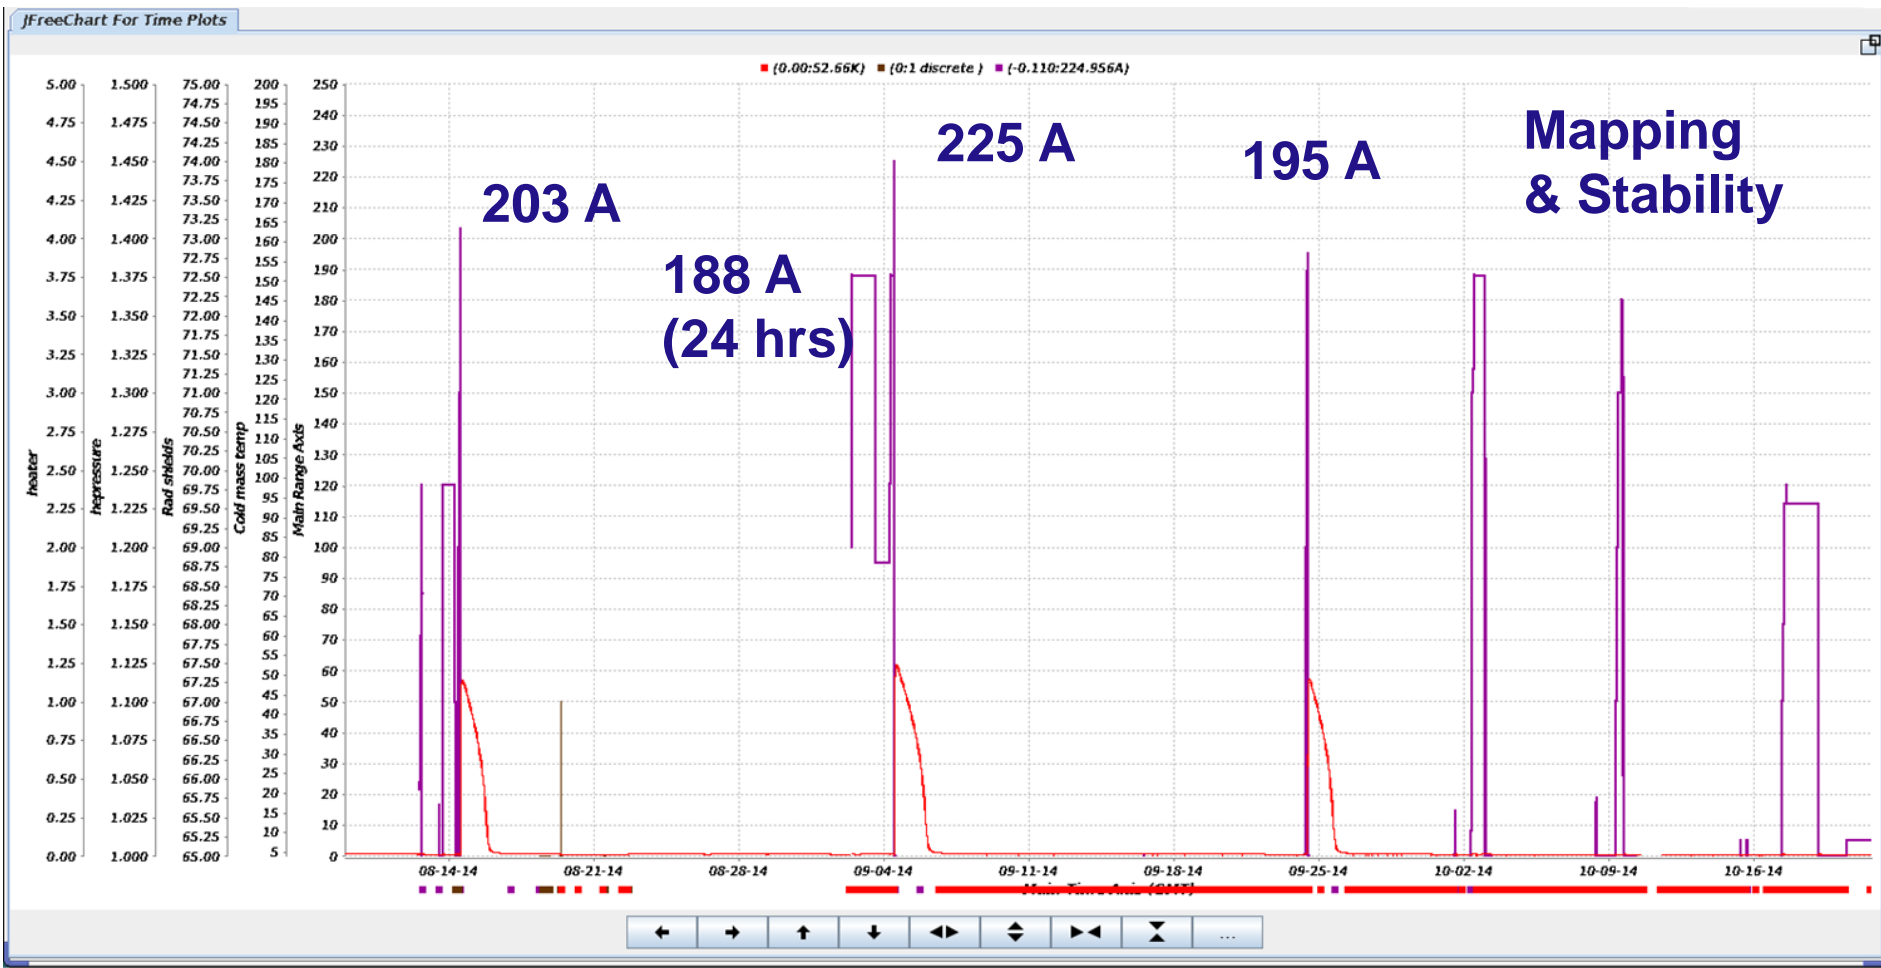
FC2 HISTORY – CURRENTS

Two *true* quenches; one – 225 A – caused by hard limit in psu

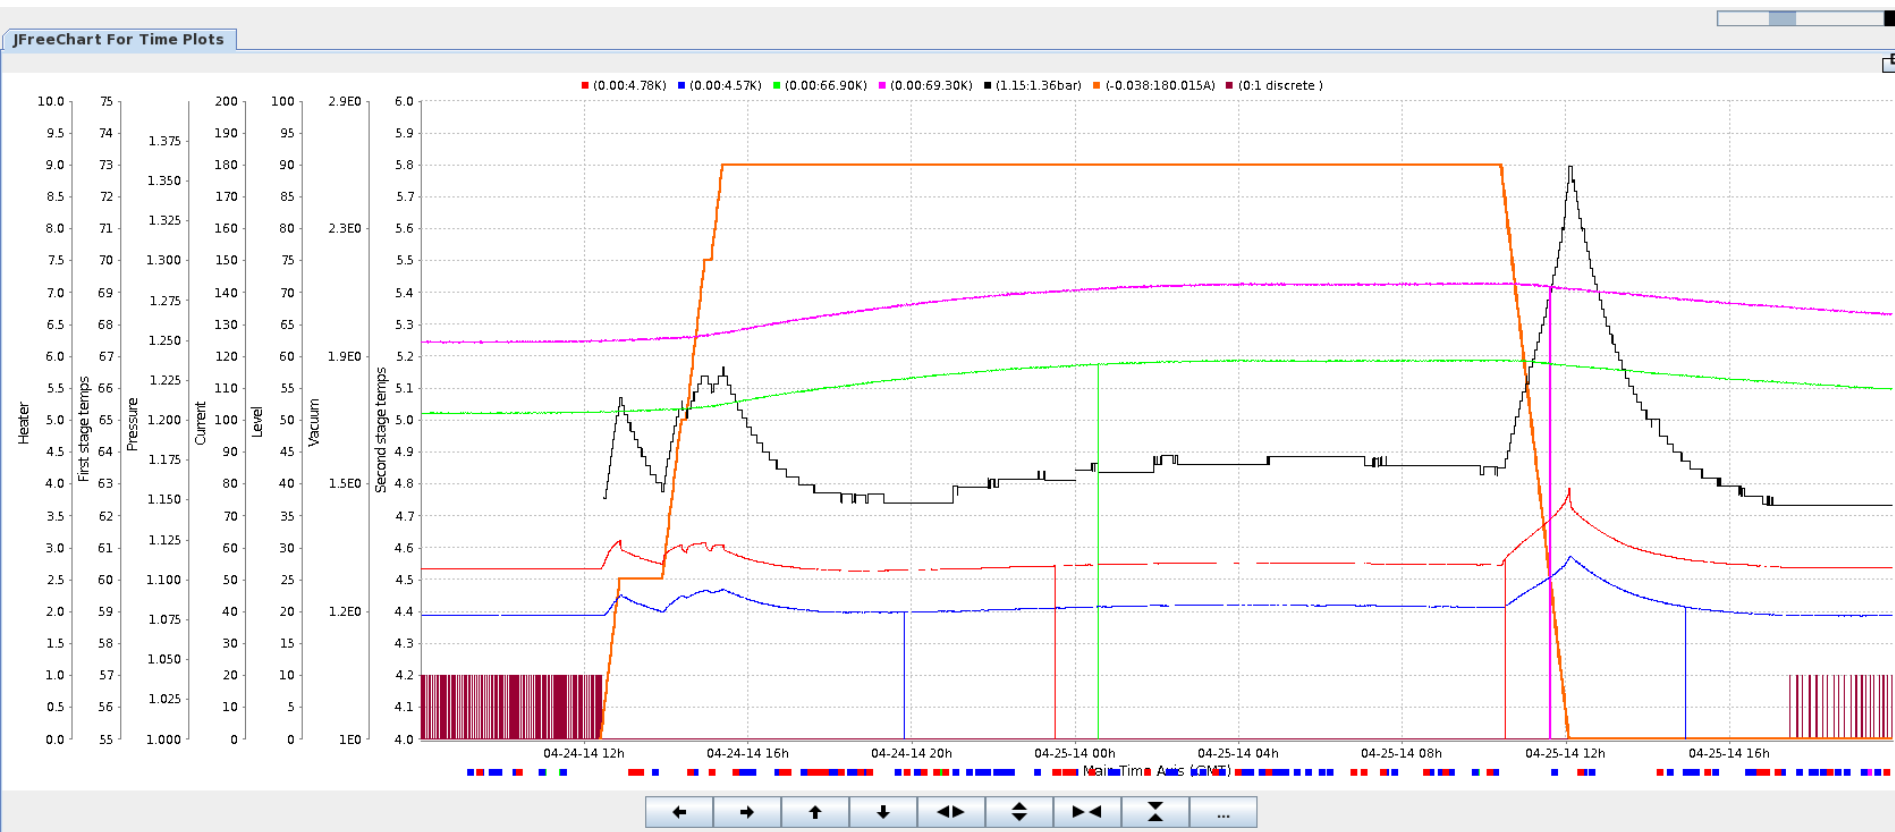
FC 1 THERMAL BEHAVIOUR

Heater operates to stabilise He temperature & pressure
→ Some excess cooling power – but little and < expected

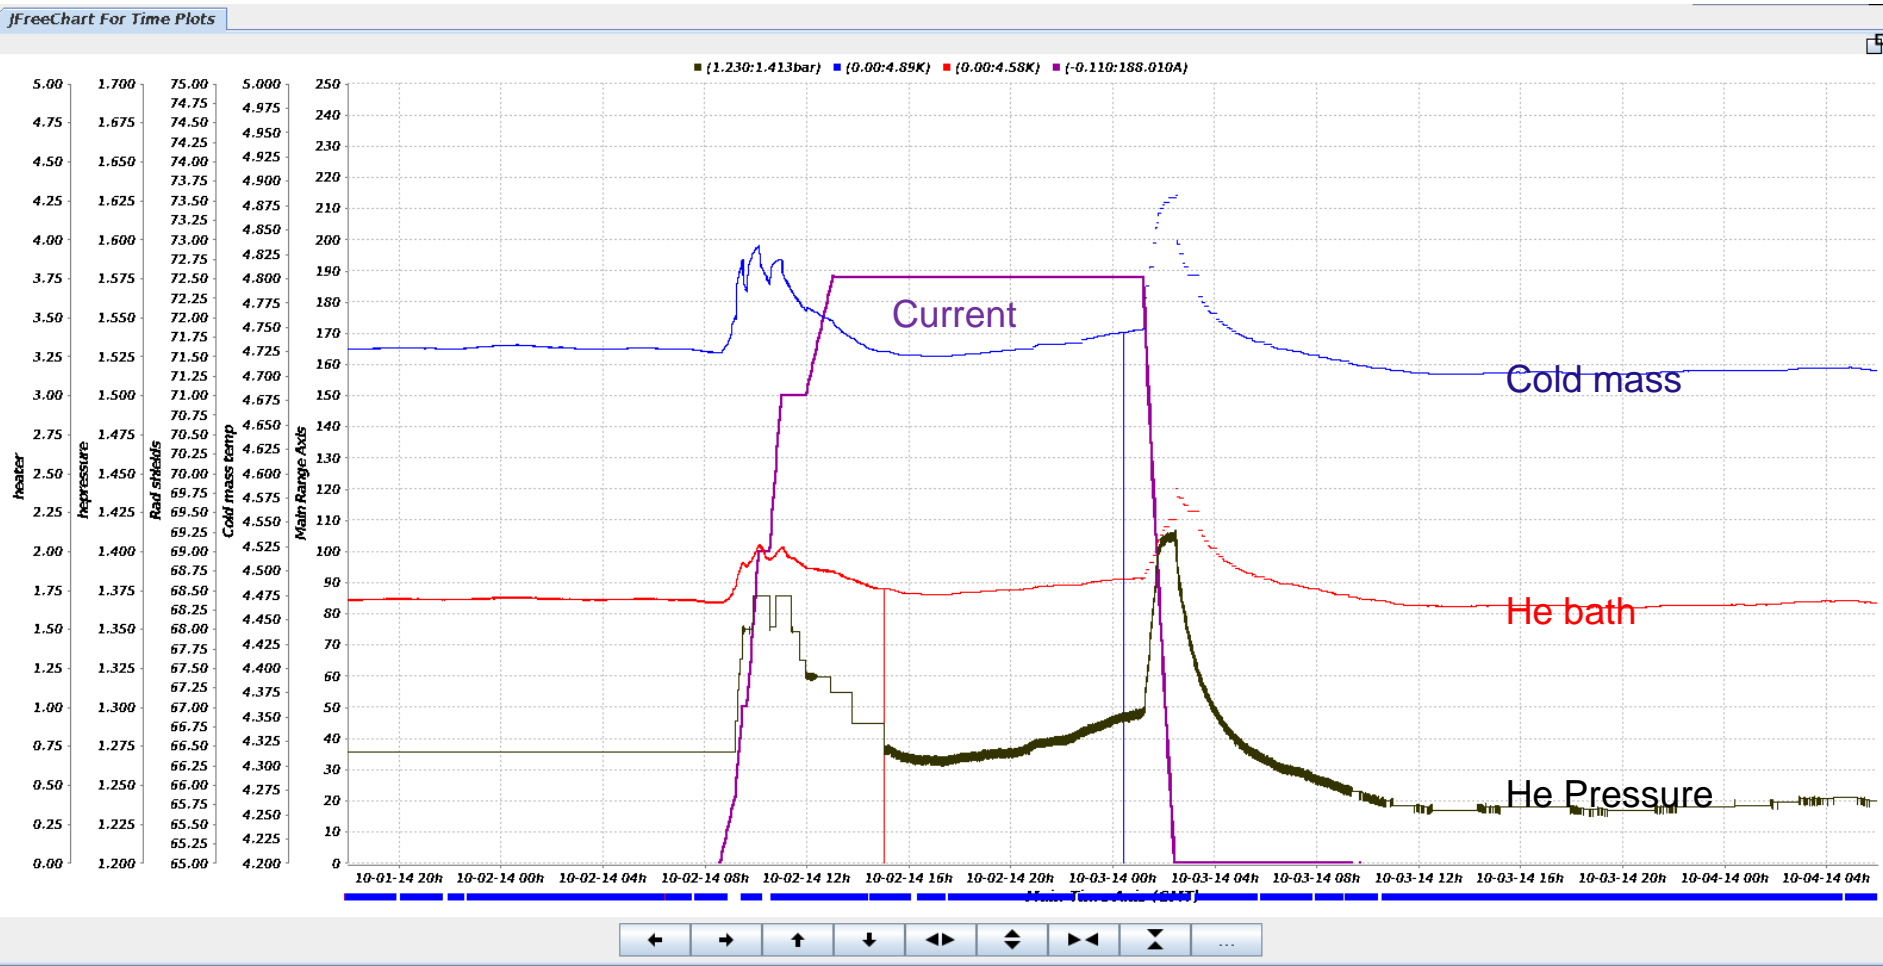
THERMAL PERFORMANCE FC 2

Heater never operates; less excess cooling power than FC1
But doesn't seem to be show stopper – there is plenty of temperature margin

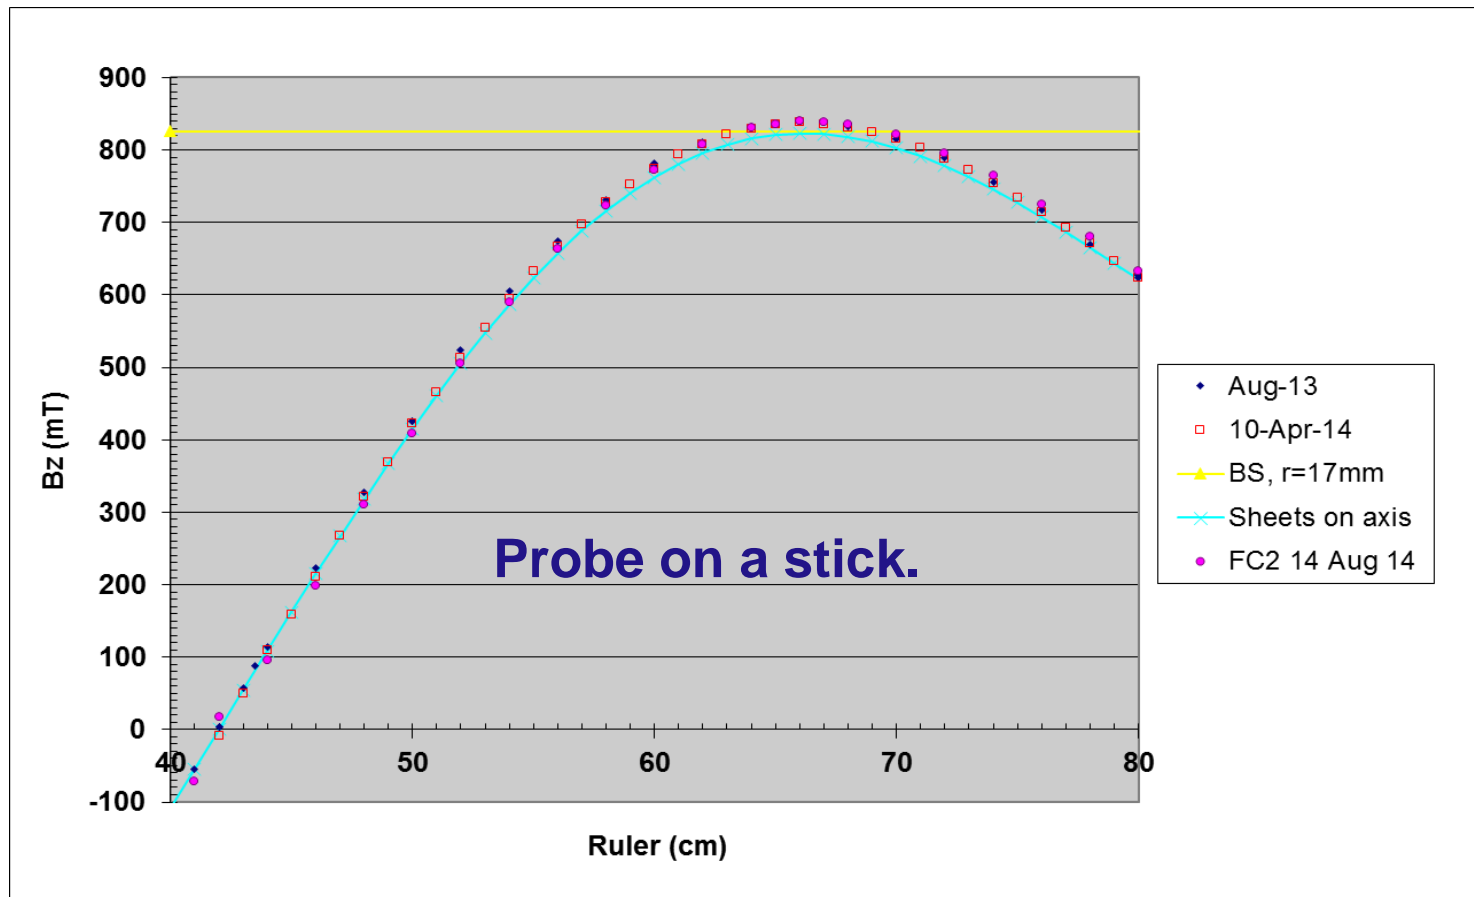
FIELDS & MAPPING

FC1 ~ FC2 and both ~ 1.5 % > calculation (see V.B.'s talk)

We might not understand the (cold) dimensions of coils

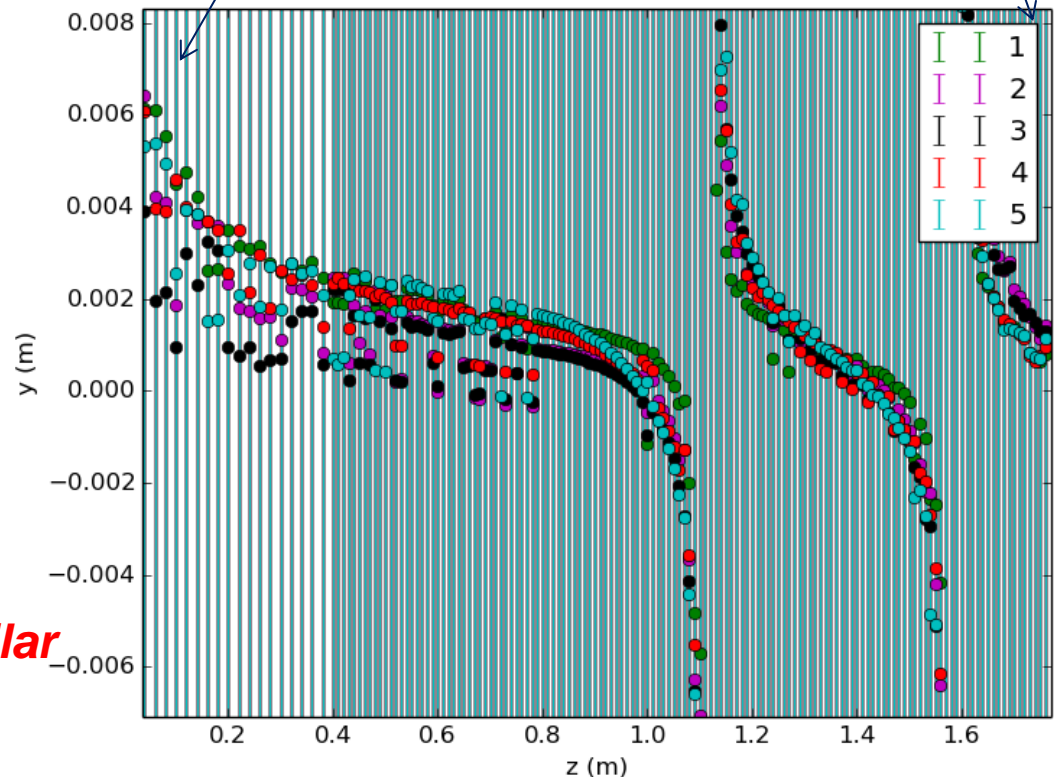
Finding the magnetic axis (y, FC2@150A)

This isn't a "pretty pattern". They're the error bars from Minuit!

My attempts with FC1 look similar

*→ Much to understand
(too much data)*
