LINAC2-LINAC3 Post-mortem

F.Roncarolo – BI-TB 02 Oct 2014

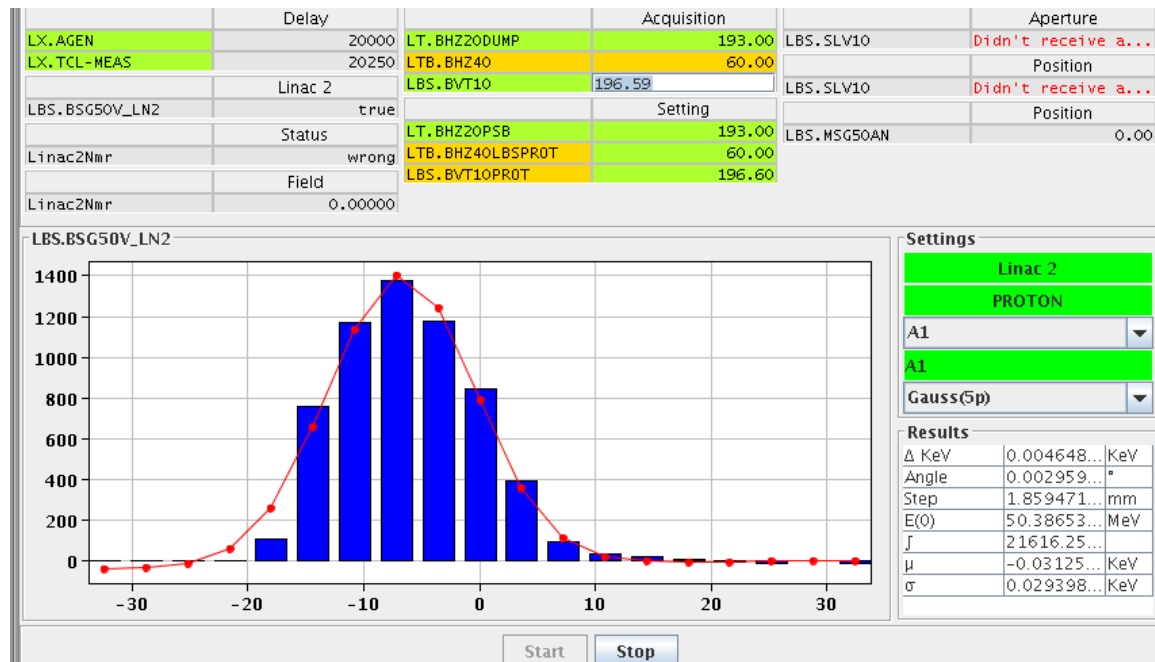
Elogbook - 16-Sep-2014

Beam moves on the grid when changing the LBS.BVT10.

No acquisition from the Linac2Nmr.

D. Oberson will have a look at the probe.

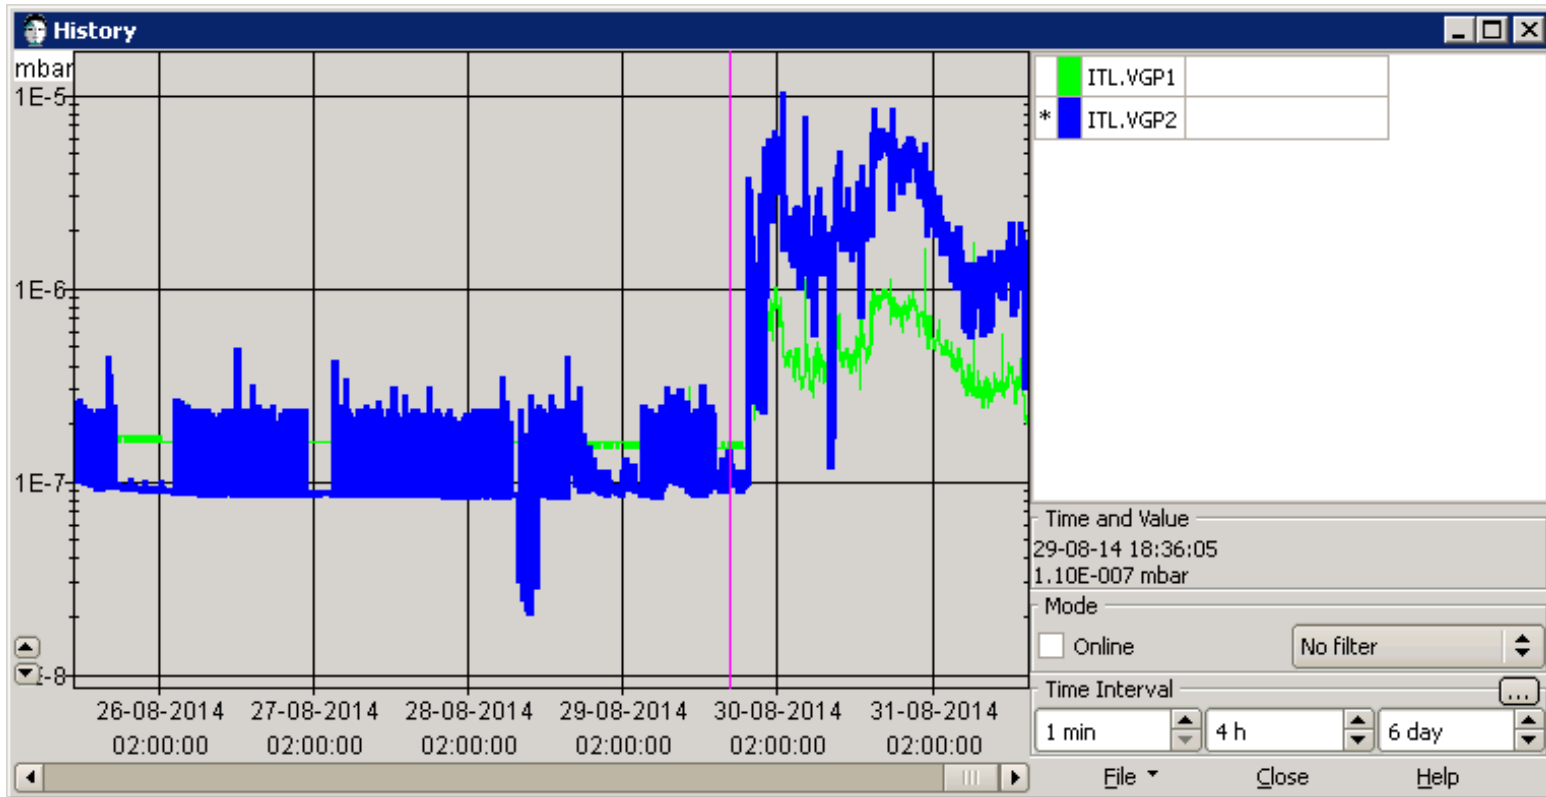
LEBT vacuum Aug 29th (A.Michet)

- New tank installed in July (equipped with slit and FC, no pepper pot detector)
- Pepper Pot detector installed Aug 22nd
- Aug 28th: Few tests with beam from 10 to 12 a.m., then detector @parking
- Aug 29th: @ ~9p.m. abrupt change of LEBT vacuum (see next slide)

Problem traced back to leak along pepper pot plate cooling circuit

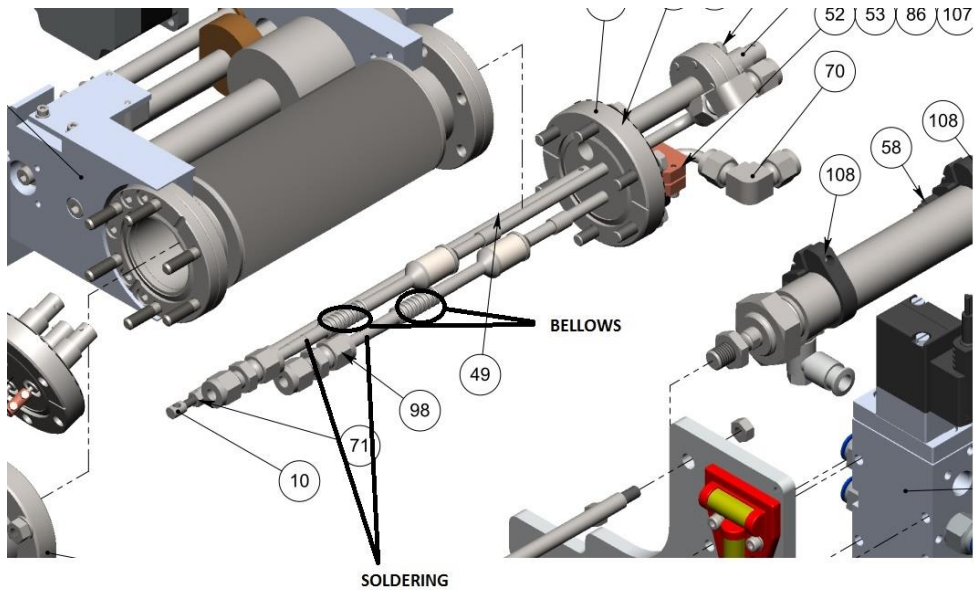
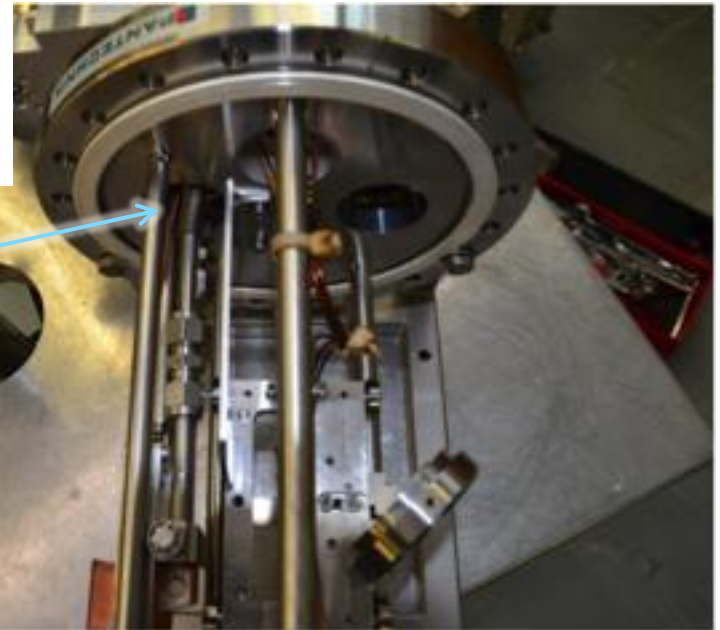
Pepper Pot - Cooling circuit

Bellow
clearly not
straight

- Panttechnik before delivery:
 - leak rate $< 1 \cdot 10^{-9}$ mbars.l.s⁻¹
 - TE-VSC (A.Michet) before installation (meas in the lab, pressurized He):
 - Leak rate $2.3 \cdot 10^{-10}$ mbar.l/s at 4 bars and $3.7 \cdot 10^{-10}$ mbar.l/s at 5 bars
 - TE-VSC (A.Michet) on Sep 1st after LEBT vacuum deterioration
 - Leak rate $\sim 10^{-4}$ mbar.l.s⁻¹ (meas in situ, pressurized He)
 - TE-VSX (A.Michet) on Sep 8th after detector removal from the tank
 - Cooling circuit put under vacuum ($\sim 10^{-8}$)
 - Injection of He around cooling circuit bellow
 - Pressure up to $\sim 10^{-6}$ mbar.l/s
- w/o dismounting cooling circuit is difficult to identify exactly where the leak is

- Detector sent back to Pantechnik for inspection and reparation
 - They have a spare bellow
 - Delivery back to CERN estimated in 2-3 weeks
 - Keep 1 year guarantee valid

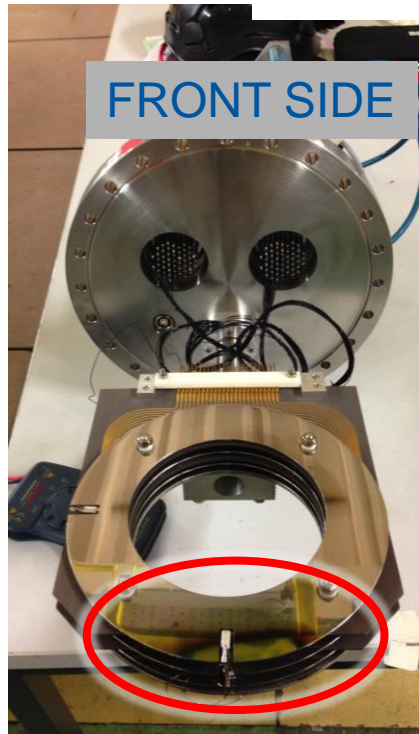
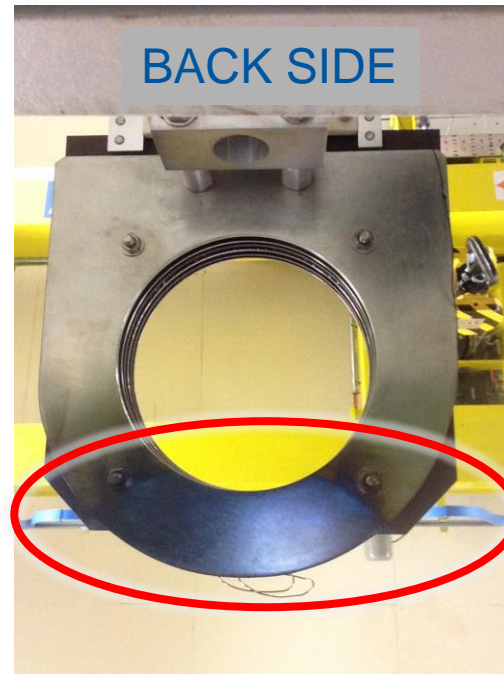
Visual Inspection Sep2014:

Looks like beam trajectory depends on SEM grid IN or OUT

- Grid is clearly sticking into the beam pipe aperture when in the parking position
- Frame and/or bias plates hit by ions and gets charged
 - confirmed by beam-based (quick) tests
 - can improve discharge (now done through HV power supply)
 - Likely requires mechanical design change
 - longer shaft
 - Protecting (dischargeable) plate?
