Mock Data Run 2015

Electron Muon Ranger (EMR)

Single Anode PMT replacement

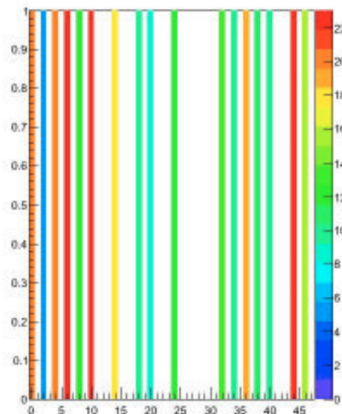
Old SAPMT

plane charge [X planes]

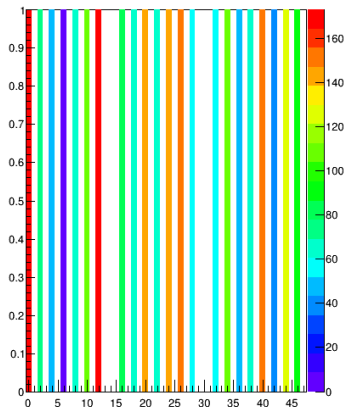
New SAPMT

plane charge [X planes]

- Much higher signals recorded in the new SAPMTs
- No more charge losses as we had before (no signal in some planes)
